# Unit 3 Primary Containment Vessel Internal Investigation

November 30, 2017

# 1. Overview of the PCV internal investigation

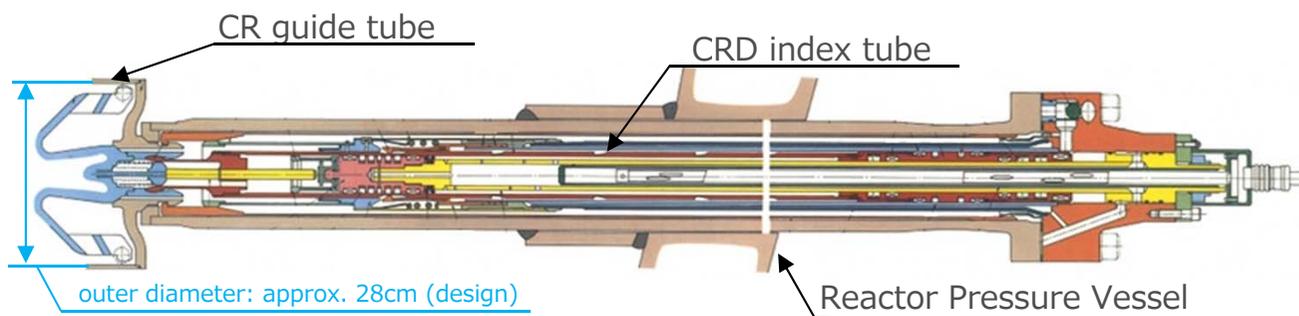
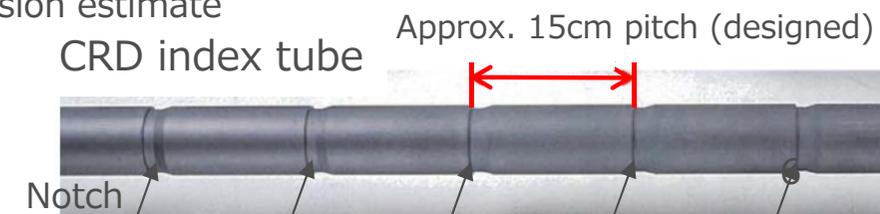
- There is the rod-shaped structure inside the cylindrical structure.
- There are notches at uniform intervals in the rod-shaped structure.

⇒ The CR was fully inserted and the CR index tube was stored in CRD guide tube at the time of the accident, so it is assumed that the cylindrical structure is CR guide tube and the rod-shaped structure is CRD index tube.

- The outer diameter of the cylindrical structure** is estimated to be **approx. 28cm** based on the photos since the interval between the notches on CRD index tube is approx. 15cm. **This estimate is almost the same as the design dimensions for the outer diameter of the CR guide tube (also approx. 28cm).**

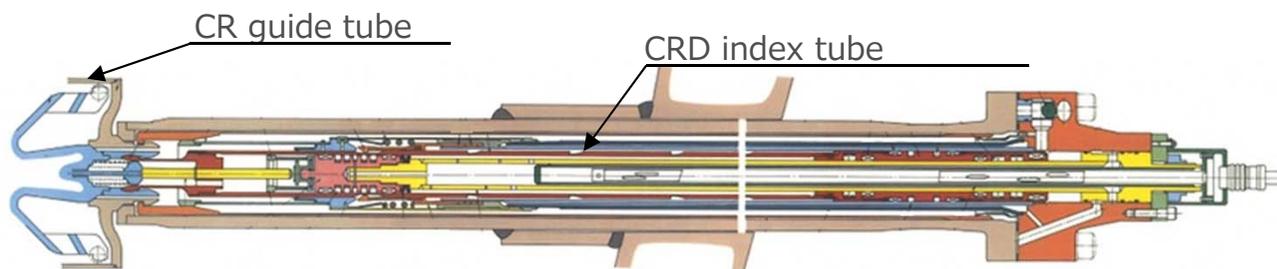
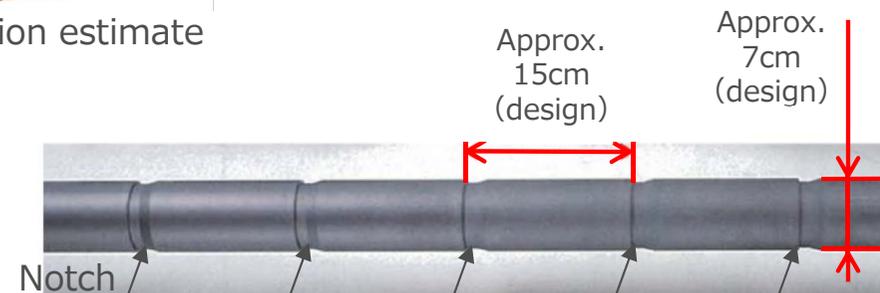
CRD index tube

□ Each interval between the notches was estimated at approx. 15cm from photos 1 and 2 by referencing the design values for the outer diameter of the CRD index tube, which is approx. 7cm. **All estimated values are almost the same as the design dimensions (approx. 15cm).** Therefore, this structure is assumed to be the CRD index tube.

Image	Notch	Estimated interval between notches
1	1~2	Approx. 15cm
2	1~2	Approx. 15cm
	2~3	Approx. 15cm
	3~4	Approx. 15cm

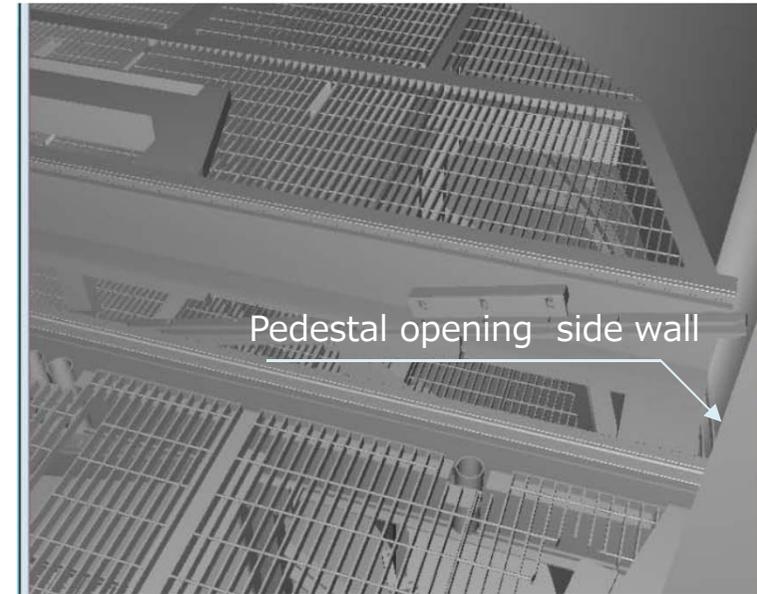
CAD image at the same angle as the photo on the left

- Grating for the platform was not found.
- Pieces of the platform were found (the platform has fallen).

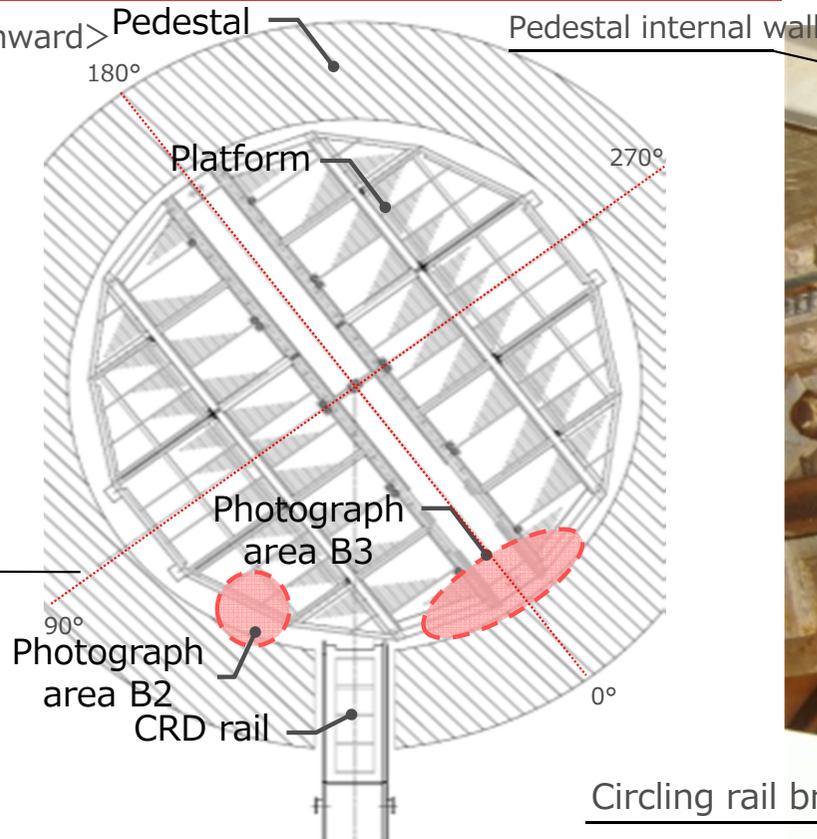
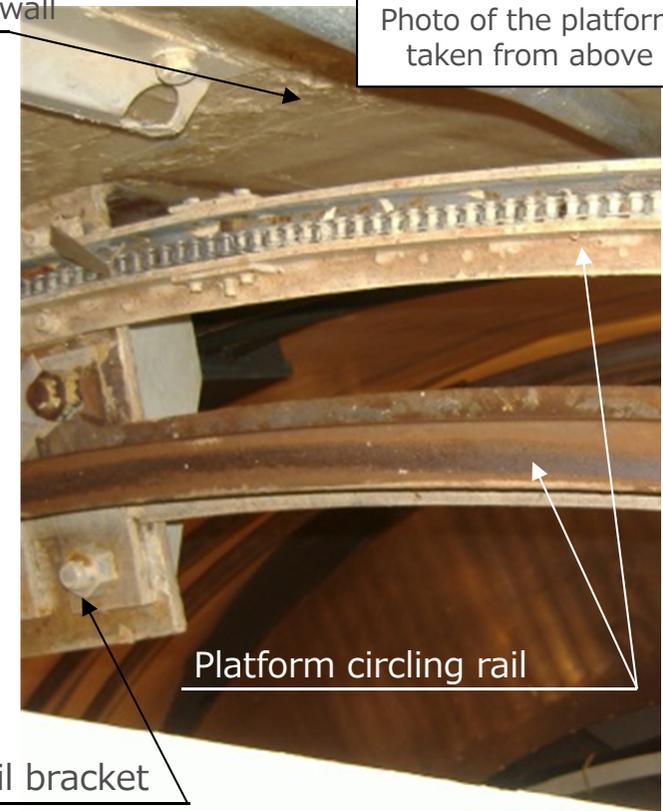
Photo of the platform taken from above

- Platform circling rail and circling rail bracket remain.
- Deposit found on the circling rail bracket.

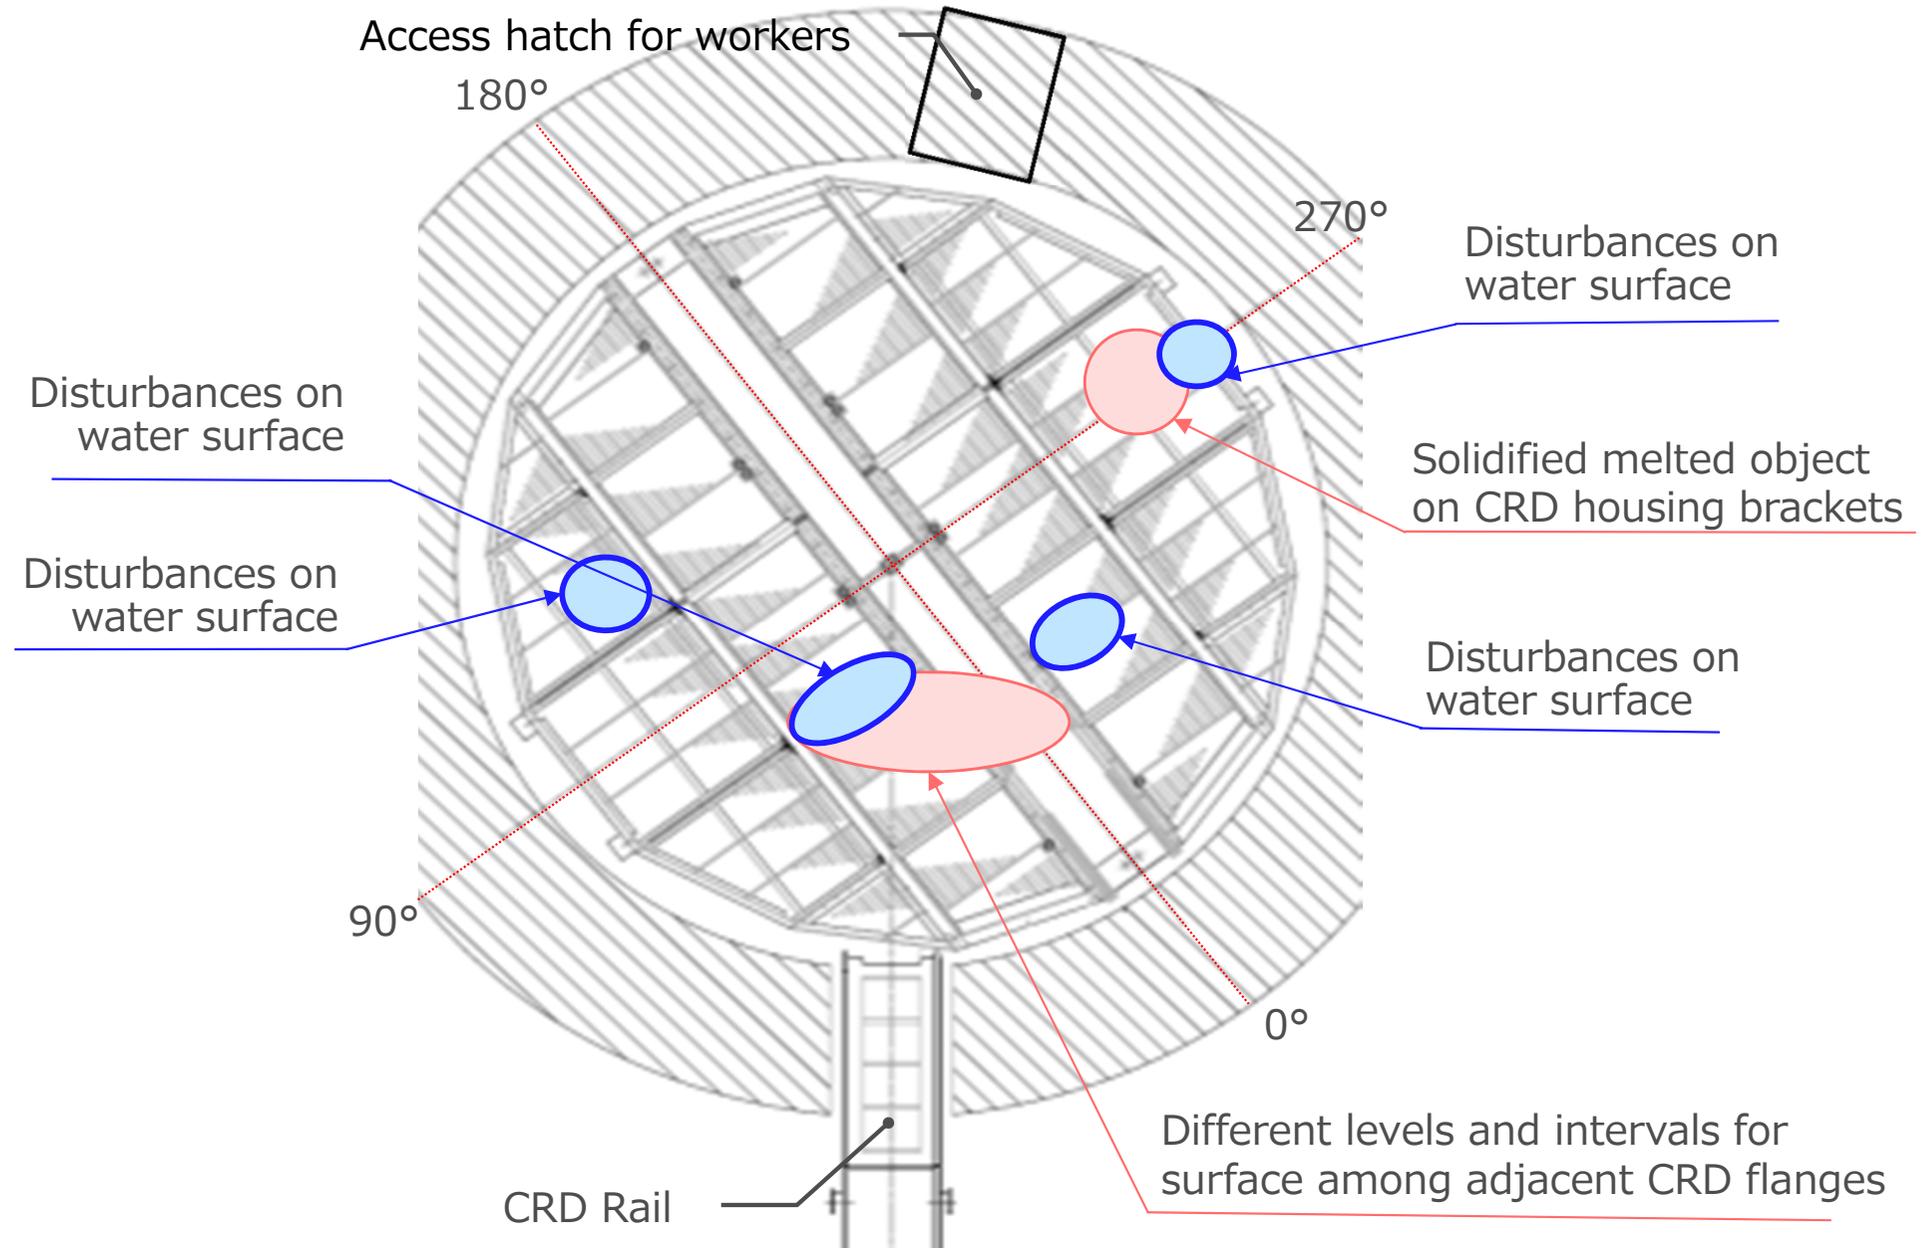
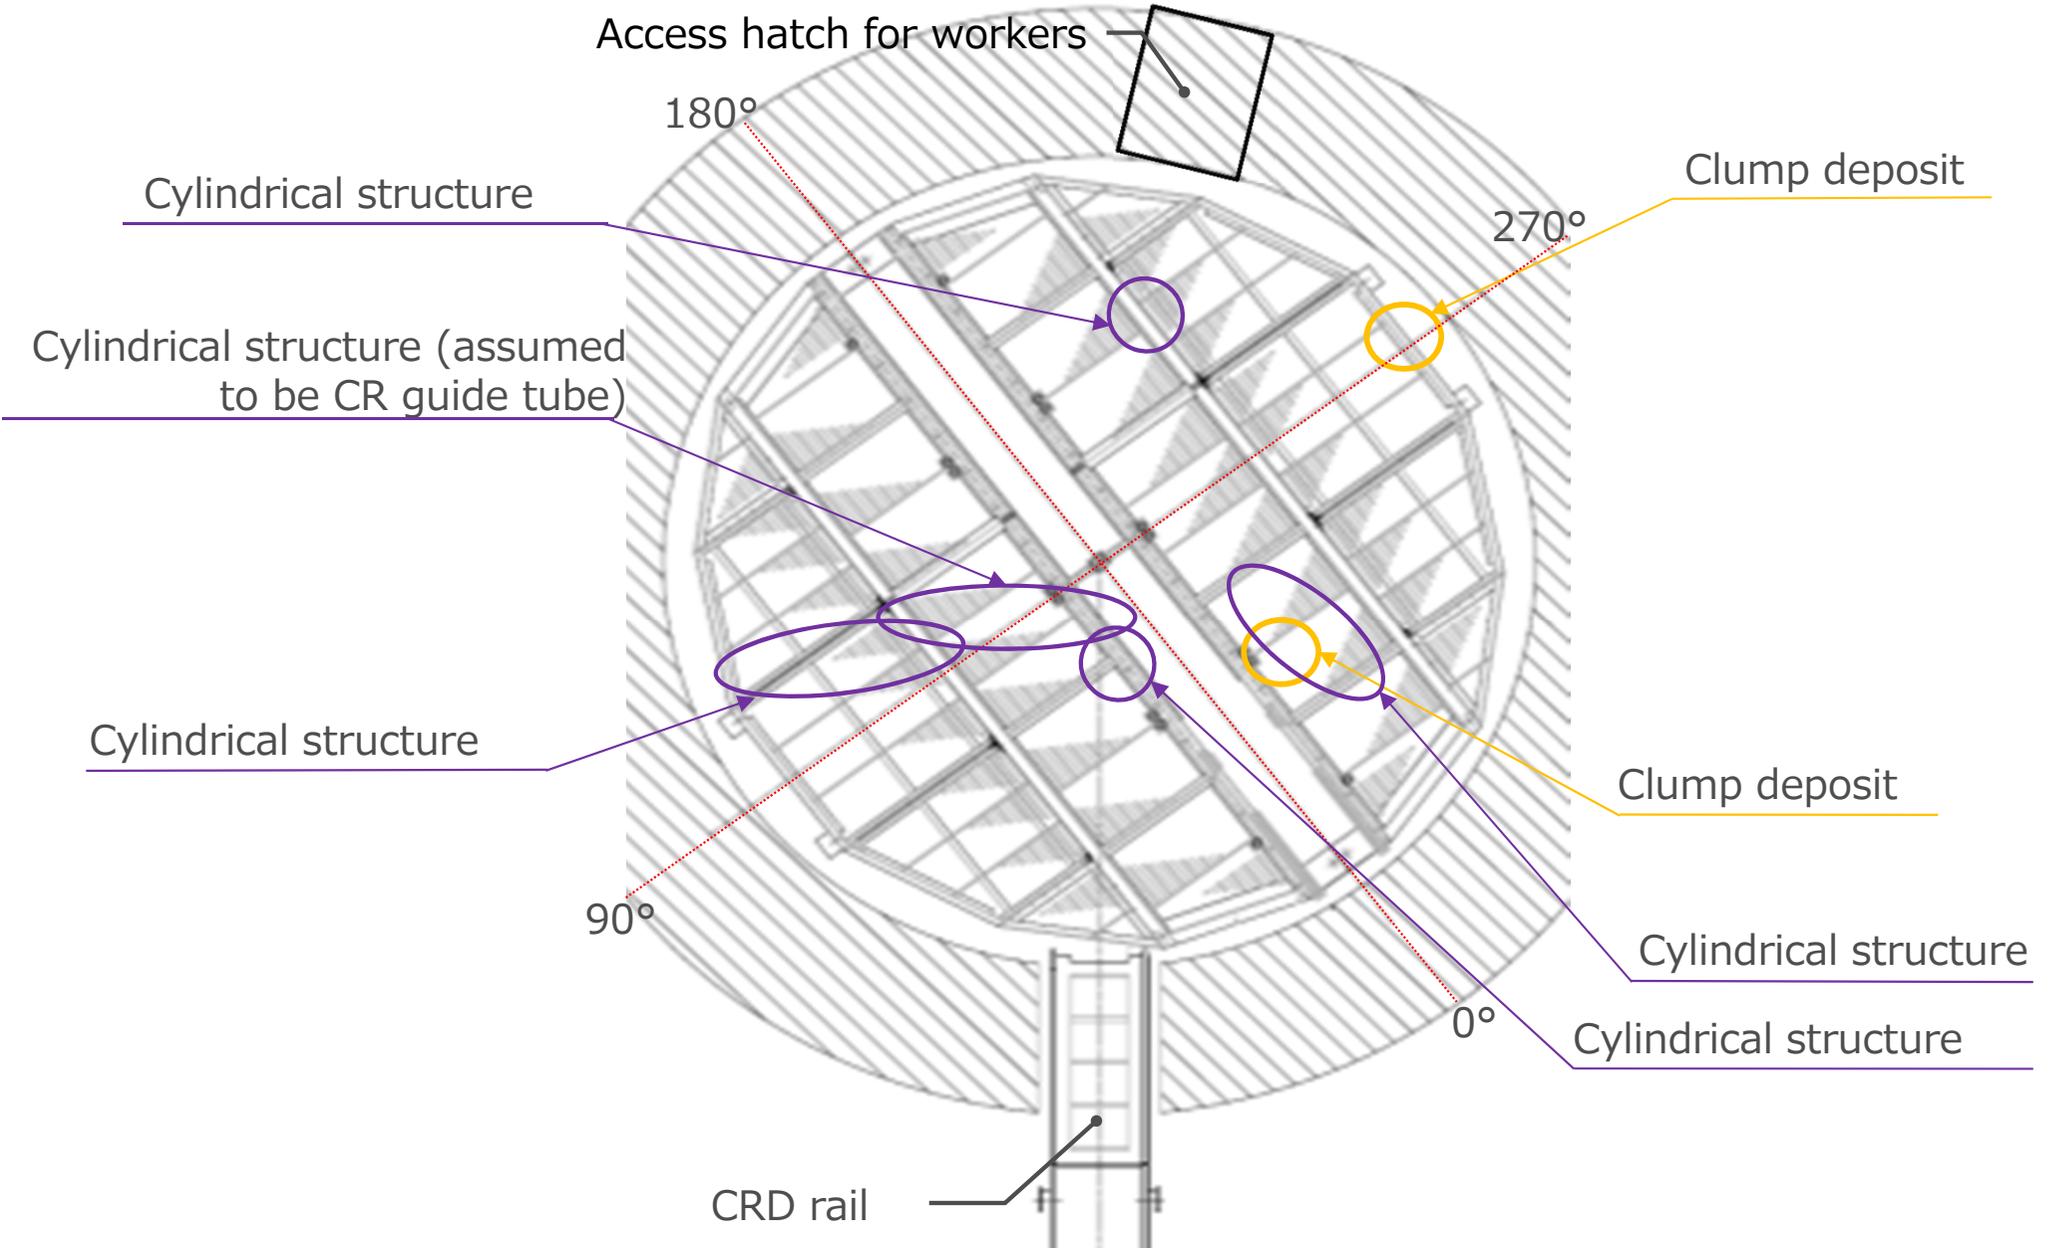
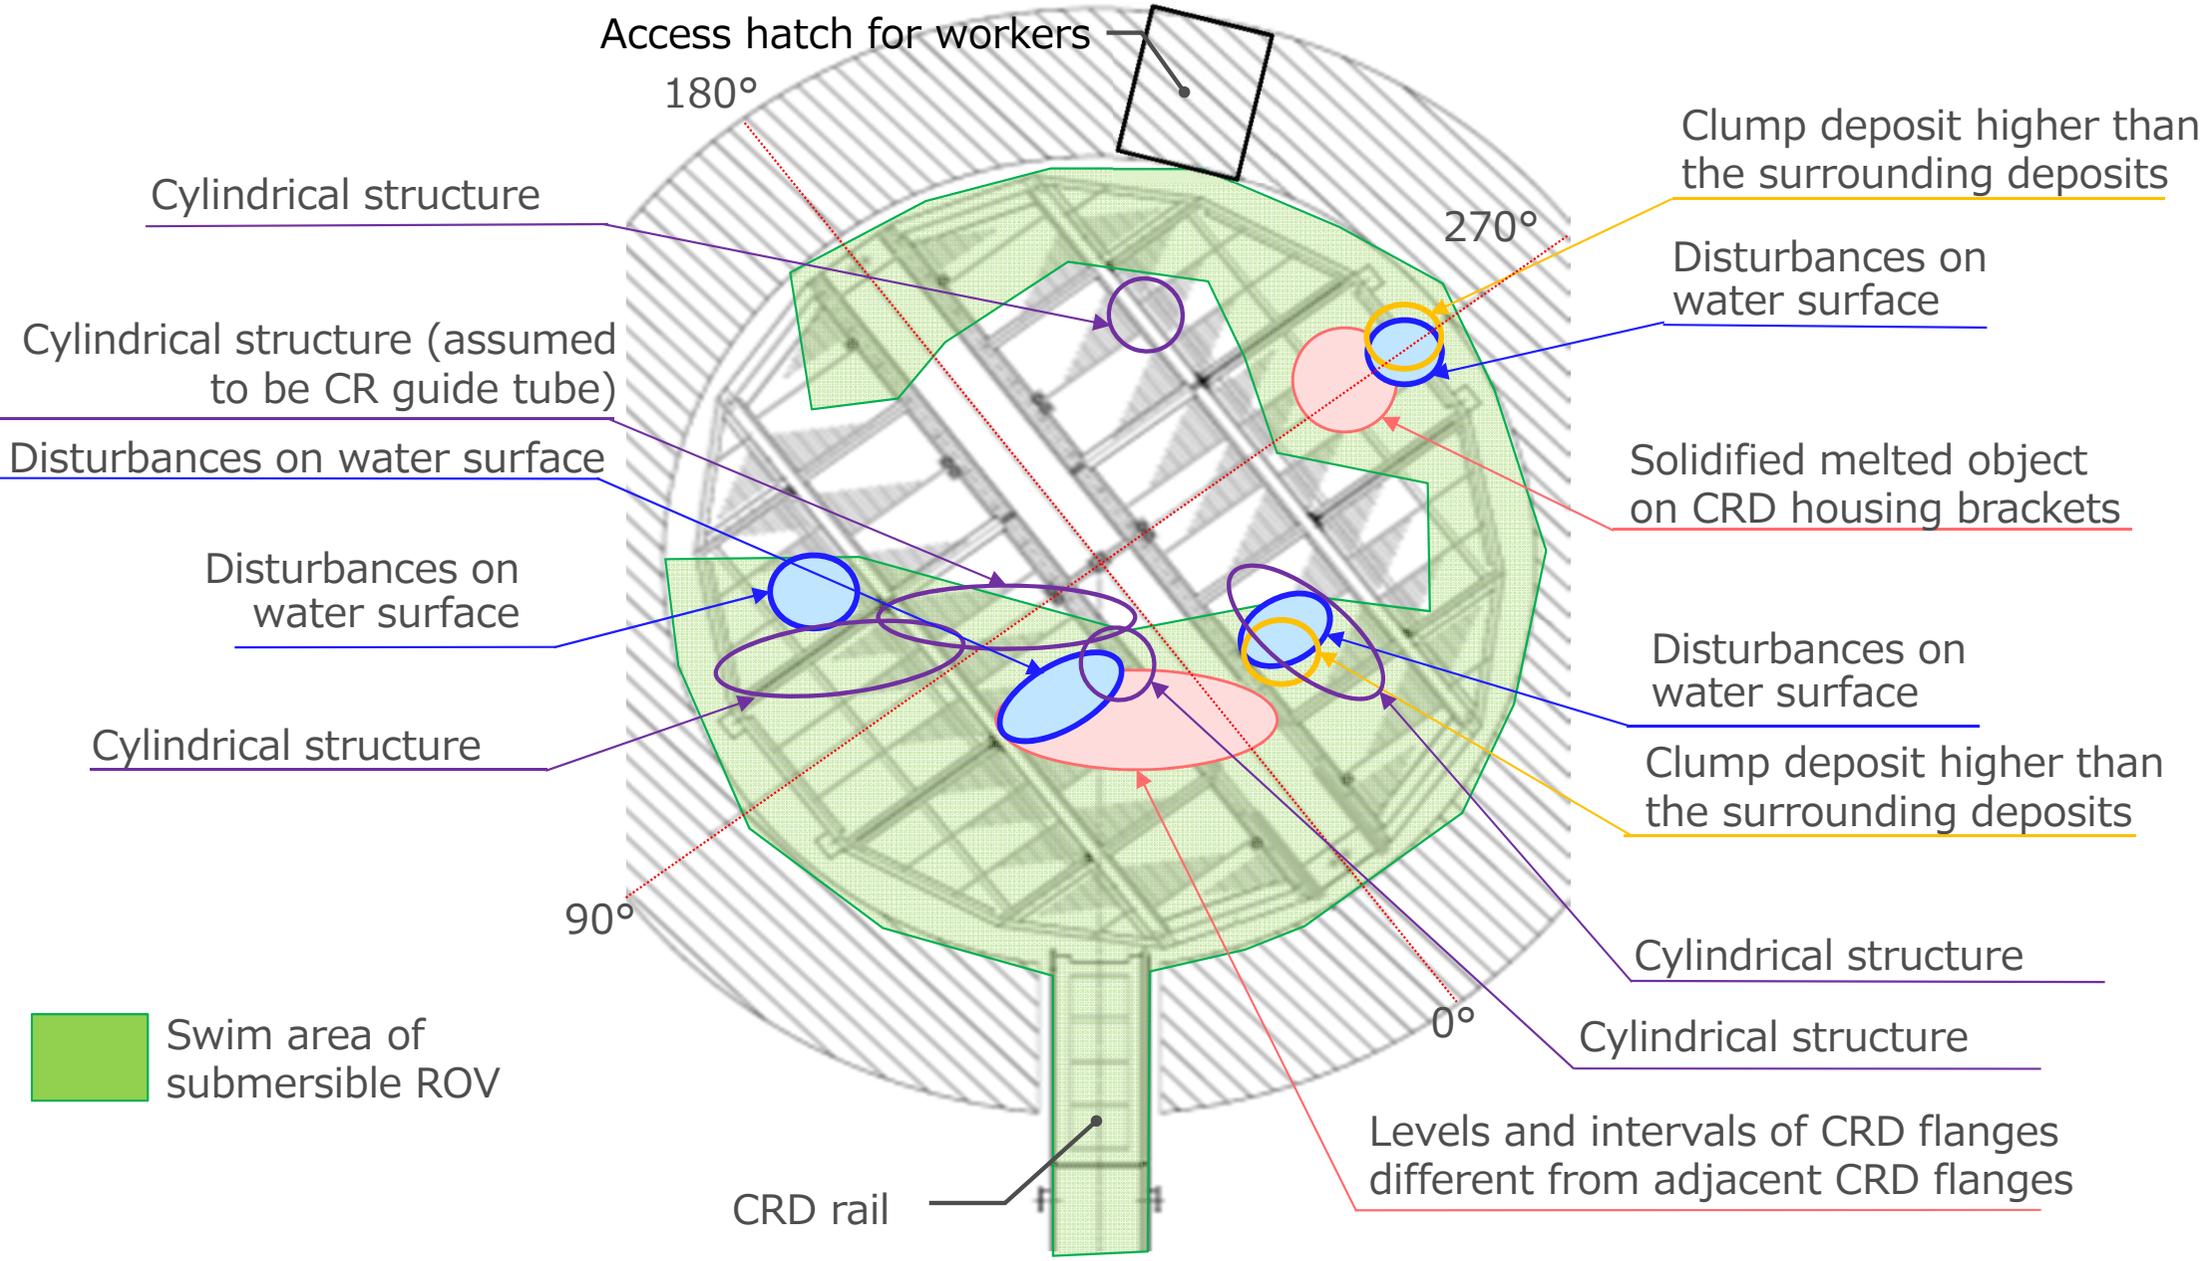
# Supplement 3. Estimated position of disturbances on the water surface and structures

- Disturbances on the water surface at ①~④ suggest the possibility that there is damage on the periphery of the RPV as well as at the center of the bottom of the RPV.

- Multiple damaged structures and solidified melted objects were found attached to the CRD flange etc. and deposits resembling sand, pebbles and clumps were found at multiple locations inside the pedestal.
- Structures assumed to be reactor internals (CR guide tube and CRD index tube) were found. Other structures were seen but could not be identified. (Refer to References 1-1 to 1-4)
- Disturbances on the water surface were seen on the periphery as well as at the center of the RPV suggesting the possibility that there might be holes at both the center and surrounding areas of the RPV.
- Access hatches for workers on the lower floors of the pedestal basement were not visible but deposits were found nearby. (The possibility that fuel debris leaked outside of the pedestal cannot be denied.)
