Survey result of damages to air-conditioning ducts etc. in the Reactor Building, Unit 4, Fukushima Daiichi Nuclear Power Station

The status of the 5th floor, R/B, Unit 4

The status of the 4th floor, R/B, Unit 4

The status of the 3rd floor, R/B, Unit 4

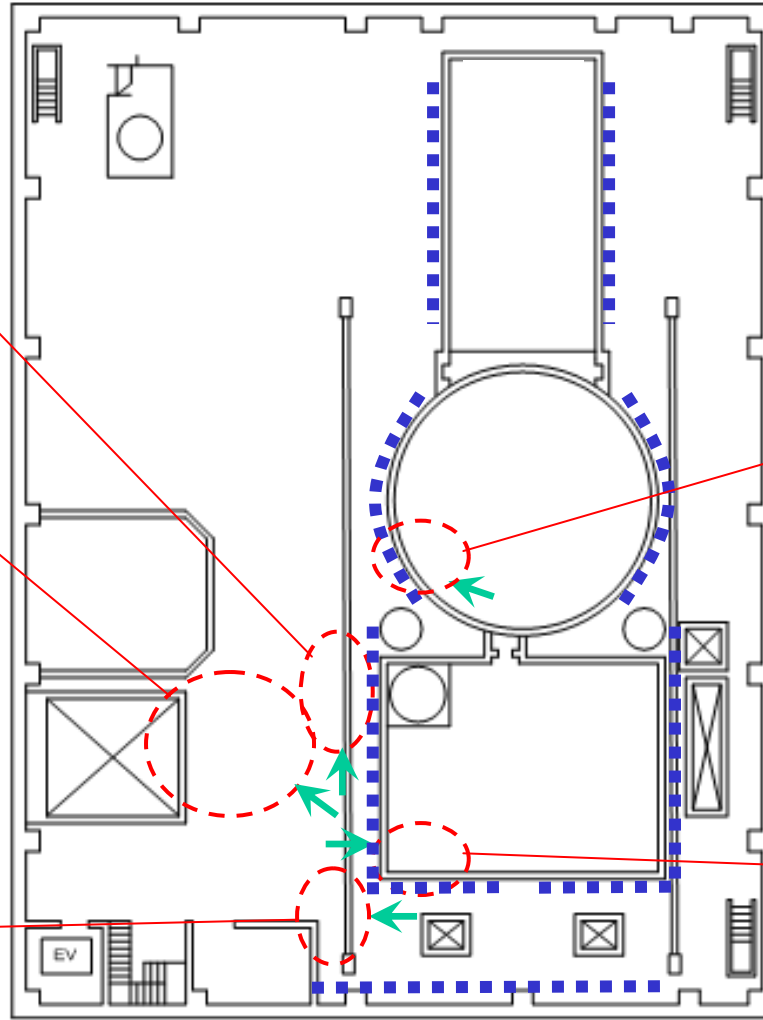
- It was likely that the explosion at Unit 4 occurred mainly on the fourth floor of the Reactor Building because (i) the floor on the fifth floor was pushed up and the floor on the fourth floor was pushed down and (ii) wire meshes attached to inlets of the air-conditioning on the fifth floor were bent to the reverse direction of the normal air flow.
- On the fourth floor of the Reactor Building, as there were no air-conditioning ducts at the original place of installation and instead, numerous rubbles presumably from air-conditioning ducts were scattered, it was possible that the explosion occurred around the air-conditioning ducts.

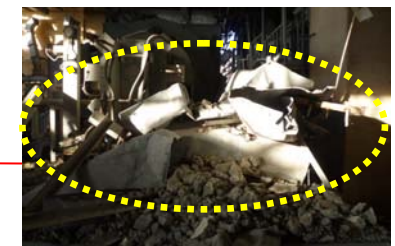
⑩ Rubbles from air-conditioning ducts
