Tokyo Electric Power Company

Result of Investigation on Unit 1 Operating Floor at Fukushima Daiichi Nuclear Power Station

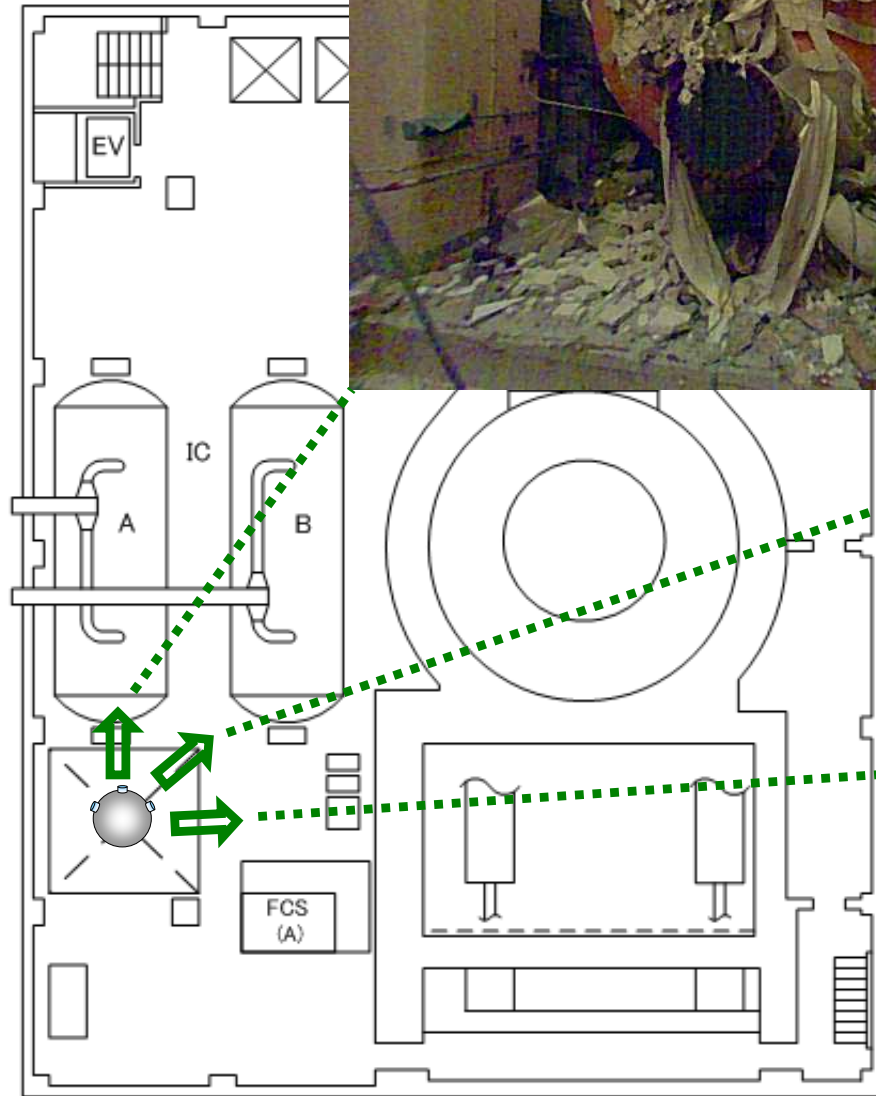
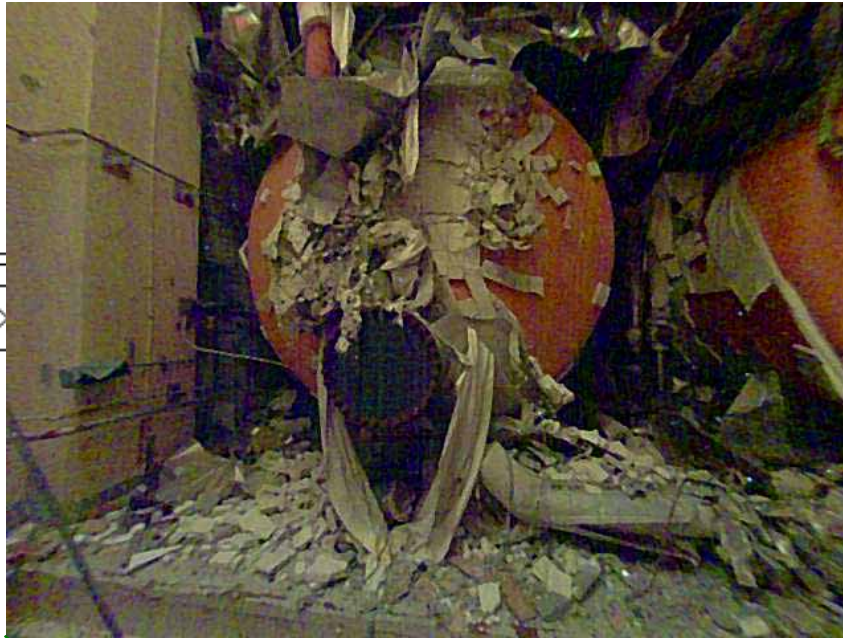
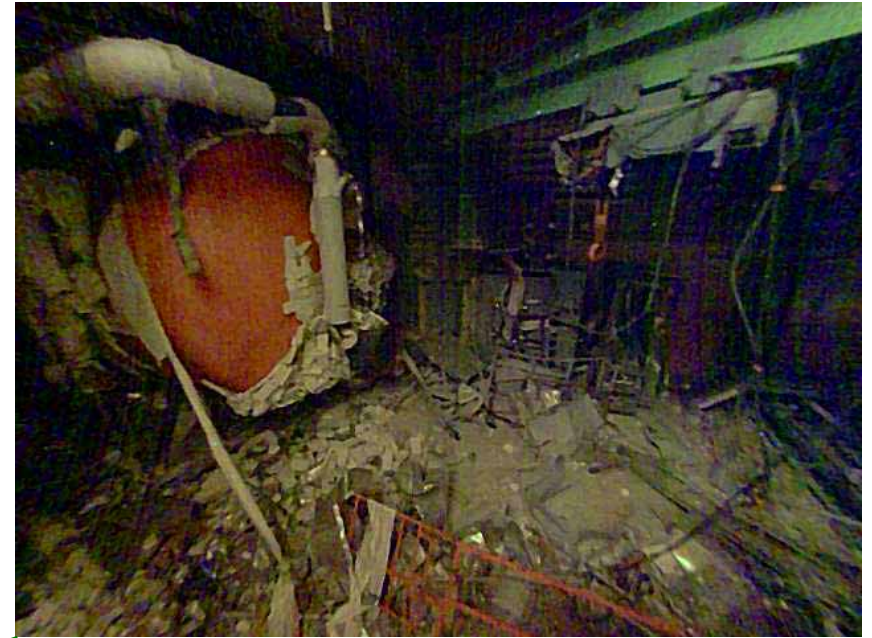
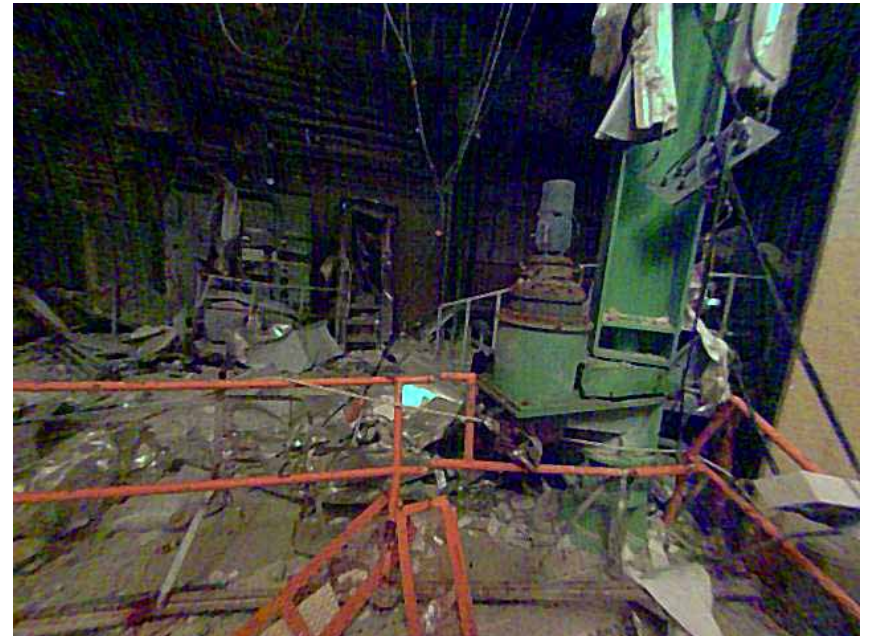
4. Investigation Result (4th floor of the Reactor Building)

The balloon was unable to reach the operation floor as it interfered with an obstacle which is assumed to be a cable.
