Water Leakage from Unit 6 Purification Equipment Pipe at Fukushima Daiichi Nuclear Power Station

Date and Time: October 4, 2012 at around 4:30 PM

Location: F tank area in the north of Unit 5-6

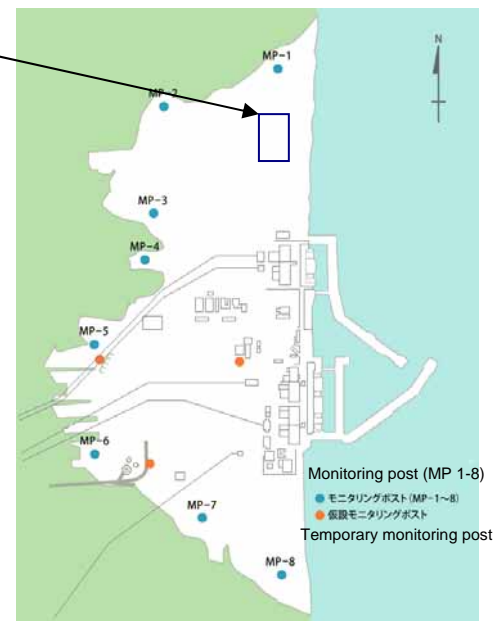
2. It was confirmed that the leakage stopped at around 4:35 PM after the pump was stopped.
3. Upon investigation, the leakage location was identified to be the hole on the joint of the pipe where the water treated in the chelate resin/zeolite absorption tower goes through.

- Hole size: Approx. 3mm x 1mm
 - Leaked water: Treated water which came from the radioactive material removal equipment (Approx. 12L)
 - Nuclide analysis results of the leaked water
I-131: Below the detection limit (1.6×10^{-2} Bq/cm³), Cs-134 : 1.5×10^{-1} (Bq/cm³),
Cs-137 : 2.4×10^{-1} (Bq/cm³)

Location of water leakage
