An Issue Found with the Minimum Flow Rate Bypass Valve of Unit 5 Reactor Core Spray System (B) at Fukushima Daiichi Nuclear Power Station

Date and Time: October 10, 2012 at around 10:37 AM

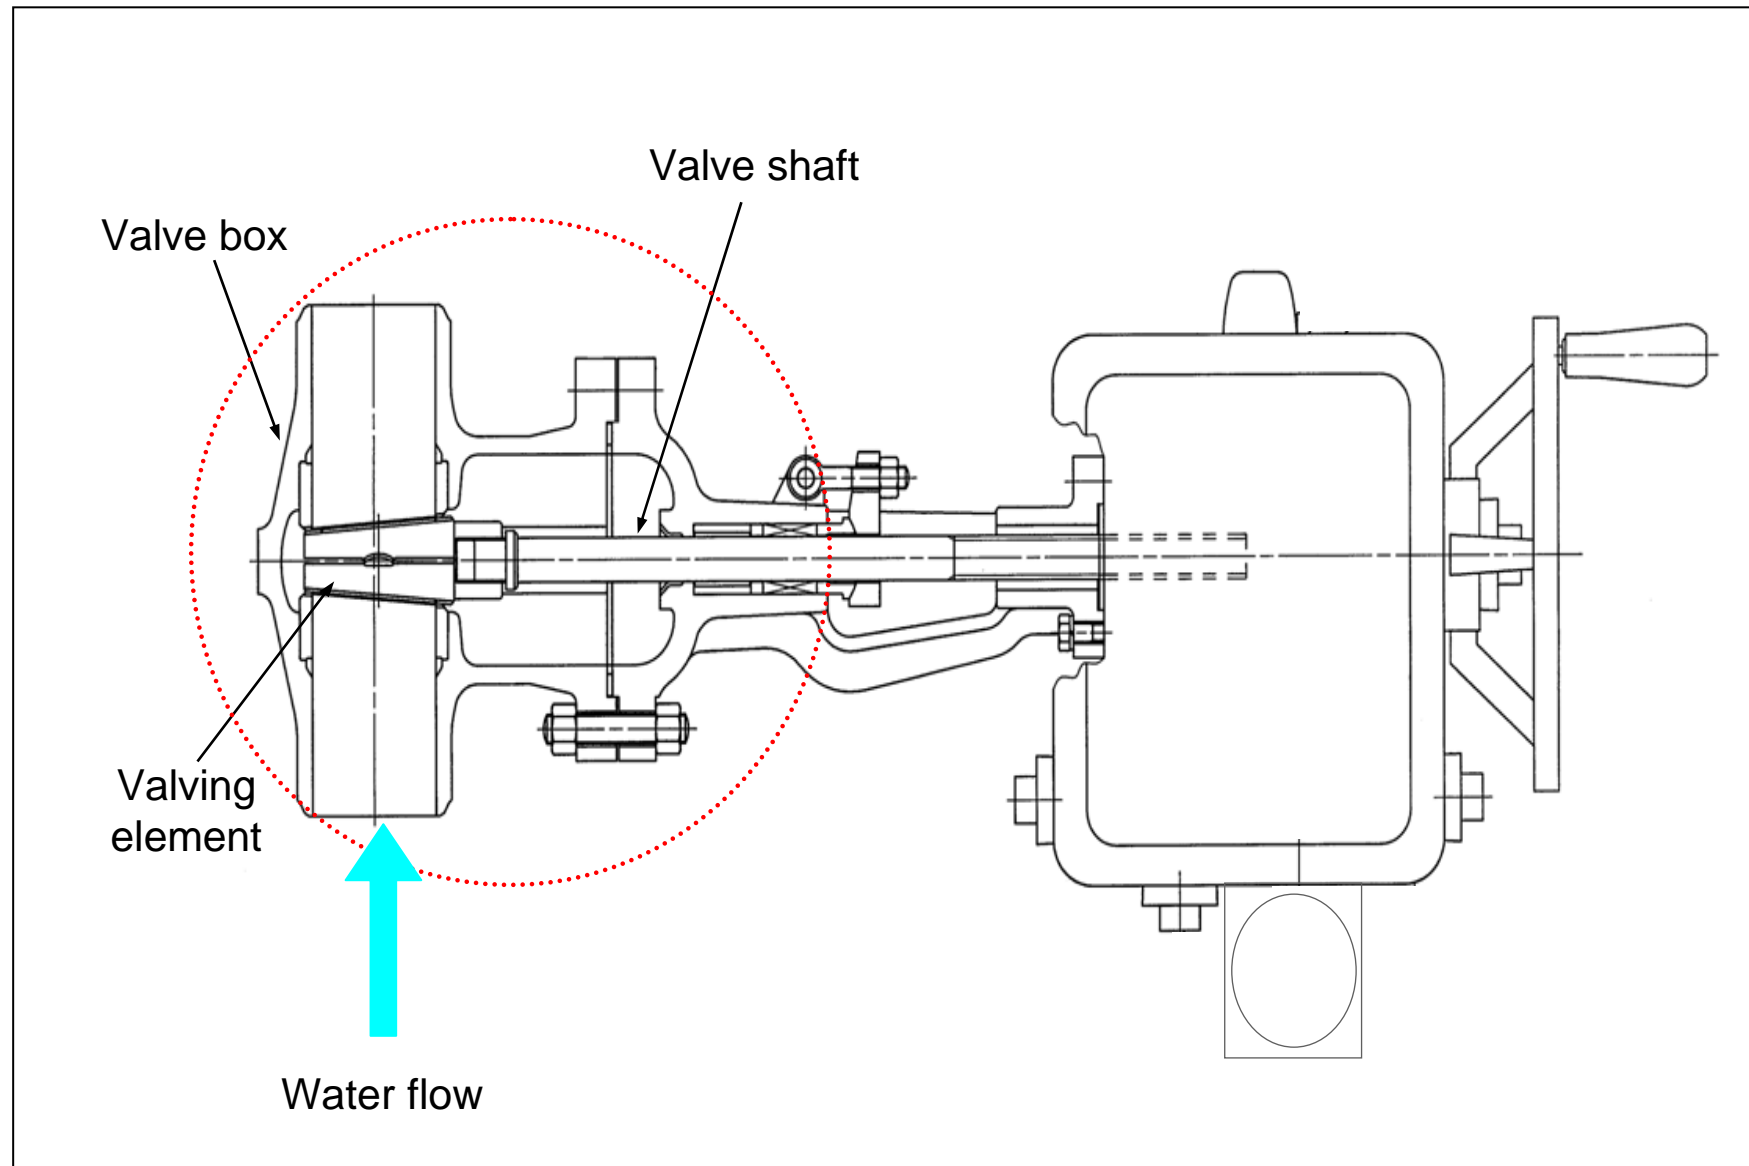
Structure of the Minimum Flow Rate Bypass Valve

One of the two valving elements (on the inlet side) of the minimum flow rate bypass valve was found to be removed.
