# Current Situation of Fukushima-Daiichi Nuclear Power Plants and Difficulties in the Defueling Plan

International Experts' Symposium on the Decommissioning of TEPCO's Fukushima Daiichi Nuclear Power Plant Unit 1-4

March 14, 2012 Tokyo, Japan

**Tokyo Electric Power Company**

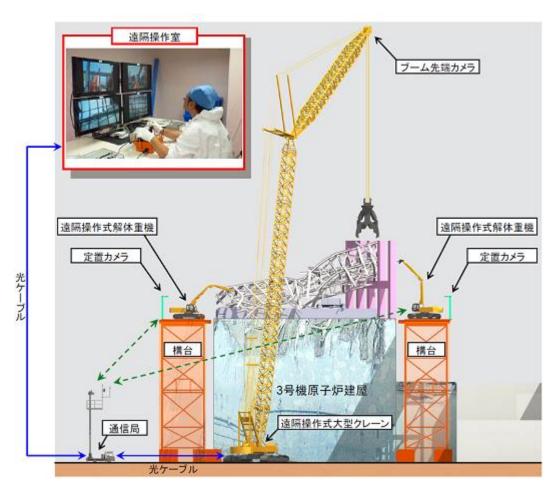
#### **Debris Removal by Remote Operation**

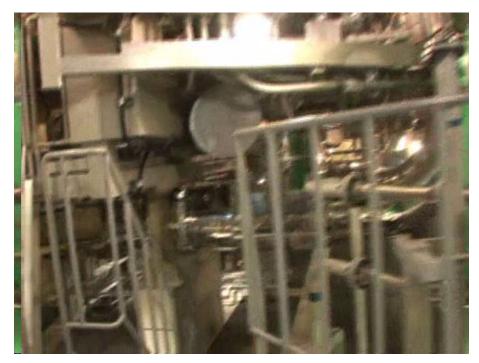
Kashiwazaki-Kariwa, Unit 4 (BWR-5, 1100MW)

- PCV inside is crowded with a lot of facilities and pipe-lines packed in.
- The floor is not flat but has many steps.
- Units 1-4 of Fukushima Daiichi are BWR-4 plants and the space is significantly smaller than this movie
