Reinforcement to prevent scattering liquid containing radioactive materials

Results of survey on trenches and pits there is a risk of outflow from

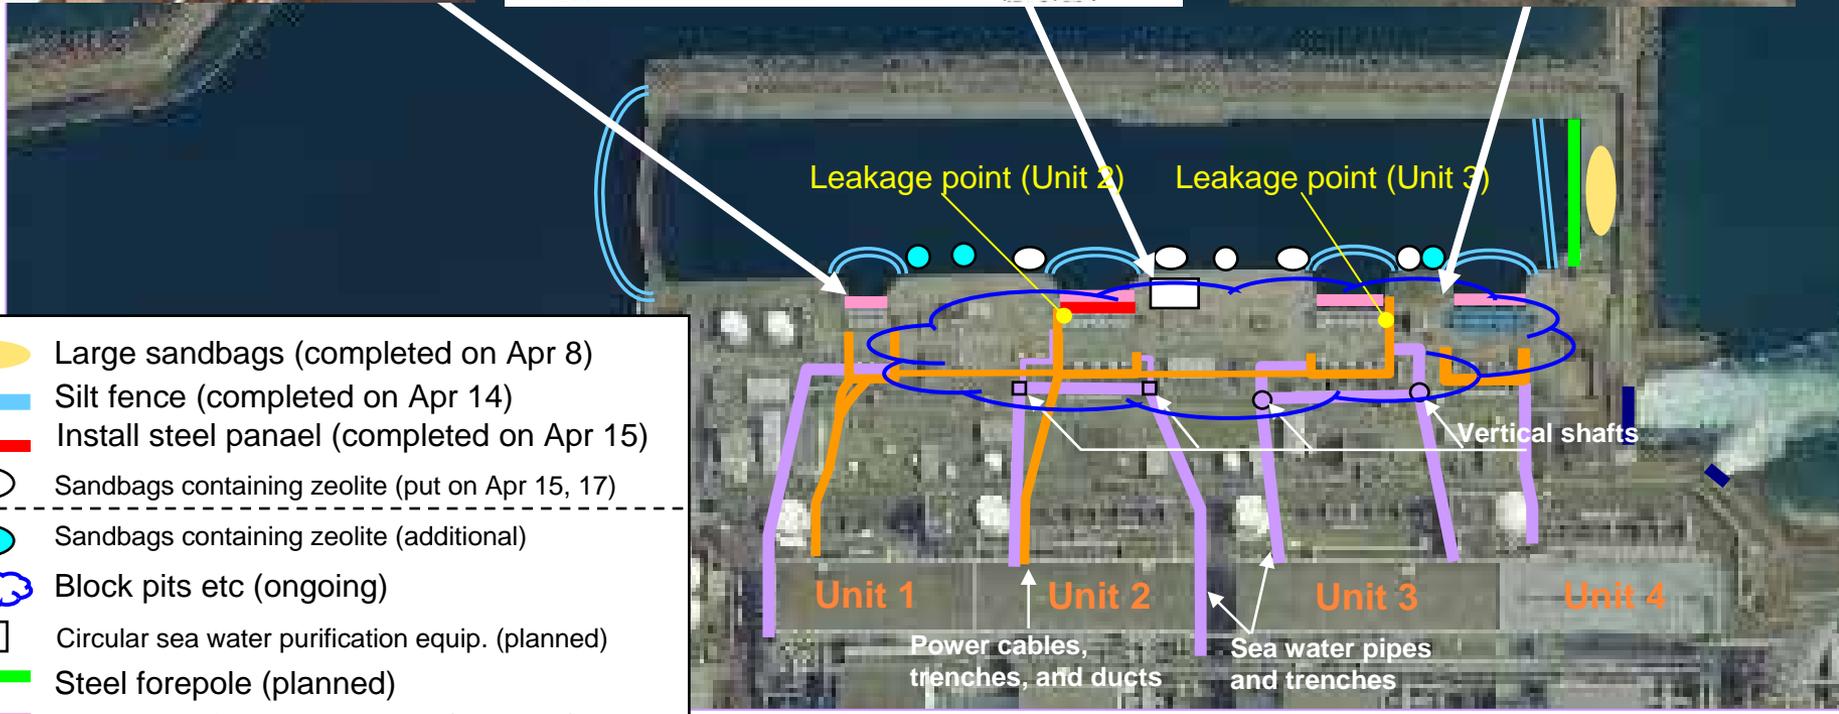
Large sandbags (completed on Apr 8)
-

Silt fence (completed on Apr 14)
-

Install steel panel (completed on Apr 15)
-

Sandbags containing zeolite (put on Apr 15, 17)
-

Sandbags containing zeolite (additional)
-

Block pits etc (ongoing)
-

Circular sea water purification equip. (planned)
-

Steel forepole (planned)
-

Waterstop for screen room (planned)
-

Waterstop for discharge (planned)
