Plan to prevent water leakage containing highly concentrated radioactive materials to
outside environment in Fukushima Daiichi nuclear power plant

June 1, 2011

Tokyo Electric Power Company

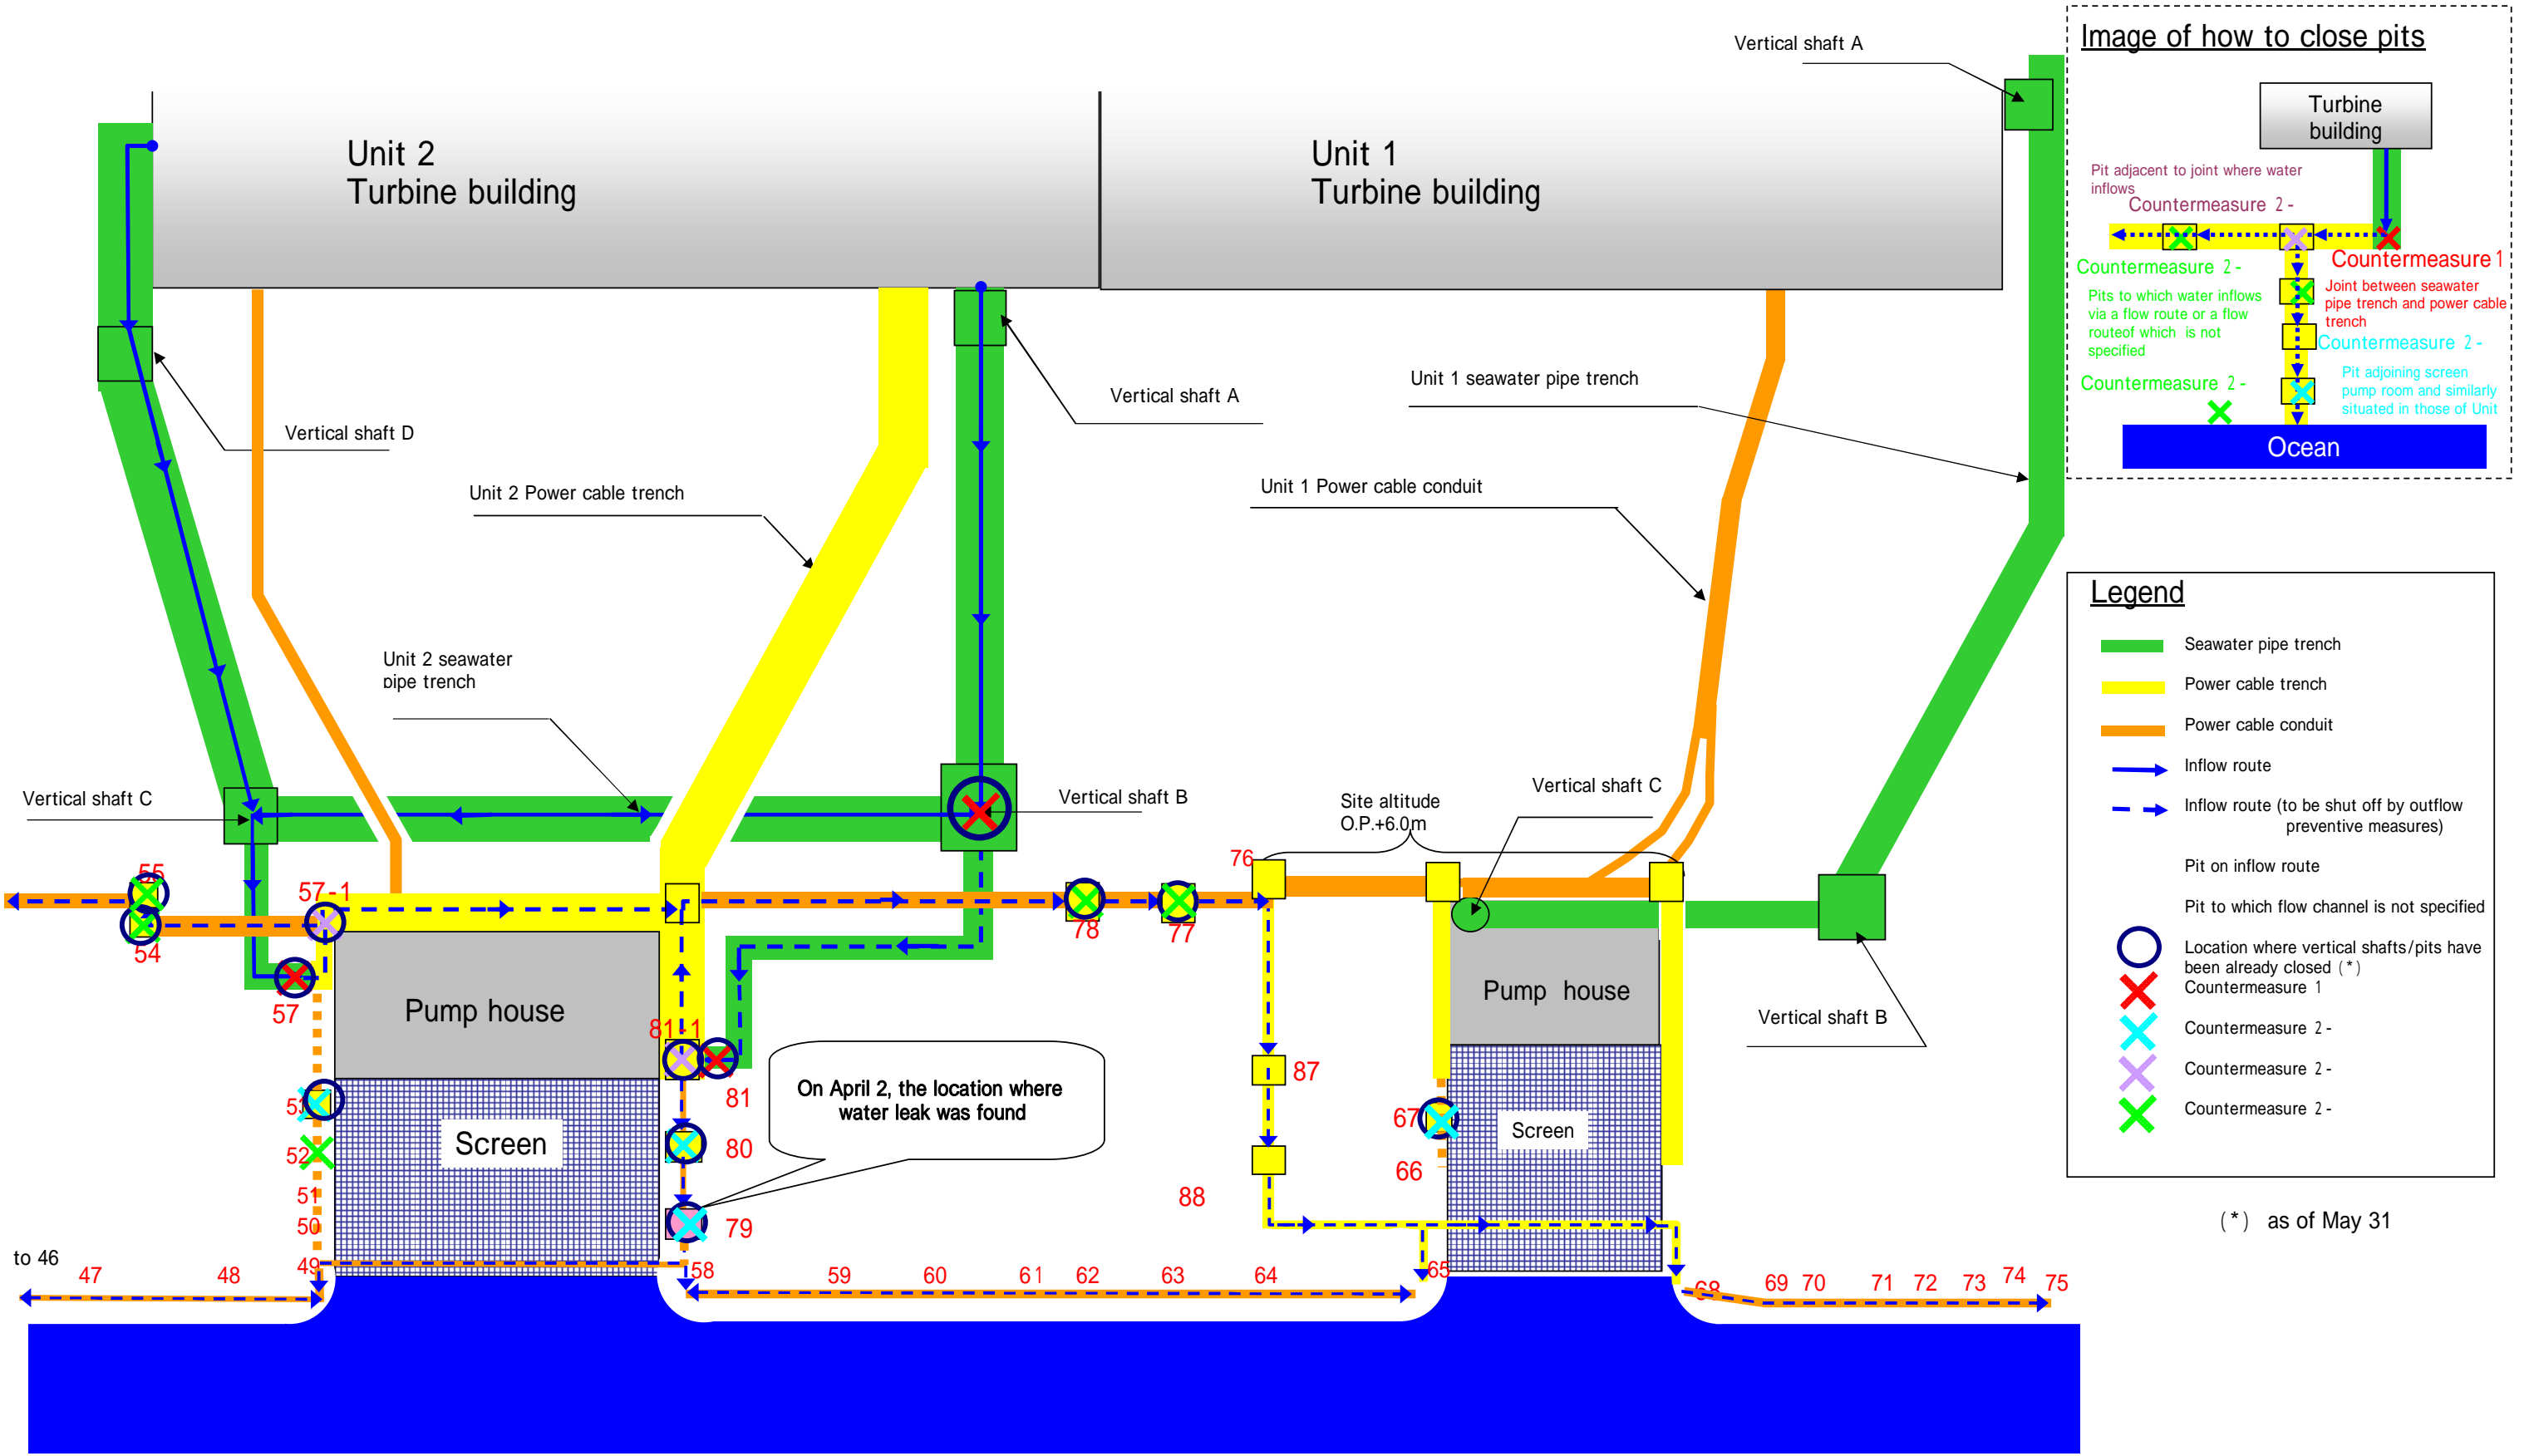
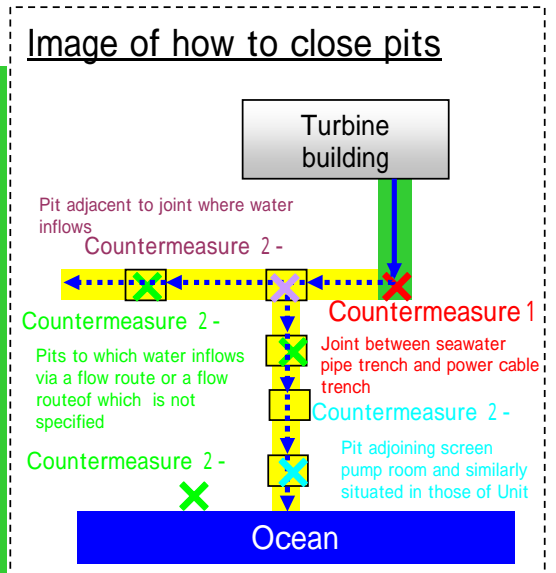
Map of plans to closing vertical shafts and pits (Unit 1 and 2)

The leakage route is shut by closing multiple pits located on the leakage route at the height of O.P. + 4.0 m. The followings were taken into consideration when selecting the pits to be closed.

Measure 2-2: Closing of the pits near the pits treated in measure 1. This is to make sure the shutting of leakage route. There are 8 parts in total.

Measure 2-3: Closing of the pits located on the extended path of leakage route and the pits whose route is unknown and possibility of leakage can not be denied. This is to make sure there will be no leakage. There are 17 parts in total.

Based on above, 35 parts in total will be closed by concrete, etc, once the debris is removed and other preparation is completed (appendix 15: Map of plans to closing vertical shafts and pits, appendix 16: Outline of closing pits) In the leakage case of Unit 2, chemicals were injected into rock bed with high water permeability located beneath the power cable conduit in order to prevent water leakage. While closely surveying the damage status of pits and grounds, such measure will be taken as necessary after closing the pits.

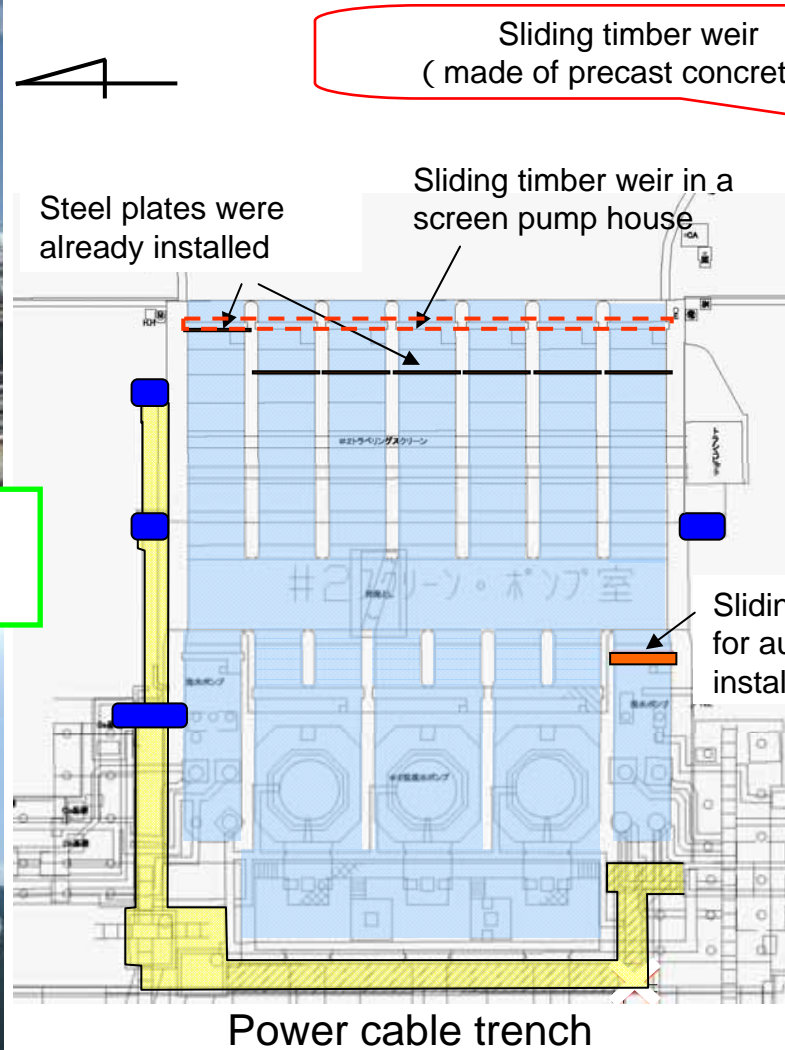
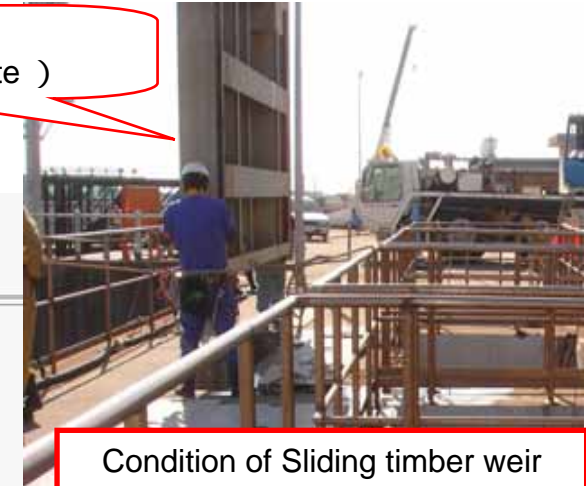
Sliding timber weir in seawater pump house for auxiliary equipment cooling was already installed (Unit 2) (Completed by May 24)

A steel plate was installed in front of screen pump room on April 15 in order to prevent dispersion of leaked water. A sliding timber weir was installed in front of the emergency equipment cooling seawater pump room on May 26.

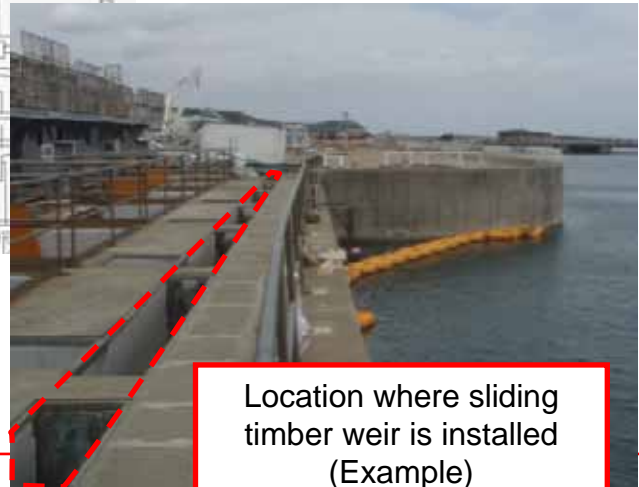
Location where sliding timber weir is installed (Example)

Condition of Sliding timber weir installment (to be planned in Units 1 to 4)
