Fukushima Nuclear Accident Analysis Report (Interim Report)

December 02, 2011
The Tokyo Electric Power Company, Inc.

This report identifies causes of the accident at the Fukushima Daiichi Nuclear Power Station (hereinafter referred to as “Fukushima accident”) based on the facts and analysis results that have been verified to date and proposes necessary countermeasures to enhance the safety of existing nuclear power plants.

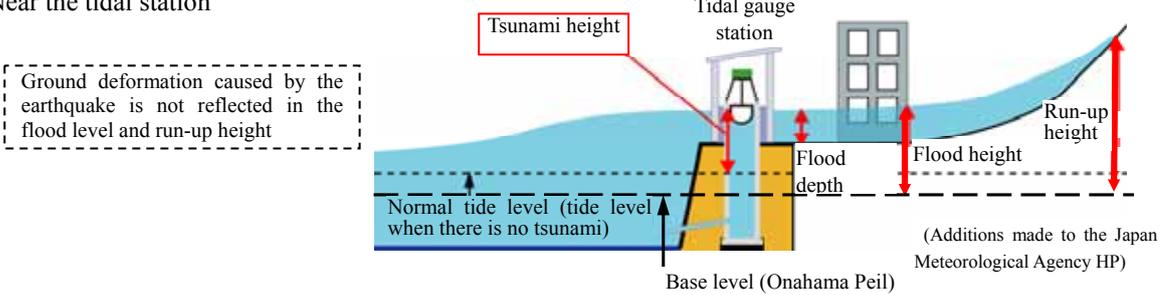
*1: There were indications that the flood height reached levels of approx. O.P. +16 to 17m in some southwest areas (approximately 6 to 7m in flood depth)

*2: Near the tidal station

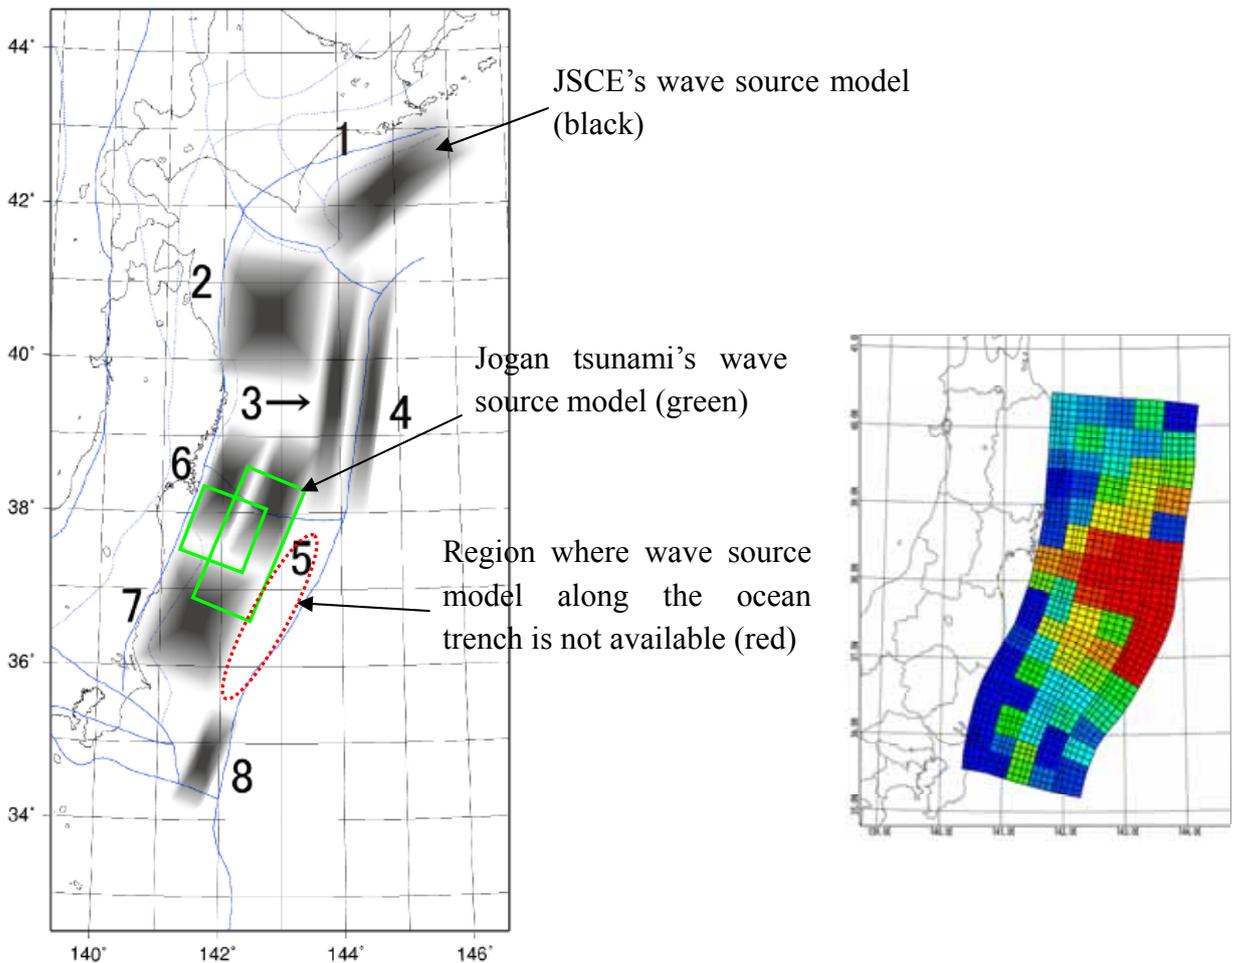
➤ It has been found that the earthquake on March 11 is considered neither as the earthquake of the opinion of the HERP nor as one of the Jogan earthquakes proposed by Dr. Satake. Rather, it was a huge earthquake, the focal area of which covered a much broader area.

JSCE's wave source and Jogan tsunami's wave source (Jogan tsunami's wave source was evaluated based on Satake et al., 2008)

Wave source of the tsunami on March 11 (Evaluated by TEPCO)

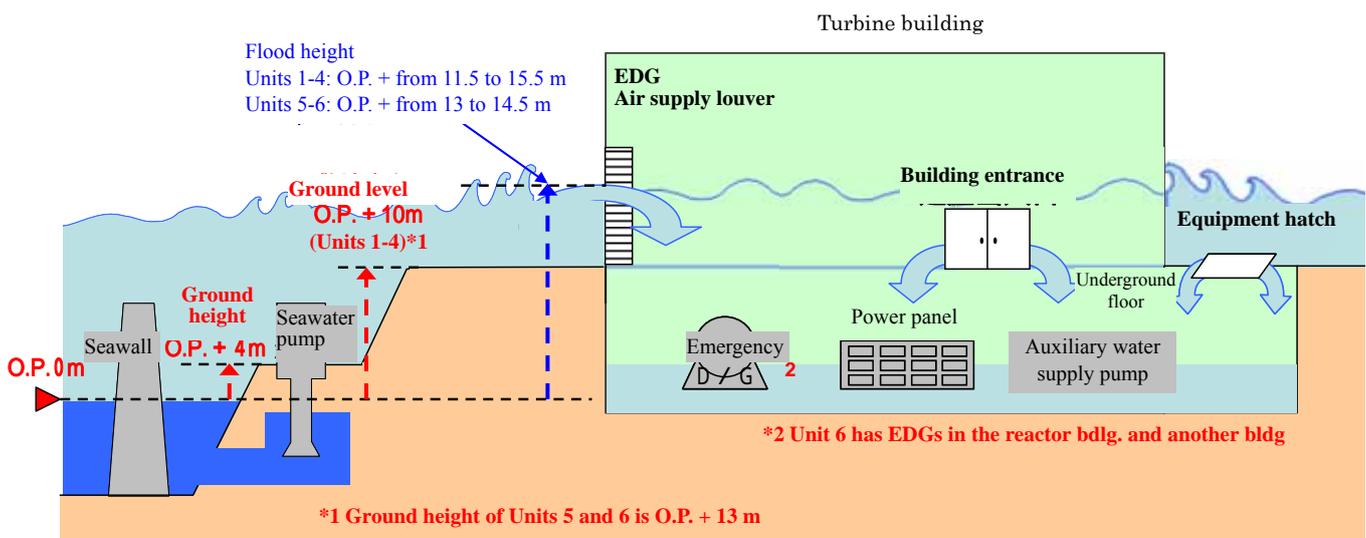
Regarding major buildings, no significant damage by the tsunami has been confirmed for their building frames such as walls and pillars. On the other hand, it was confirmed that flooding by the tsunami induced damage on building doorways located above the ground, EDG air supply louvers, equipment hatches on the ground, cables running through trenches and ducts underneath the buildings, and piping penetrations. It is considered that the water went into the buildings through these openings above the ground, cables running through trenches and ducts underneath the buildings, and piping penetrations. [Attachment 7-1]

Note that countermeasures for preventing overflows were taken for the necessary areas to prevent damage of important components caused by overflow from internal water piping, etc. Barriers and watertight doors were installed to prevent flooding from neighboring areas. However, at the Fukushima accident, water inundated from louvers and other upper sections into the building and remained in highly watertight areas (EDG room, etc.).

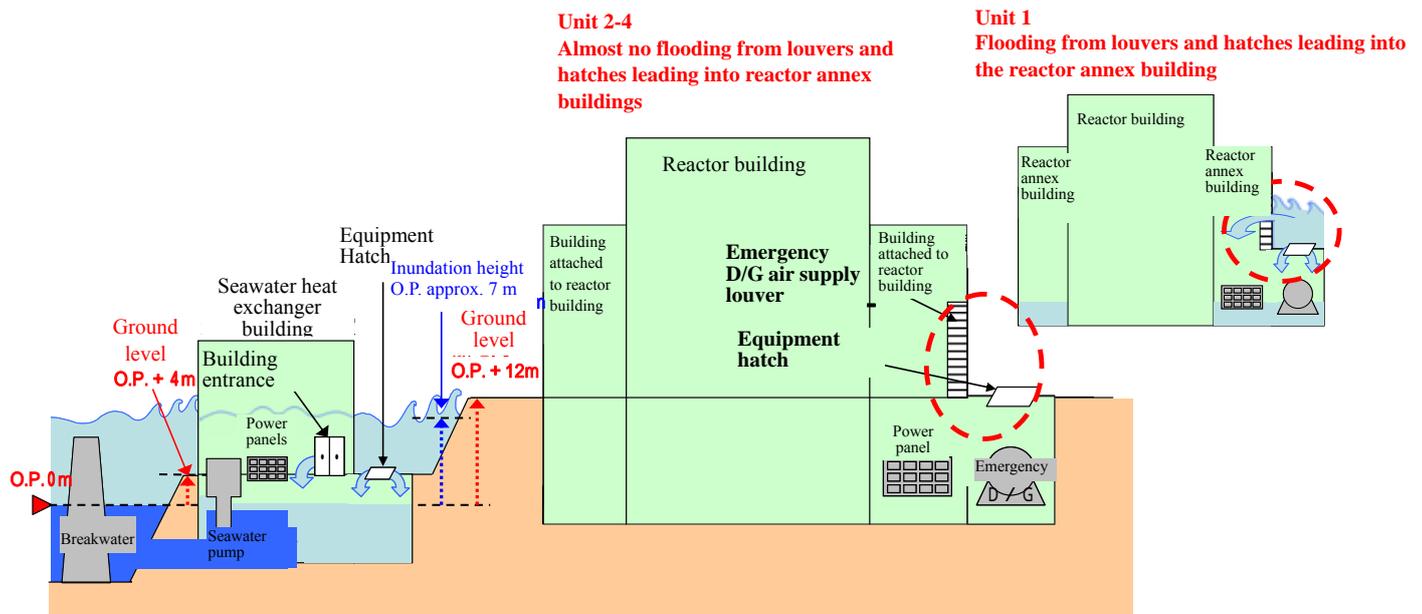
At Unit 1, water inundation was found through the openings on the ground (EDG air supply louvers and equipment hatches on the ground) facing the south side of the reactor building where the tsunami ran up most intensively. There was water inundation through these openings into the reactor annex building, and all three EDGs and emergency power supplies (C systems and HPCSs) lost their functions.

There was no inundation through openings on the ground into the reactor or turbine buildings at Units 2 and 4, since the flood depth on the ground level was minimal. However, inundation was found at some areas in the Unit 3 reactor annex building and Units 1 to 3 turbine buildings. The tsunami is considered to have entered these buildings via cables and piping penetrations connected to underground trenches and ducts. [Attachment 7-5]

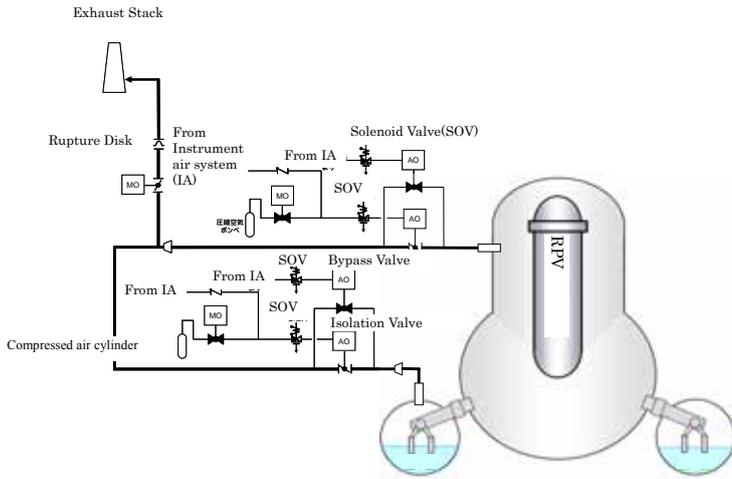
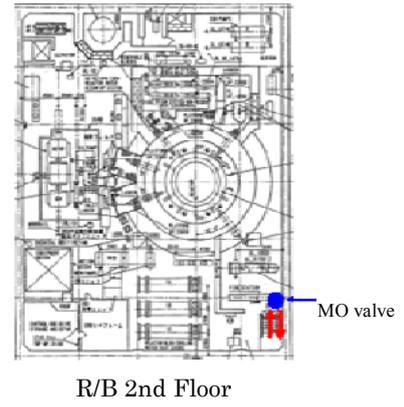
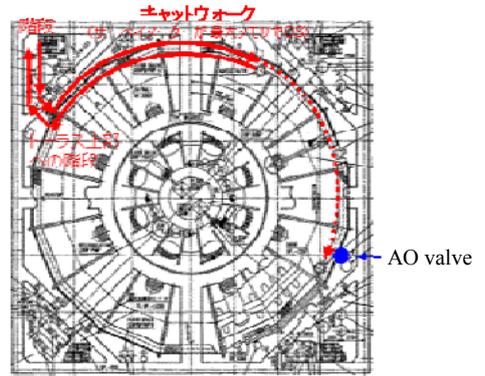
Fukushima Daiichi Unit 1 Event Sequence Leading to PCV Venting

- On March 12 at 9:02, evacuations from Okuma Town (part of the Kuma District) were confirmed as being completed.
- On March 12 at 9:04, operators headed into the reactor building for venting, and at around 9:15, the motor-operated valve was opened 25% in accordance with the procedures.

- Subsequently, operators tried to open the air-operated valve on the basement floor of the reactor building. However, the radiation dose in the reactor building was high; therefore, the venting operation could not be conducted. Accordingly, a temporary air compressor was procured, and after the confirmation of connections, the temporary air compressor was set up and started. At 14:30, a pressure drop in the D/W was confirmed, and it was deemed that there would be a "release of radioactive material" by venting. [Attachment 8-4]

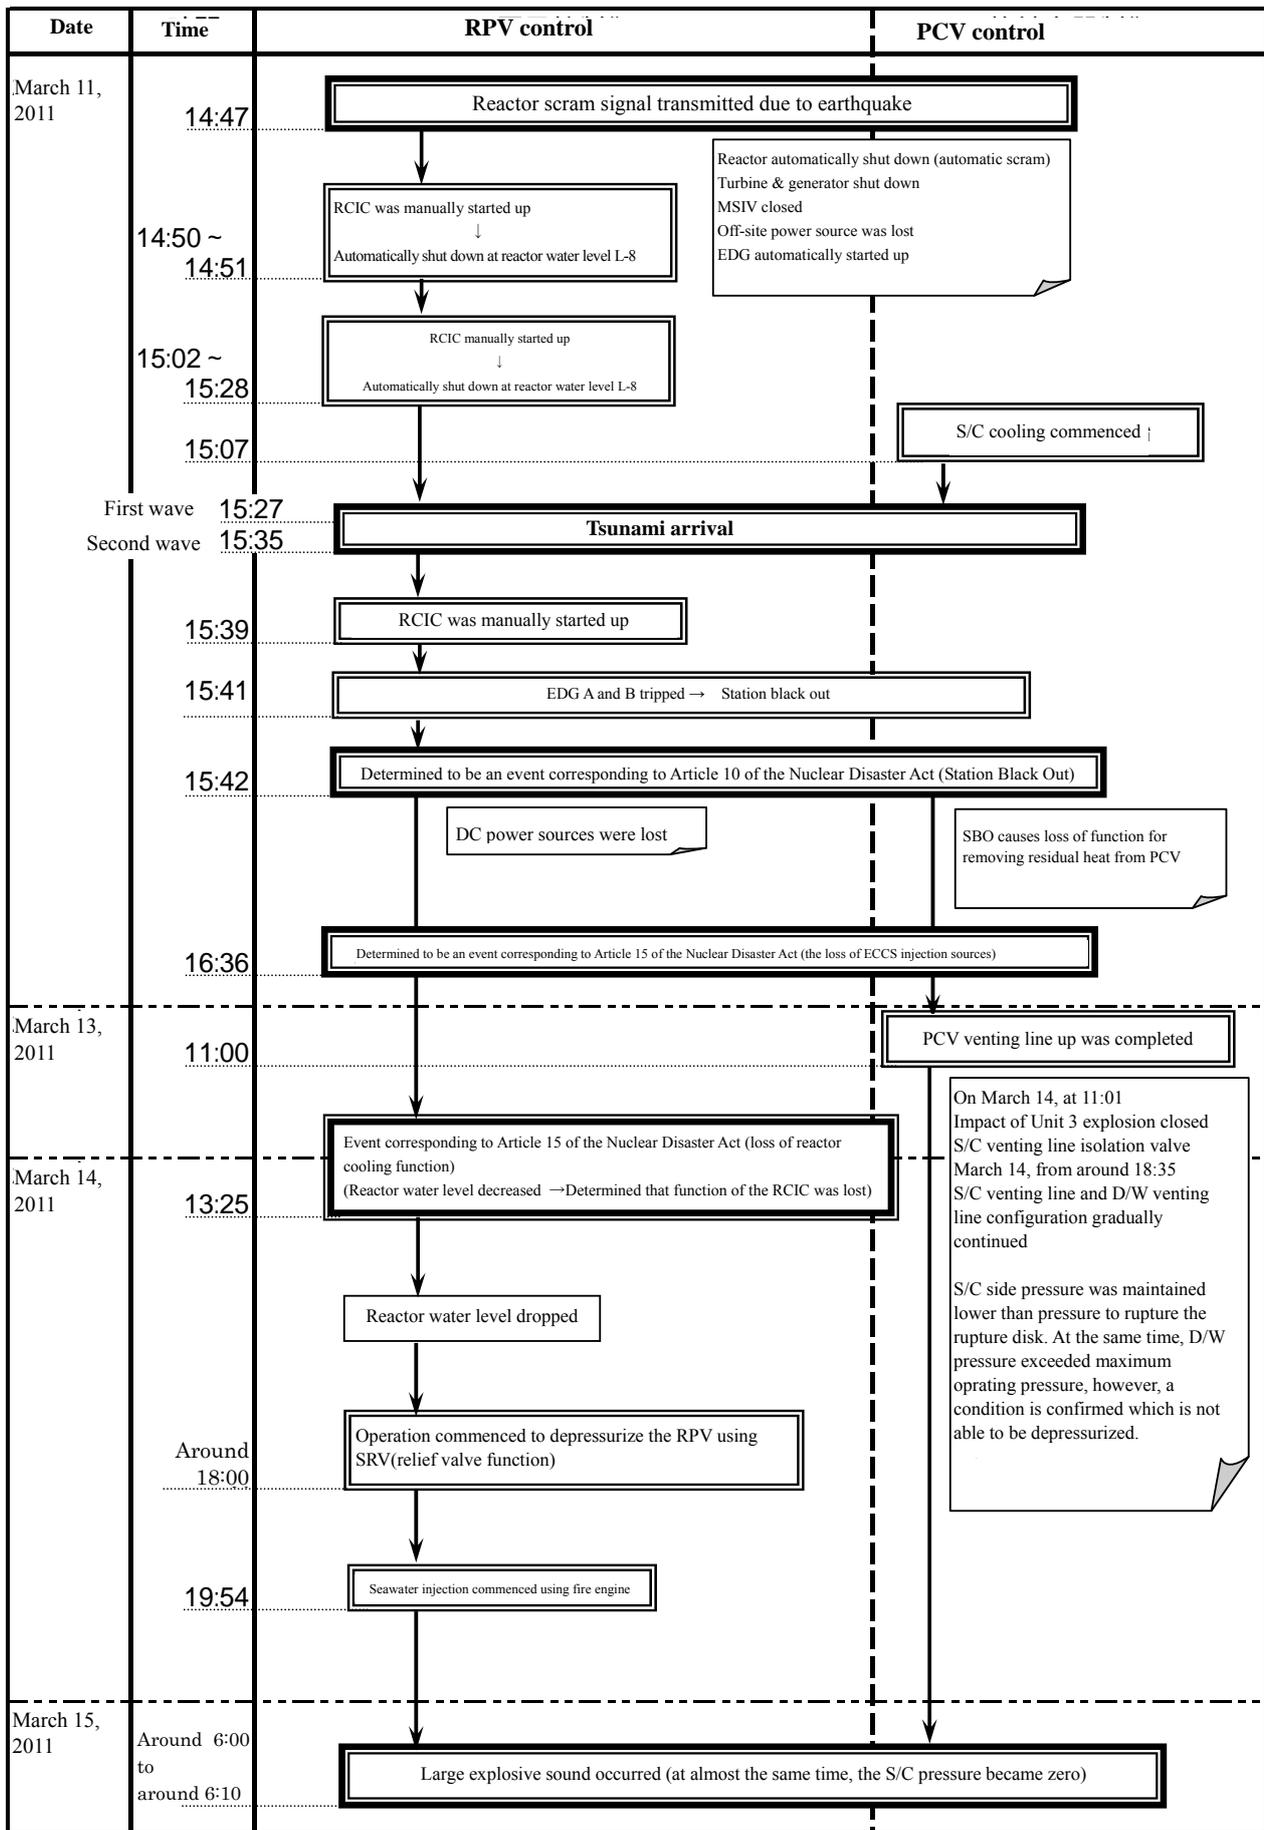
Course of Accident Progression after Earthquake at Fukushima Daiichi Unit 2

- On March 15 from 6:00 to around 6:10, a large explosive sound occurred. At almost the same time, it was confirmed that the pressure indication for the S/C was 0 MPa[abs] (As described in “9. Plant Hydrogen Explosion Assessment,” the explosive sound is believed to have resulted from the explosion at Unit 4).

- Meanwhile, the D/W pressure maintained at 730 kPa [abs] as of 7:20 on March 15. However, at the time of the next measurement at 11:25, the D/W pressure had decreased to 155 kPa [abs]. During this period, it is believed that gas in the PCV has been released into the atmosphere in some way. Around this time, the monitoring car reading near the main gate drastically increased.

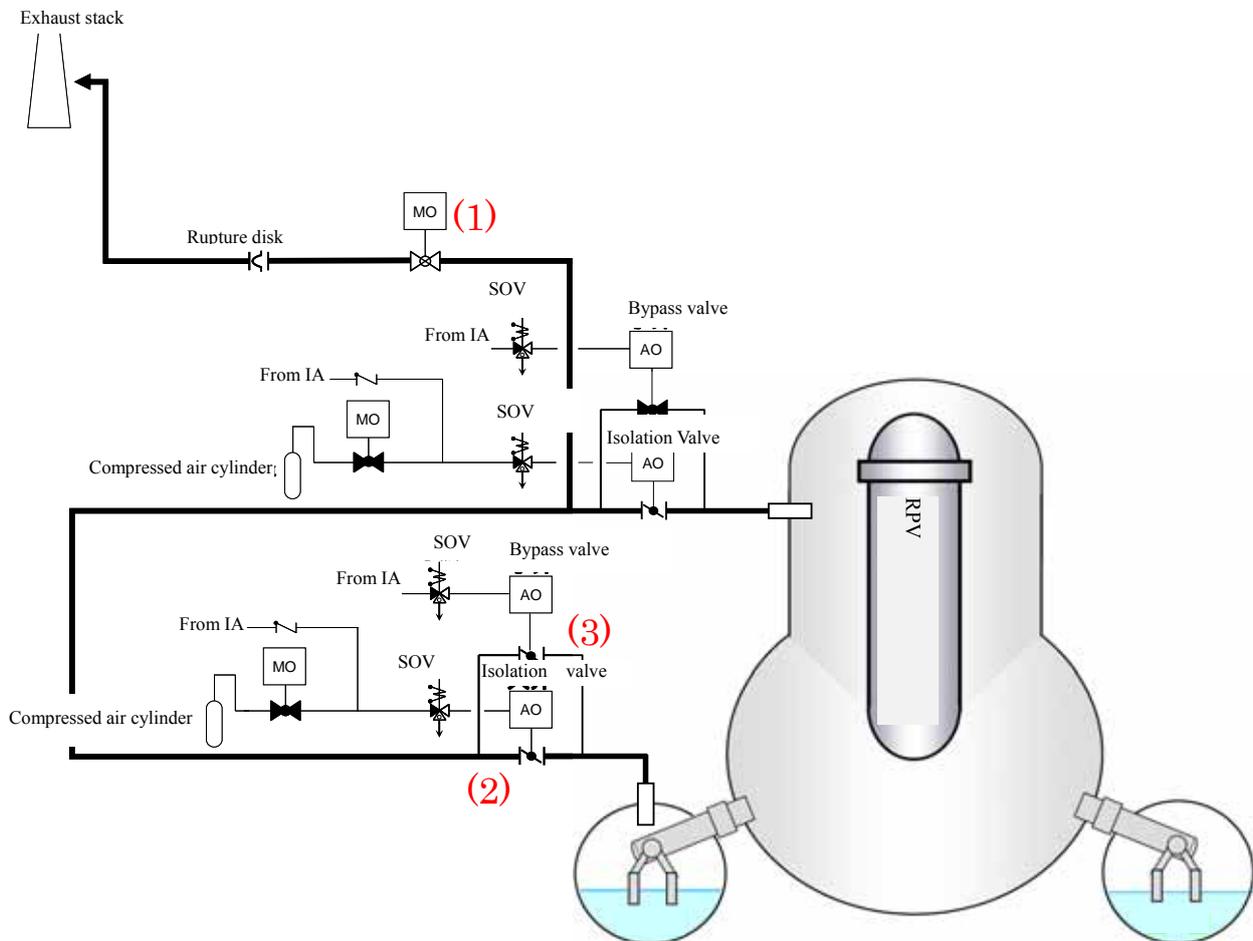
Fukushima Daiichi Unit 2: Valves operated on PCV venting line

on the venting line from the D/W; however, a few minutes later, it was confirmed to be closed. The D/W pressure did not decrease from 750 kPa[abs] but remained high, and no effect from the venting was shown.

- At between 6:00 and 6:10, a large explosive sound occurred. At almost the same time, the pressure of the S/C showed 0 MPa[abs] (Described in “9. Plant Hydrogen Explosion Assessment,” and the explosive sound is believed to have resulted from the explosion at Unit 4).
- Meanwhile, the D/W pressure maintained at 730 kPa[abs] as of 7:20.
- The D/W pressure as of 11:25, which was when the next measurement was made, had decreased to 155 kPa [abs], and it is thought that during this time, the gas in the PCV was released into the atmosphere in some way, and the monitoring car reading near the main gate drastically increased.

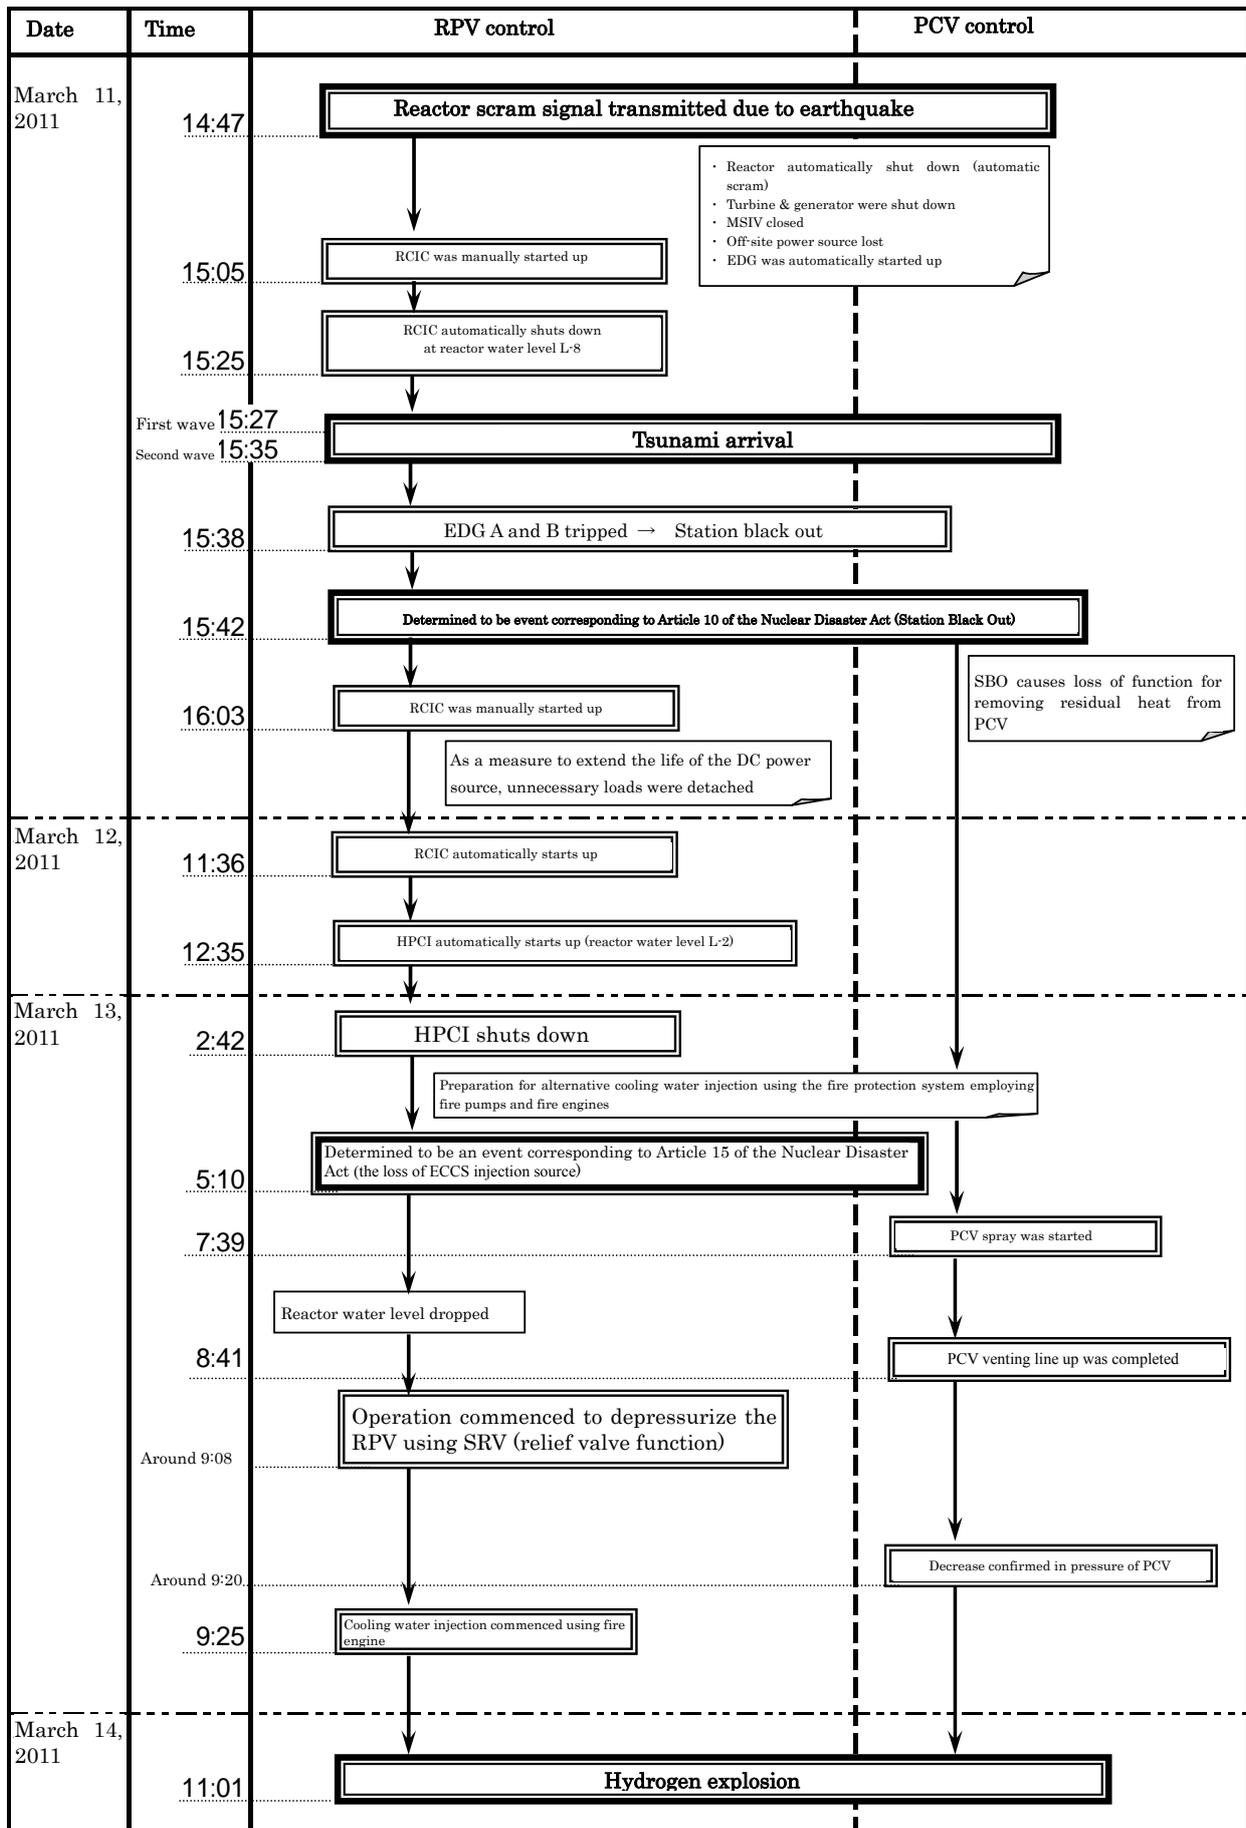
Course of Accident Progression after Earthquake at Fukushima Daiichi Unit 3

- Likewise, since there could be accumulated hydrogen in the reactor building, as with Unit 1, “opening a blow out panel,” “making holes in the reactor building roof,” and other such methods to release hydrogen from the reactor were reviewed. However, those countermeasures were not implemented because they required working in elevated places without lights, etc., and in high-dose areas; and there was a high probability of inducing an explosion by sparks, etc. In

addition, with respect to “making holes in the reactor building wall by the water jet,” which has a low risk of explosion, the equipment for such measures was procured, but such equipment had not arrived at the power plant before the explosion of Unit 3.

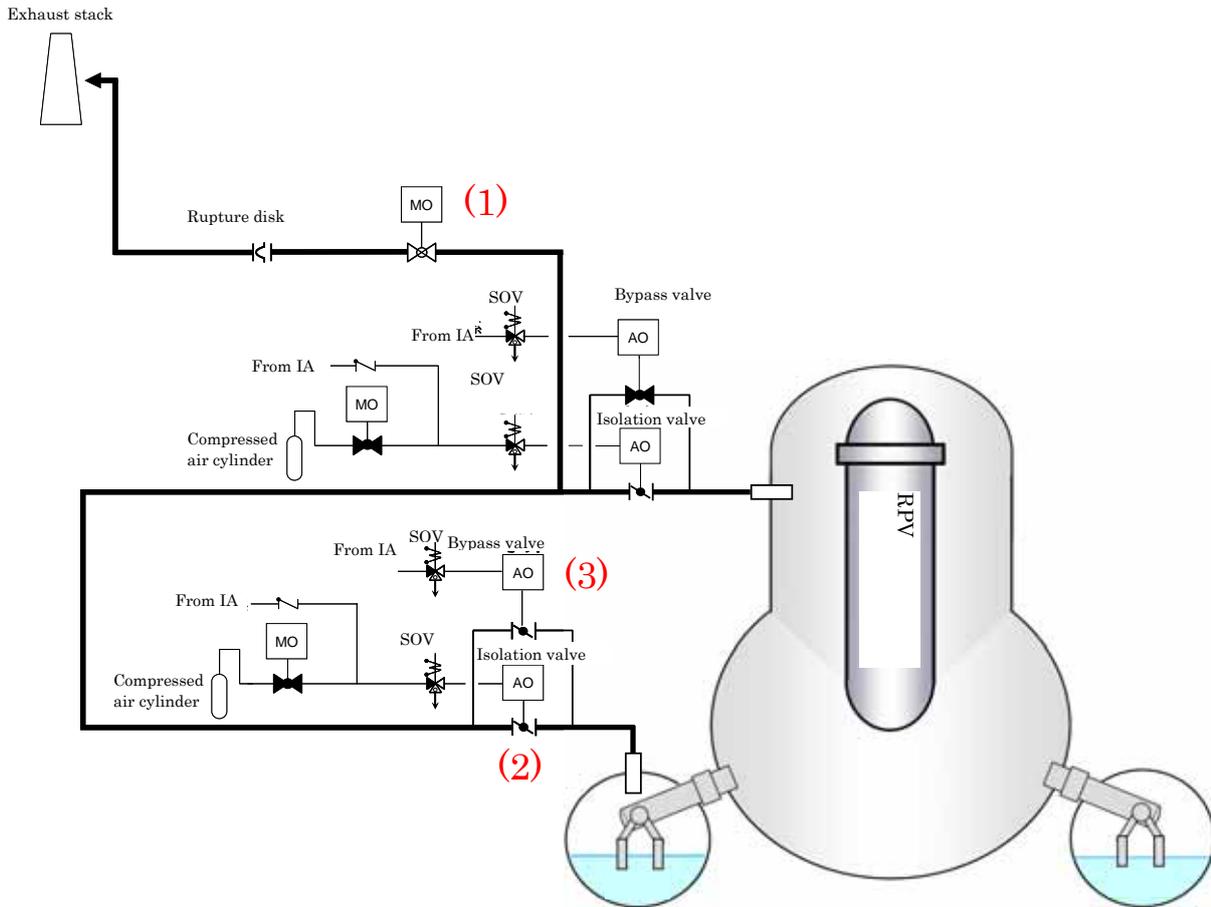
Fukushima Daiichi Unit 3: Valves operated on PCV venting line

- On March 13 at 11:17, due to decreasing pressure of the compressed air cylinder, the aforementioned air-operated valve << (2) >> was closed. Therefore, the air cylinder was replaced and the valve opened again at 12:30.
- After that, the valve needed to be maintained to be an open; however, operators could not keep the valve open due to the difficulty of the high room temperature at the torus room.
- On March 13 at around 17:52, workers headed to the field to set up a temporary compressor at the truck bay of the turbine building and connected it to the instrument air system. At around 21:10, as the D/W pressure decreased, it was deemed that the air-operated valve <<(2)>> on the vent line from the S/C was opened.

- On March 14, beginning at around 2:00, the D/W pressure was uptrending; therefore, at 5:20, another air-operated valve <<(3)>> (bypass valve), which was also on the vent line from the S/C, was opened and it was confirmed to be open at 6:10.

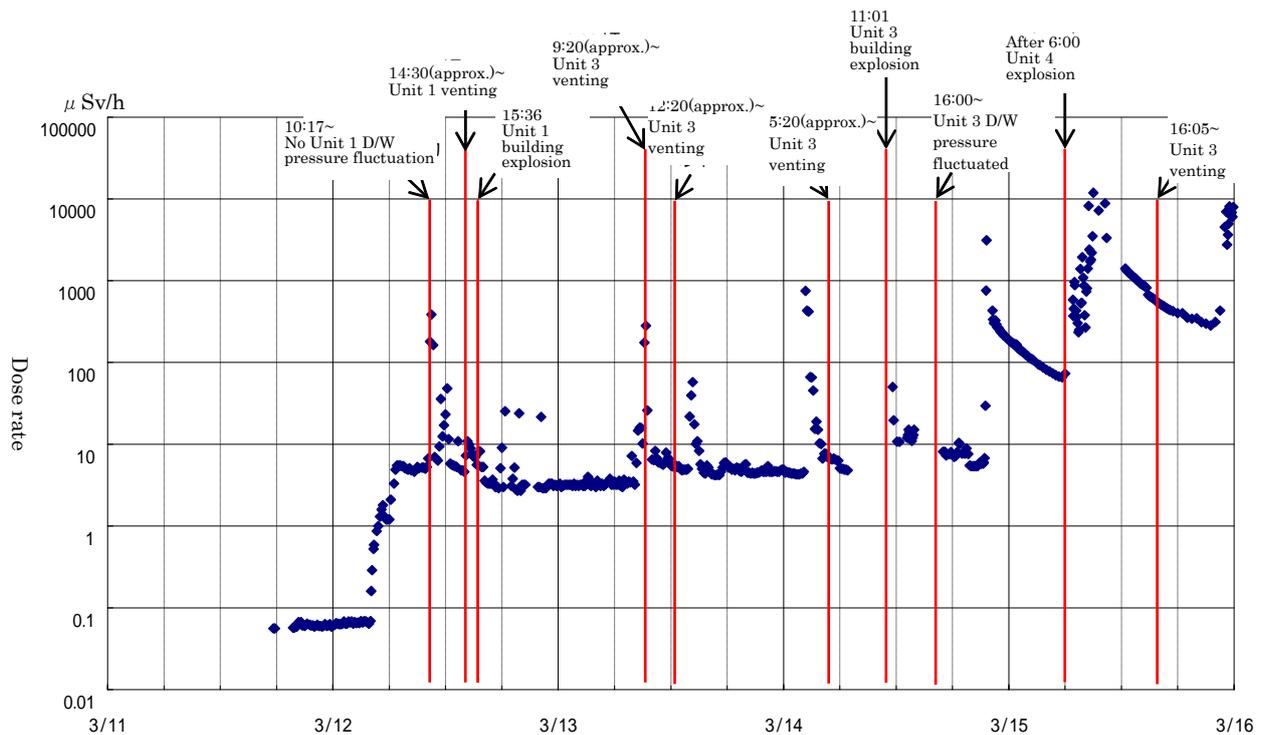
On the night of March 14, it is postulated that core damage occurred at Unit 2, and thereafter, there was a rise in the background. In particular, at 11:25 on March 15, when the Unit 2 D/W pressure dropped from 730 kPa[abs] to 155 kPa[abs]. At this time, a significant increase was confirmed in the background level with the radiation dose rate exceeding 1,000 μ Sv/h and reaching a maximum of 10,000 μ Sv/h.

Dose rate in vicinity of Fukushima Daiichi NPS main gate

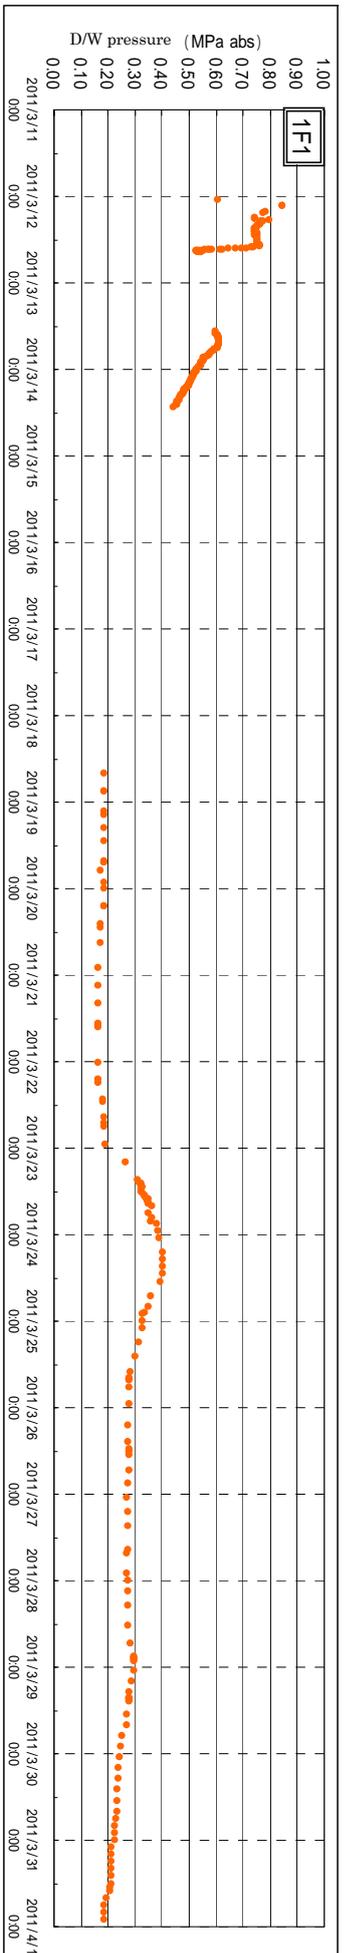
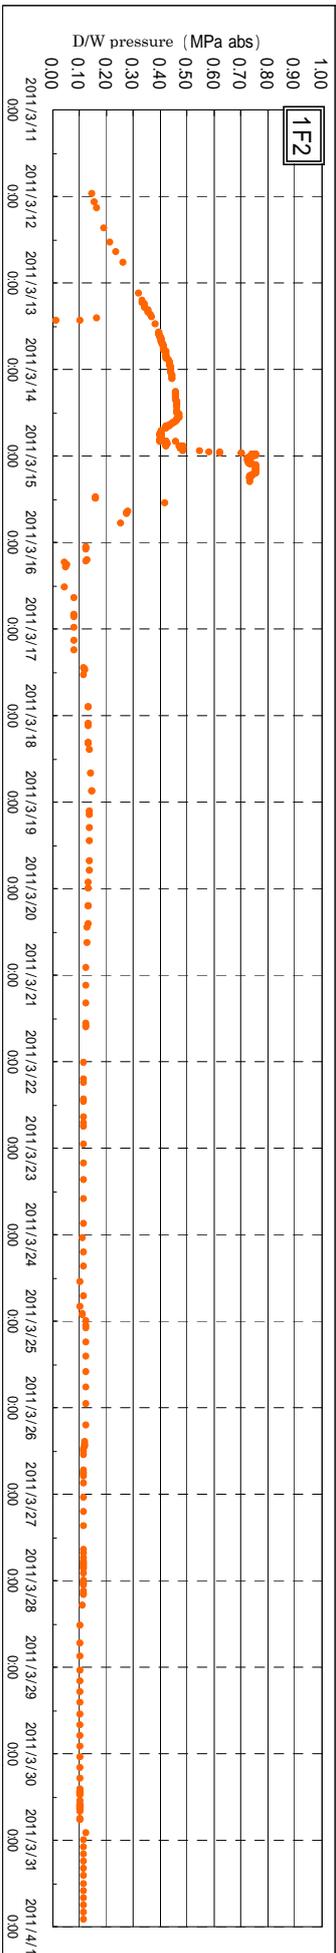
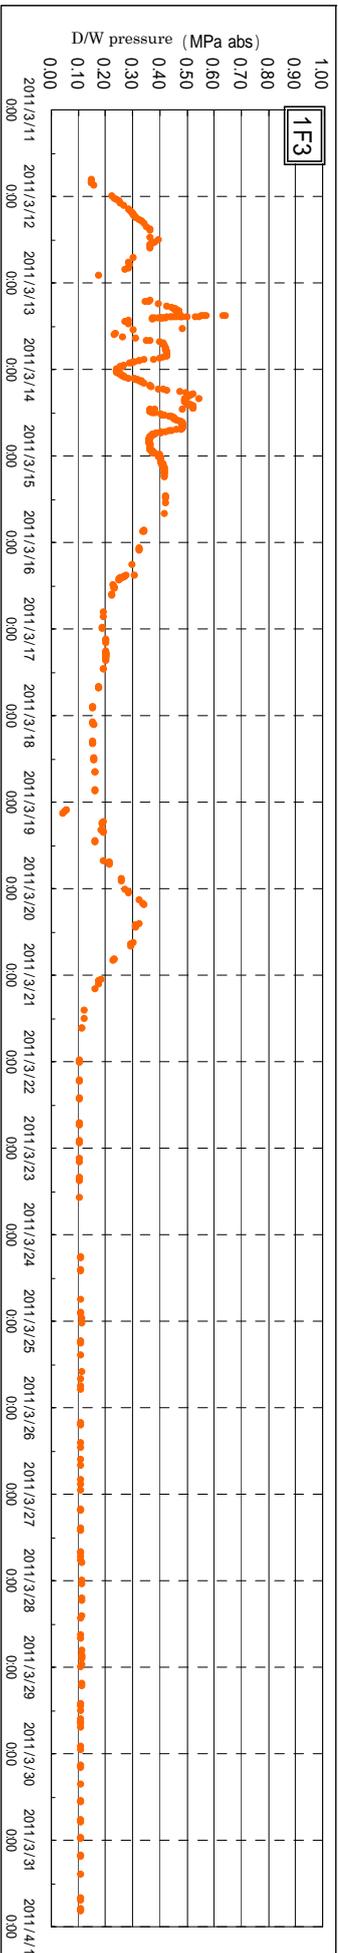
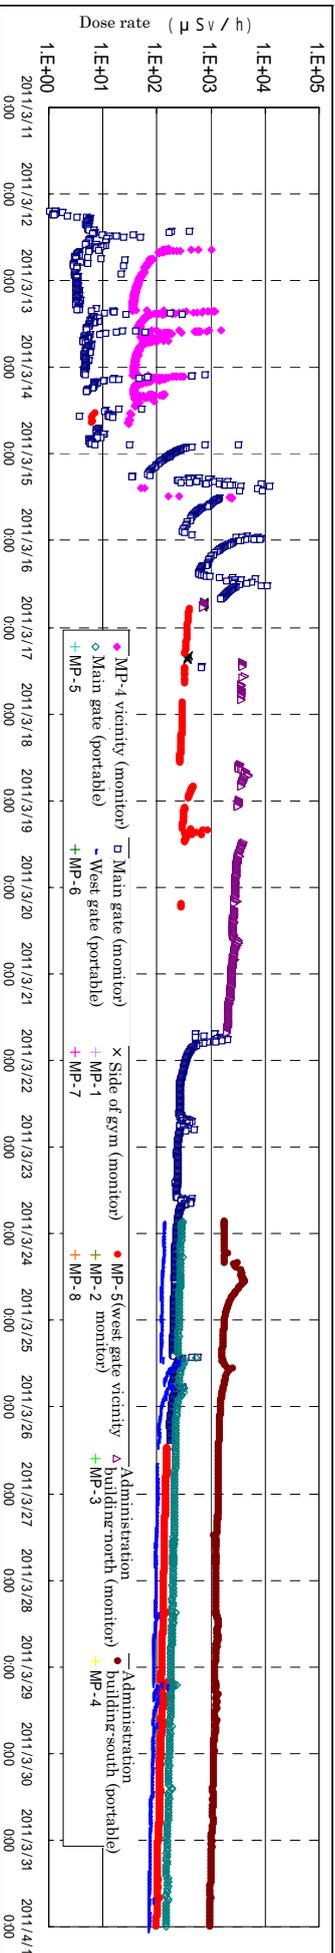
As discussed previously, during the period through March 16, there were several releases of radioactive materials and the background level was high. However, although some peaks were seen, the radiation dose rate overall declined. This downward trend in the radiation dose rate corresponds to the half-life of iodine 131.

As a result, it is inferred that there was an increase in the background level due to the radioactive material released at the outset of the accident falling, and after that, the background level declined due to the decay of the radioactive material which had adhered to the ground and other places.

Dry well pressure and monitoring data from inside and outside the Power Station

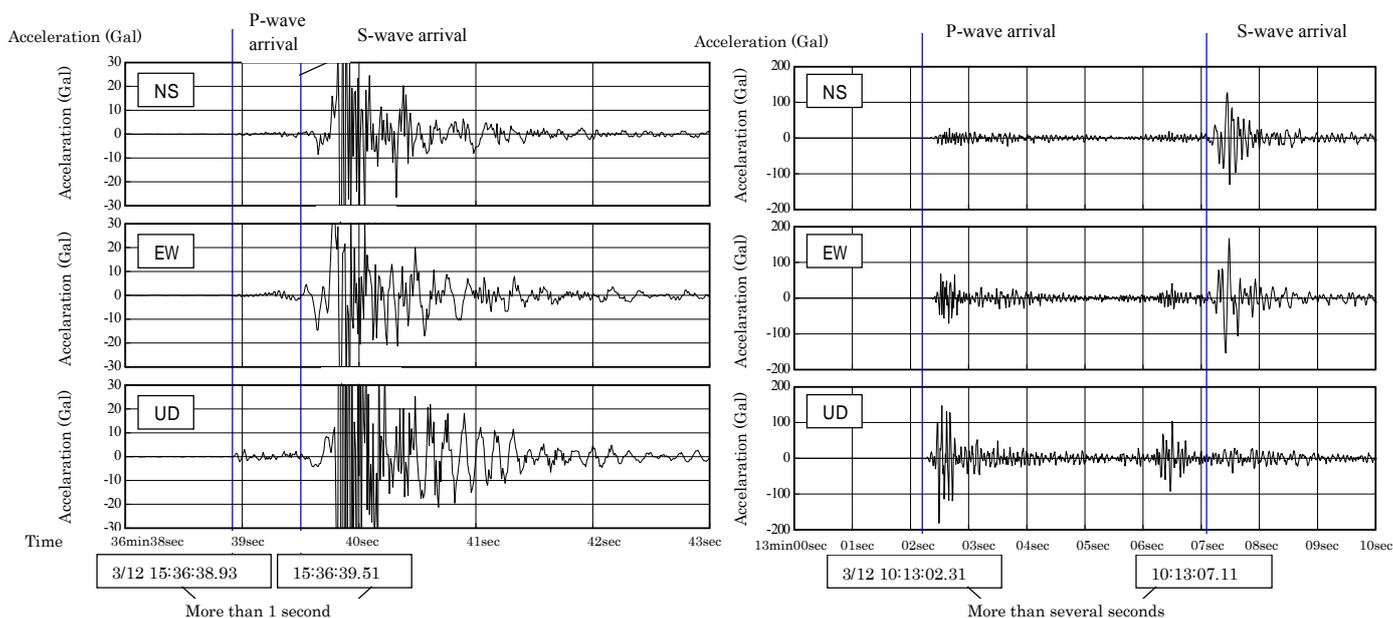
Applying this principle to the vibrations recorded by the on site seismometers the difference in the arrival times of the P and S waves for the vibration caused by the explosions on the power station were small, at less than one second. In the case of seismic vibrations having a remote epicenter, the difference in the arrival times will be several seconds. Therefore, a distinction can be made between the vibrations due to an explosion and vibrations due to an

Examples of accelerograms of explosions and earthquakes (observation point D)

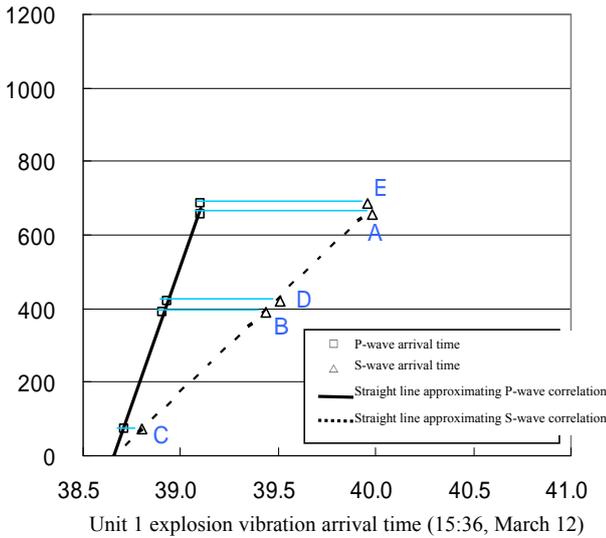
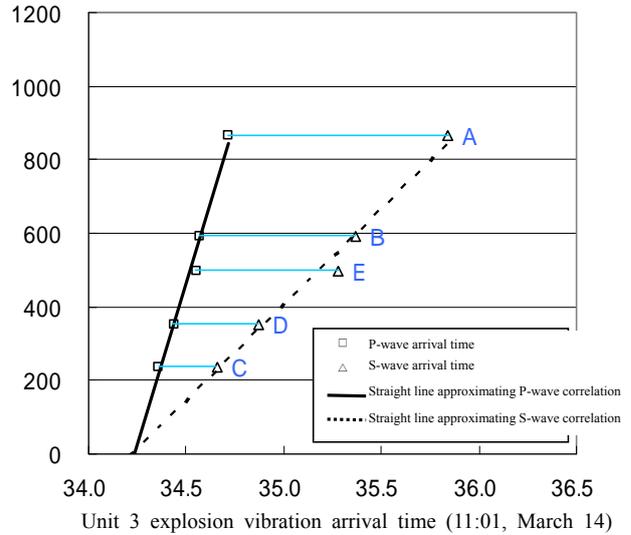
Diagram correlating the arrival times of P and S waves at the time of the Units 1 and 3 explosions and distance from Units 1 and 3

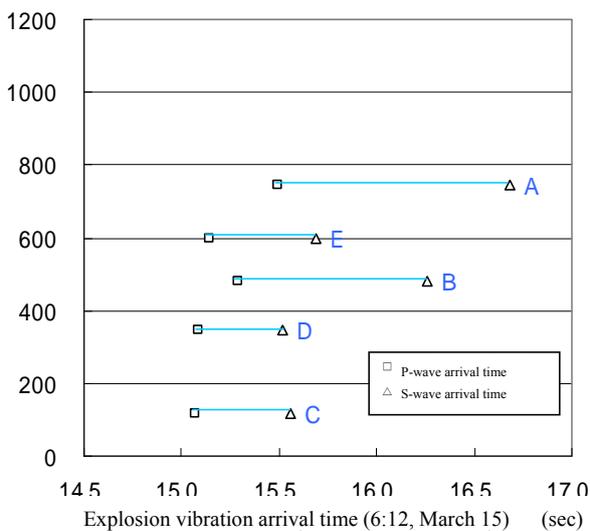
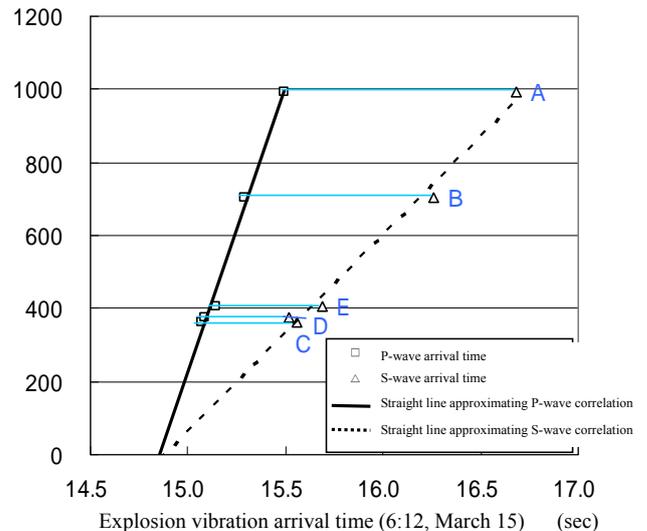
When the vibrations recorded at 6:12 on March 15 were analyzed using the relationship between the arrival times and the respective distances for Units 2 and 4 using the same methodology, no relationship could be found in the data in a case arranged by the distance from Unit 2. However, when arranged by the distance from Unit 4, very accurate linear patterns were confirmed to be formed for both the P and S waves. Accordingly, the vibrations in question are the result of the explosion at Unit 4.

Diagram correlating the arrival times of P and S waves from the 6:12 ground vibration and distance from Units 2 and 4

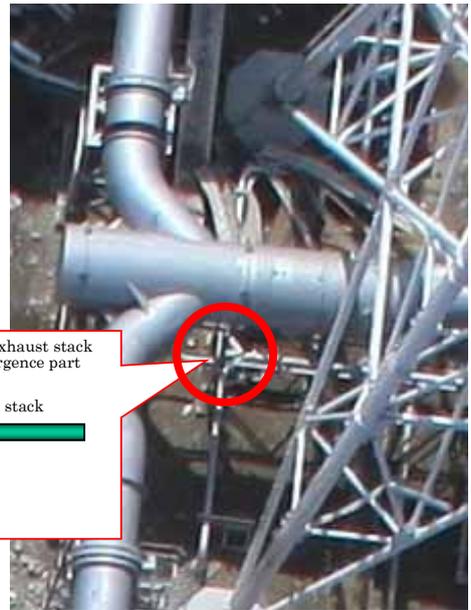
SGTS pipe

Flow path of the PCV venting gas flow from Unit 3 to Unit 4

conducted while all AC power sources were lost. Similarly, Unit 4 also lost all AC power sources, and the valves of the SGTS, which are designed to be able to operated even during an emergency, were open due to the loss of power, and a line was configured that allowed vented gas from the Unit 3 PCV to flow into Unit 4 through a SGTS pipe. It is believed that there is sufficient probability that hydrogen generated in the Unit 3 reactor flowed into Unit 4 through this pathway where it accumulated and exploded.
