Fukushima Nuclear Accident Analysis Report (Interim Report)

December 02, 2011
The Tokyo Electric Power Company, Inc.

This report identifies causes of the accident at the Fukushima Daiichi Nuclear Power Station (hereinafter referred to as “Fukushima accident”) based on the facts and analysis results that have been verified to date and proposes necessary countermeasures to enhance the safety of existing nuclear power plants.

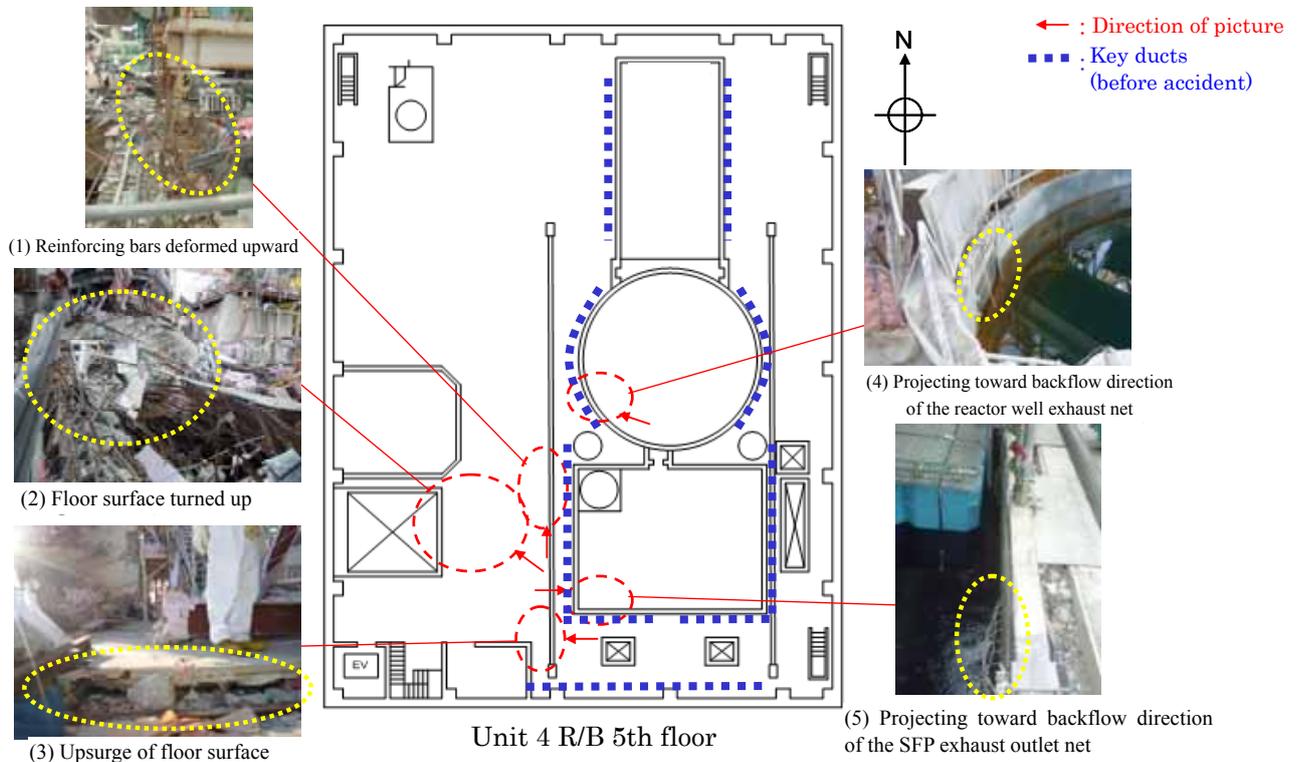
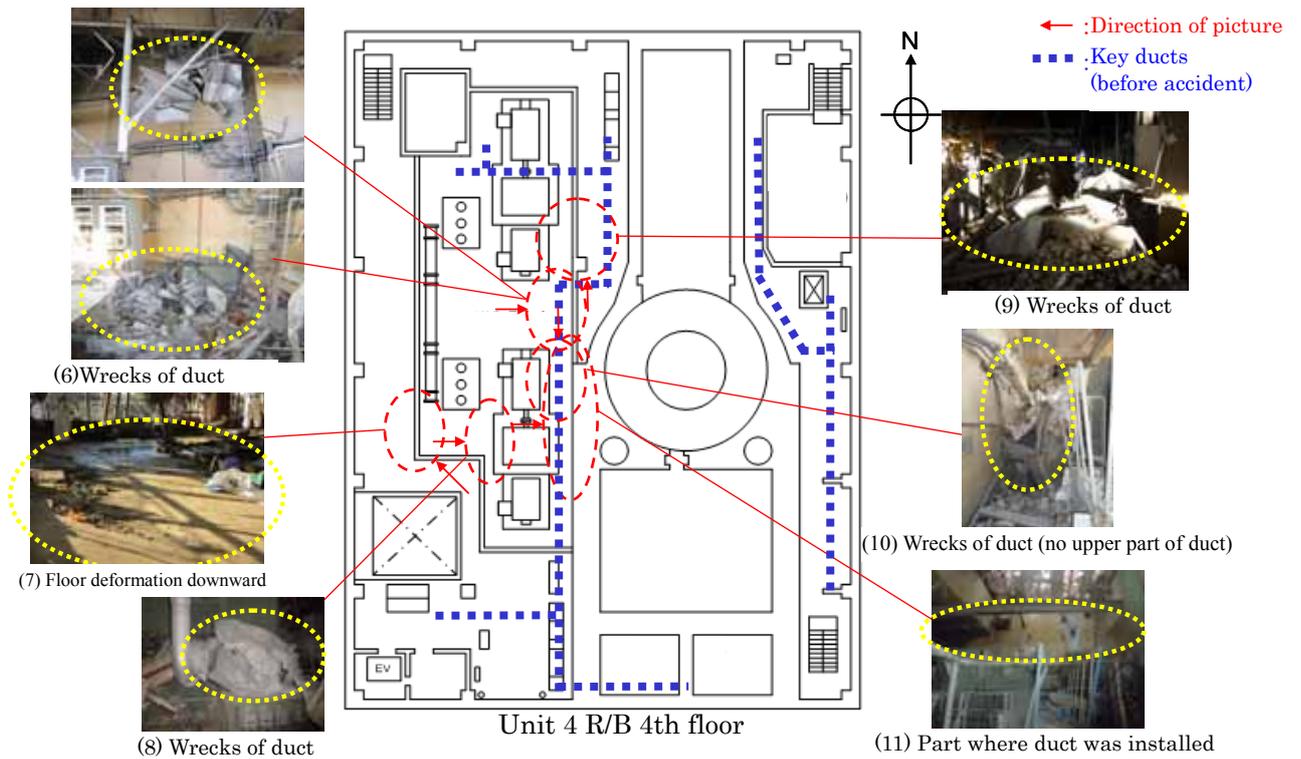
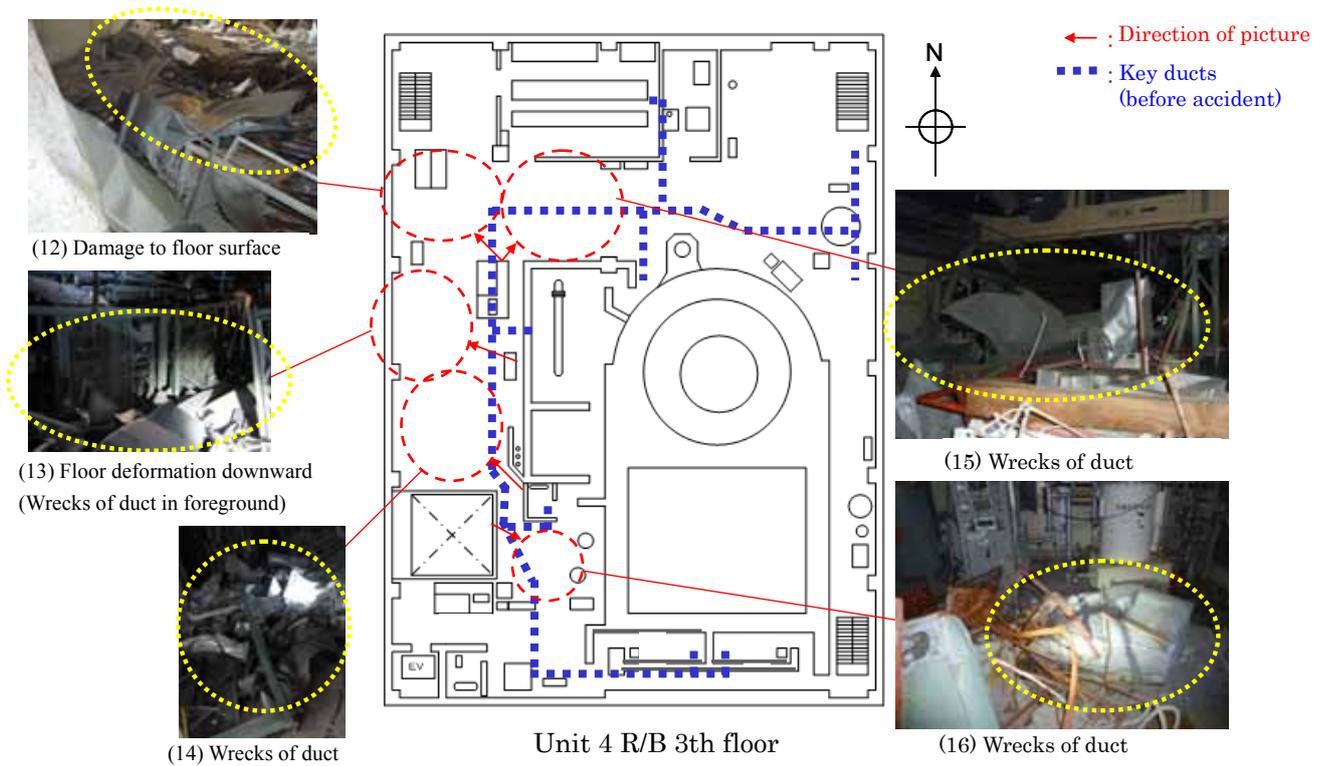
- Most of the south wall, along which the exhaust duct of the fifth floor had been installed, fell through, and remains of the duct were not found.
- On the southwestern part of the fifth level, the floor surface sustained significant damage and the reinforcing bars were bent upward (1). In addition, zone 1 was ripped up toward the refueling level, and deformation due to a force from below (floor surface, crane rail, etc.) was observed ((2), (3)).

- Buckling in a reverse direction was found on the exhaust outlet net of the SFP and the reactor well through from the fourth floor ((4), (5)).
- On the west-side of the fourth floor of the reactor building, in addition to the floor surface deformed downward near a location where the floor on the fifth floor was significantly damaged, there are several pieces of debris that are inferred to be the wrecks of the exhaust duct ((6) to (11)).

- On the west-side of the third floor of the reactor building, just as on the fourth floor, the floor surface was deformed downward, and significant damage was observed on the floor in the northwest area, and nearby, there are several pieces of debris that are inferred

From these facts, the fifth floor surface was destroyed by an upward force due to the pressure of an explosion that occurred on the fourth floor. On the west-side of the fourth floor of the reactor building, there are also no ducts where they were originally installed, and debris that is inferred to be the wrecks of the duct was scattered about. Therefore, it is assumed that the location where the main pressure arose due to the explosion might be near the duct on the west side of the fourth floor. In addition, it is believed that the hydrogen, which back-flowed through the exhaust duct, caused explosions on both the third and fifth floor, and damage occurred in the building and other areas due to the pressure.

From the above, the condition on site where the explosion occurred is thought to coincide with the inference that Unit 3 vented flow back-flowed through the pipes and ducts of the SGTS from the second floor of the Unit 4 reactor building and flowed into locations inside the building.

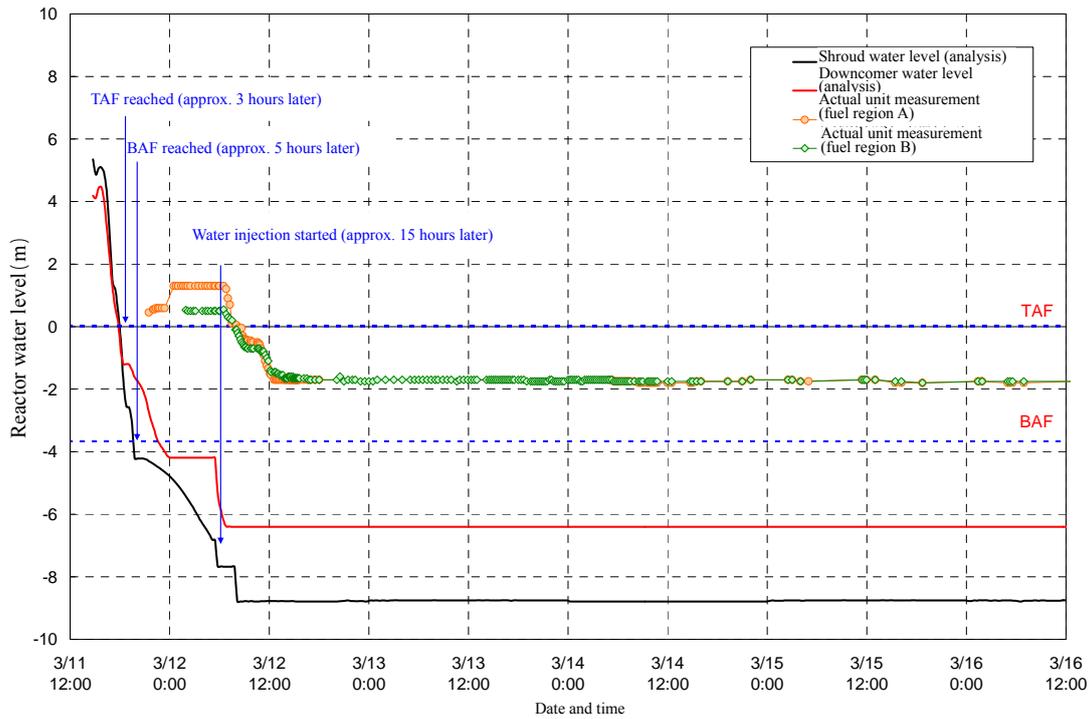
In the analysis, the reactor water level reached the TAF approximately 3 hours after the earthquake (March 11, 14:46). The fuel temperature exceeded 1200°C and core damage started approximately 4 hours after the earthquake. The water level continued to decrease and dropped to the bottom of Active Fuel (BAF) at around 20:00 on March 11.

Unit 1 Changes in reactor water level

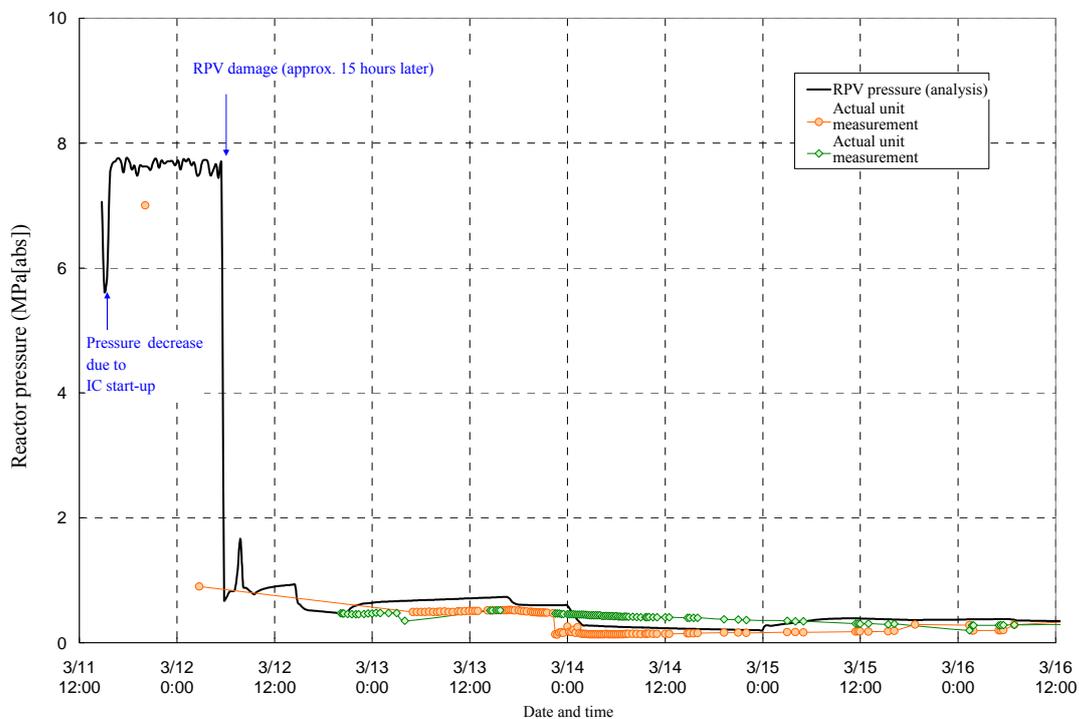
During this time, the reactor pressure was maintained at around 8MPa due to the operation of the SRV, and the steam that was discharged from the SRV was condensed in the S/C. Then according to the analysis, approximately 15 hours after the earthquake (March 11; 14:46), some type of leakage from the RPV occurred that caused a significant decrease in the reactor pressure that had been maintained at around 8MPa.

Unit 1 Changes in reactor pressure

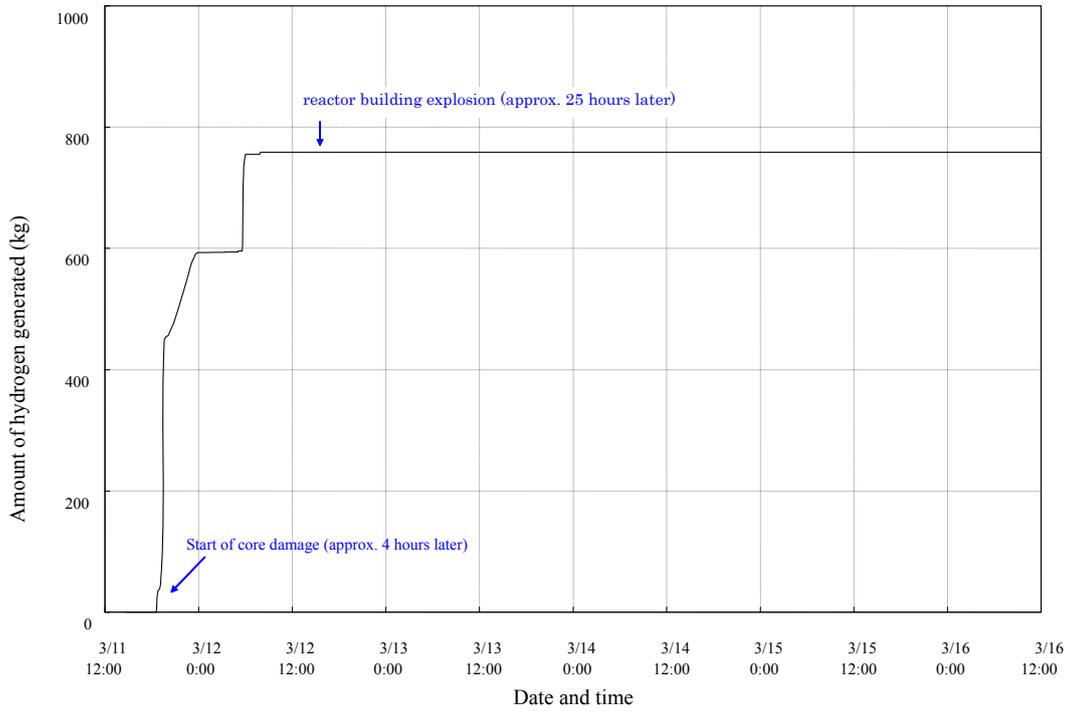
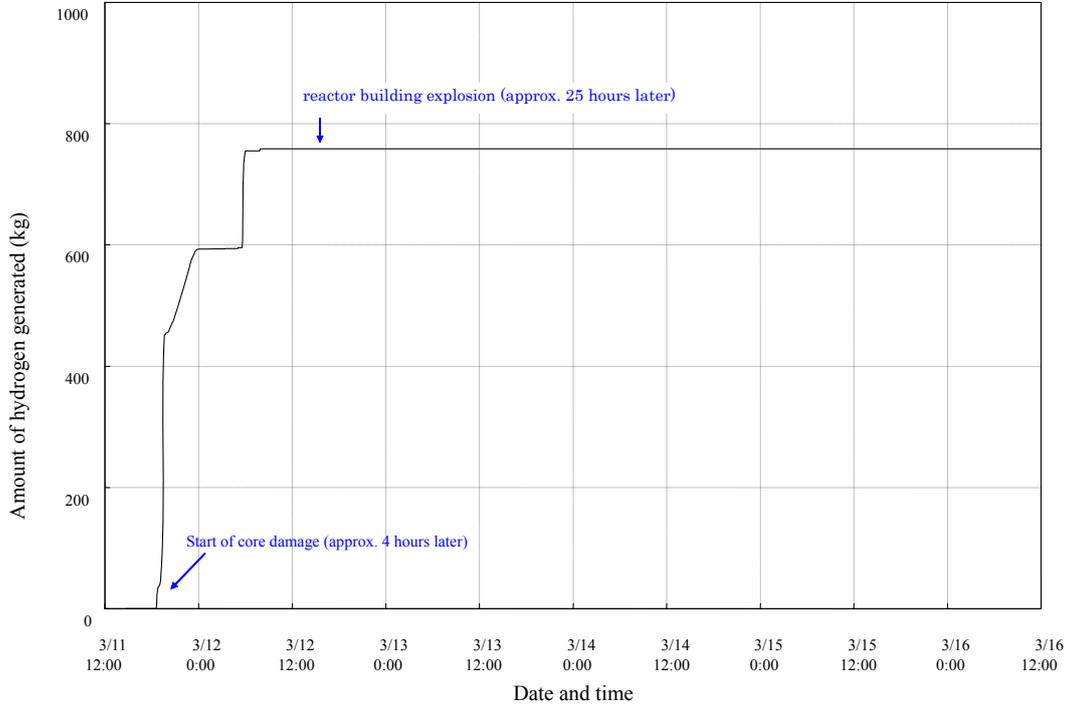
In addition, as the fuel temperature increased and core damage started, etc., hydrogen, which is a non-condensable gas, was generated by the water-zirconium reaction. The amount of hydrogen generated at 15:36 on March 12 was approximately 750kg. This was when the explosion occurred in the reactor building possibly due to hydrogen.

Unit 1 Changes in the amount of hydrogen generation

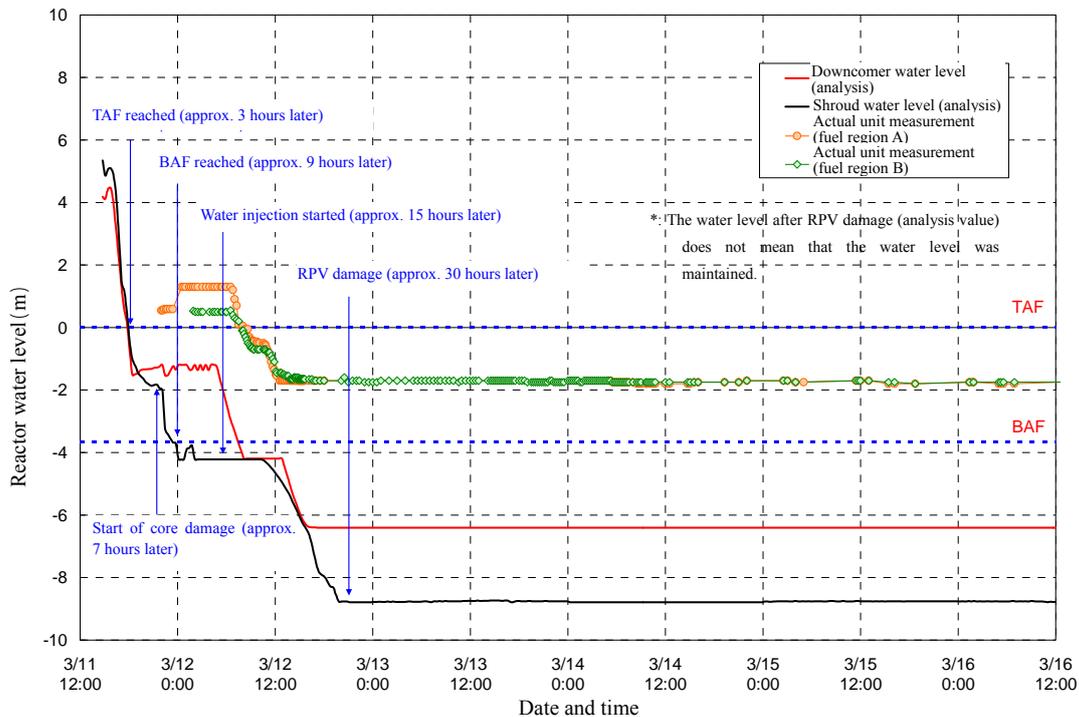
A parameter study was performed on the operation of the IC after the tsunami. A sensitivity analysis was conducted assuming that the IC was temporarily started after the tsunami. This assumption influenced the analysis result of the core condition, such as slight delays in the core damage and core melting process. However, the analysis result did not show a significant change in the ultimate core condition.

Changes in Unit 1 reactor water level (assuming that the IC was functioning temporarily)

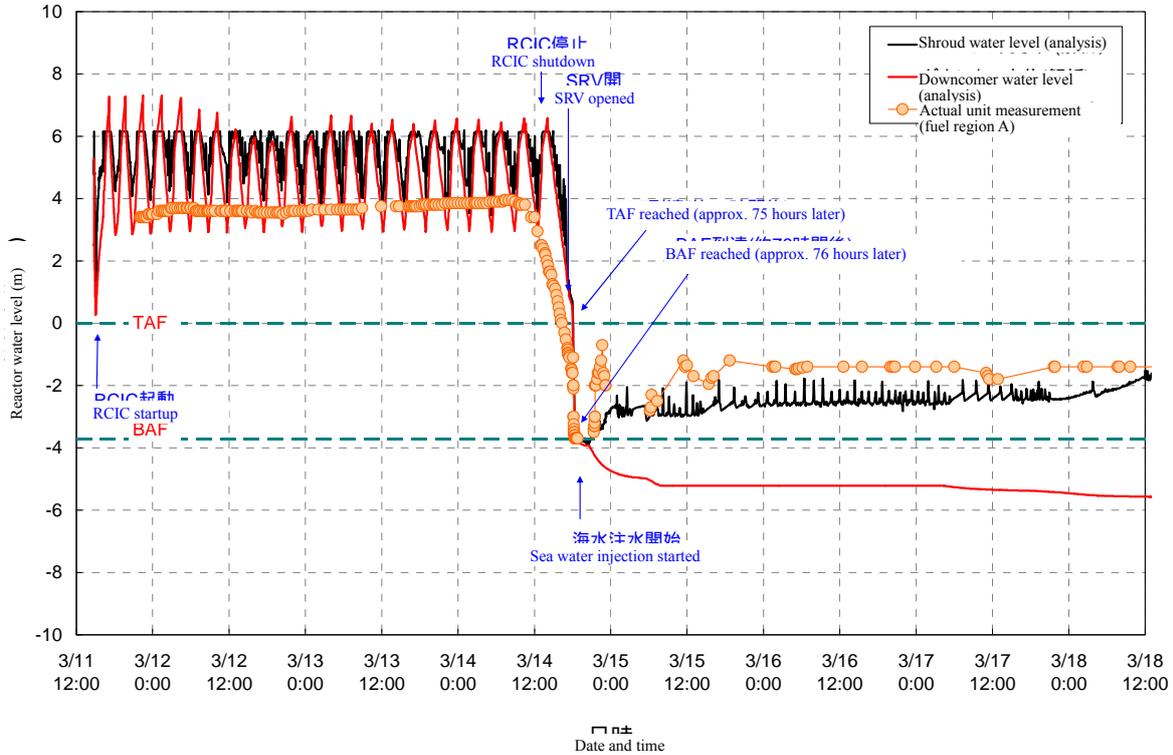
Unit 2 Changes in reactor water level [Case 1]

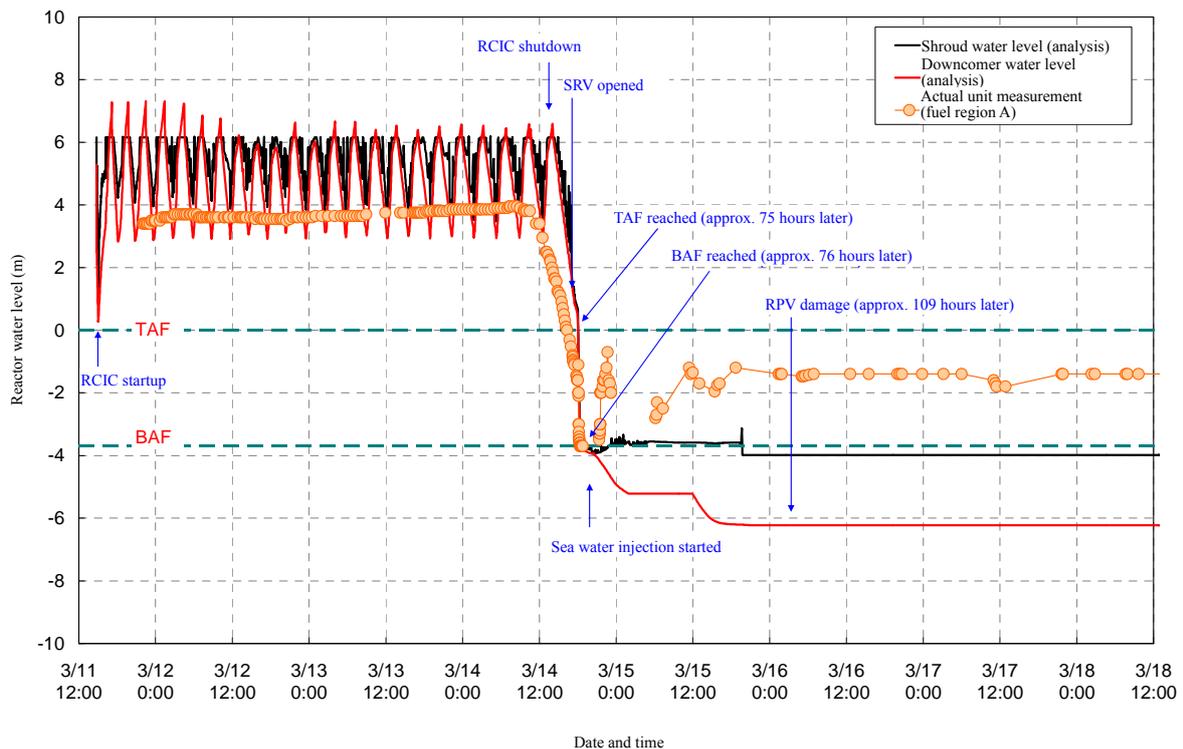
In Case 2, where much amount of fuel is exposed, the RPV would be damaged at around 4:00 on March 16.

Unit 2 Change in reactor water level [Case 2]

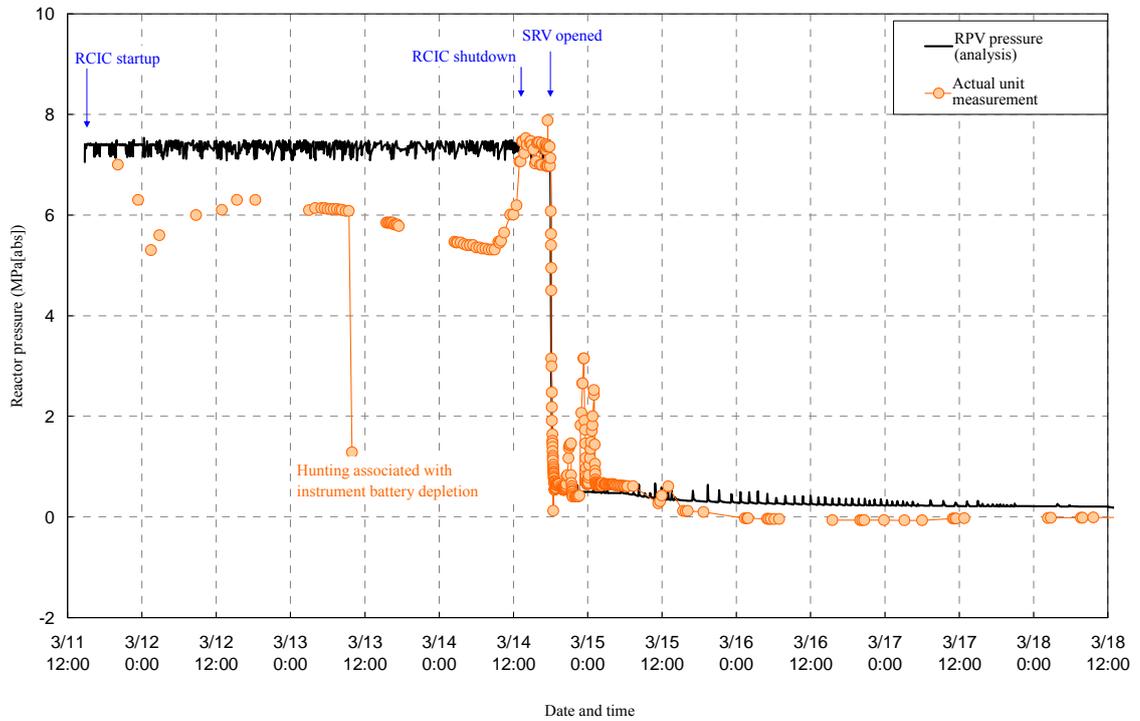
The actual reactor pressure measurement showed a low value of about 6 MPa[abs] during the operation of the RCIC. However, this behavior could not have been simulated in the analysis. The reason is still unknown at this stage, including the problems of the instruments.

Unit 2 Changes in reactor pressure [Case 1]

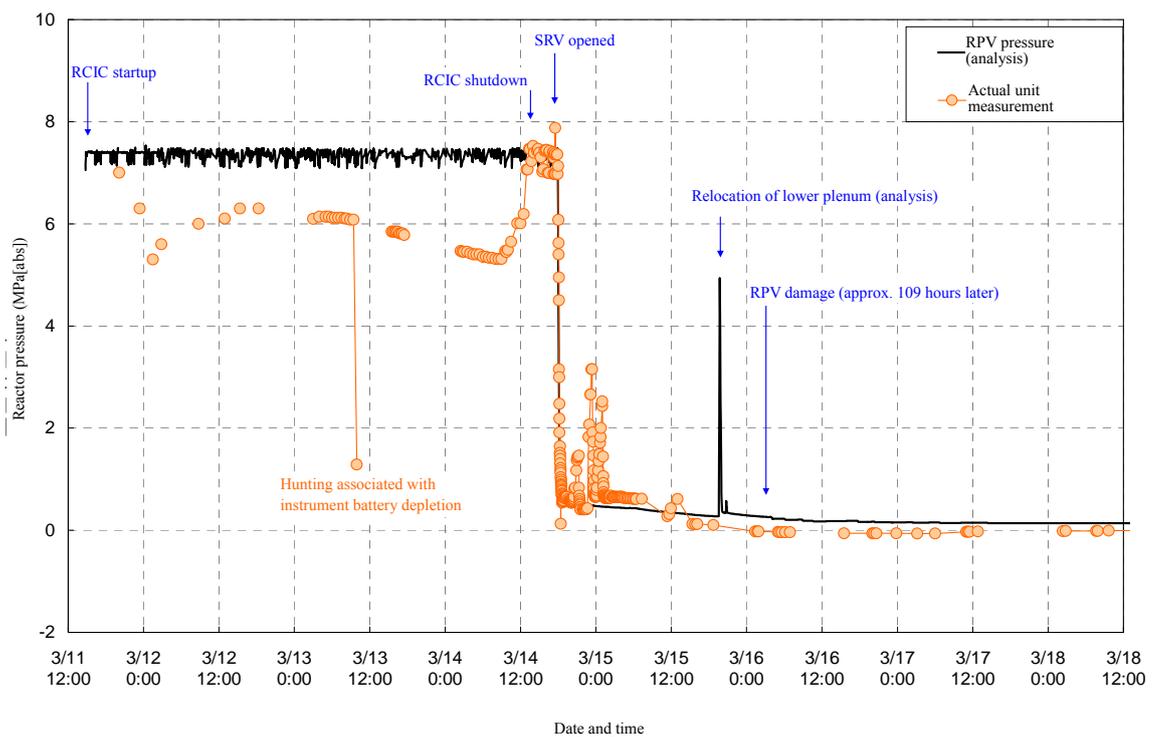
Unit 2 Changes in reactor pressure [Case 2]

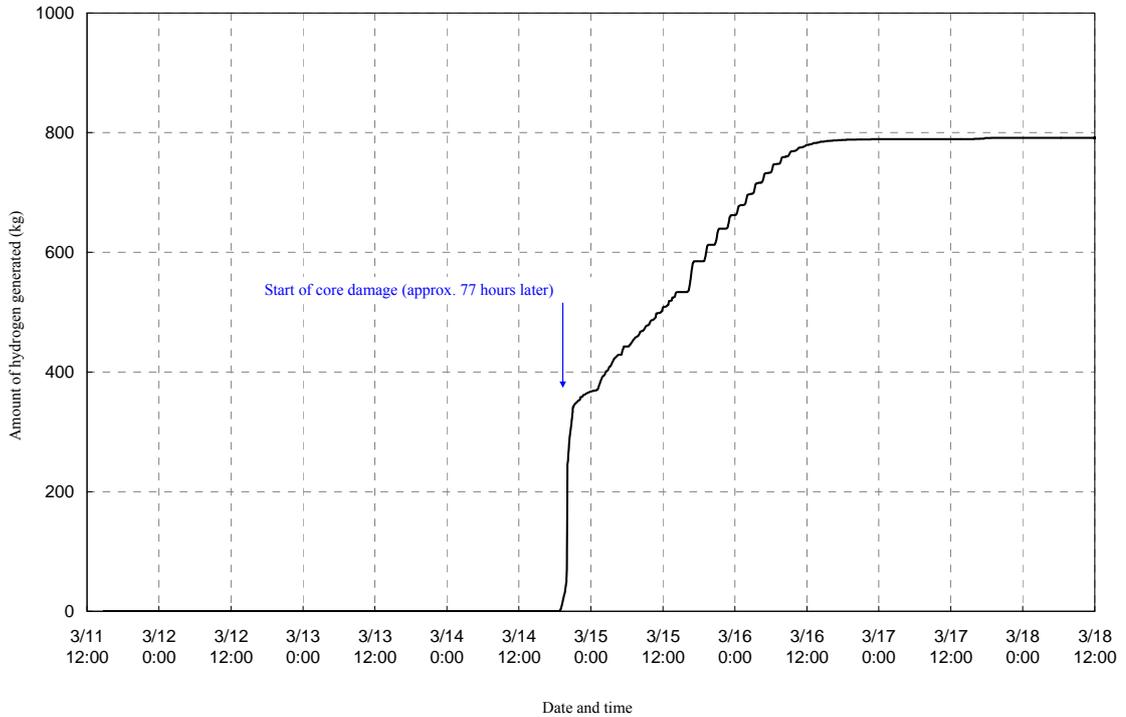
The amount of hydrogen generated increases when water/steam is supplied after the shape of the heated fuel cladding is maintained to a certain degree. Accordingly, the amount of hydrogen generated calculated in the analysis was approximately 800 kg for Case 1 and approximately 350 kg for Case 2.

Unit 2 Changes in the amount of hydrogen generation [Case 1]

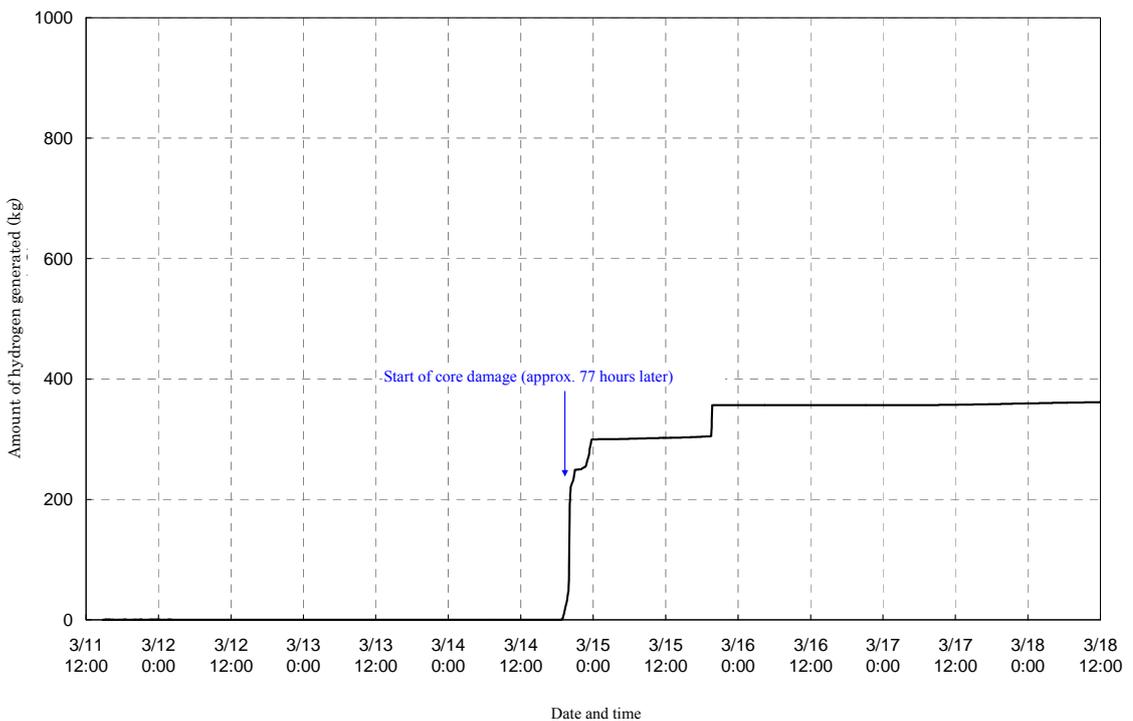
Unit 2 Changes in the amount of hydrogen generation [Case 2]

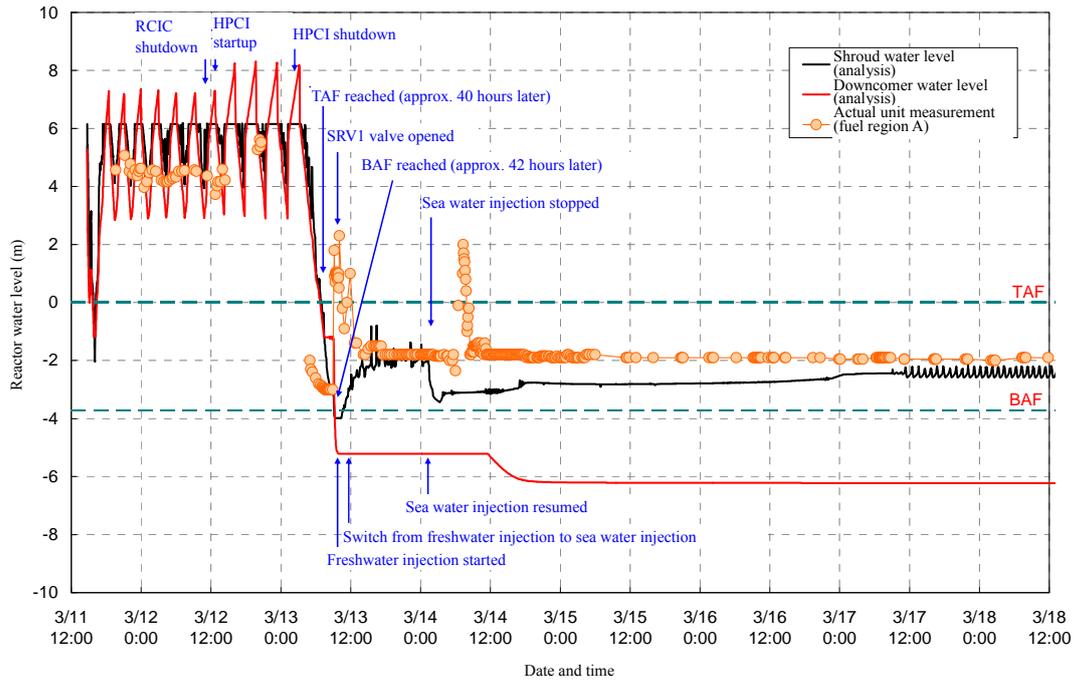
Unit 3 Changes in reactor water level [Case 1]

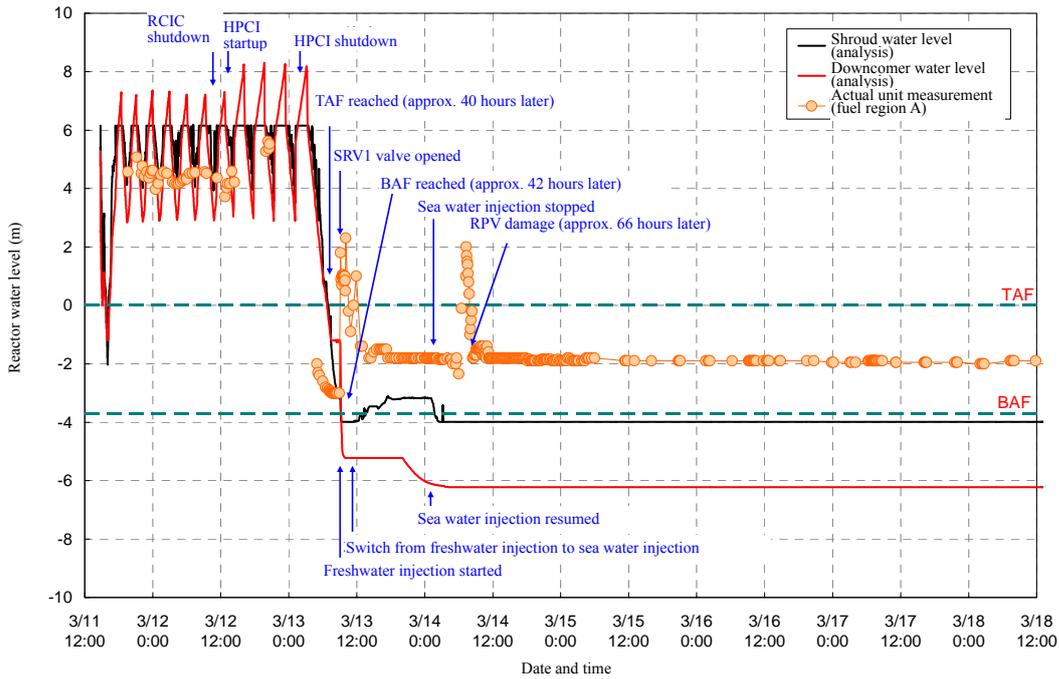
In Case 2, where more fuel is exposed, the RPV would be damaged at around 8:00 on March 14.

Unit 3 Changes in reactor water level [Case 2]

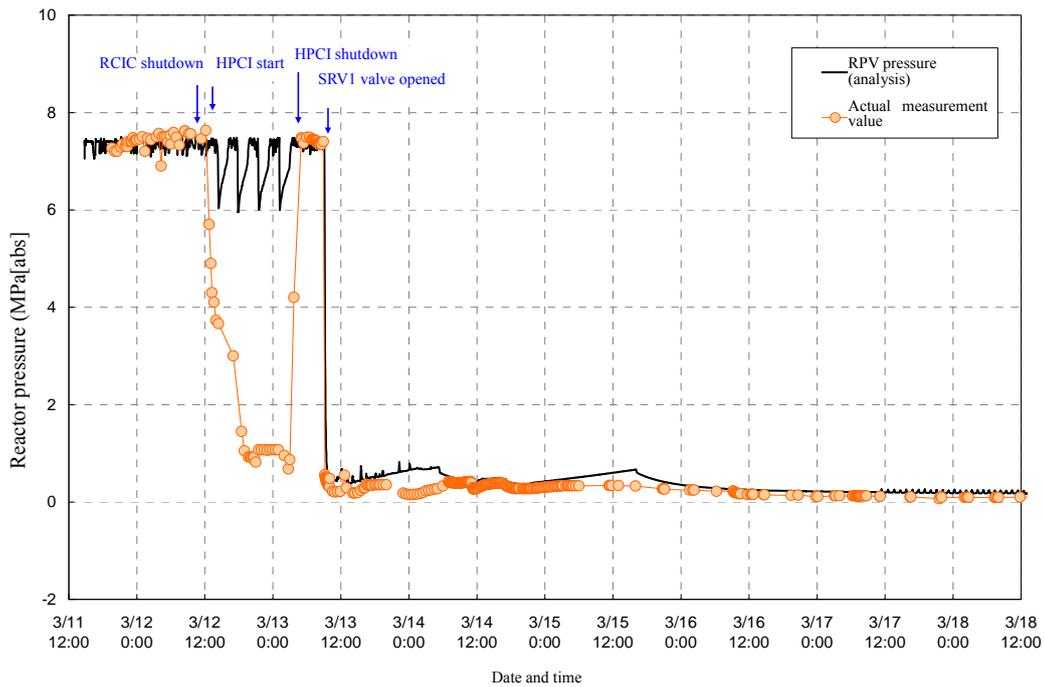
The SRV was opened at around 9:08 on March 13, and both the analysis and actual measurement data shows the rapid decrease in the reactor pressure.

Unit 3 Changes in reactor pressure [Case 1]

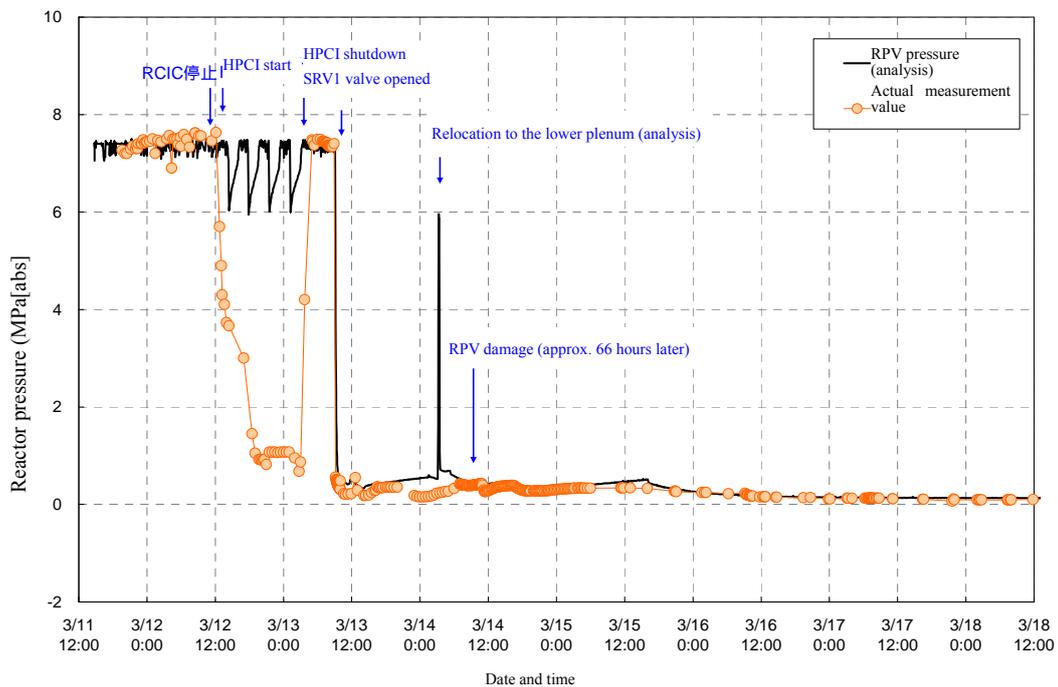
Unit 3 Changes in reactor pressure [Case 2]

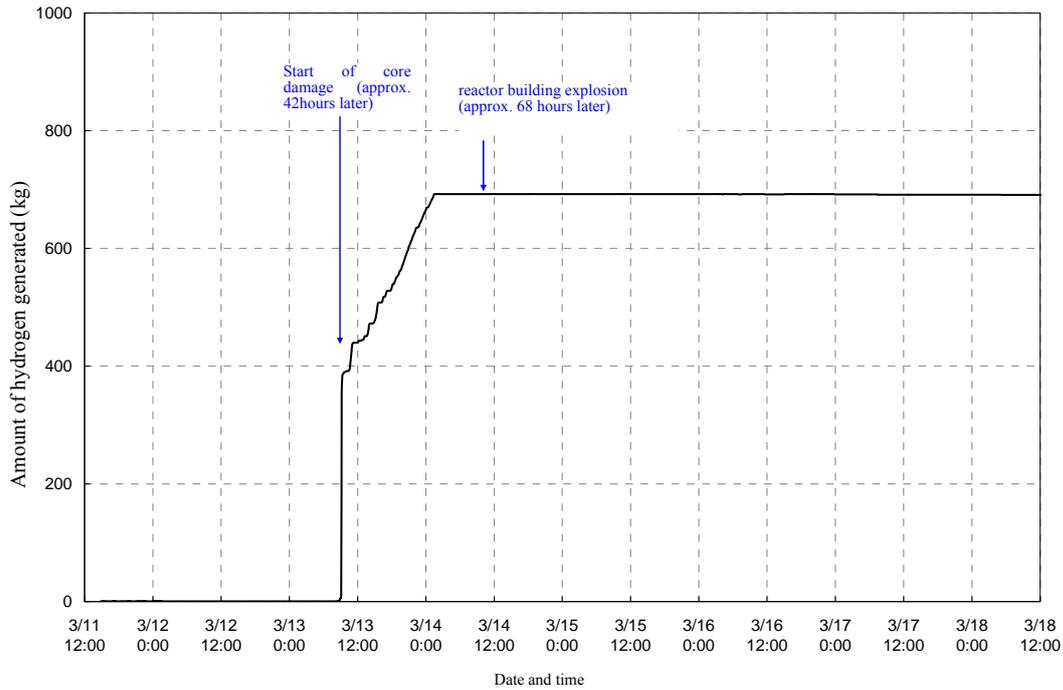
On March 14 at 11:01, an explosion occurred at the reactor building that is considered to be due to hydrogen. The amount of hydrogen generated increases when water/steam is supplied after the shape of the heated fuel cladding being maintained to a certain degree. Accordingly, the amount of hydrogen generated calculated in the analysis was approximately 700 kg for Case 1 and approximately 600 kg for Case 2.

Unit 3 Changes in the amount of hydrogen generation [Case 1]

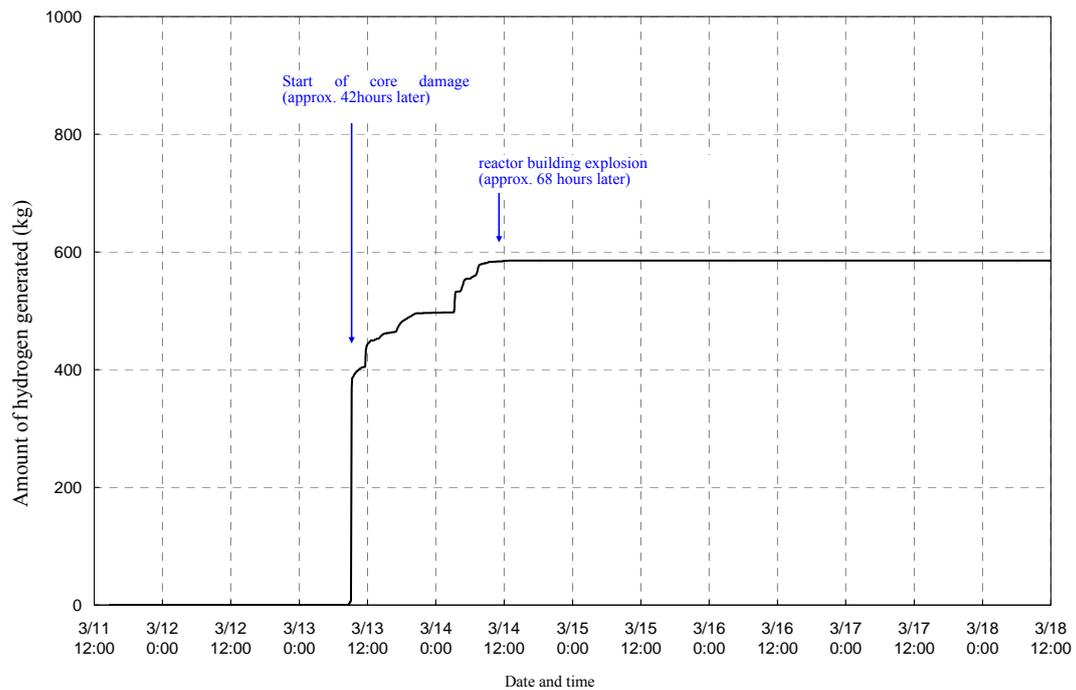
Unit 3 Changes in the amount of hydrogen generation [Case 2]

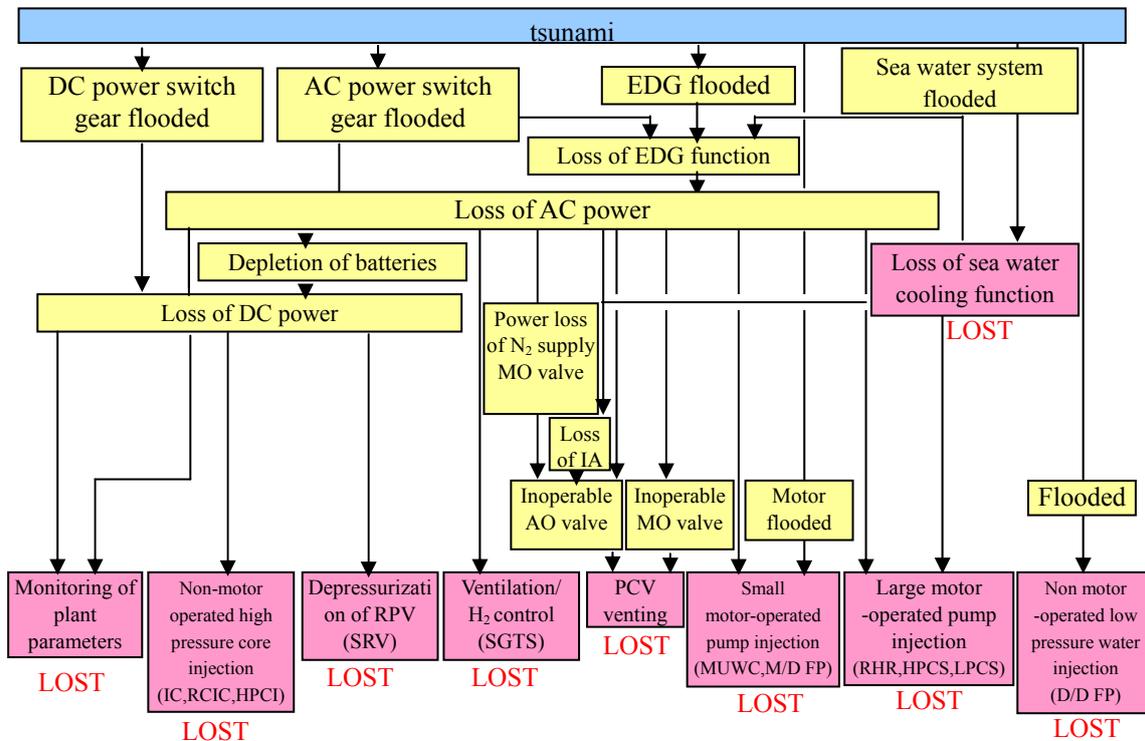
Preparations had been made to receive power from neighboring units in the event that AC power and DC power were not available. However, in the case of this accident, the direct tsunami damage was so widespread that the neighboring units were all in the same condition.

Causes leading to the loss of critical functions to prevent core damage and mitigate impacts

Therefore, lessons on the equipment and functions that can be recognized from this accident can be identified as below from the perspective of ensuring functions from 2) to 7) in “10.2 Issues on facilities and functions.” It is necessary to take countermeasures to maintain functions by preventing tsunami flooding as well as alternative means for securing functions against loss of power and heat removal capability in an extended period of time.
