Regarding the steps to be taken regarding the leakage of water containing radioactive materials at the water desalination of Fukushima Daiichi Nuclear Power Station

December 8, 2011  
Tokyo Electric Power Company

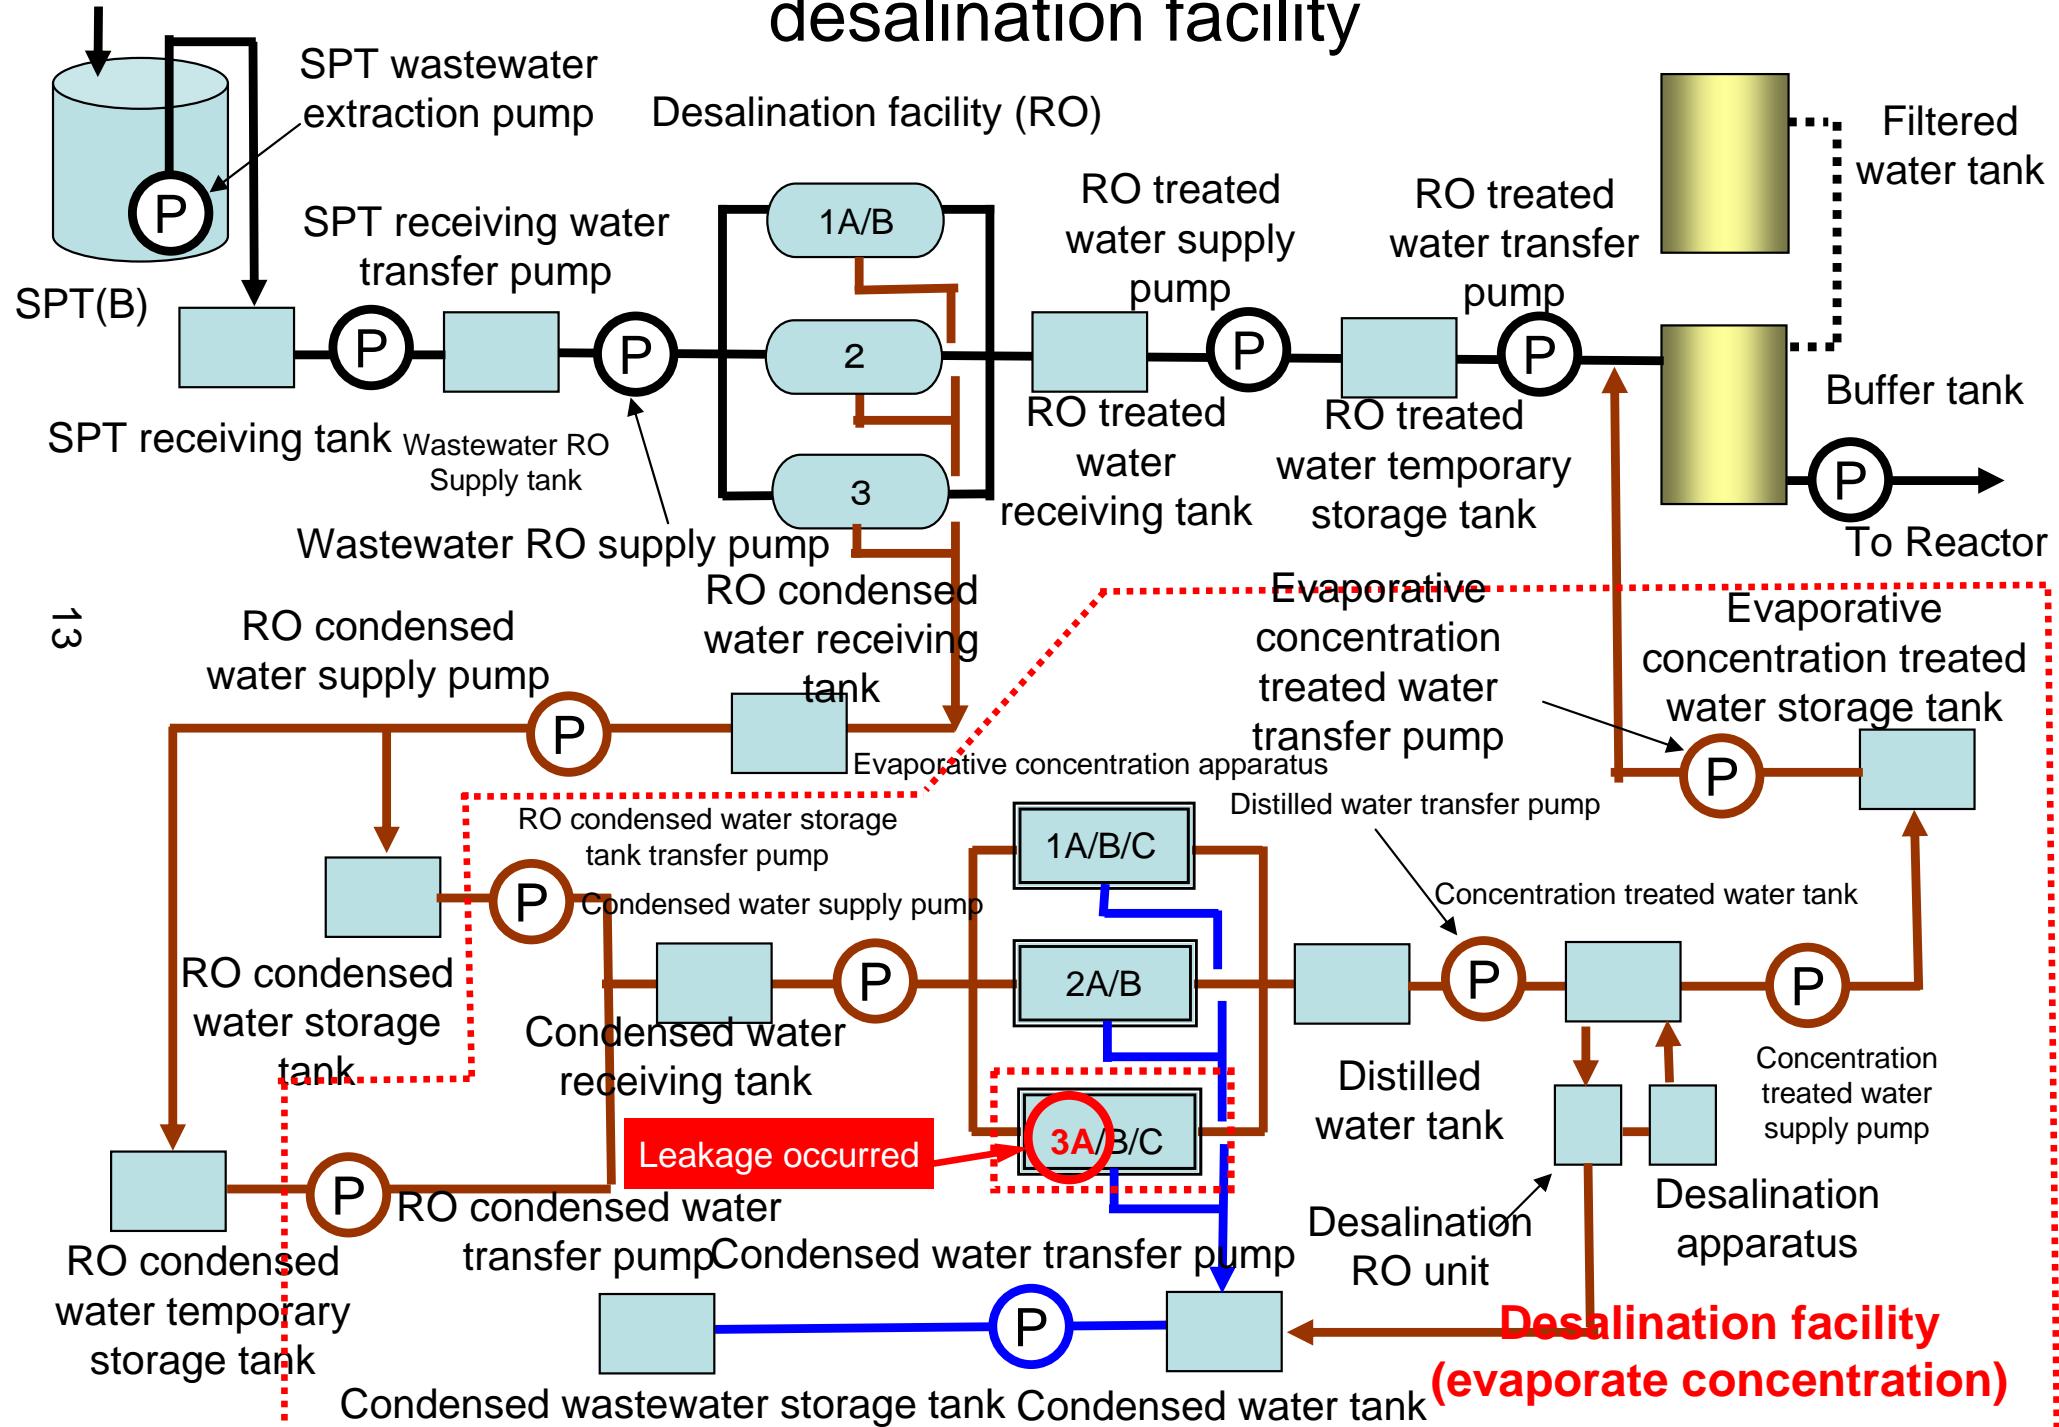
Appendix 2

# System diagram of water desalination facility

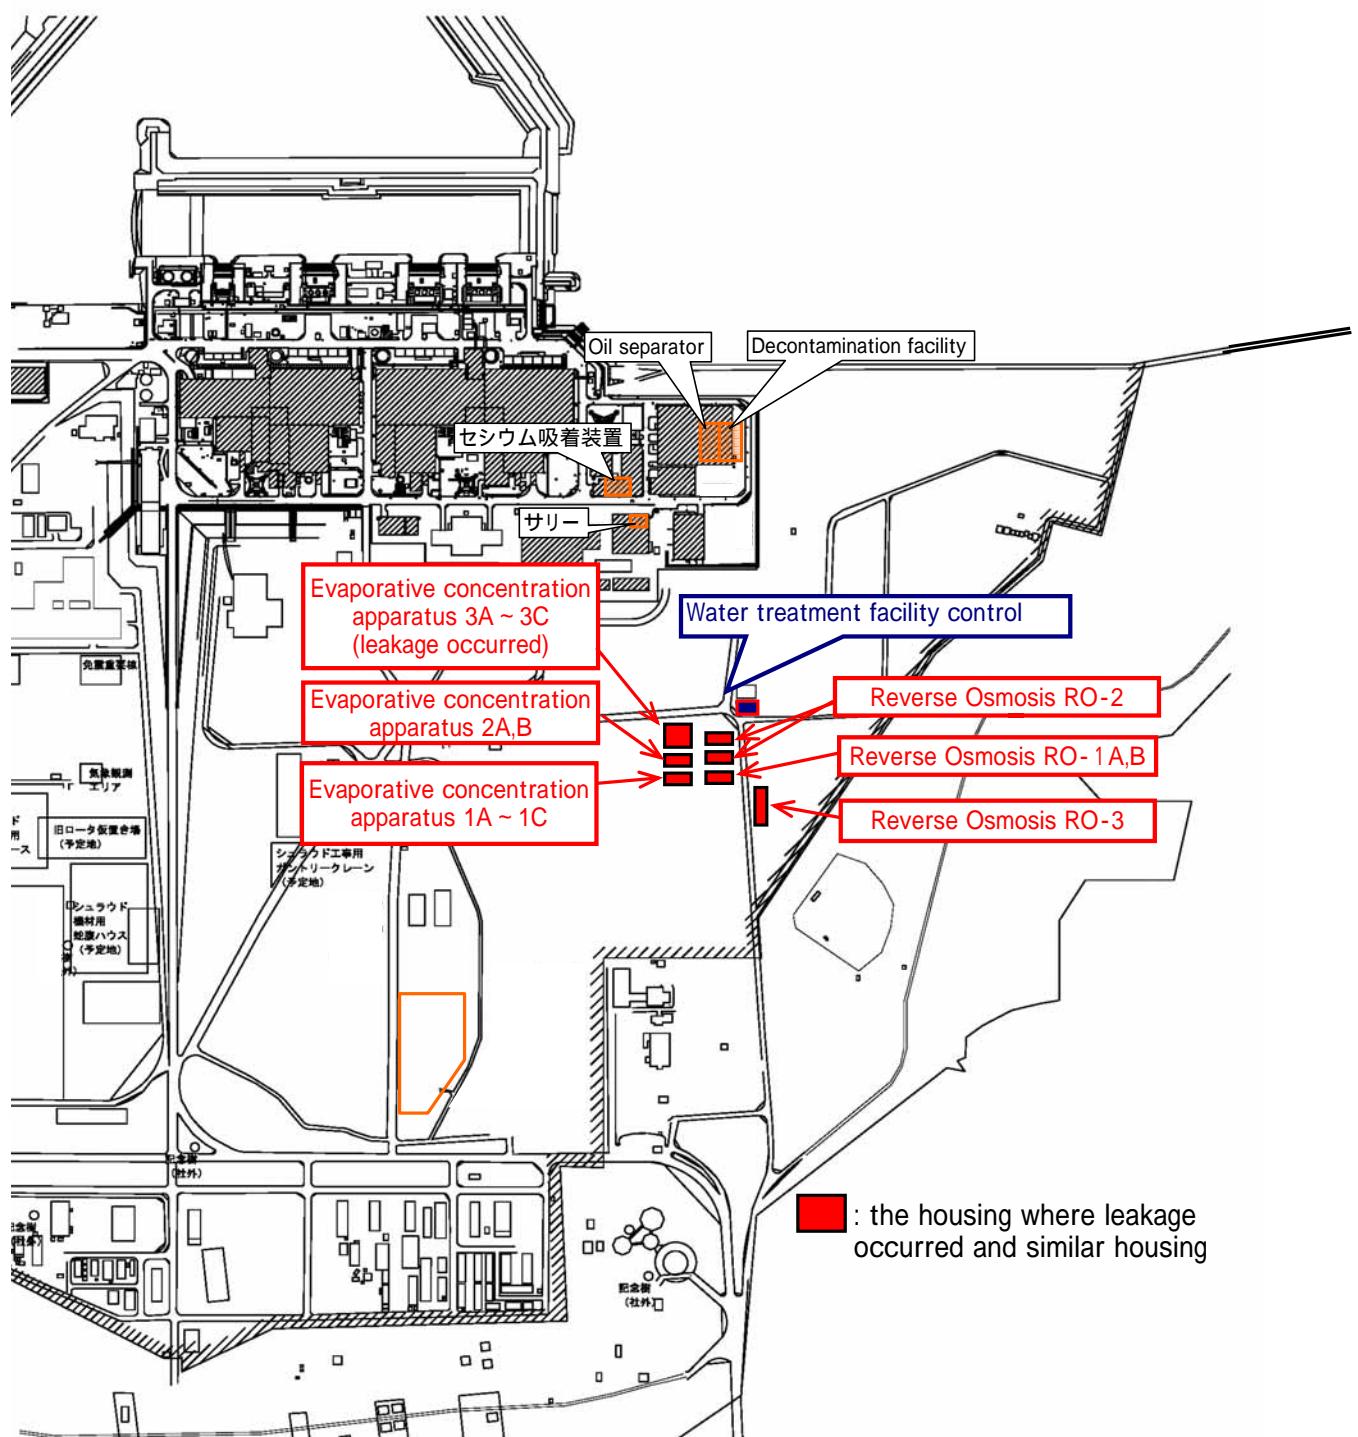
RO3 bellows housing (to be repaired)

Schematic location diagram of the housing where leakage occurred and similar housing

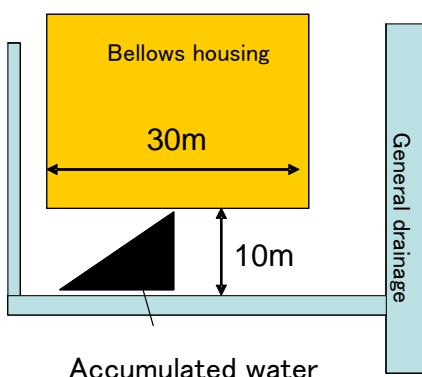
## Evaluation of leaked volume to the general drainage

①Visual observation: approx 1 L/min (approx 180 ml in 10 sec)

•Flowing into U shaped gutter to applying sandbags was the duration of leakage. This was  $240 - (75 + 10 + 10) = 145$  min.

•The total volume of leakage to the general drainage was assuming conservative leakage velocity of 1L/min,  $1L/min \times 145\text{ min} = 145L$  rounded up to [approx 150L]

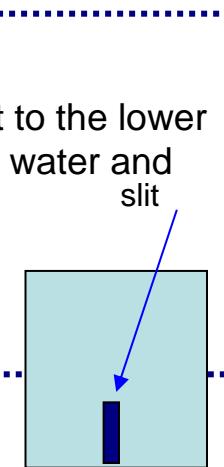
As the test was not successful, we made a slit to the lower side part of a plastic container, poured 5cm of water and measured the water outflow.

- width 2mm, height 20mm: 120cc/min
- width 3mm, height 30mm: 270cc/min
