Measures Taken at Fukushima Daiichi Nuclear Power Station and
Fukushima Daini Nuclear Power Station (December 2011 Edition)

Fukushima Daiichi Nuclear Power Station

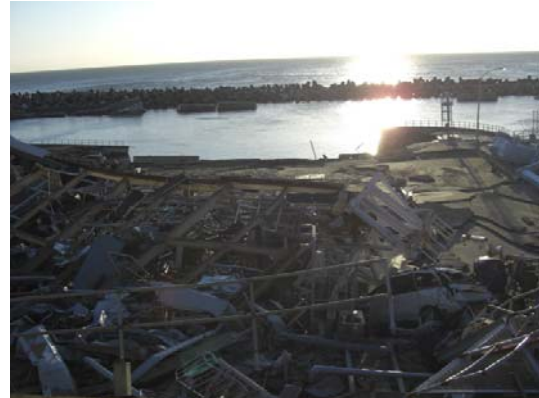
Seaside after the tsunamis struck

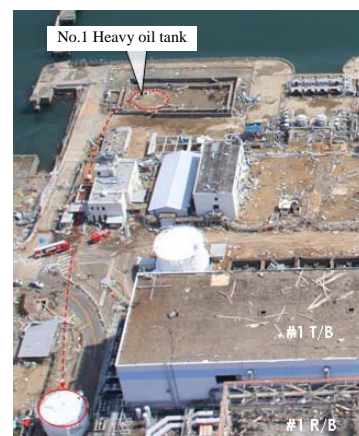
A heavy oil tank was washed away in the tsunamis up to a place near the north side of the Unit 1 turbine building.

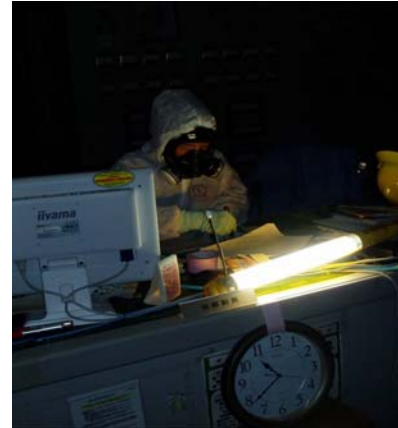
Working with a temporary light at the vice shift supervisor seat

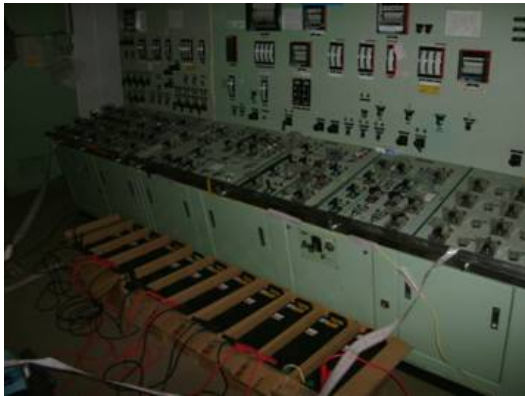
Instruments connected to temporary accumulators as power supplies

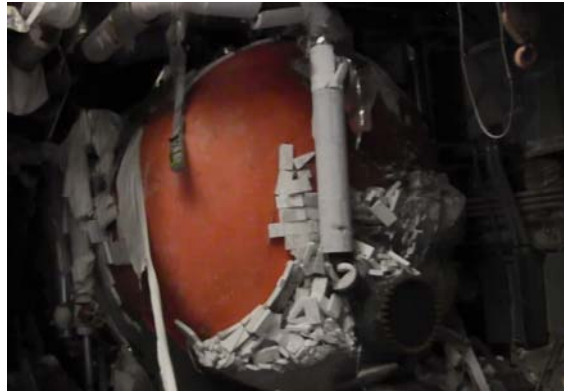
Appearance of the IC
(Photo taken on Oct. 18, 2011)

The vermillion colored part indicates the IC shell. The silver-colored insulation material was seemingly stripped off due to the impact of the explosion.

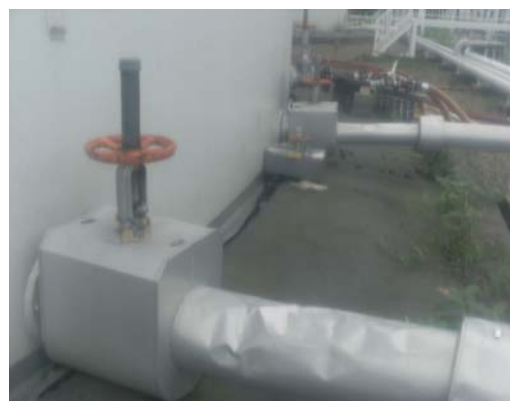
Outlet valve of a filtrate tank

Outlet valves for other than the FP line needed for the reactor water injection were closed.

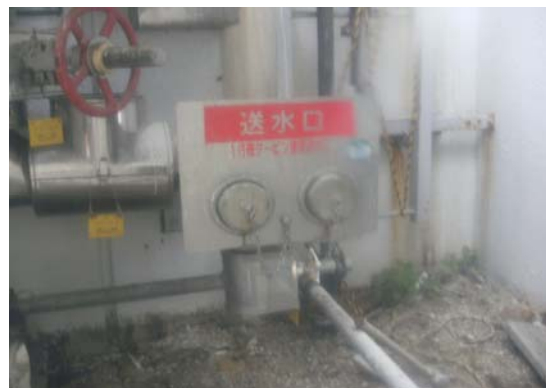
Outlet of Fire Protection System of Unit 1

- At around 2:00 on March 12, the power generation team and fire brigade headed for the target area to find the outlet of the FP line outside the building. At the work

- At around 3:30 on March 12, together with a TEPCO employee who was familiar with the site, the work team again headed for the site and finally found the outlet. At around 4:00, freshwater (1,300 liters) loaded in a fire engine was injected. A fire engine had malfunctioned in the tsunami near the Security HQ on the side of Units 1 to 4. When the work team tried pumping water from the fire engine to inject water, the radiation dose in the work site started rising at around 4:20. Thus, the work team temporarily suspended the water injection operation and returned to the Seismic Isolated Building. Later, contamination monitoring confirmed contamination. The contaminated members of the work team were isolated in another room.

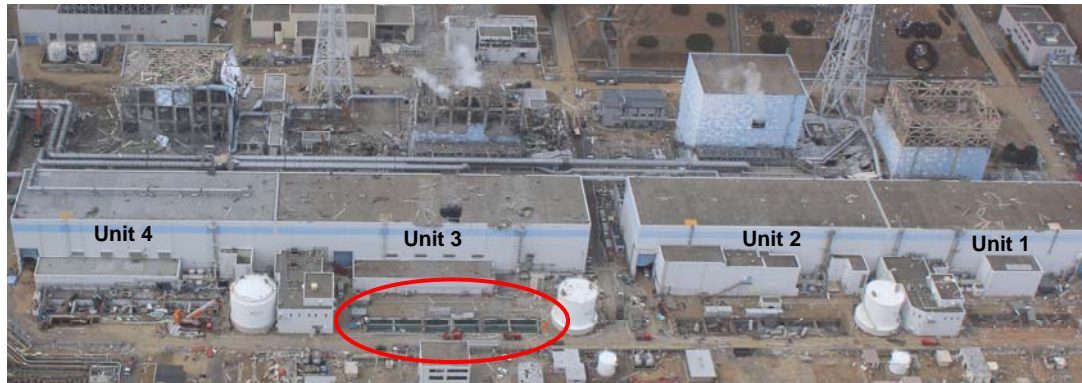
Reversing valve pit of Unit 3

(The reversing valve pit of Unit 3, where seawater containing less debris had accumulated, was used as the water source.)

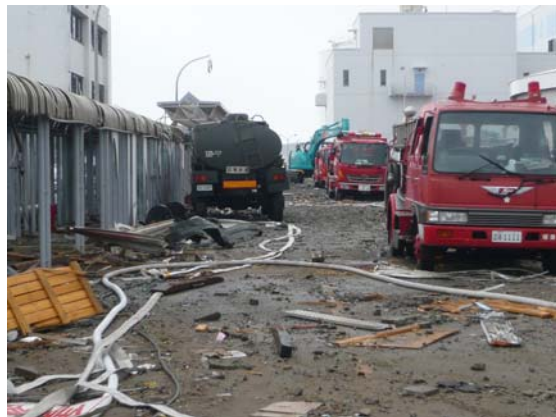
Water injection by a fire engine (photo taken on a later day)

- The fire brigade succeeded in connecting three fire engines in series to form a water injection line, using the reversing valve pit of Unit 3 as a water source. The fire brigade started seawater injection at 19:04 on March 12.

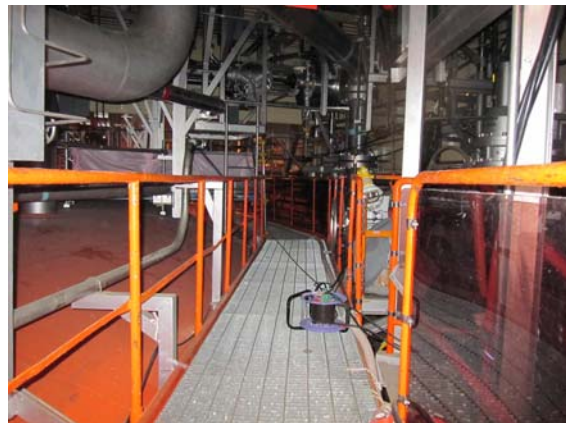
Catwalk (Unit 5, with light)

In complete darkness, operators using flashlights headed for the AO valve site. As the radiation dose was on the rise, however, they had to return.

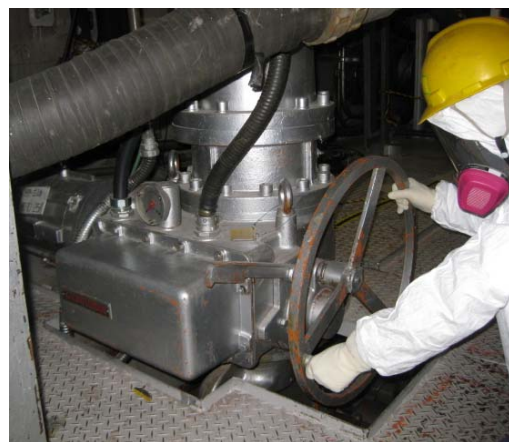
Image of rotating the RHR injection valve (Unit 5,

The manual handle was very heavy to rotate in the narrow area.

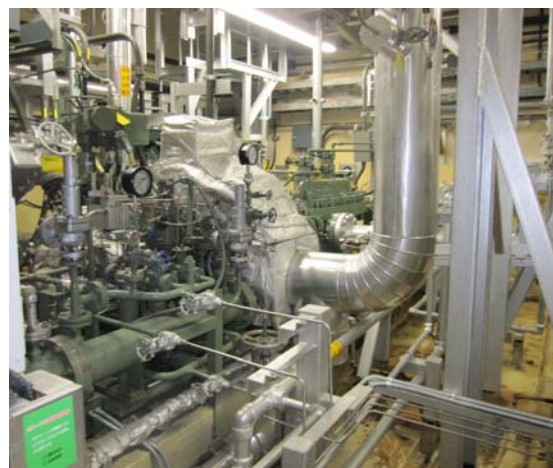
RCIC (with light, Unit 5)

The silver color (insulation material) body in the center is a turbine, while the green color unit behind is a pump. There are many pipes and supporting posts. Operators using flashlights moved around on the flooded floor to perform operations.

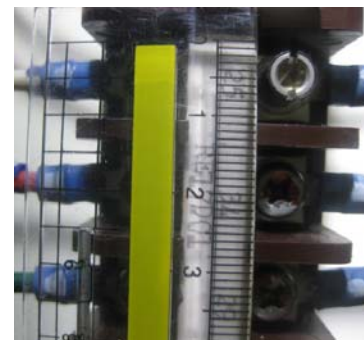
Terminal block (photo taken on a later day)
The block was approx. 1cm wide to connect with wire.

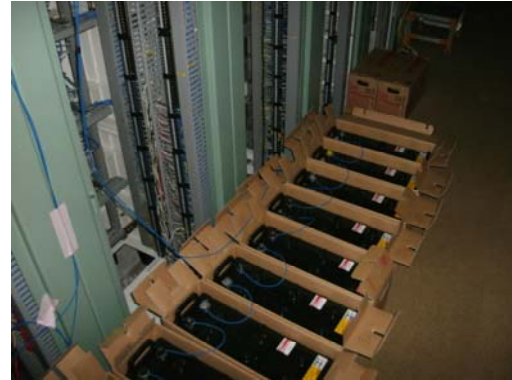
Ten 12V batteries in serial connection
(Photo with light taken on a later day)

- Operators connected ten 12 batteries serially to supply the DC power needed to start up the SRV. Wire-cutting and coat stripping needed fine finger work. Wires and terminals were directly connected and fastened with insulation vinyl tape, which could have resulted in accidental electric shock and/or short circuit. Using flashlights alone, the full-face mask provided a narrow view. The insulation vinyl tape sometimes twisted around the rubber gloves. At times, the wire accidentally came into contact with the battery, sparking and fusing part of the terminal.

Wires and terminals were tightened with insulation vinyl tape. Accidental electric shocks and/or short circuits occurred, sparking and fusing part of the terminal.

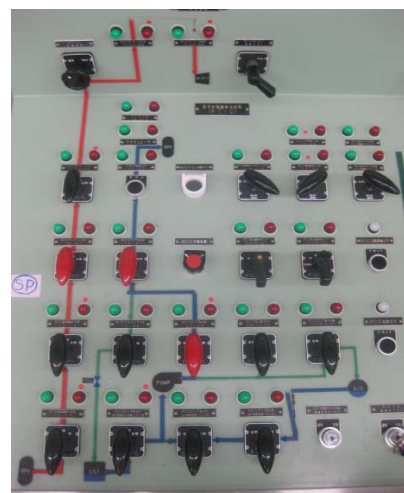
RCIC control panel (photo taken on a later day)

The open or closed valve state indicates the operating state.

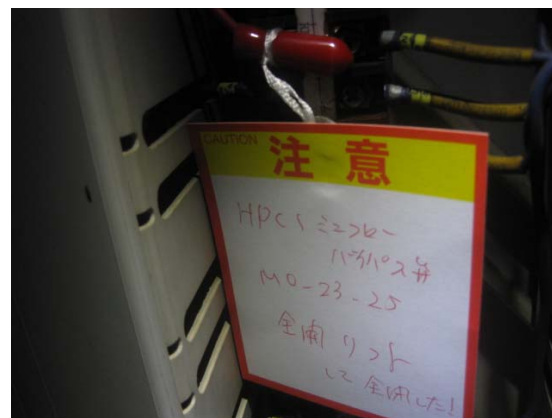
HPCI control panel

To limit the rising S/C water level, the keying circuit of the minimum flow valve was fully closed.

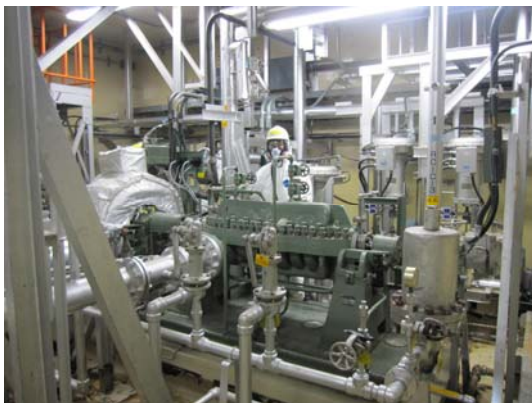
RCIC (Unit 5, with light)

- From 5:08 on March 13, operators tried starting up the RCIC on the RCIC control panel in the Main Control Room after setting a low flow rate with the FIC so that the bite-in state of the mechanical structure would have no impact during the RCIC startup. However, the mechanical structure of the steam stop valve was dislocated, resulting in the closure of the valve and stoppage of the RCIC.

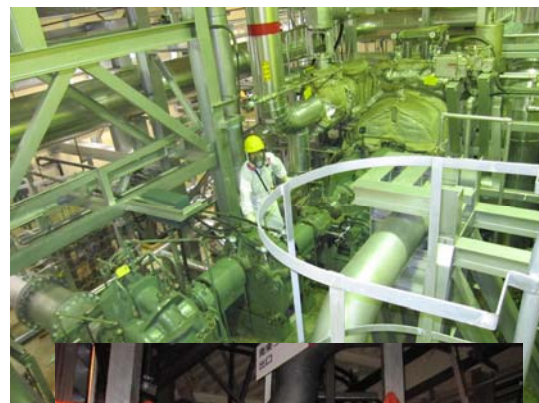
There are many pipes and supporting posts in the RCIC area around the flooded floor to perform operations.

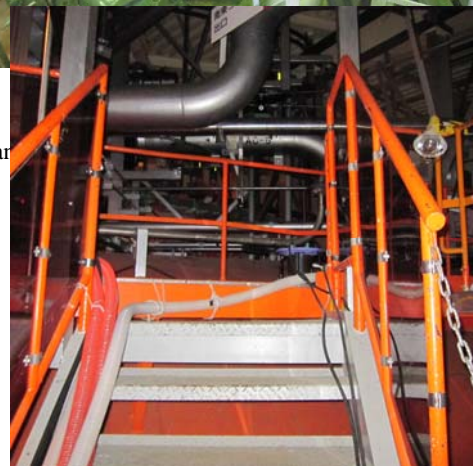
Torus room entrance (Unit 5, with light)

100 Operators headed for the muggy room to manipulate the S/C spray valve manually using flashlights in complete darkness.

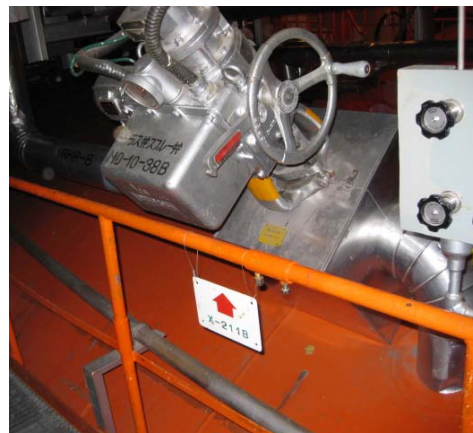
S/C spray valve (Unit 5, with light)

The orange area is a torus; The S/C spray valve is located on the upper torus. The operator cannot manipulate the handle without placing his/her feet on the torus.

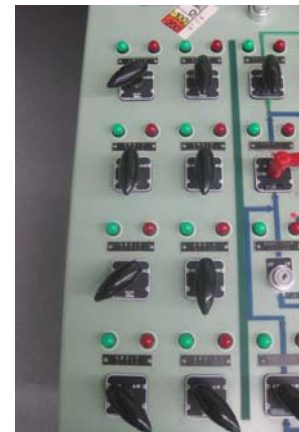
SRV control panel (photo taken

- At around 9:40 on March 13, the operation to connect ten batteries serially was completed and they were connected to the SRV control panel. Operators opened the SRV with the operation switch and maintained the reduction in pressure

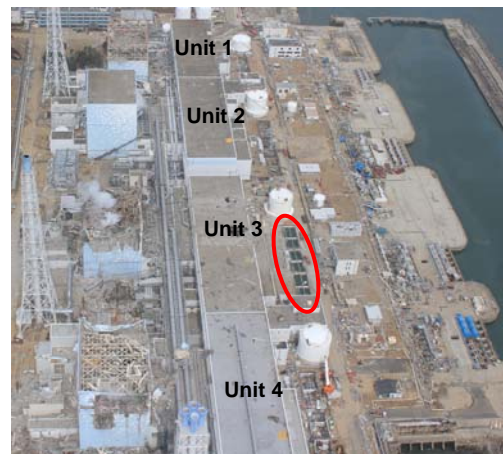
Condenser reversing valve pit of Unit 3

- The fire brigade was injecting freshwater from the anti-fire water tank to which water was being supplied. At 12:20 on March 13, however, the nearby anti-fire water tanks had little freshwater left. The fire brigade started to shift the water injection line to the seawater injection line of the reversing valve pit of Unit 3. Because the fire brigade had prepared for the shift in a short time, the formation of an alternative line was completed at 13:12 and seawater injection commenced.

- At 1:10 on March 14, the reversing valve pit of Unit 3 had little seawater left. The fire brigade thus stopped supplying water from the pit via the fire engine and thus prevented the fire engine pump from burning out. The fire brigade was able to draw in seawater to inject into Unit 3 by approaching the fire engine beside the reversing valve pit of Unit 3 and lowering the sucking position of the hose and resumed seawater injection from 3:20.

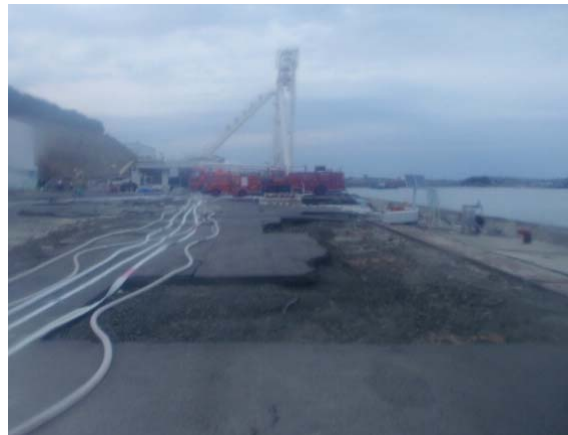
The fire-engine-based water injection from the Shallow Draft Quay

- From 13:05 on March 14, immediately after the instruction of Site Superintendent, the fire brigade headed for the work sites to check the situation. They were exposed to high radiation doses when passing through roads with scattered debris. The water injection line was also unavailable because the fire engine and hose had damage.

- The fire engine that supplied seawater from the Shallow Draft Quay to the reversing valve pi of Unit 3 remained in service and available for operation. Thus, the Emergency Countermeasures Headquarters decided to use the fire engine to supply seawater from the Shallow Draft Quay to Units 2 and 3 and promoted preparation for a water injection line.
- At around 16:30 of the 14th, The fire engine was started up to resume the seawater injection line.

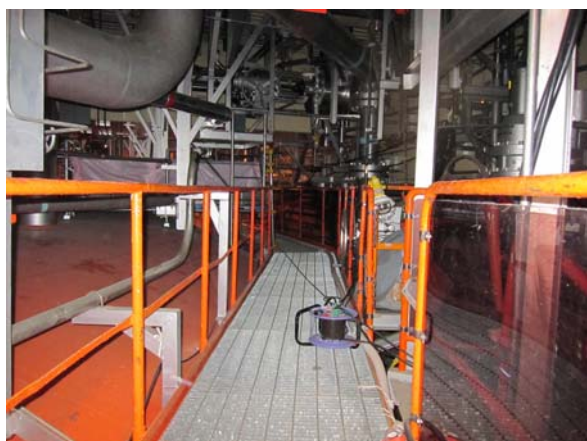
Condition of torus room (Unit 5, lighted)

The orange-colored section is the torus. The S/C vent valve is located in the upper area of the torus room (inside the red circle of the right photo) and the valve cannot be inspected without stepping on the torus. When the operator stepped on the torus relying only on torchlight in total darkness, his shoes melted by heat.

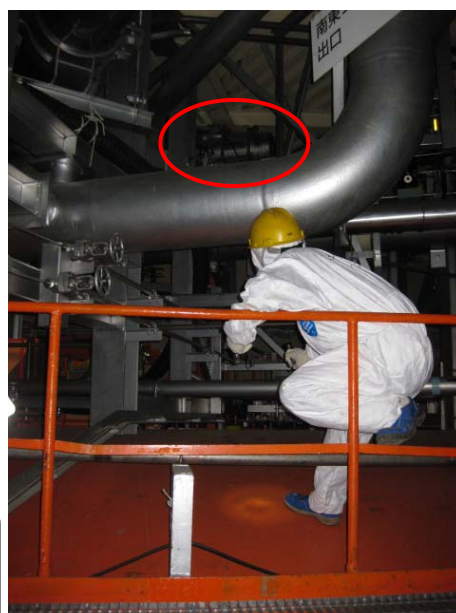
Image of the S/C vent valve inspection work

- At 5:50 on March 13, a press release was issued regarding the implementation of vent operations.
- Later, a reactor operator went to the torus room on the basement floor of the reactor building to inspect the open/close condition of the S/C vent valve (AO valve) large valve and found that the temperature in the torus room had increased further. When he stepped on the upper part of the torus with the intent of inspecting the open/close condition of the S/C vent valve (AO valve) large valve, the boots he wore melted by heat and hence he gave up inspecting the open/close condition. About 8:00 on March 13, he returned to the main control room.

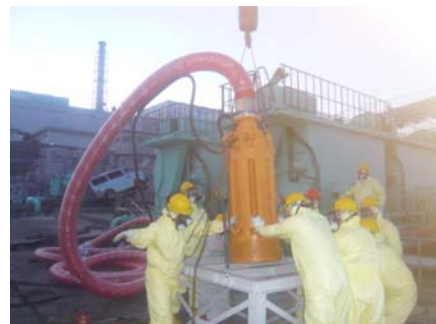
- Due to the outage, approximately 2.5 months had passed since Unit 5 had been shut down and approximately 7 months since Unit 6 had been shut down, and **the decay heat inside the reactor at the time of the earthquake was comparatively less than when the plant is operating.**
- As a result of verifying the soundness of the Unit 5 and Unit 6 RHR seawater pumps, the recovery team determined that the pumps could not be used. In cooperation with the Head Office, consideration

Work conditions for installation of underwater pump

began to be given to **connecting general service underwater pumps to a seawater system pipe temporarily for restoration as an RHR alternative cooling seawater pump.**

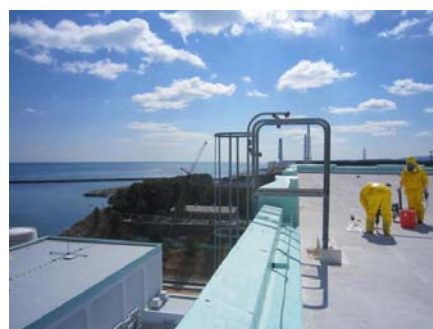
Work conditions on the roof

capacity might be lost due to aftershocks, as a precaution, it was decided **to examine measures for preventing the retention of hydrogen gas. On March 18, a boring machine was used to drill holes at three locations (diameter ranging from approximately 3.5 centimeters to approximately 7 centimeters) on the roof (concrete) of the Unit 5 and Unit 6 reactor buildings.**

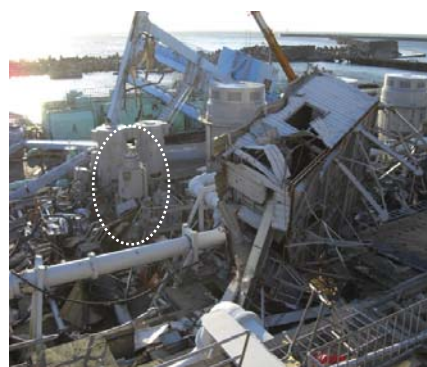
- **With regard to the seawater pump for cooling the Unit 6 DG (6A), although it had been covered with seawater in the tsunami, operators and recovery teams conducted a visual inspection of the inundation situation of the outdoor seawater pump area, the external condition of the damage and other such conditions, and carried out measurements of insulation resistance and other functions**

Condition of seawater pump area
(: indicates the DG (6A) seawater pump)

to verify soundness, and it was started up at 19:07 on March 18.

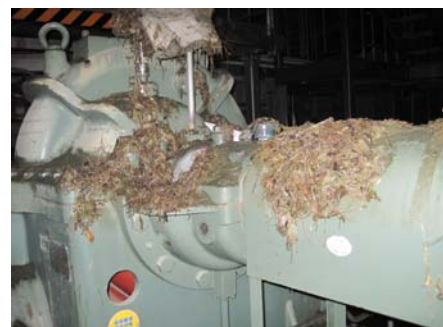
Submerged seawate pump (the photo was taken at a later date)

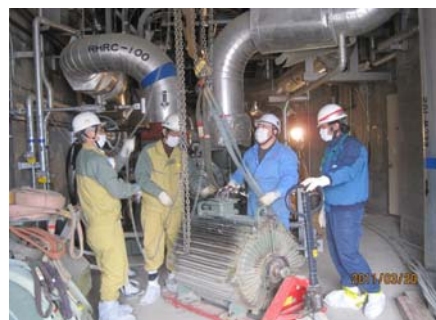
- With regard to the motor for part of the seawater system facility important from conducting heat removal of the reactor at Unit 4, the insulation resistance was not restored, so the motor was disassembled and inspected and, along with this, preparations were made for its replacement. From the results of the disassembly and inspection, it was determined that the existing motor could not be used, so **it was decided to use a motor**

**Pump motor recovery work
(photo of work conditions at a later date)**

transported by land from the Kashiwazaki-Kariwa Nuclear Power Station. During transport of the motor, the door of the Unit 4 Hx/B did not open, so the work of delivering the motor was difficult with the door having to be destroyed along with other problems.
