# Fukushima Nuclear Accident Analysis Report

June 20, 2012  
Tokyo Electric Power Company, Inc.

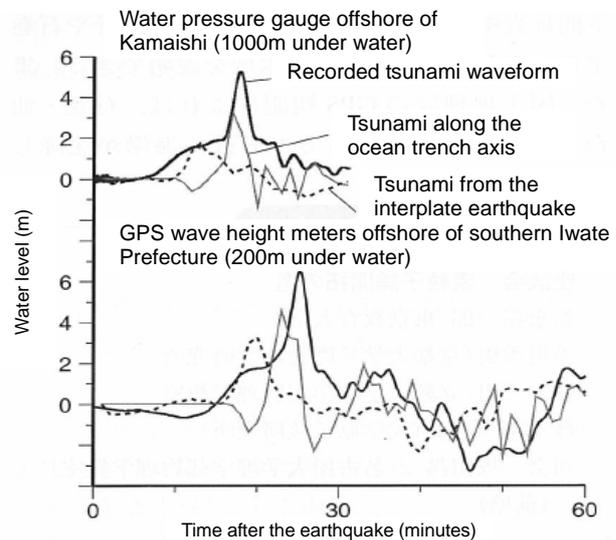
Figure 3 – Waves (bold line) recorded using the ocean-bottom water pressure gauge offshore of Kamaishi (above, Earthquake Research Institute of the University of Tokyo) and the GPS wave height meters (below, Port and Airport Research Institute). The dotted lines indicate tsunami waveforms that were derived from an interplate earthquake. The gray lines indicate tsunami waveforms that were derived from only the earthquake along the ocean trench axis. The initial rise of the observed waveform can be explained using the interplate earthquake, and the maximum wave using the tsunami that occurred along the ocean trench axis. Tsunami source of the 2011 off the Pacific coast of Tohoku Earthquake (excerpt)

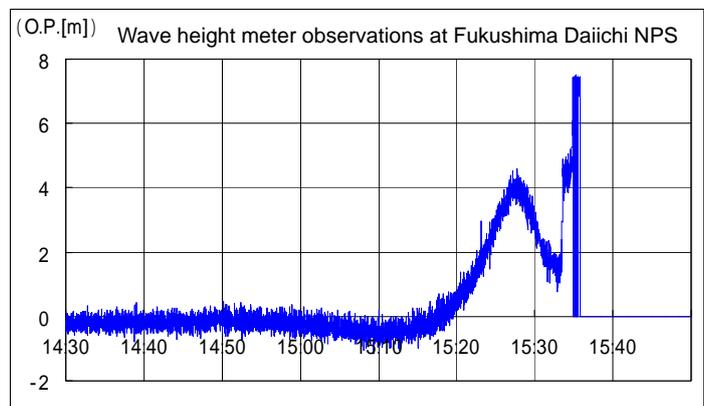
An ultrasound type wave height meter belonging to TEPCO was installed approximately 1.5 km offshore from Fukushima Daiichi NPS, but it was damaged by the second tsunami wave and collected data only until 15:35. However, according to the waveform data collected, the tsunami began rising at around 15:15 and, after a gradual rise, peaked at about 15:27.

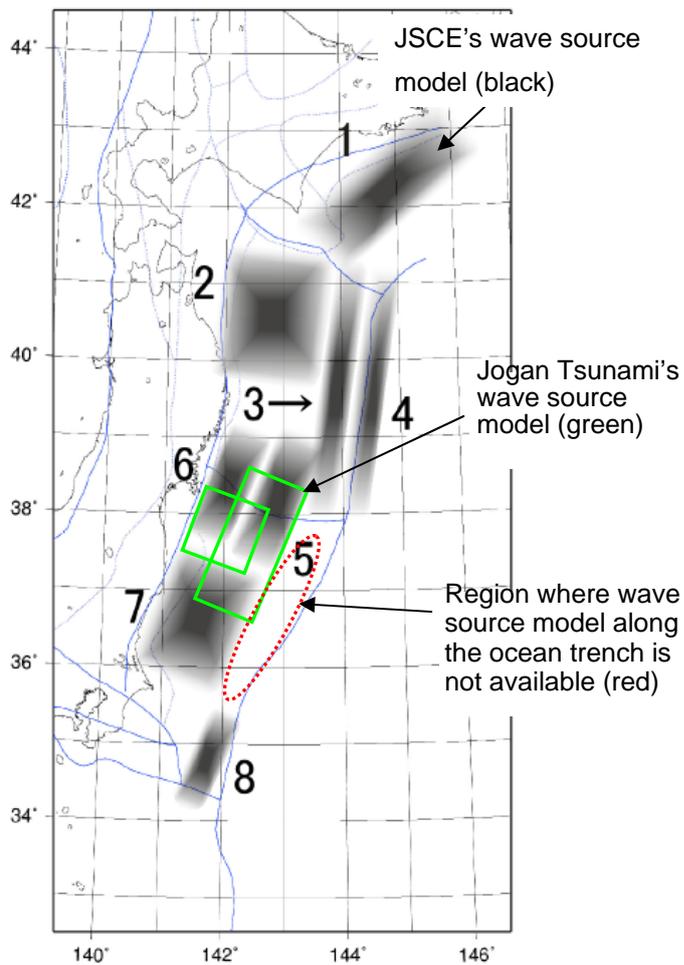
Attachment [3-20]

JSCE's wave source and Jogan tsunami's wave source (Jogan tsunami's wave source was evaluated based on Satake et al., 2008)

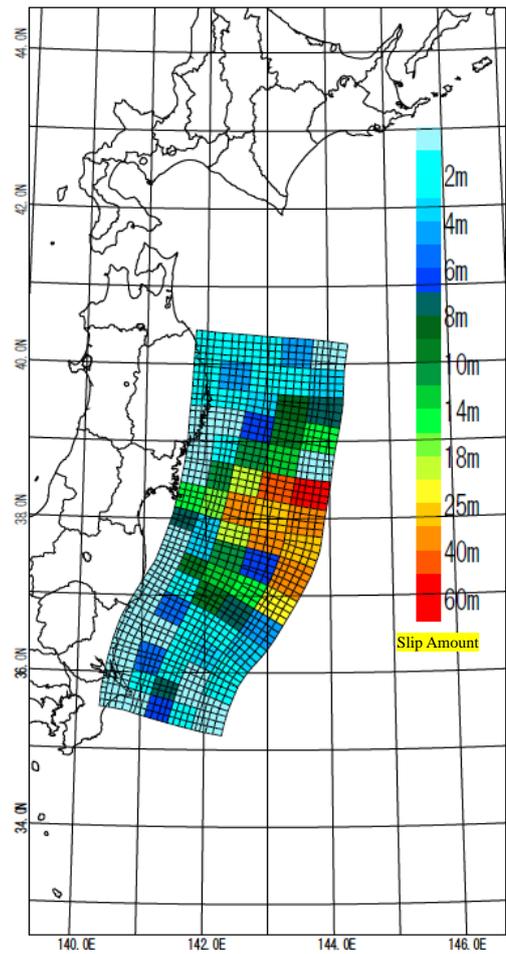
Wave source of the tsunami on March 11 (Evaluated by TEPCO)<sup>1</sup>

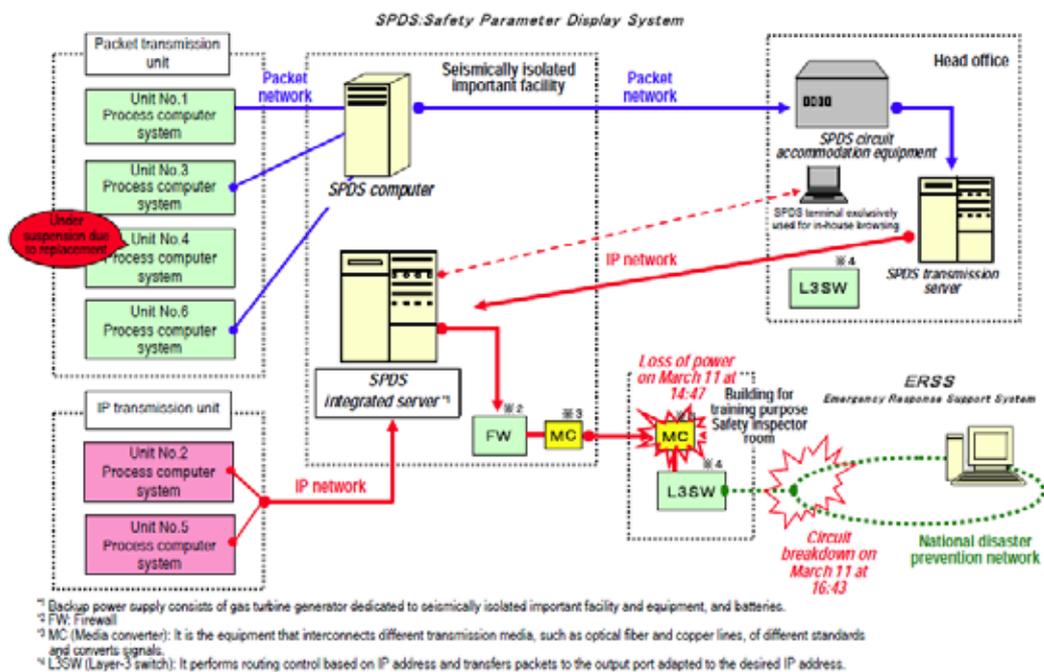
- When the SPDS was investigated in detail, transmission failure for Unit 1 and 3 was recorded at 14:49 on March 11, which likely indicates that, for Unit 1 and 3, the process computer stopped transmitting data due to some reason at that time and plant data became unavailable at the seismic isolated building as well. For Unit 6, which used the same transmission method as Unit 1 and 3, plant data continued to be transmitted with no issues. Unit 4 used the same transmission method as

- Data transmission from Fukushima Daiichi NPS was conducted with no issue, but the government's dedicated network for nuclear disaster (public telecommunication service) connecting to the ERSS failed at around 16:43 on March 11 and transmission ceased. This rendered it impossible for data to be transmitted from SPDS to ERSS (Dedicated network was common-use for Fukushima Daiichi and Daini NPS).

**Structure of Fukushima Daiichi Nuclear Power Plant' SPDS: Transmission conditions on March 11, 2011 when the earthquake occurred**

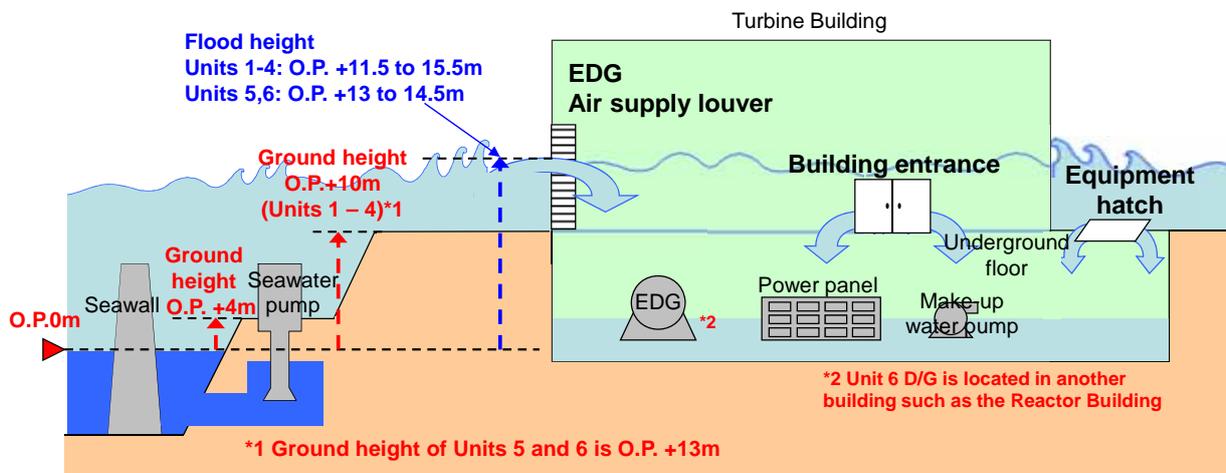
Regarding major buildings, no significant damage by the tsunami has been found on structural parts such as exterior walls and pillars. On the other hand, it was confirmed that flooding by the tsunami induced damage to building entranceways, EDG intake louvers, and aboveground equipment hatches, which cover aboveground openings on the building, as well as cable and pipe penetrations connected to underground trenches and ducts. It is considered that the water went into the buildings through these aboveground openings and cable / pipe penetrations connected to underground trenches and ducts. [Attachment 7-1]

Flooding measures were implemented in necessary locations to prevent important equipment from being damaged by flooding from water pipes and other components located inside the building. Water barriers and watertight doors were installed to prevent flooding from adjacent areas. However, during the accident, water flowed in from louvers and other higher elevation areas, and, in some cases, water remained after flowing into highly watertight areas (EDG room).

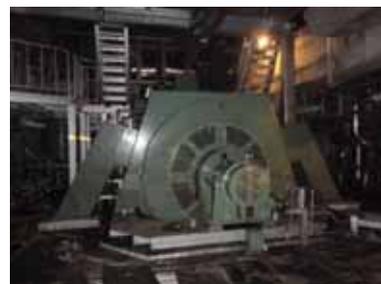
For every unit at Fukushima Daini NPS, three (A, B, H) EDGs are installed. At Unit 1, water flooded into the R/B (annex) from aboveground openings. All three EDGs were damaged by water and lost their functions. Even for the EDGs themselves that were not damaged by flooding, if the power panels or pump motors of the EDG seawater systems were damaged by water, they lost ability to cool their engines and, thus, their functions. All EDG seawater systems lost functions except three subsystems of Unit 3 (B, H) and Unit 4 (H). As a result, a total of nine EDGs failed: Unit 1 EDG (A, B, H), Unit 2 EDG (A, B, H), Unit 3 EDG (A), Unit 4 EDG (A, B).

Water damaged Unit 1 D/G (A)

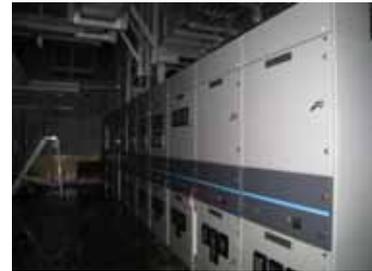
On the other hand, power panels installed in the heat exchanger buildings on the seaside area were damaged by water that flowed into buildings. All seven subsystems except one low voltage power panel (P/C) subsystem in Unit 3 heat exchanger building was damaged by water. As a result, all eight RHR seawater systems, except one for Unit 3, lost their functions. [Attachment 7-7]

Water damaged Unit 1 M/C power panel (water on floor)

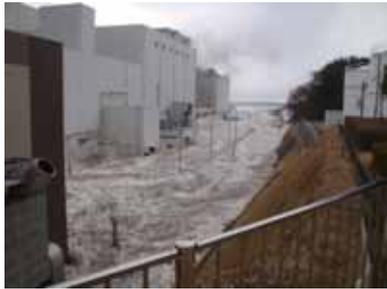
However, there were five locations in the major building area where duct hatch covers were swept away or damaged by the tsunami, creating openings.

State of tsunami in the premises of buildings (Unit 1 south side)

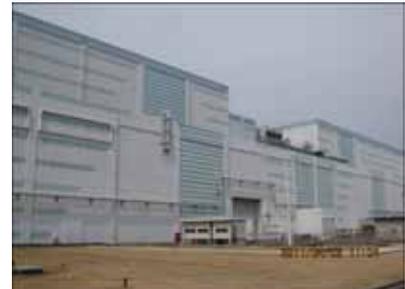
Unit 3,4 T/B  
(No traces of tsunami damage)

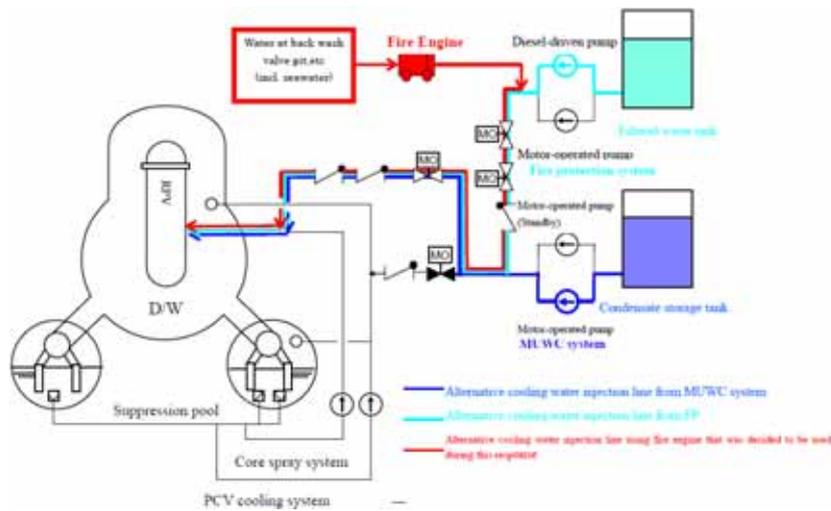
Alternative cooling water injection line  
 (Line up for injecting cooling water using fire engine)

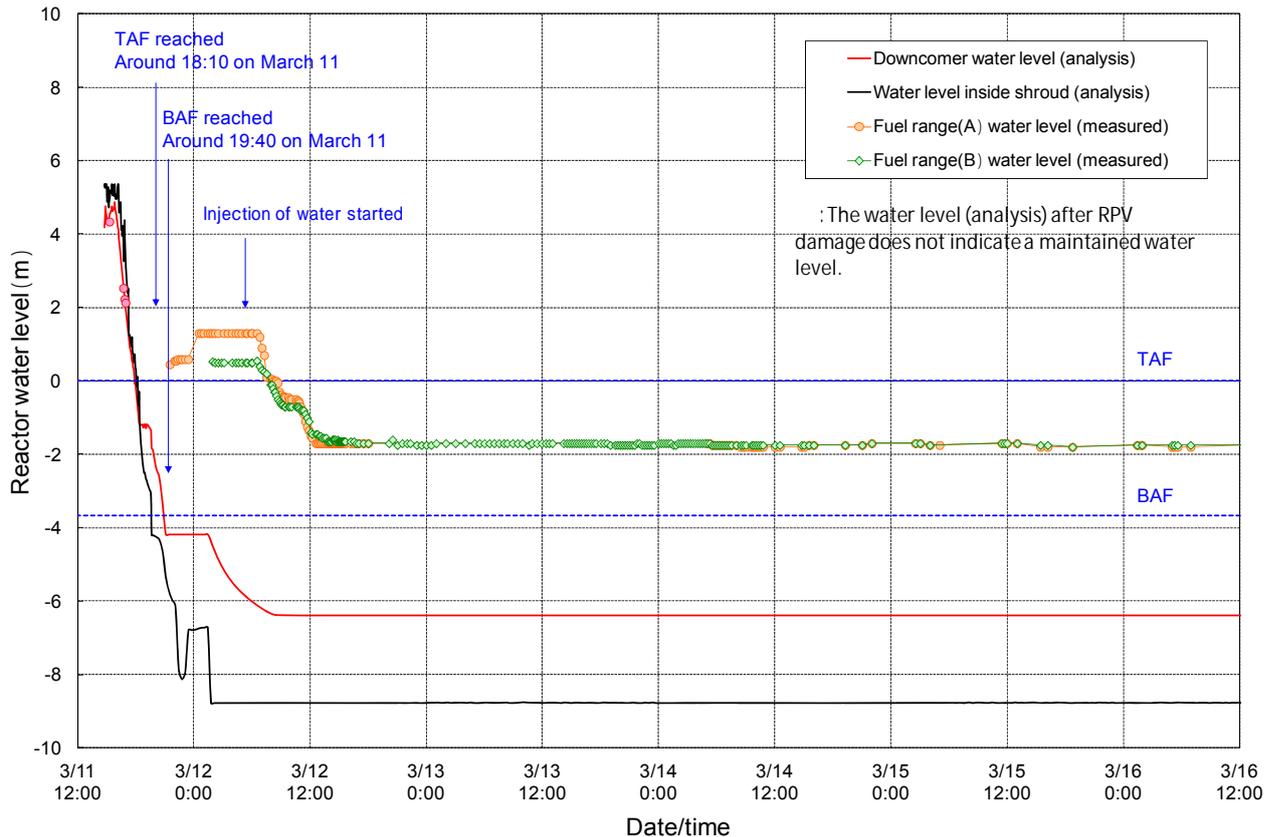
<Reactor water level movement>

After the theoretical IC shutdown, reactor water level analysis value would drop following the escape of the majority of vaporized reactor coolant steam from the SRV into the S/C. It would be approx. three hours after earthquake occurrence when reactor water level reached TAF, while it would be approx. four hours after earthquake occurrence when core damage began (when fuel max. temp. analysis value exceeded 1200°C). Reactor water level would continue to decrease from that point onward, reaching bottom of active fuel (BAF) approx. five hours after earthquake occurrence. As stated earlier, the water level AMV is not considered to be the correct value.

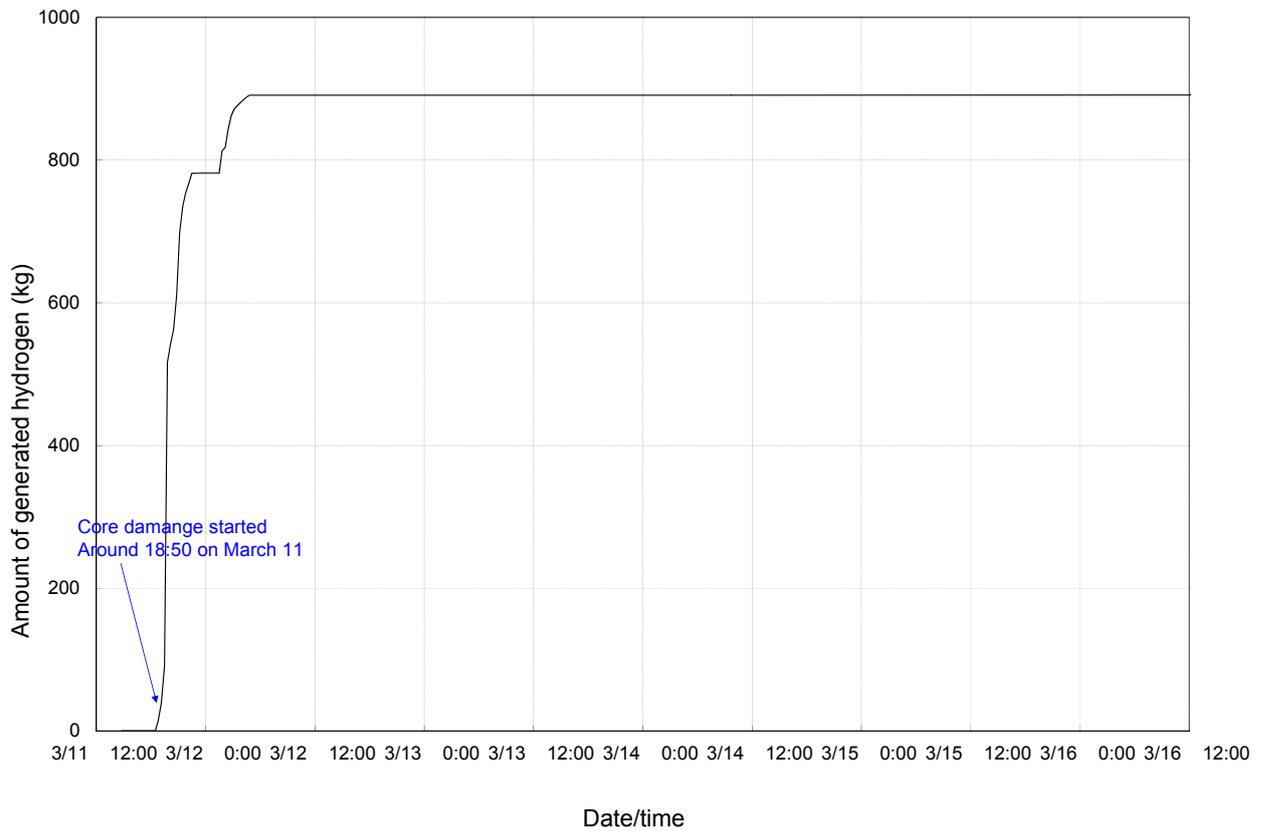
<Amount of hydrogen generated>

Hydrogen gas (a non-condensable gas) is generated due to zirconium-water reaction accompanying the start of core damage and fuel temperature increase. Approx. 890kg of hydrogen had been produced as of the time of the R/B explosion thought to be caused by hydrogen at 15:36 on March 12.

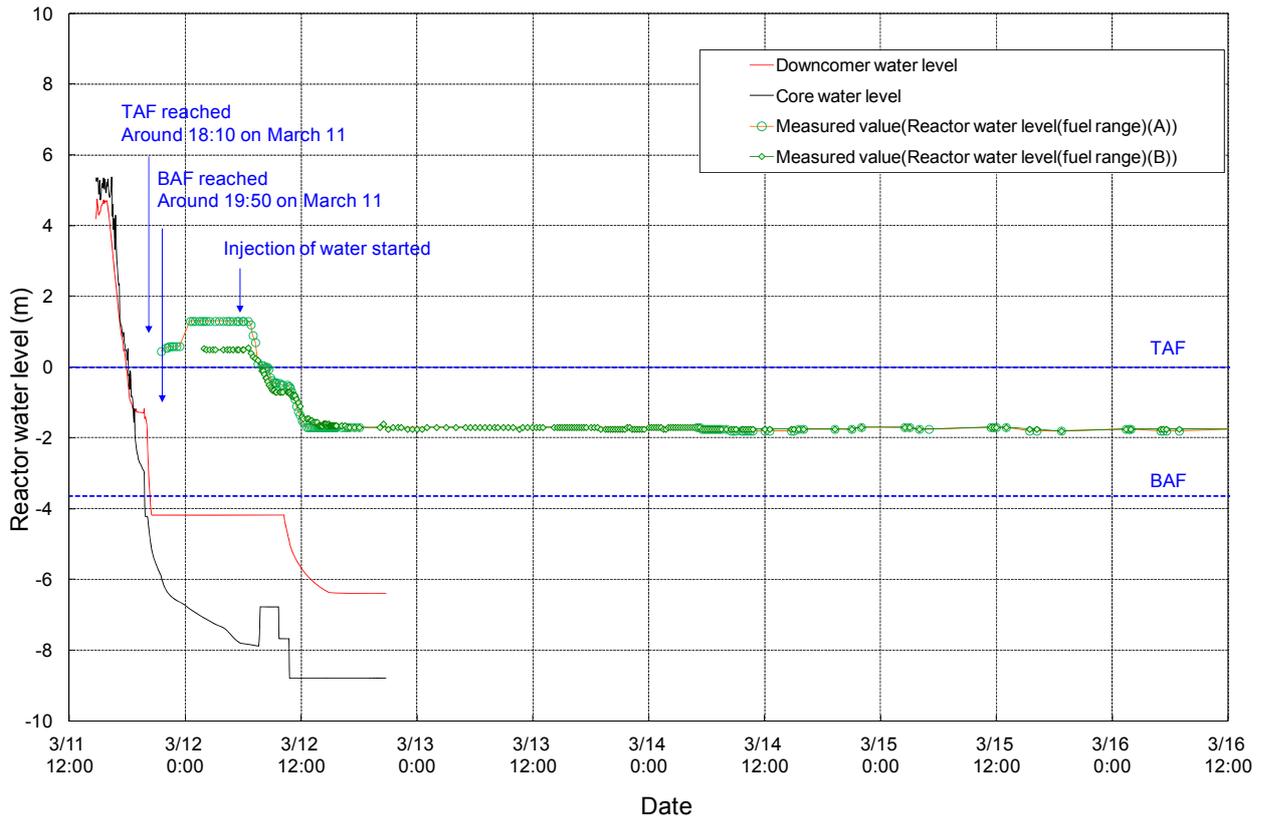
Unit 1 reactor water level (assumes IC system has temporarily functioned)

Sensitivity analysis was carried out as a parameter study, assuming the IC temporarily operated after tsunami arrival.<sup>1</sup> Although processes such as core damage and core meltdown were temporarily delayed, the final state of the core was not effectively changed as a result.

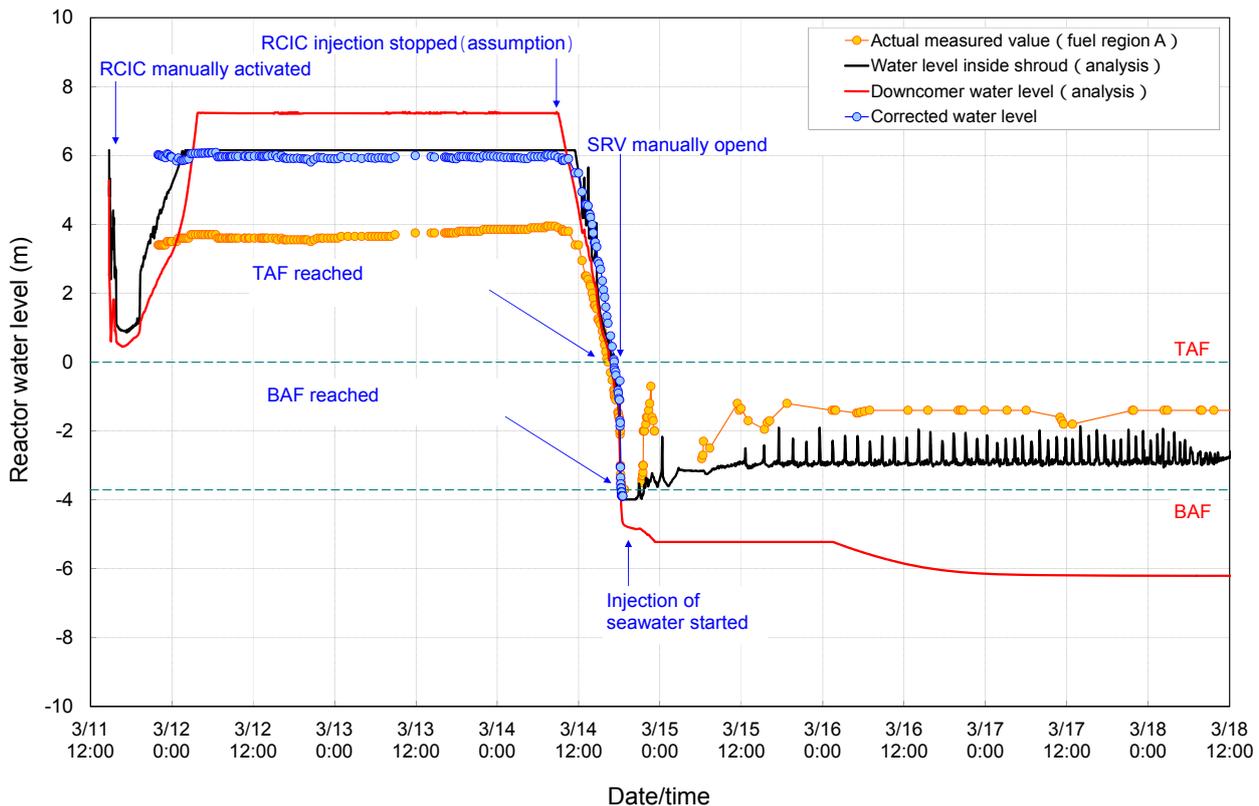
First, reactor water level during RCIC operation period transitioned around 4,000mm. This value was measured by the fuel zone water level indicator. This instrument is used to monitor water level during reactor loss of coolant accident (LOCA). Since it is calibrated by atmospheric pressure and saturation temperature, the measured reactor water level was corrected using reactor pressure and D/W temperature<sup>1</sup>. This resulted in

Normally, the RCIC trips when reactor water level is height L-8(TAF+5,653mm) to prevent steam containing water droplets from flowing into the turbine. Therefore, reactor water level should not rise to point of reference surface level. However, since control power was lost at Fukushima Daiichi Unit 2 during this accident, the RCIC continued operating without trip at L-8. This is believed to have caused reactor water levels to rise up to the point of reference surface level.

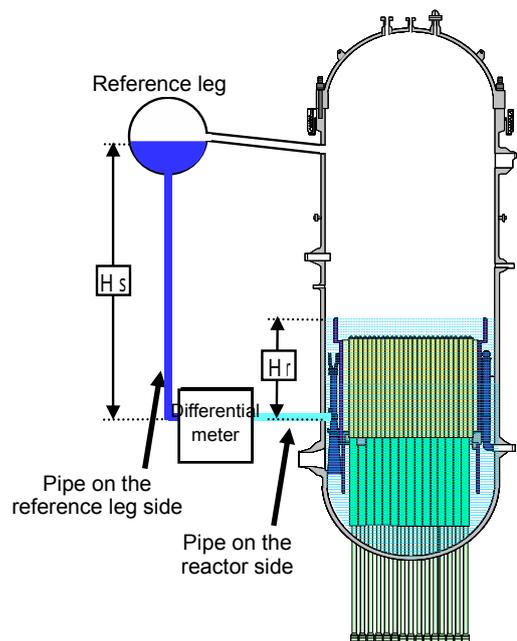
Due to the structure of the water level indicator, the pressure difference ( $H_s - H_r$  in the figure to the right) between the point of reference measurement pipe and reactor side pipe stops changing when reactor water level rises above the point of reference surface level. Therefore, reactor water level appears to plateau at the point of reference surface level height. This matches up with the corrected water level indicator display values measured during the accident.

Since there is no mechanism to maintain water level at point of reference height, it is likely that the reactor water level during RCIC operation period was above the point of reference surface

level. Furthermore, it can be assumed that it rose above the main steam pipe height (TAF+approx. 7,301mm). In that case, reactor water would flow into the main steam pipe, causing the steam that drives the RCIC turbine to become a two-phase flow.

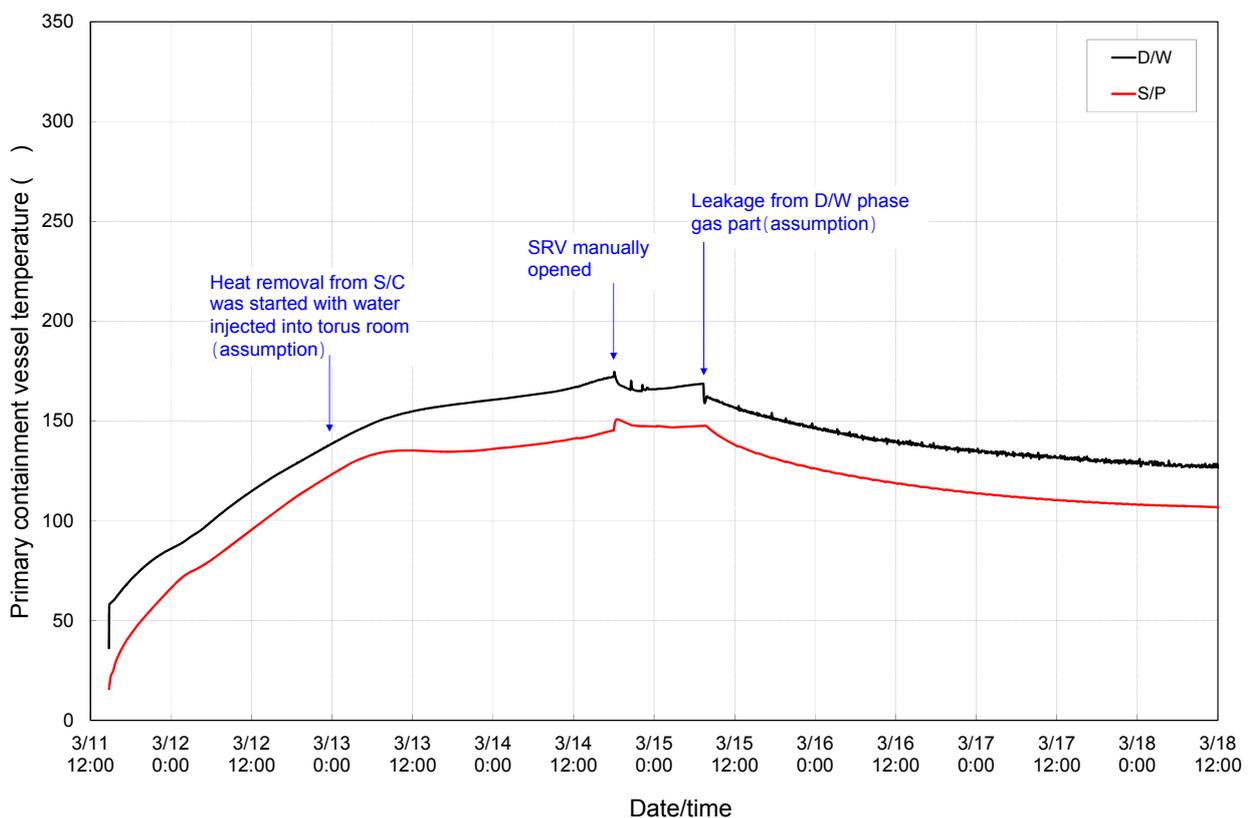
Scenario: “heat removal due to leakage from PCV (D/W)”

- D/W pressure AMV rose sharply around 22:40 on March 14, and pressure remained high afterwards. However, this type of sudden increase and sustained high pressure cannot be simulated when assuming leakage from the D/W.
- According to knowledge gained from past research,<sup>1</sup> leakage from the PCV due to overheating has a higher chance of occurring via gaskets, and the temperature required for this to occur is approx. 300°C. However, PCV temperature within the analysis did not reach 300°C.

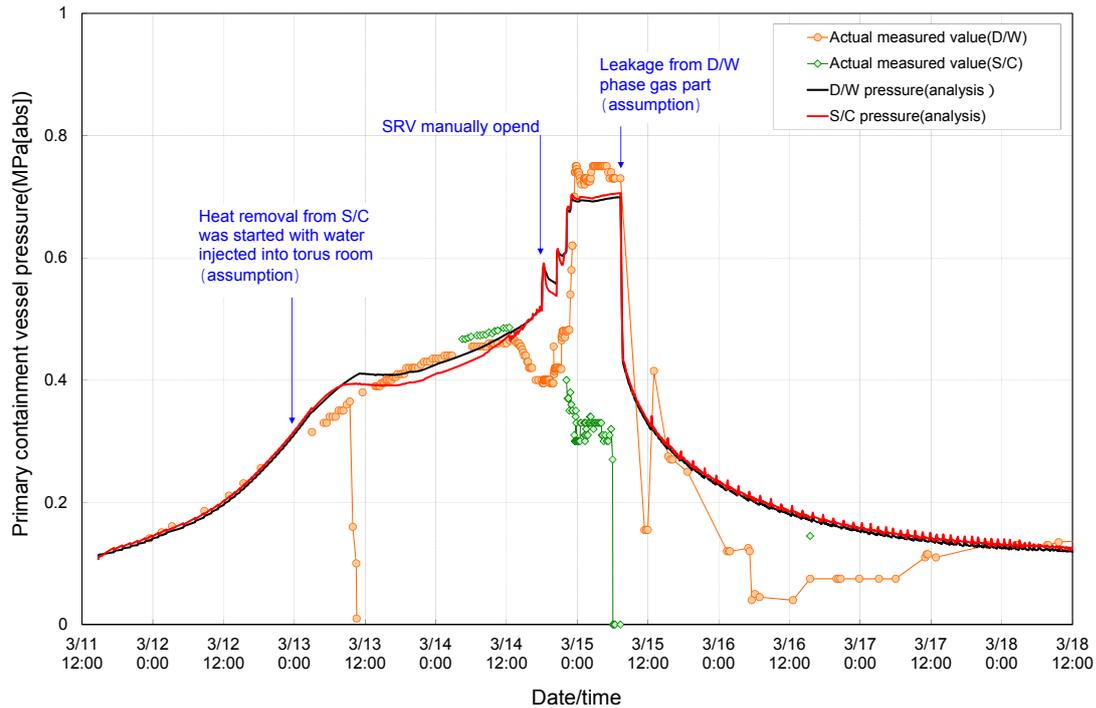
Therefore, analysis was performed assuming the second scenario occurred (tsunami flooding within the torus room containing the S/C leading to removal of heat from the S/C, which has a large surface area, through heat transfer into floodwater via the walls). The results showed D/W pressure slowly rising while the RCIC was operating, then rising sharply due to hydrogen generation caused by core damage. This generally recreated

the movements observed in actual equipment.

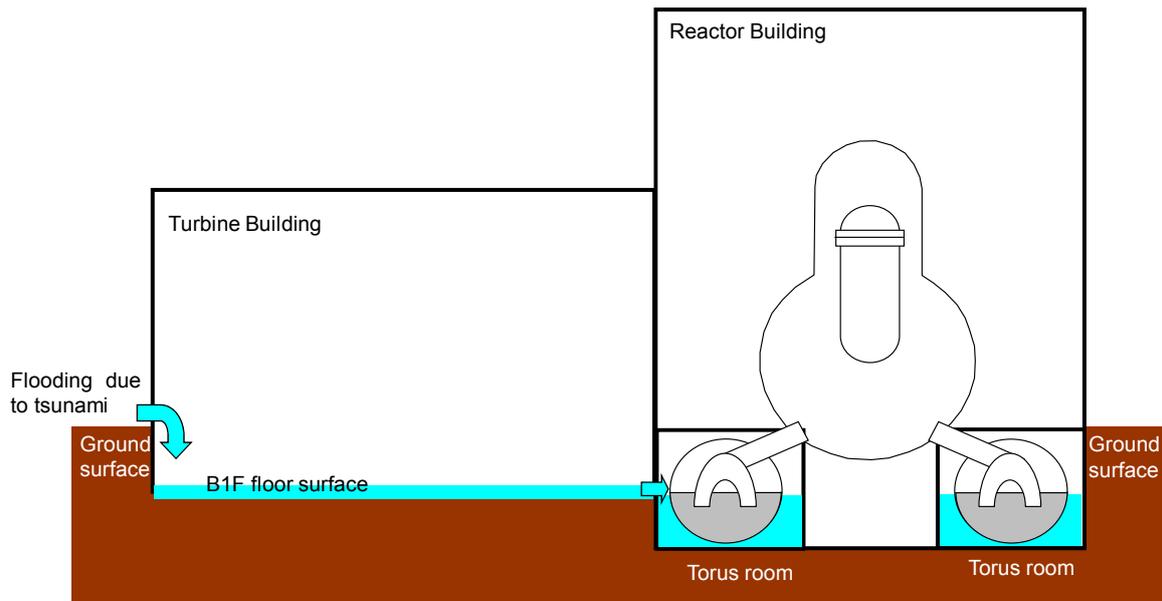
However, it is possible that the torus room on the lowest floor of the R/B experienced tsunami flooding. Factors suggesting this include confirmed flooding in the RCIC room and T/B basement floors in early post-tsunami stages, along with water traveling via cable penetration seals between each building confirmed via water levels at buildings where water is currently pooled.

Specifically, there are penetration seals connecting the T/B and R/B torus rooms. The sealing function of these penetration seals could have been lost due to tsunami floodwater pressure, which would naturally lead to T/B and torus room flooding.

A look at cross sections for the T/B and R/B shows the torus room would be flooded halfway in this case.

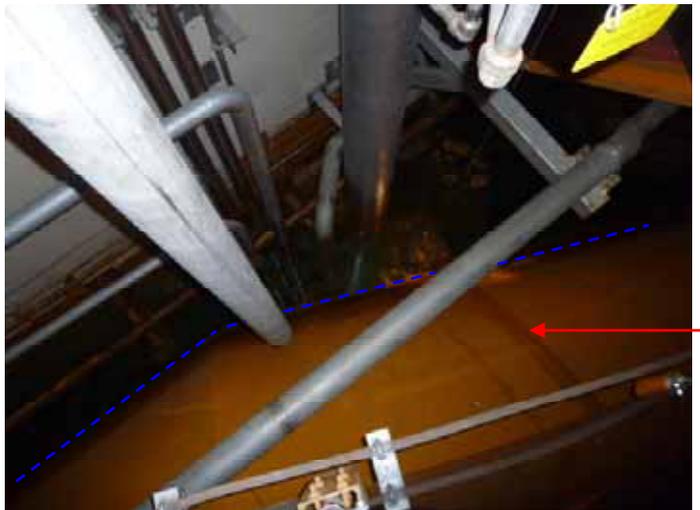
The Fukushima Daiichi Unit 4 torus room, which is almost identical to the structure of the Fukushima Daiichi Unit 2 torus room, was confirmed to be flooded to approx. half of the S/C height. Although Unit 4 may have been undergoing outage and Unit 2 was in operation, this difference does not negate the possibility that torus room flooding seen in Unit 4 could have also occurred in Unit 2.

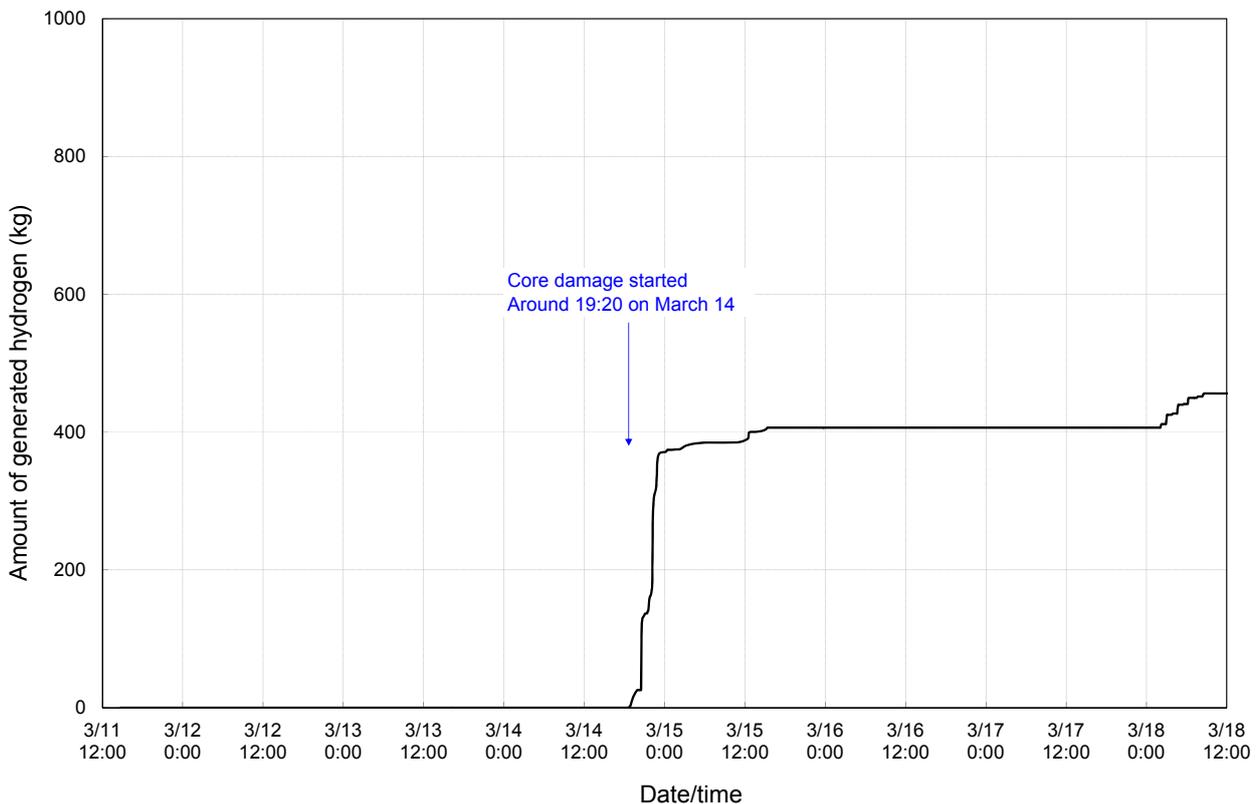
Analysis assumes that the time when core damage (fuel max. temperature analysis value exceeding 1200°C) began was approx. 77 hours after earthquake occurrence (14:46 on March 11). Hydrogen generation due to zirconium-water reaction would accompany core damage commencement and fuel temperature increase.

The amount of generated hydrogen calculated via analysis is approx. 460kg.

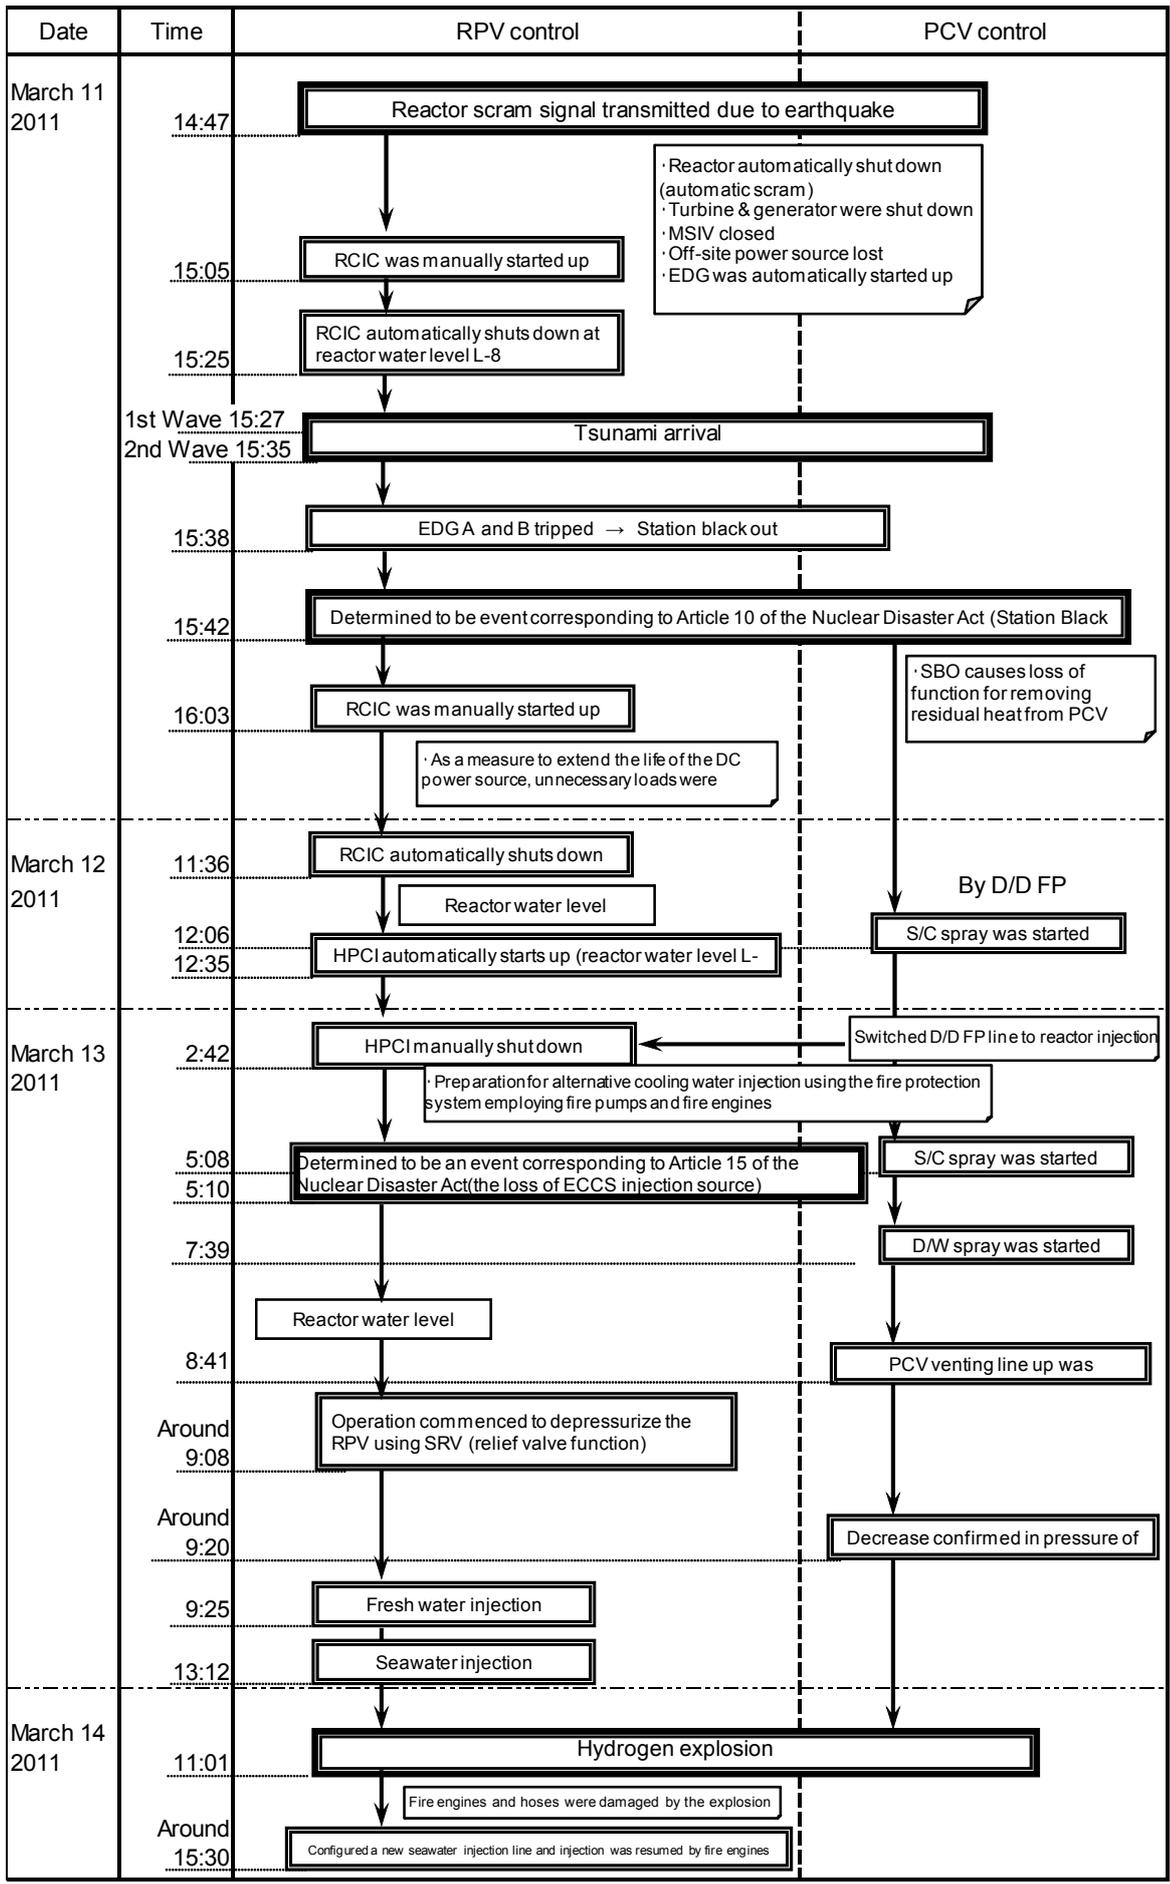
Course of Accident Progression after Earthquake at Fukushima Daiichi Unit 3

It was during injection and venting that the explosion at Unit 3 R/B occurred at 11:01 on March 14. Devices to avoid explosion were being transported to the station after the explosion at Unit 1 R/B on March 12, but they did not make it in time. Although injection stopped due to the explosion, operable fire engines were used to assemble an injection line from the unloading wharf. Seawater injection restarted around 15:30.

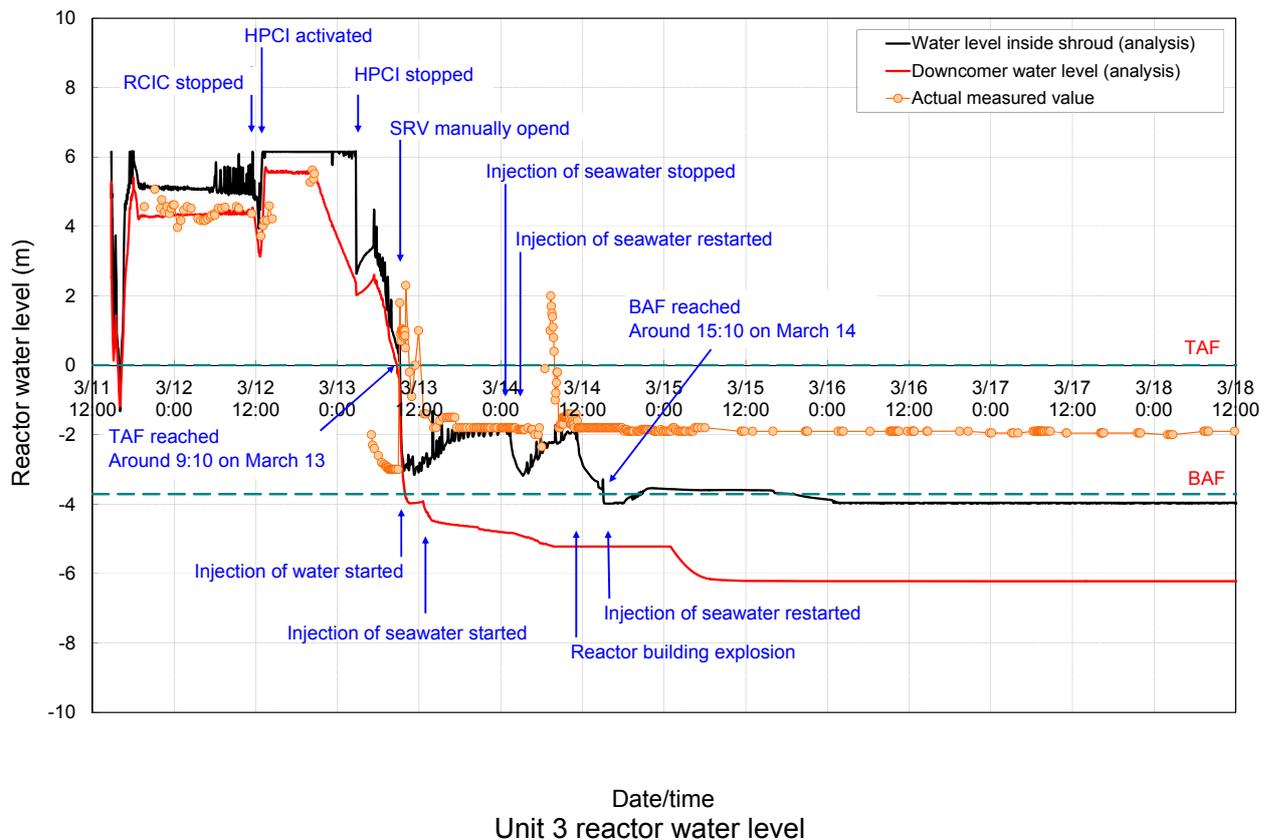
Therefore, analysis using a changed injection amount was performed to simulate actually measured reactor water levels during this operation period. Reactor water level analysis values dropped due to HPCI system shutdown at 02:42 on March 13. Analysis results showed reactor water levels reached TAF approx. 42 hours after earthquake occurrence (14:46 on March 11), and reached BAF approx. 72 hours after earthquake occurrence.

However, since analysis values transitioned at higher values than AMV between HPCI system shutdown and SRV opening, the actual time where TAF was achieved may have been earlier than those determined in the analysis.

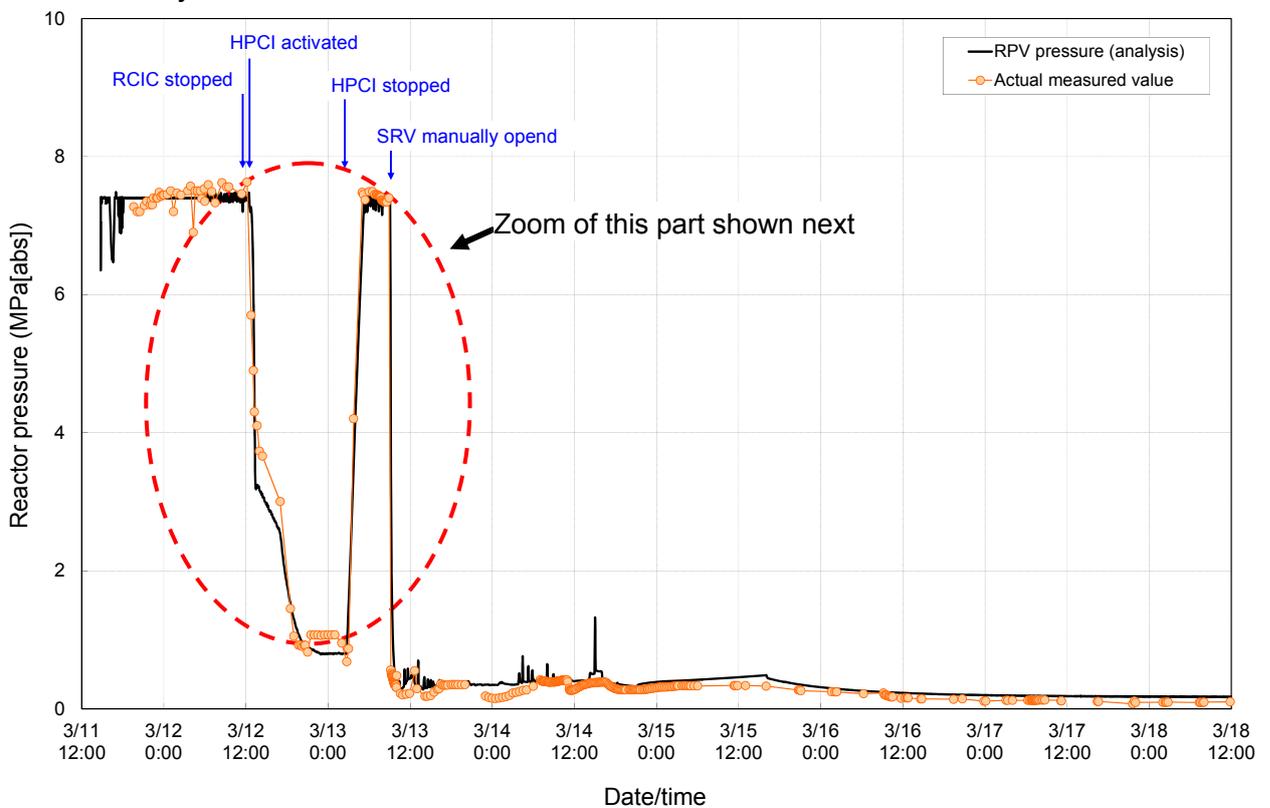
Unit 3 reactor pressure

Reactor pressure AMV was mostly stable while the RCIC was operating, but dropped due to HPCI system activation. Both of these use reactor steam to drive their turbines.

As for reactor pressure AMV moving at low values while the HPCI system was operating, this was assumed to be caused by continued HPCI system operation via flow rate adjustment. This would lead to a reactor pressure increase after HPCI system shutdown, since turbines would no longer use up steam. These movements are the same as both AMV and analysis values.

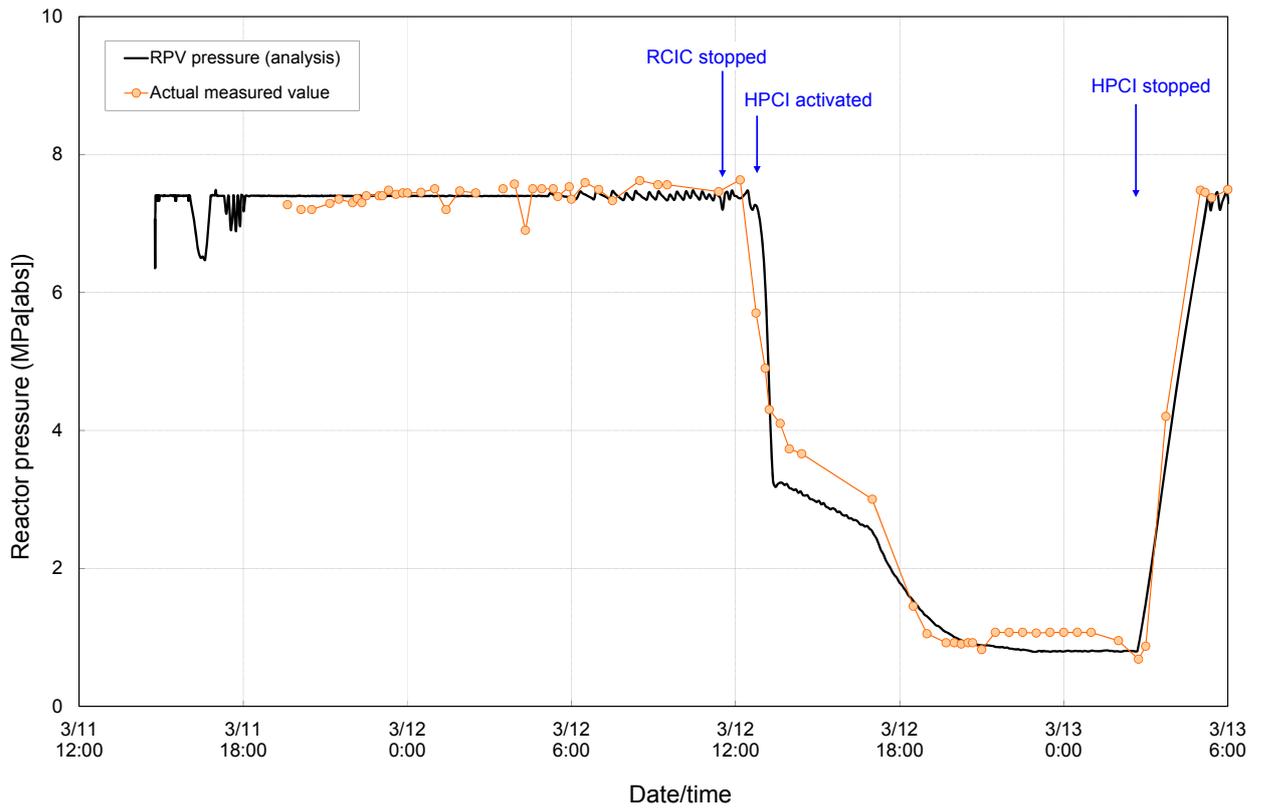
Unit 3 reactor pressure (RCIC, HPCI systems operational time zoomed)

As for reactor pressure drop after HPCI system activation, the AMV shows the rate of decrease slowed down midway. Since flow rate was adjusted for the HPCI system as stated earlier, it was assumed in analysis that the injection amount was increased after HPCI system activation, with the flow rate adjusted to decrease the injection amount after water level increase. Results showed that the turbine flow rate decreased after the injection amount decrease, and the increase in amount of generated steam temporarily slowed down reactor pressure drop speed, which generally matched AMV.

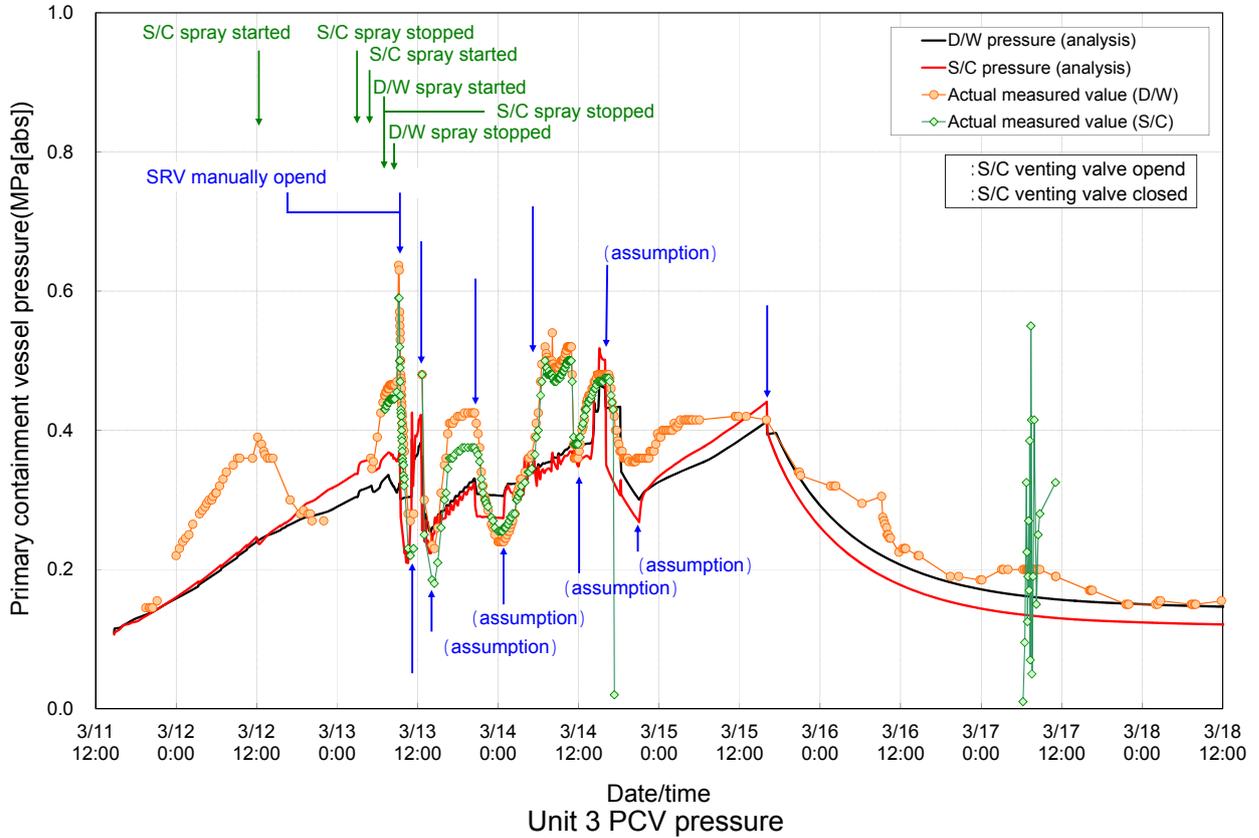
Unit 3 PCV pressure AMV kept rising until around 12:00 on March 12, then dropped until around 22:00 of the same day. When compared against analysis results, AMV increase from around 12:00 of March 12 was higher (max. 150kPa), while analysis could not recreate the later AMV decrease until 22:00 of the same day.
