# Fukushima Nuclear Accident Analysis Report

June 20, 2012  
Tokyo Electric Power Company, Inc.

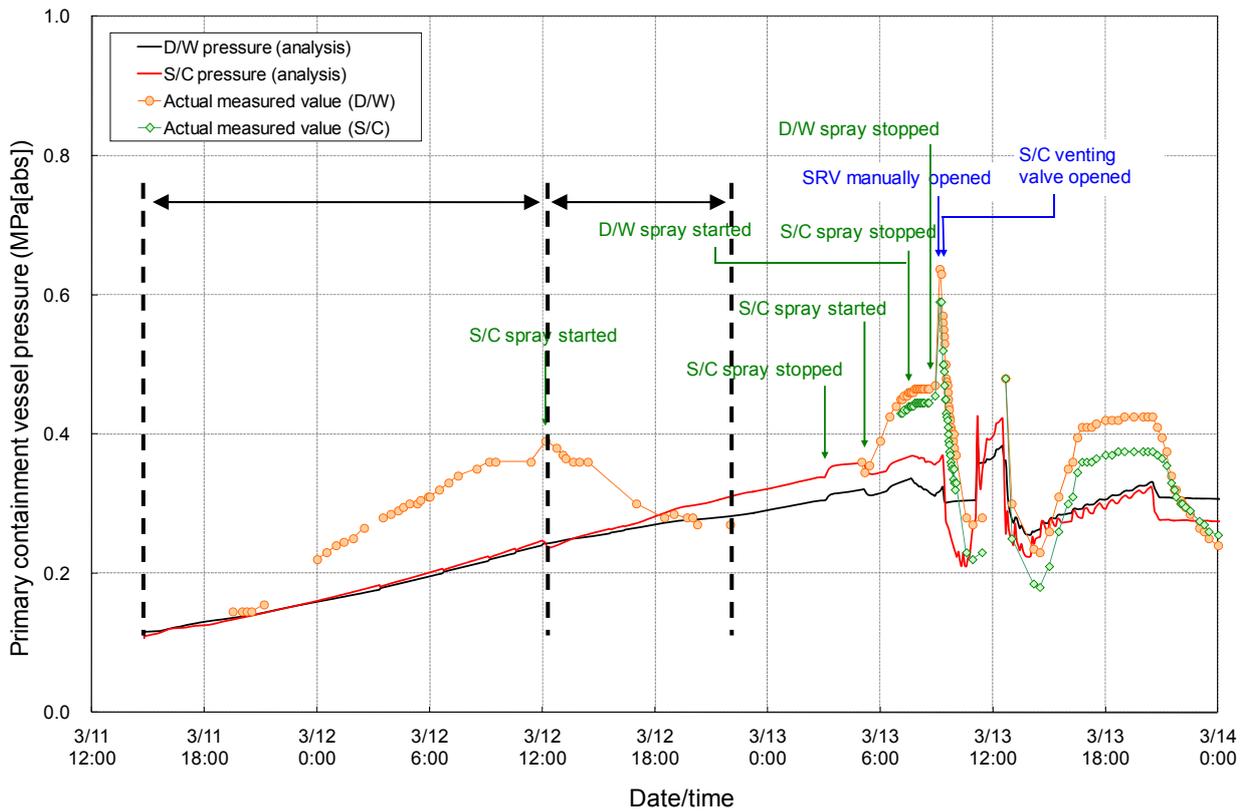
Unit 3 PCV pressure (initial period zoomed)

PCV pressure increase during this period is assumed to be caused mainly by SRV operation and RCIC exhaust steam. Since both lead to steam condensation in the S/C pool, PCV pressure increase is restricted. Assuming that energy is directly routed to D/W instead of S/C, PCV pressure increase may be recreated. Since reactor coolant pressure

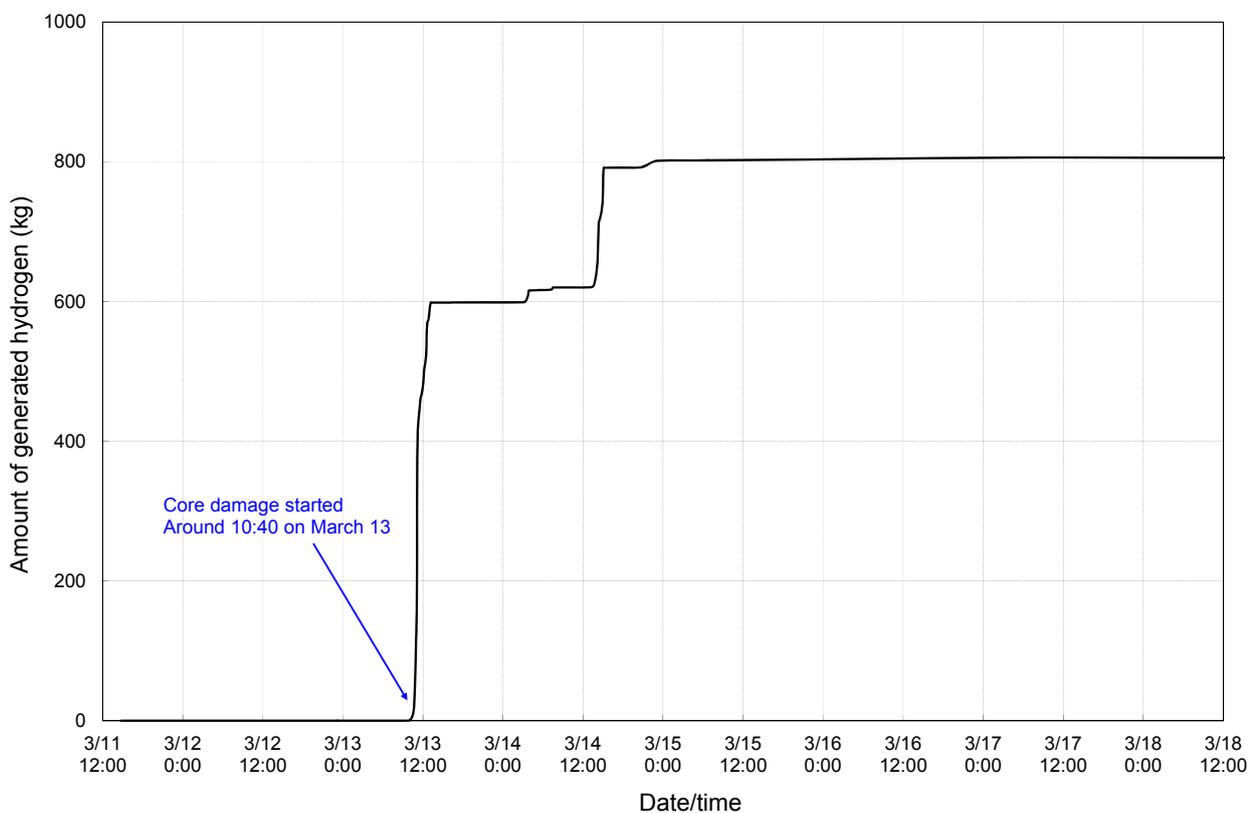
Unit 3 hydrogen generation

Core damage (fuel max. temperature analysis value exceeded 1200°C) began approx. 44 hours after earthquake occurrence (14:46 on March 11). In the analysis, hydrogen was generated due to zirconium-water reaction accompanying the start of core damage and fuel temperature rising.

An explosion at the R/B, thought to be due to hydrogen, occurred at 11:01 on March 14. Analysis calculations estimate the amount of hydrogen generated one week after earthquake occurrence to be approx. 810kg.

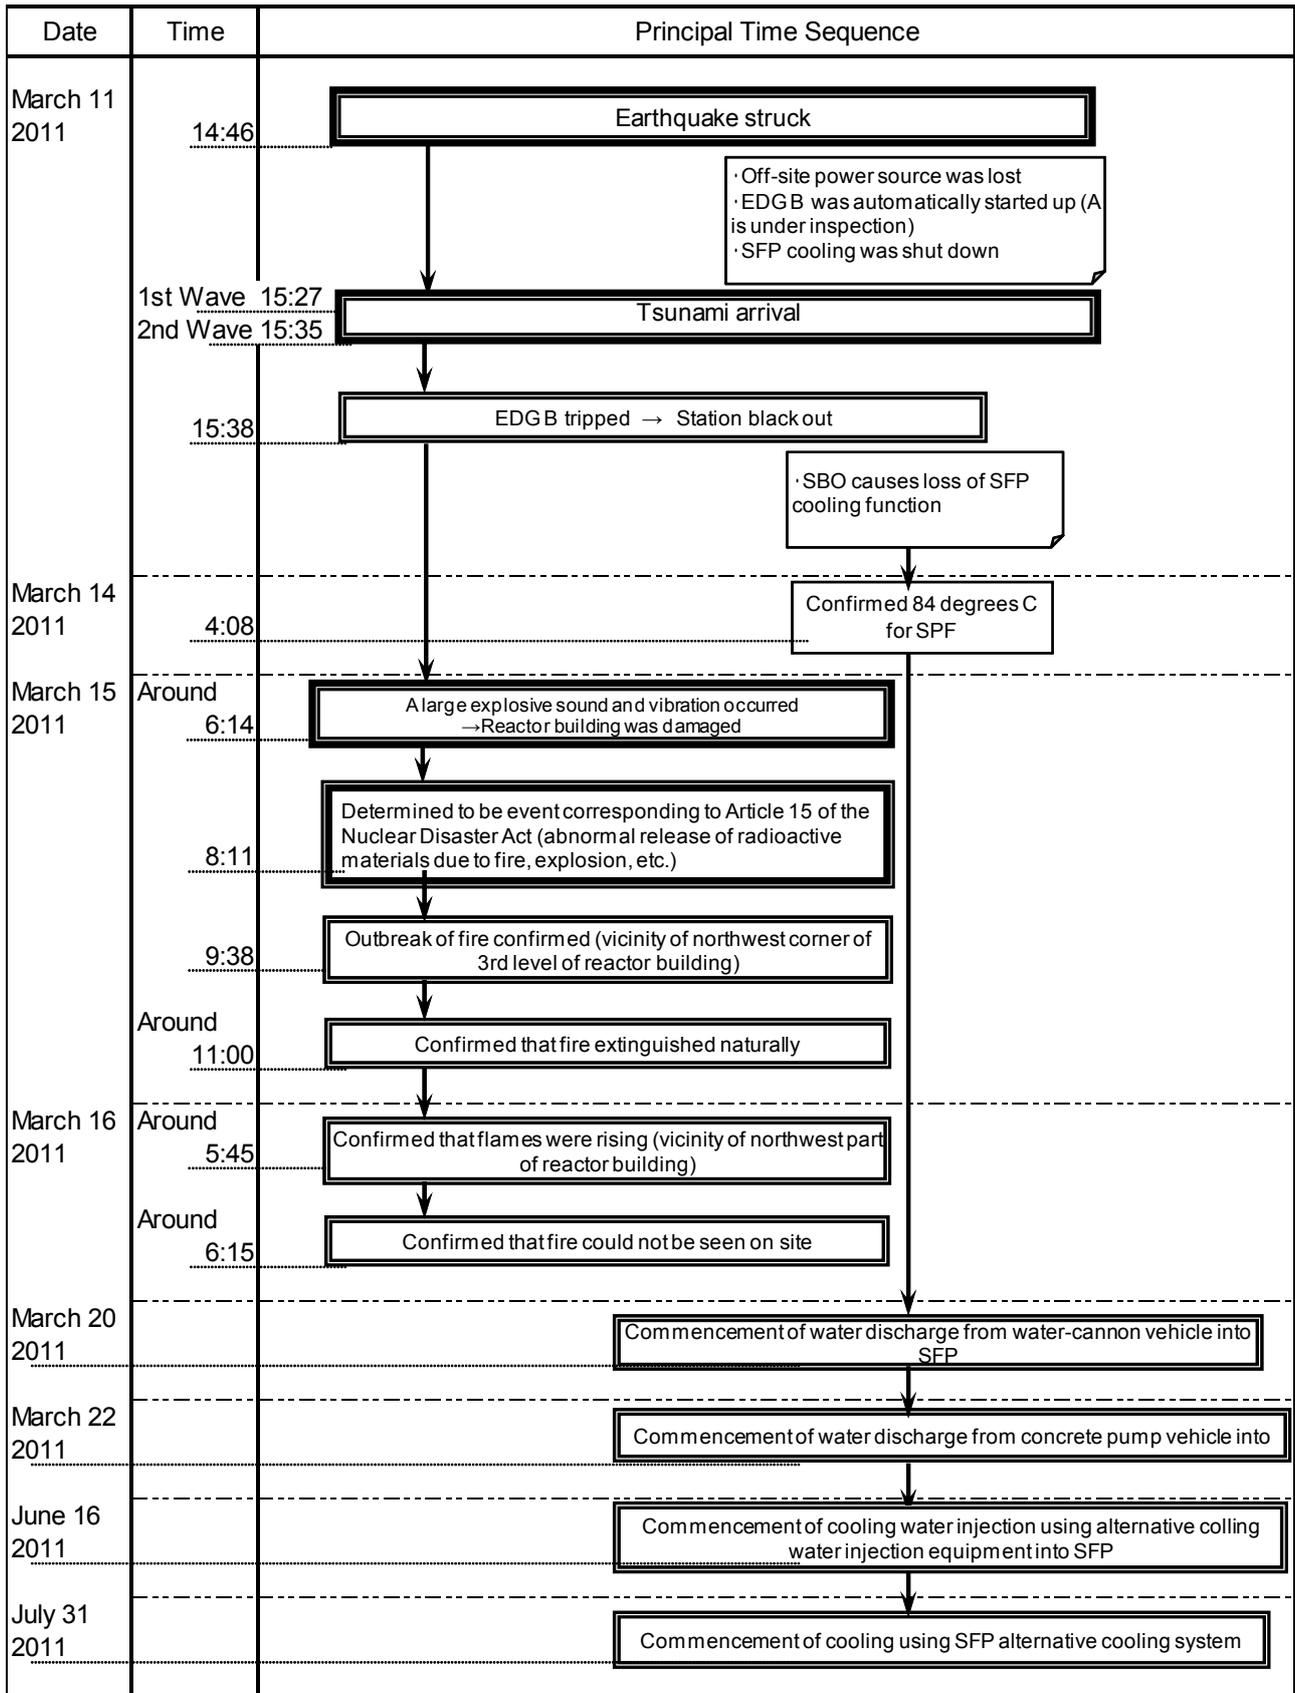
Course of Accident Progression after Earthquake at Fukushima Daiichi Unit 4

- It was between these reports of fires that METI issued a legally mandated order to “work toward extinguishing fires in the SFP and preventing criticality recurrence” at 10:30 on March 15 (another order was issued at an unknown time within the same day to “perform SFP cooling water injection as soon as possible”).

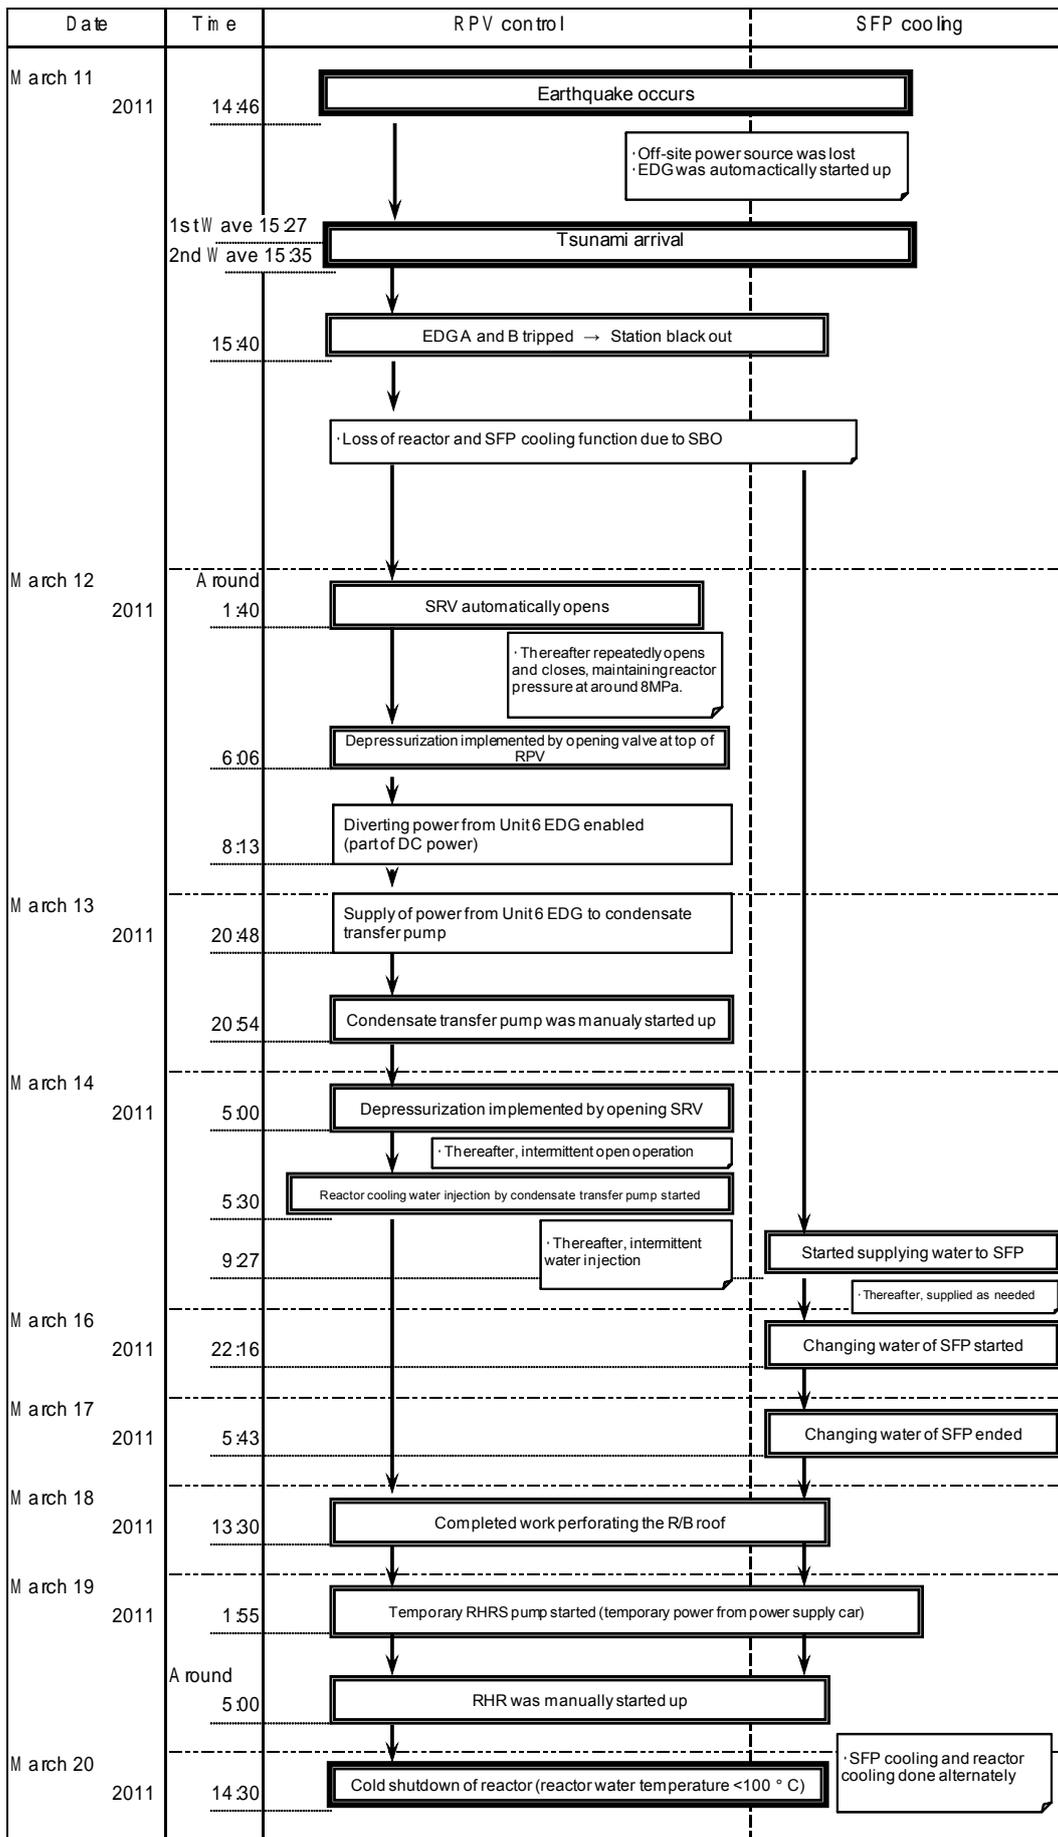
Course of Accident Progress after Earthquake at Fukushima Daiichi Unit 5

Cold shutdown was achieved for Unit 5 while event progression was controlled. This was due to power source cross-ties with Unit 6, which allowed the early restoration of monitoring instruments needed for accident response, alongside restoration of functions needed for reactor depressurization, MUWCs, and RHR/RHR seawater system.

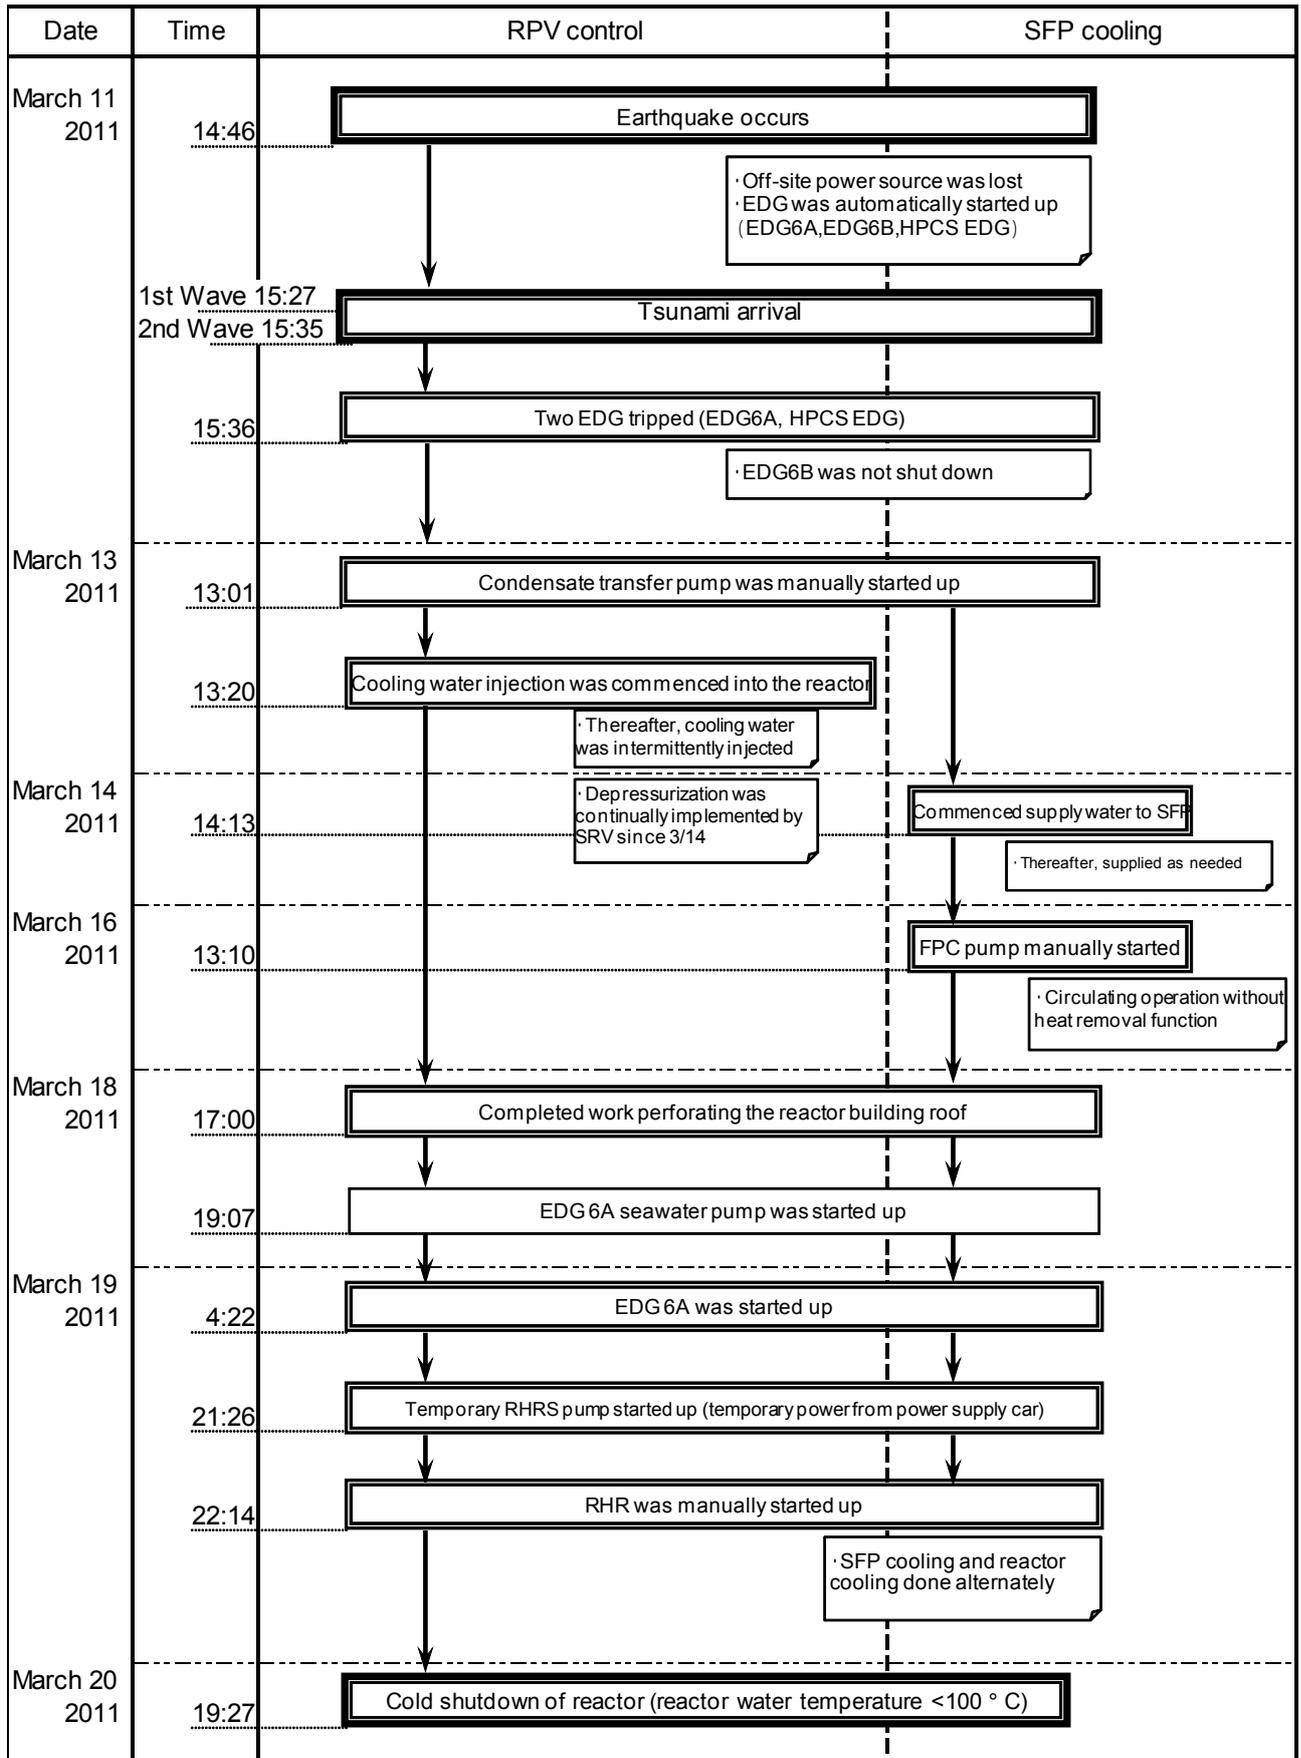
Course of Accident Progression after Earthquake at Fukushima Daiichi Unit 6

Cold shutdown was achieved for Unit 6 while event progression was controlled. This was because one EDG had been ensured, monitoring instruments needed for accident response could be confirmed, and RHR/RHR seawater system were restored early on through cooling water injection via MUWCs. Cooling function was ensured through the last item.

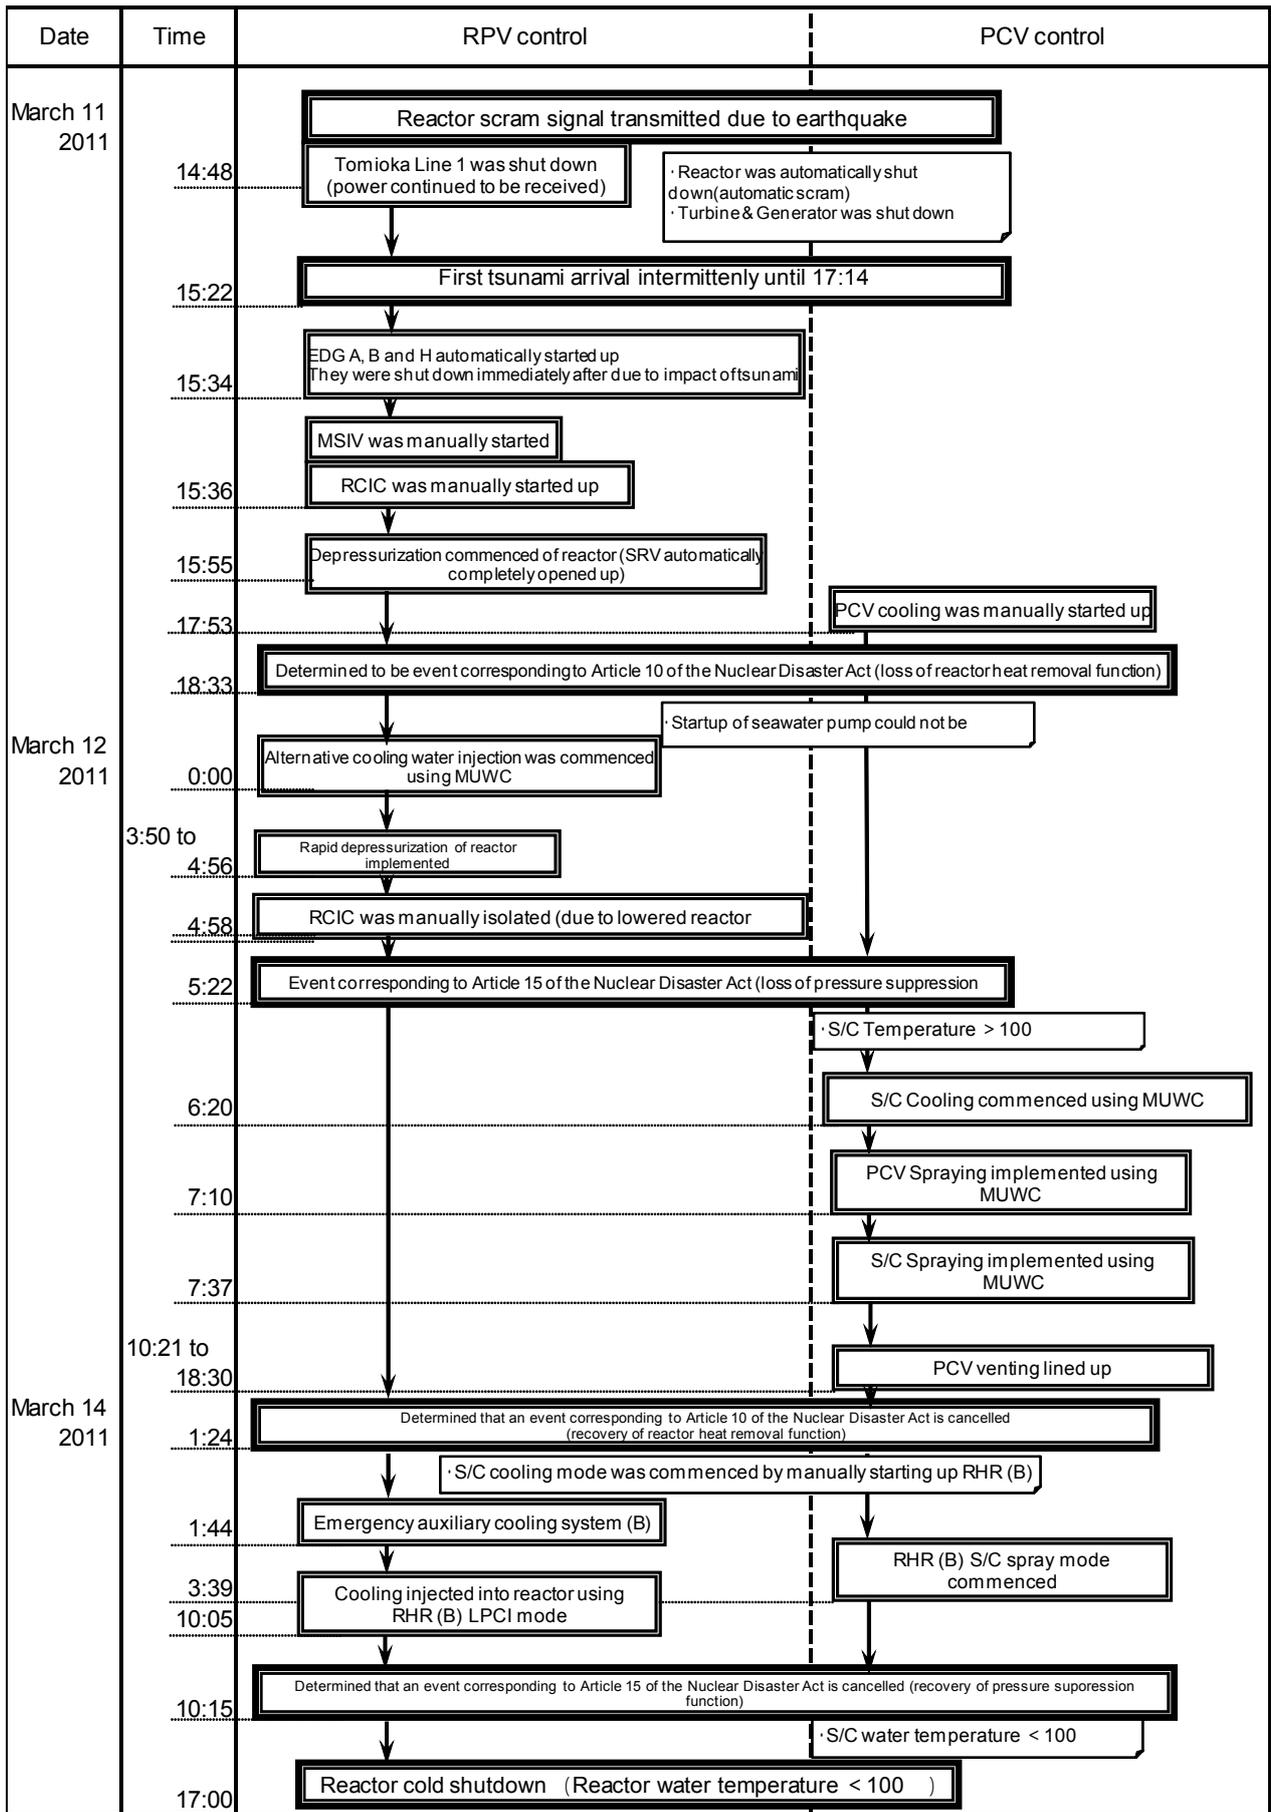
Course of Accident Progression at Fukushima Daini Unit 1 after Earthquake

- The RHR cooling system pumps (B) were used to begin injection of S/C water into the reactor via low pressure injection line at 10:05 on March 14. At the same time, emergency cooling was performed via a circulation line. Here, reactor water was sent to the S/C via SRV, where S/C water would be cooled by the RHR heat exchanger (B), before being injected into the reactor again via low pressure injection line (S/C→RHR cooling system pumps (B)→RHR heat exchanger (B)→low pressure injection line→reactor→SRV→S/C). These actions aimed toward early cooling of reactor water alongside cooling by S/C. As a result, reactor water temperature dropped below 100°C at 17:00 of the same day, and it was confirmed the reactor had entered cold shutdown.

- Since signs of hydrogen concentration increase (hydrogen: approx. 5%, oxygen: approx. 2%) were seen via CAMS at 05:12 on March 16 (approx. two days after cold shutdown), the flammability control system was operated. This suppressed hydrogen/oxygen concentration below the flammable range.

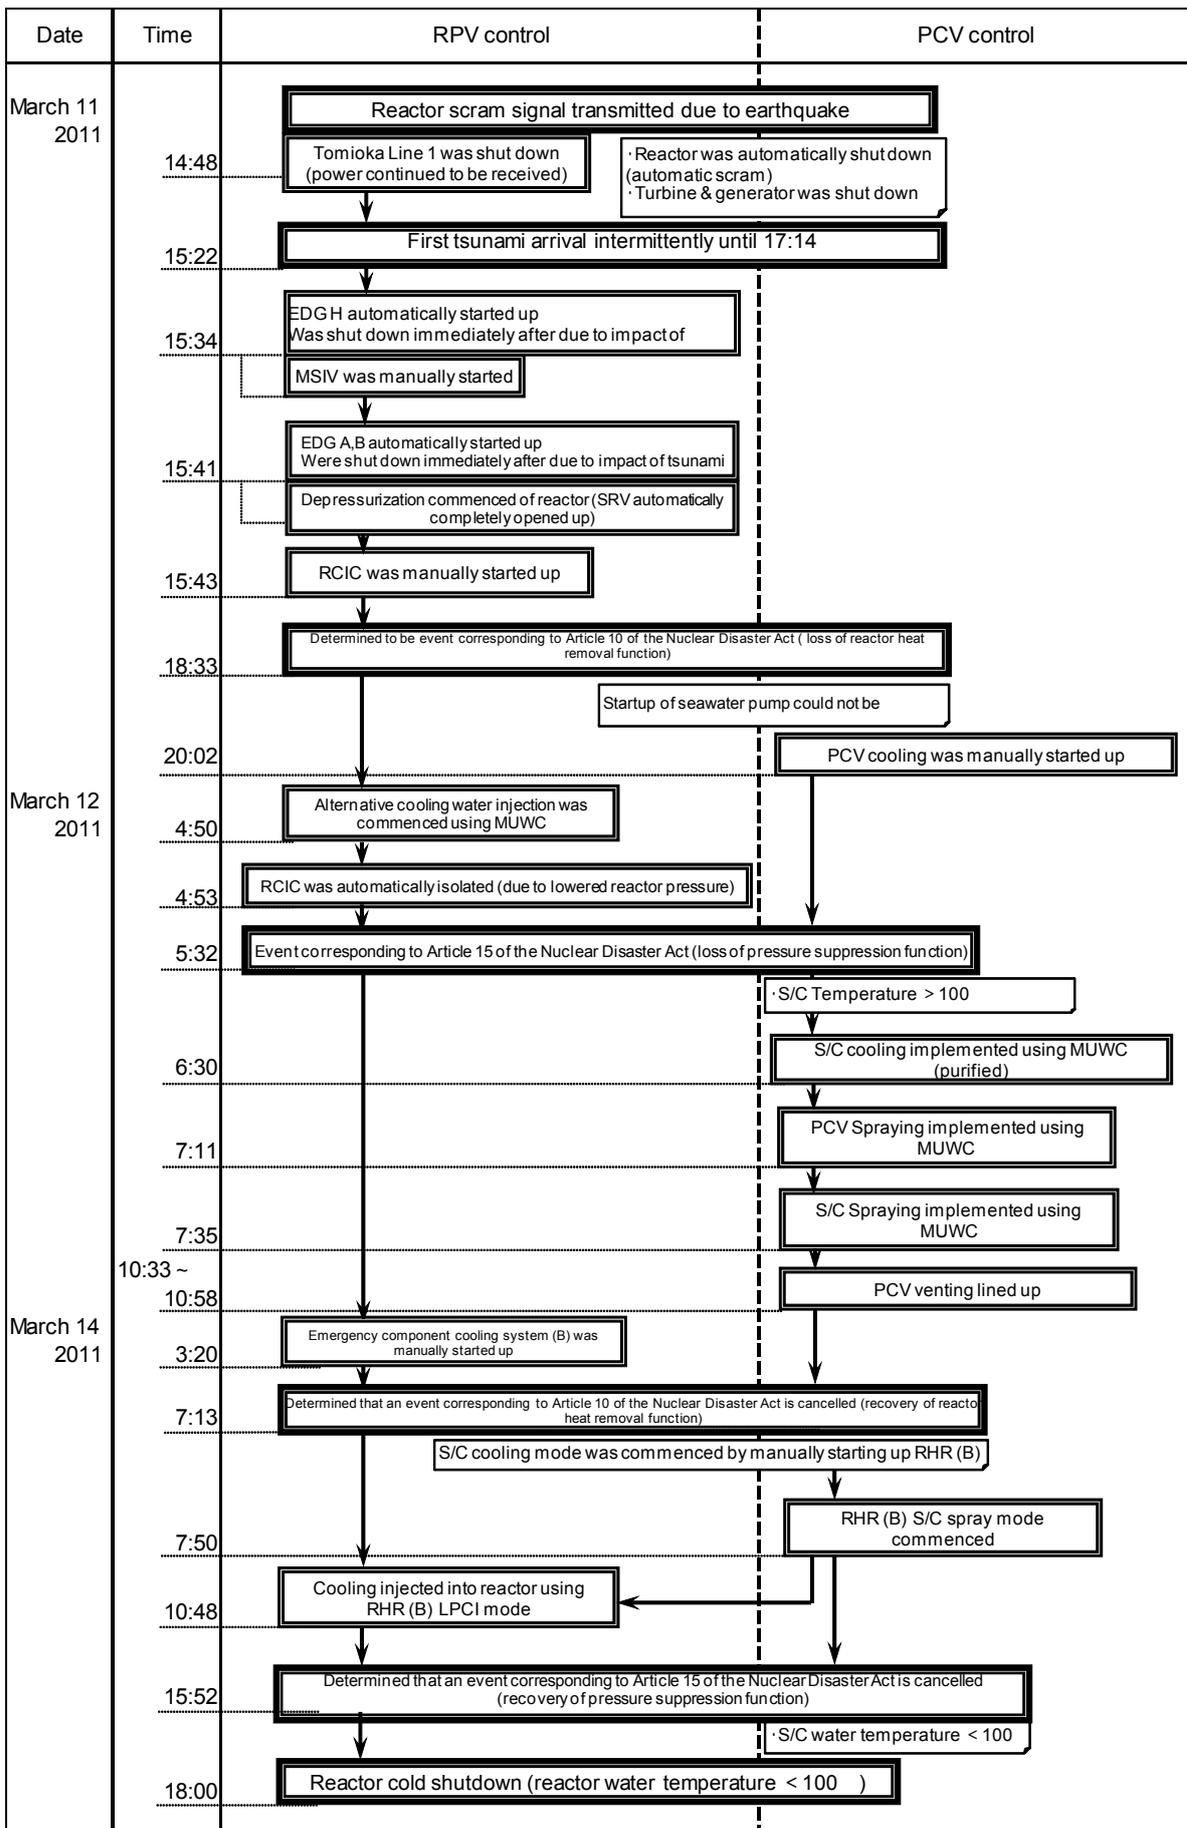
Course of Accident Progression at Fukushima Daini Unit 2 after Earthquake

the S/C via SRV, where S/C water would be cooled by the RHR heat exchanger (B), before being injected into the reactor again via low pressure injection line (S/C→RHR cooling system pumps (B)→RHR heat exchanger (B)→low pressure injection line→reactor→SRV→S/C). These actions aimed toward early cooling of reactor water alongside cooling by S/C. As a result, reactor water temperature dropped below 100°C at 18:00 of the same day, and it was confirmed that the reactor had entered cold shutdown.

- Since signs of hydrogen concentration increase (hydrogen: approx. 5%; oxygen indicator was non-functional) were seen via CAMS at 07:58 on March 16 (approx. two days after cold shutdown), the flammability control system was operated. This suppressed hydrogen/oxygen concentration below flammable range. The reasons for hydrogen detection are the same as those for Fukushima Daini Unit 1.

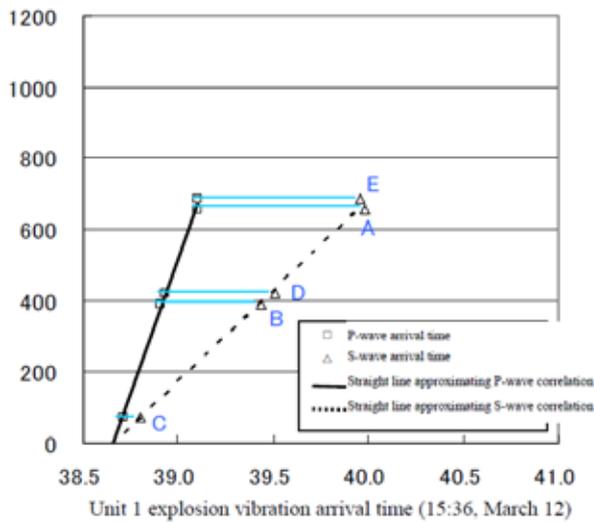
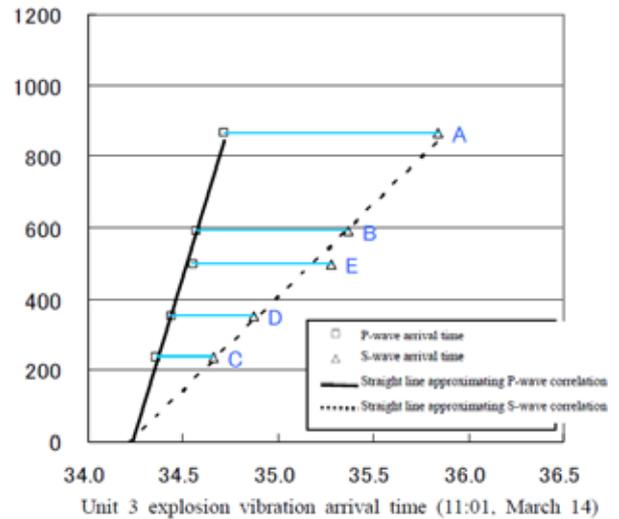
Diagram correlating the arrival times of P and S waves at the time of the Units 1 and 3 explosions and distance from Units 1 and 3

Meanwhile, for the explosions that occurred at Unit 1 and Unit 3, for which the times have been determined, if the distance between each unit and the seismometers is plotted on the vertical axis and the P wave and S wave arrival times are plotted on the horizontal axis, when the P wave and S wave observation records are organized, the records for an accurate line thereby confirm the origin of the vibrations.

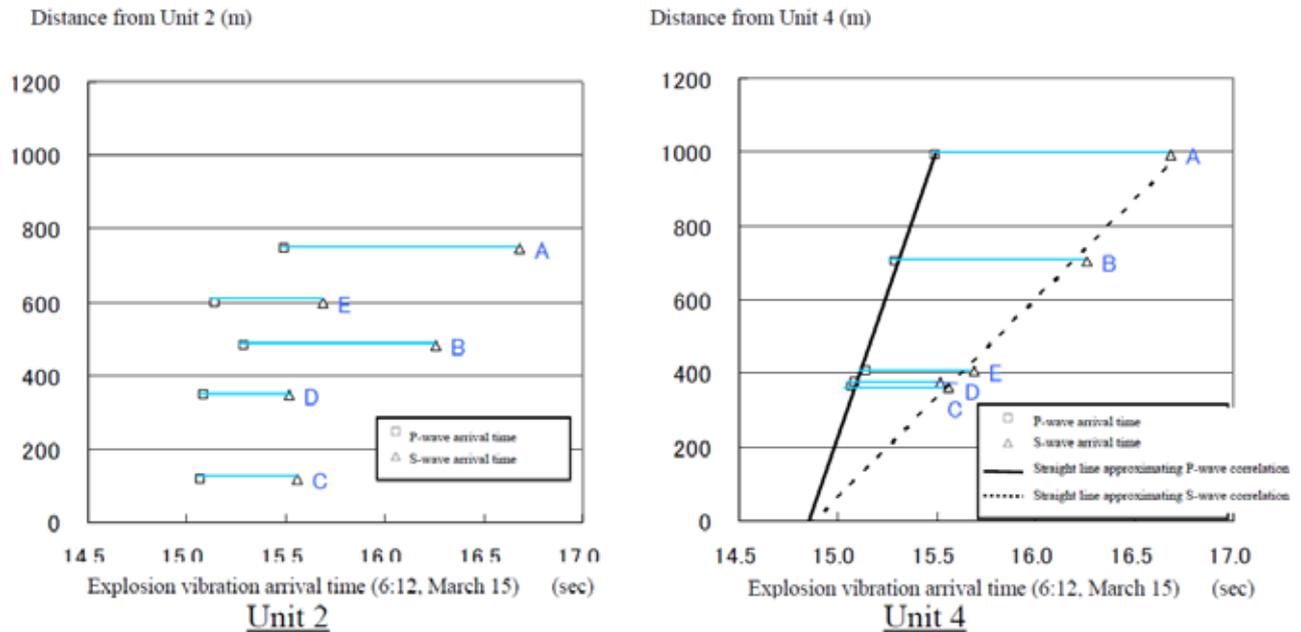
Diagram correlating the arrival times of P and S waves from the 6:12 ground vibration and distance from Units 2 and 4

When the relationship between the distances from the seismometers to Unit 2 and Unit 4 and arrival times were analyzed for the vibrations recorded at 6:12 on March 15, no relationship could be found for the Unit 2 data. However, an accurate linear relationship was seen for both the P waves and S waves when compared with Unit 4 distance data. Accordingly, the aforementioned vibration was estimated to be caused by the Unit 4 explosion.

From this analysis it is hypothesized that three explosions occurred at the Fukushima Daiichi NPS, the Unit 1 and Unit 3 explosions captured on news media and the Unit 4 explosion confirmed through seismometer observation records. Therefore, it was determined that the large vibration and sound experienced at 6:14 on March 15 was caused by an explosion at Unit 4 at 6:12.

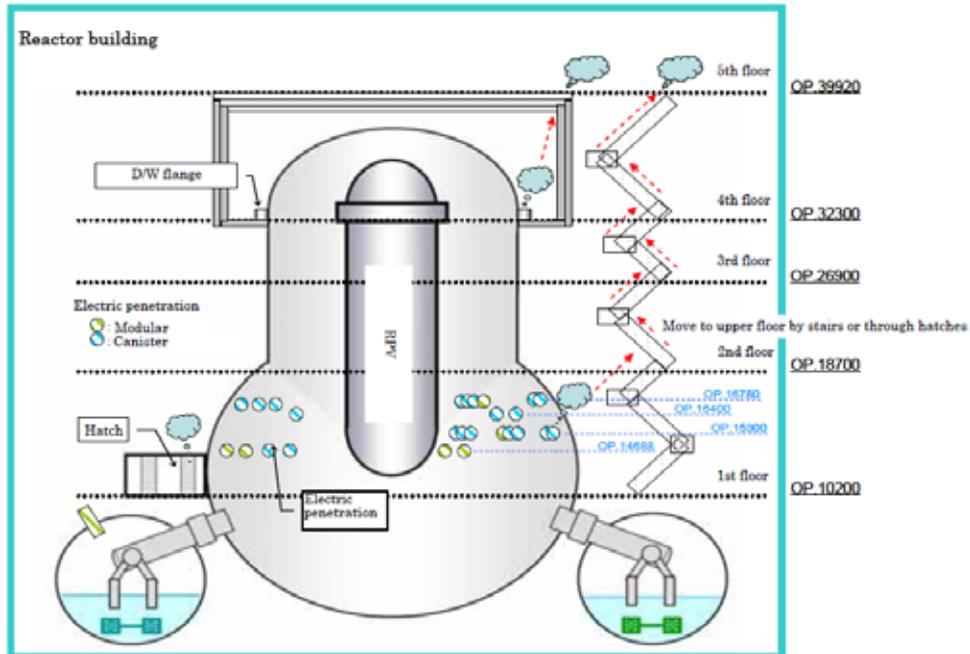
It is unclear what path the leaking hydrogen took, but possibilities for the leak from the PCV includes seals on the head of the PCV, hatches used for equipment and people, and also electrical cable penetration. Silicone rubber is used for seals to prevent leaks, but it is possible that these seals were exposed to high temperatures and lost functionality. It is estimated that this area in the PCV is mainly where the hydrogen leaks directly into

There are possibilities that the inferred leakage flow paths differ between Unit 1 and 3 according to system configuration

In addition to direct leakage from the PCV, it is also possible that hydrogen leaked from the vent line through SGTS lines and into the reactor building when the PCV was vented. Unit 1 has not been inspected due to high radiation levels, but an investigation of the SGTS equipments in Unit 3 is underway. The path by which hydrogen flowed into the reactor building will be examined based on the results of this investigation.

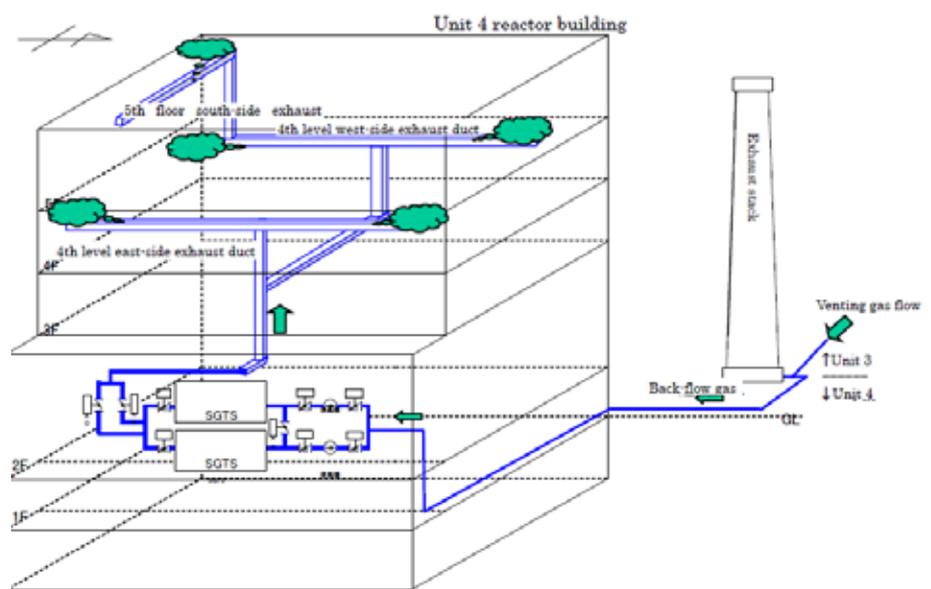
In consideration of these conditions an investigation into the cause of the explosion at Unit 4 has revealed the possibility that vent flow, including hydrogen gas from Unit 3, flowed into Unit 4 through the stack junction. The Unit 4 PCV venting piping is connected to

the Unit 4 SGTS and lead into the stack; however, these piping merge with

the Unit 3 SGTS piping near the stack.

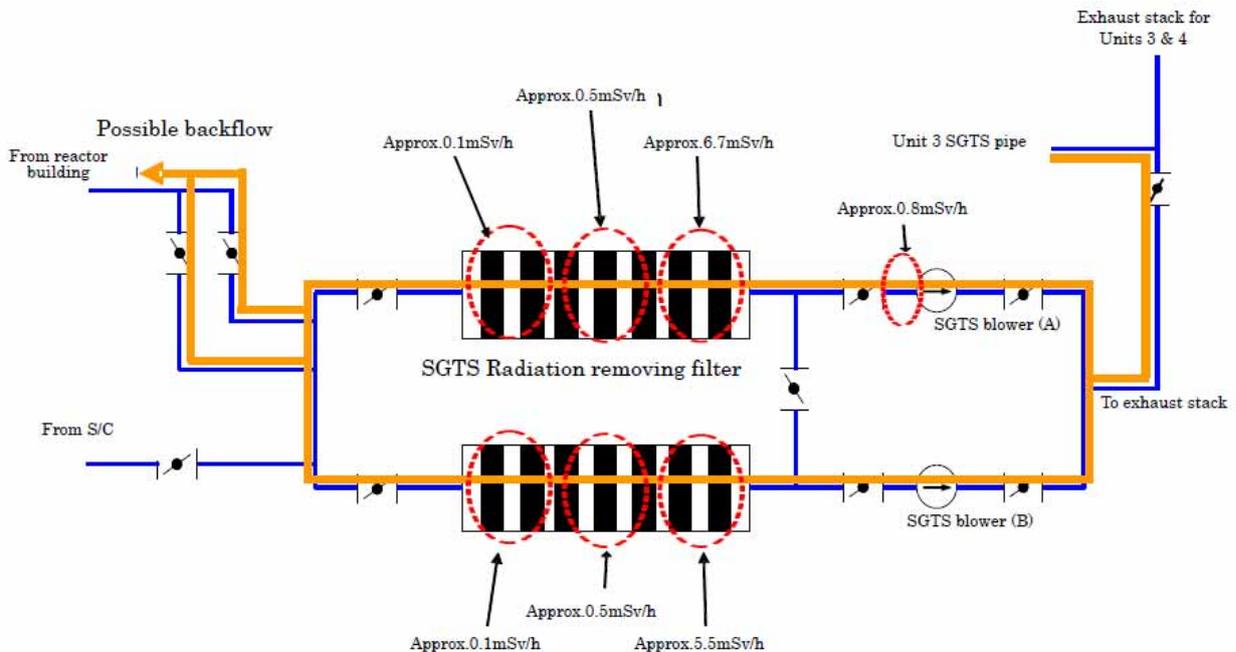
Results of measurement of amount of radiation in Unit 4 SGTS  
(conducted on August 25, 2011)

On the other hand, the SGTS filter on the downstream side should get higher levels of contamination if Unit 3 PCV venting gasses flowed backwards. In order to confirm this factual relationship radiation levels were measured for the train that holds the Unit 4 SGTS filter. (Implemented on August 25, 2011)

The results of the investigation were different from normal and confirmed that radiation levels on the exhaust side of the SGTS filter train (the downstream side) were high and that the radiation levels gradually decreased in approach of the inlet (upstream side). This means that contaminated gases flowed through the Unit 4 SGTS piping from the downstream side to the upstream side and indicates the possibility that Unit

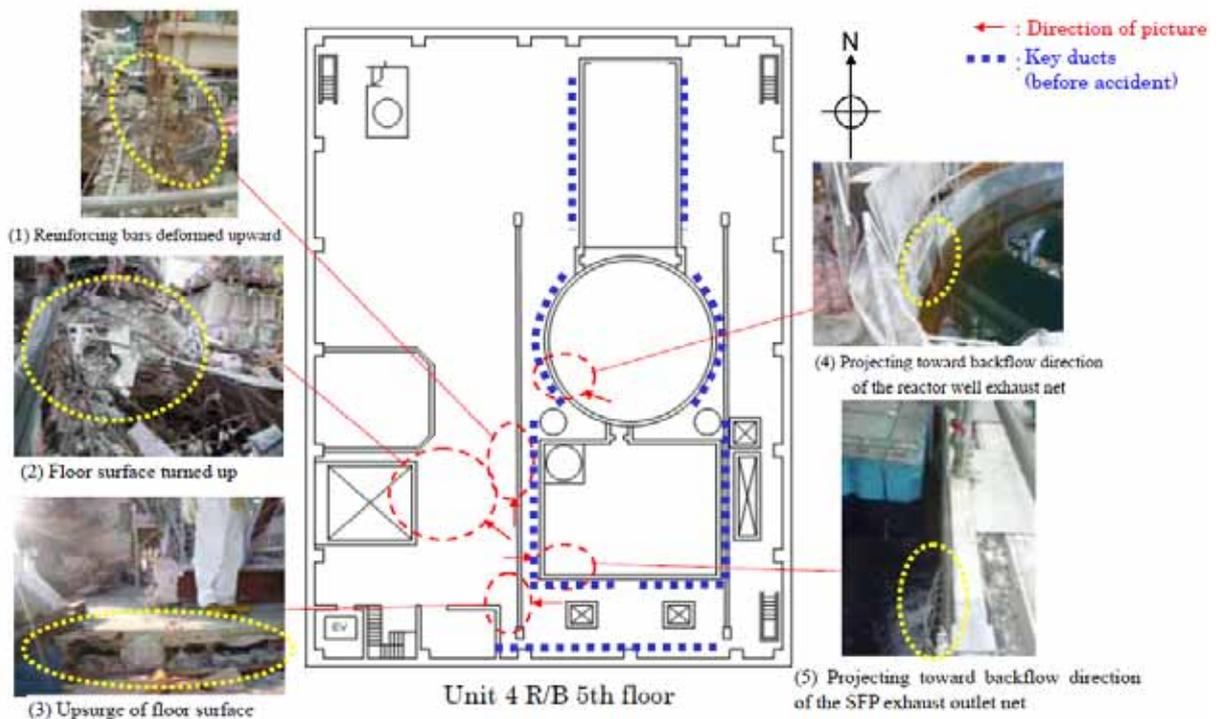
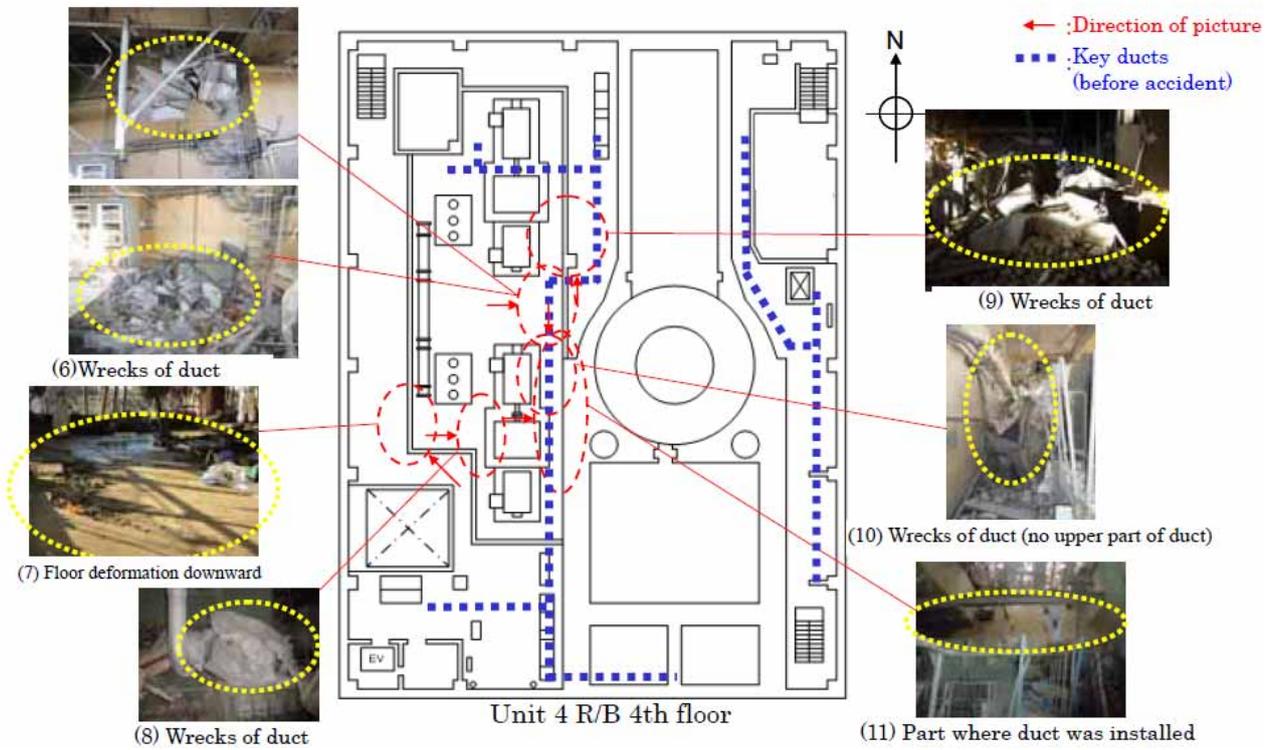
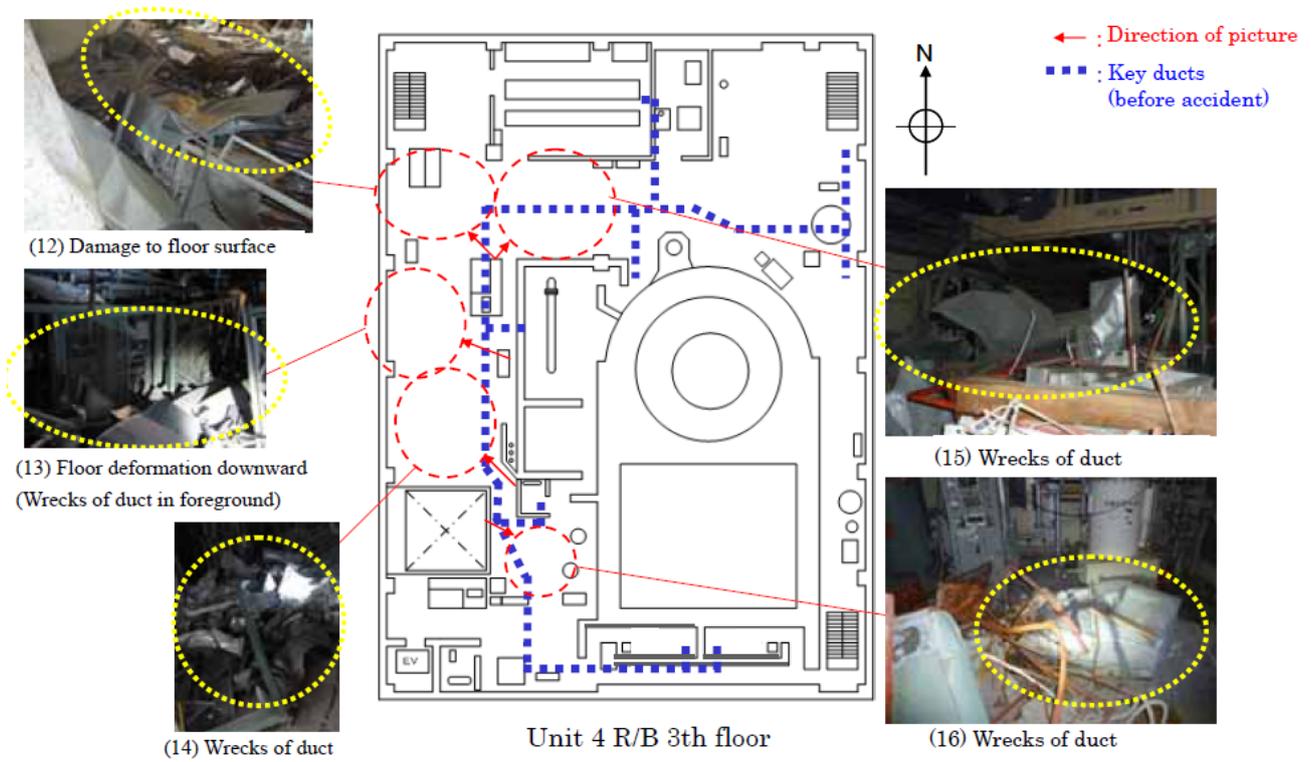
to the upward force of the explosion that occurred at Unit 4. Furthermore, the ducts that were installed on the southwest side of the 4th floor the reactor building were no longer present and rubble that is assumed to be the remains of the ducts was scattered about, therefore it is a possibility that most of the pressure from the explosion was generated near the ducts on the southwest side of the 4th floor. Also, it is assumed that explosions on the 3rd and 5th floors caused by hydrogen that flowed back through exhaust ducts damaged the building.

As mentioned above, the examination of the remnants of the explosion in the field fit the hypothesis that Unit 3 vent flow flowed back into the reactor building from the 2nd floor of the Unit 4 reactor building via the SGTS piping/ducts.

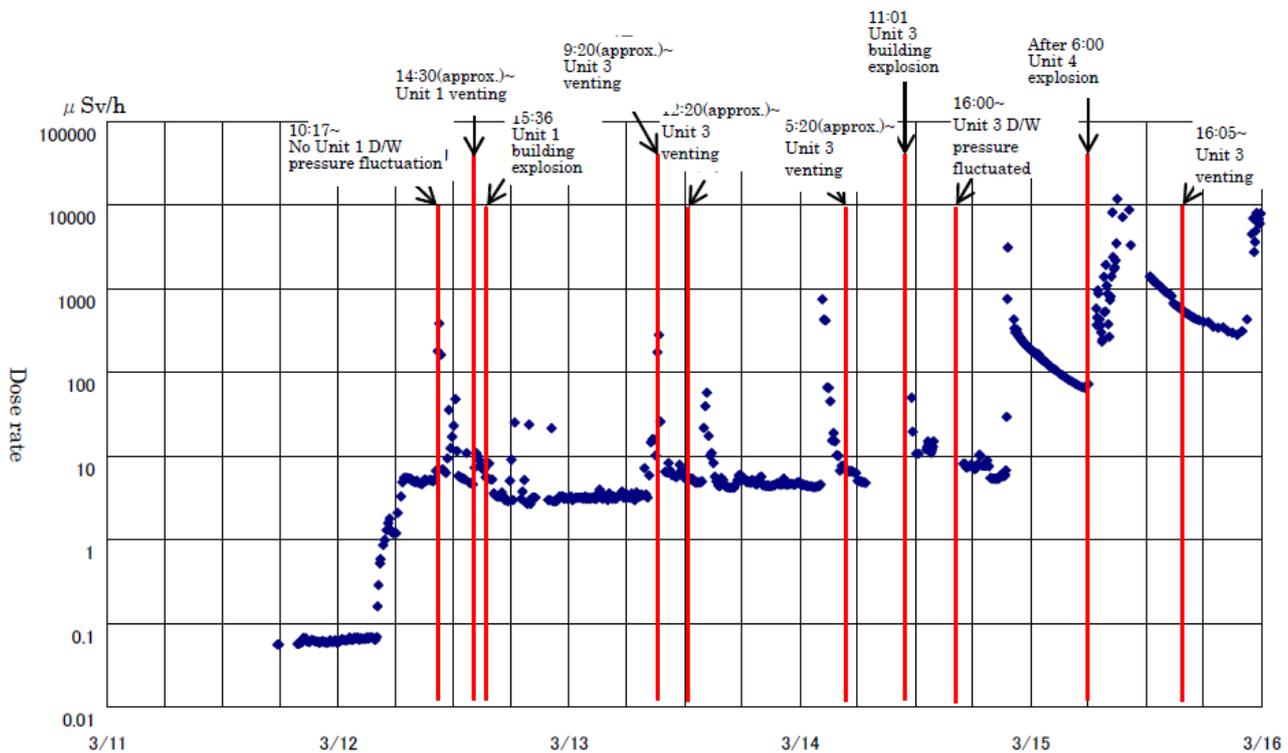
Dose rate in vicinity of Fukushima Daiichi NPS main gate

There were no changes to dose rate near the main gate until the early morning of March 12, at which time dose rate as a whole increased at around 04:00, which is thought to be the result of radioactive materials released in conjunction with the reactor core damage of Unit 1. After this initial venting operation of Unit 1 took place at 10:17 on March 12, and depressurization was confirmed at around 09:20 on March 13 as the result of initial venting operation of Unit 3. Dose rate increased slightly during both venting operations and it is thought highly likely that gasses scrubbed in the S/C were released from the vent lineup. Also, on March 15, dose rate increased to approximately 10,000 $\mu$ Sv/h on two occasions, but this is thought to be the result of highly contaminated gasses leaking directly through the building from the PCV and is not a result of S/C venting operations. This section will analyze in more detail the release of radioactive materials in conjunction with venting operations and examine factors that led to contamination of the area to the northwest of the Fukushima Daiichi NPS.
