# Fukushima Nuclear Accident Analysis Report

June 20, 2012  
Tokyo Electric Power Company, Inc.

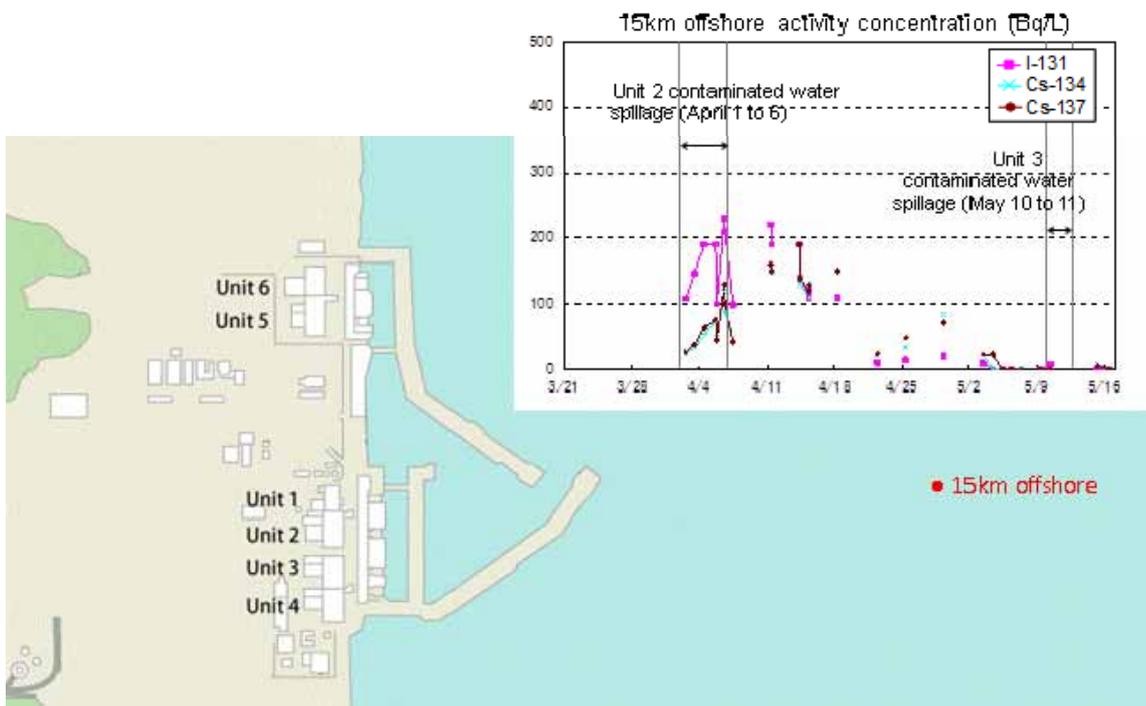
Ocean monitoring has been continuously conducted in order to monitor the impact of highly concentrated contaminated water flowing from the Unit 2 and Unit 3 intake screens. As a result, from around April 5 through around April 20 peak increases were observed not only around the power station but also at points 15 km and 30 km off the coast of the power station that are thought to be the result of the Unit 2 contaminated water leak.

Thereafter a decreasing trend in radioactive concentration is indicated and by the beginning of May overall values were detection limits or below (approximately 10 Bq/L). Furthermore, with regard to the impact of the Unit 3 leak, results of monitoring 15 km off the coast on May 15 revealed that almost all values were detection limits or below and no impact has been observed to date.

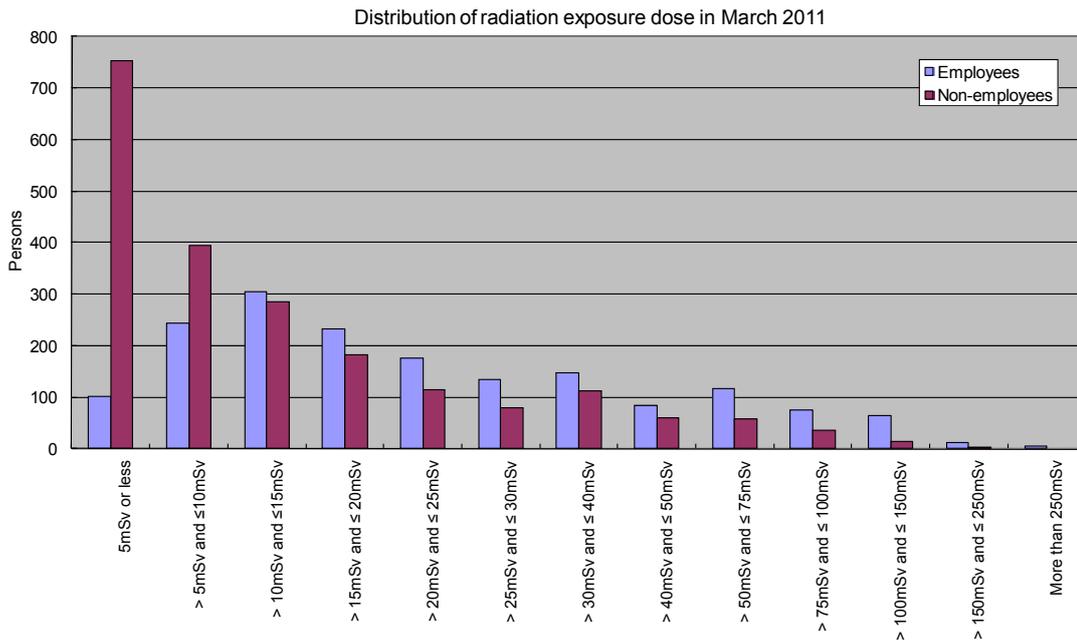
The employee and nonemployee exposure radiation level distribution for March 2011 is shown below. According to this, it is clear that the exposure by TEPCO employees is pushing up the average.

Six workers suffered an exposure that exceeds the emergency worker radiation level limit of 250mSv; however, all of these workers were TEPCO employees who were operators or electrical/instrument engineers that were in the MCR following the accident to monitor instruments. As soon as it was discovered that these workers suffered a dose that exceeded 250mSv they were immediately removed from the Fukushima Daiichi NPS and have undergone health examinations and have been examined periodically by physicians. No impact to their health has been seen.

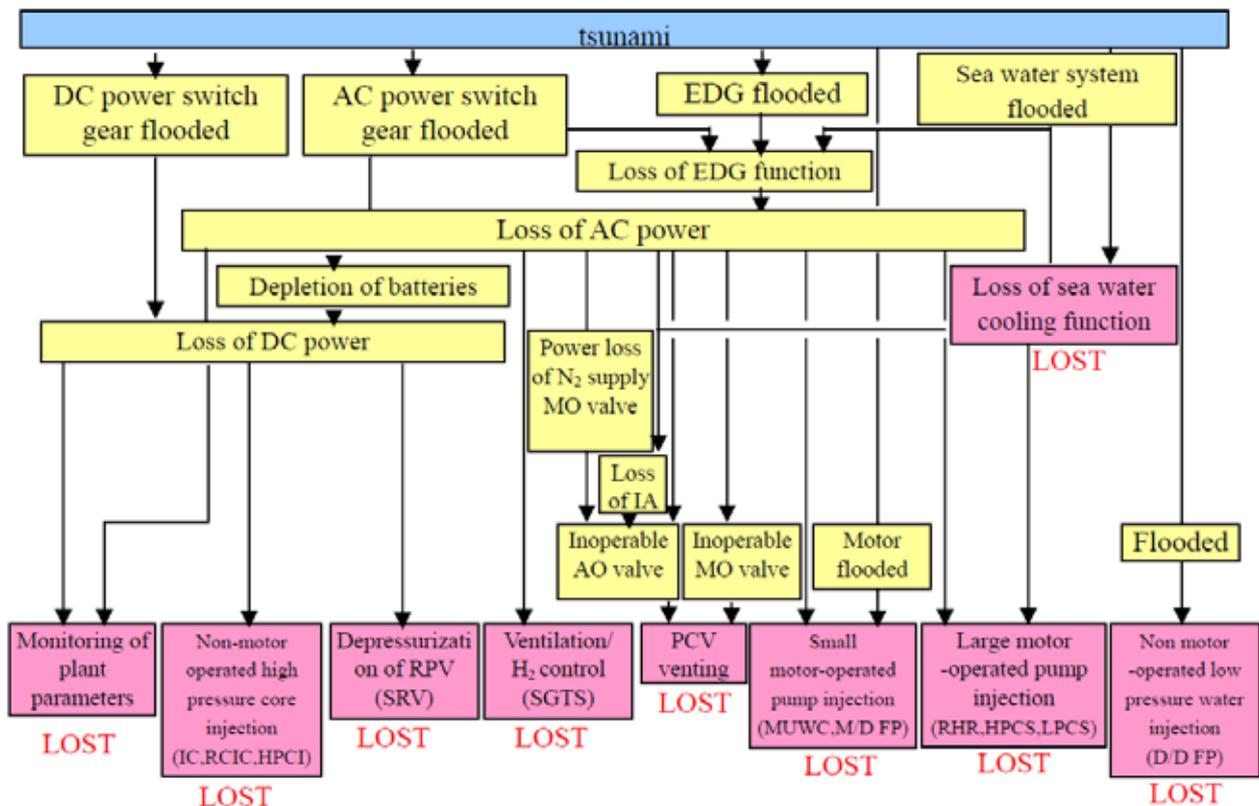
Causes leading to the loss of critical functions to prevent core damage and mitigate impacts

This caused outdoor equipment as well as indoor equipment, especially EDGs and power-related equipment, to lose their functions. Furthermore, all units, except Unit 3, lost DC power, which is necessary for control and instrumentation.

- The relationship of events that led to the loss of vital functions based on the accident's progression is provided below.

- The accident was caused by the fact that multiple safety functions were lost simultaneously due to the tsunami inundation, and the causes in terms of the event are the “simultaneous loss of all AC power and DC power for an extended period of time” and “the loss of heat removal function of emergency seawater systems for an extended period of time.”

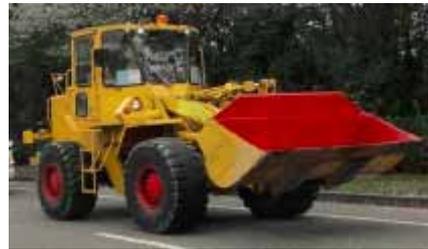
Example: Allocation of wheel loader and power shovel

During the accident response, debris due to the tsunami and explosion scattered in the field interfered with the passage of fire engines and other vehicles as well as

response activities. Therefore, it is necessary to provide, in advance, heavy machinery for debris removal to use for accident response. Attention should also be paid to the location of parking lots on-site so they do not impact important facilities when they are washed away by the tsunami.
