Inspection of the Structures inside Unit 4 Reactor

From November 27, 2012, the structures inside Unit 4 reactor (representative unit) for which opening of the reactor and fuel removal have been completed are being visually inspected for the purpose of obtaining more information on seismic impact. (Previously announced on November 26, 2012)

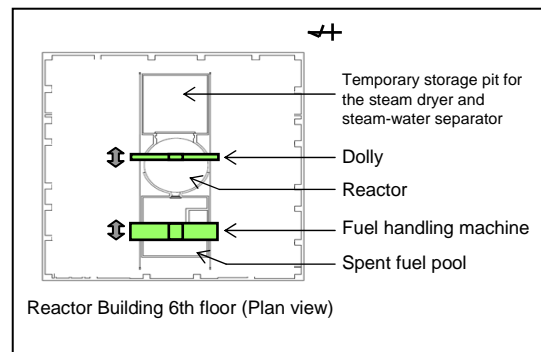
Inspection conducted on the dolly (Photo taken on November 30)

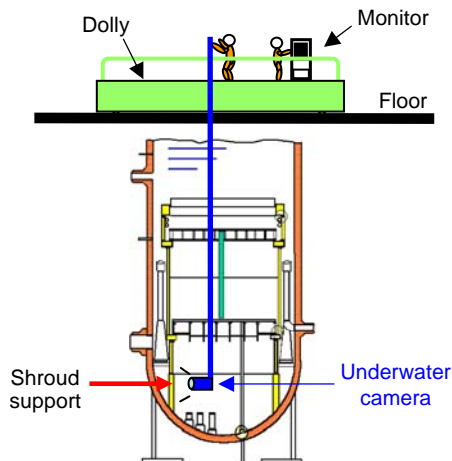
< Shroud support inspection >

As of November 30, fuel assemblies (2 out of 8), core shroud*³, fuel support*⁴, (part of) shroud support and control rod guide pipe*⁵ have been visually inspected and no problem was found.
