Report on the Current Seismic Safety and Reinforcement of the Reactor
Buildings at Fukushima Daiichi Nuclear Power Station (No.1)
(Supplement) (Revision 2)

December 2012
Tokyo Electric Power Company

Report on the Current Seismic Safety and Reinforcement of the Reactor Buildings at Fukushima Daiichi Nuclear Power Station (No.1) (Supplement) (Revision 2)

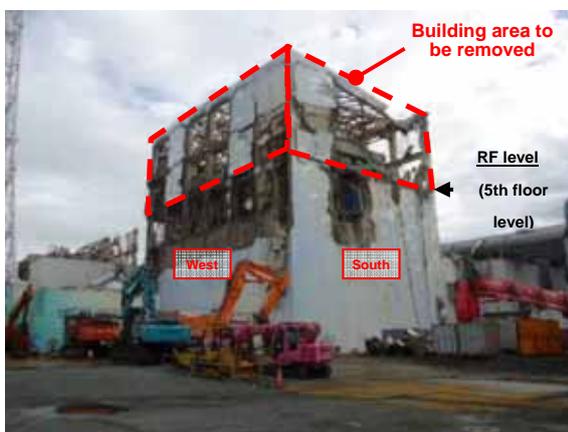
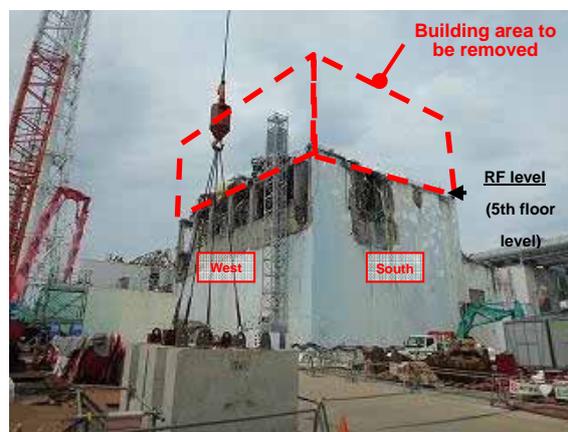
Figure-1.3.1 Progress of Debris Removal from Upper Part of RF (Southwest-side)

Progress in removing debris above the RF is shown in Figure-1.3.1, and progress in removing machinery from the RF in Figure-1.3.2. At the stage of the 2011 Report, debris above the refueling floor and the weight of machinery were taken into account, but with regard to the debris, the removal work which started in late November 2011 was completed in early July 2012. Also with regard to the machinery, the removal of large machinery (head of primary containment vessel and head of the reactor pressure vessel) etc., was commenced in late July 2012, and is scheduled to be completed in October 2012. Therefore, in the assessment estimating the time of spent fuel removal, weight reduction due to removal of such debris and machinery is taken into account.

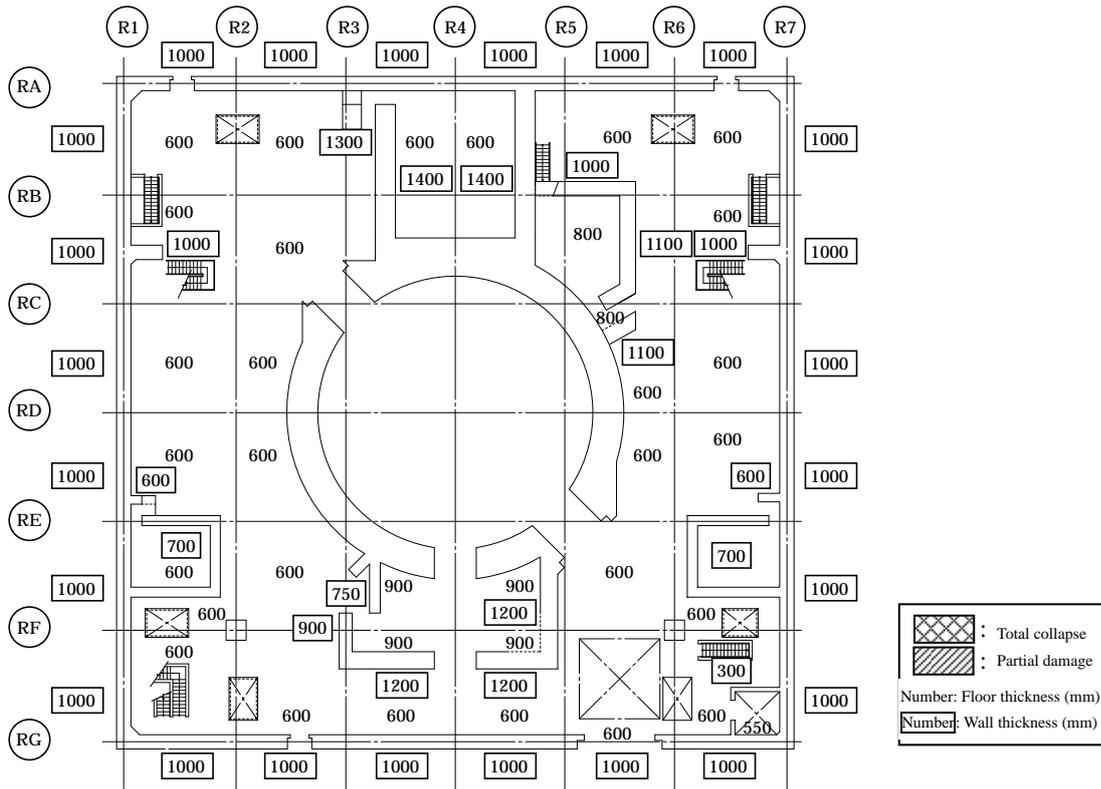
Figure-2.3.1 Damage Conditions (1st Level: No Damage)

Taking into account the investigation results of the Accident Investigation Report, the specific details of the damage to the reactor building frame have been consolidated based on visual inspections conducted of the walls and floors affecting seismic safety. For each span, the degree of damage was classified into three grades (no damage, partial damage, total collapse). The conditions of the damage to each reactor building levels are shown in Figure-2.3.1 to Figure-2.3.8. Locations where partial bulging was confirmed in exterior walls in the "Report on the Seismic Safety of Unit 4 Reactor Building at Fukushima Daiichi Nuclear Power Station in Consideration of the Partial Expansion of the Exterior Wall" (Tokyo Electric Power Company, June 2012) (hereinafter, "June 2012 Report") were classified as partial damage.

Of the damaged areas, locations where repairs are desirable from the standpoint of human safety or durability of components are scheduled to be repaired to the extent possible.

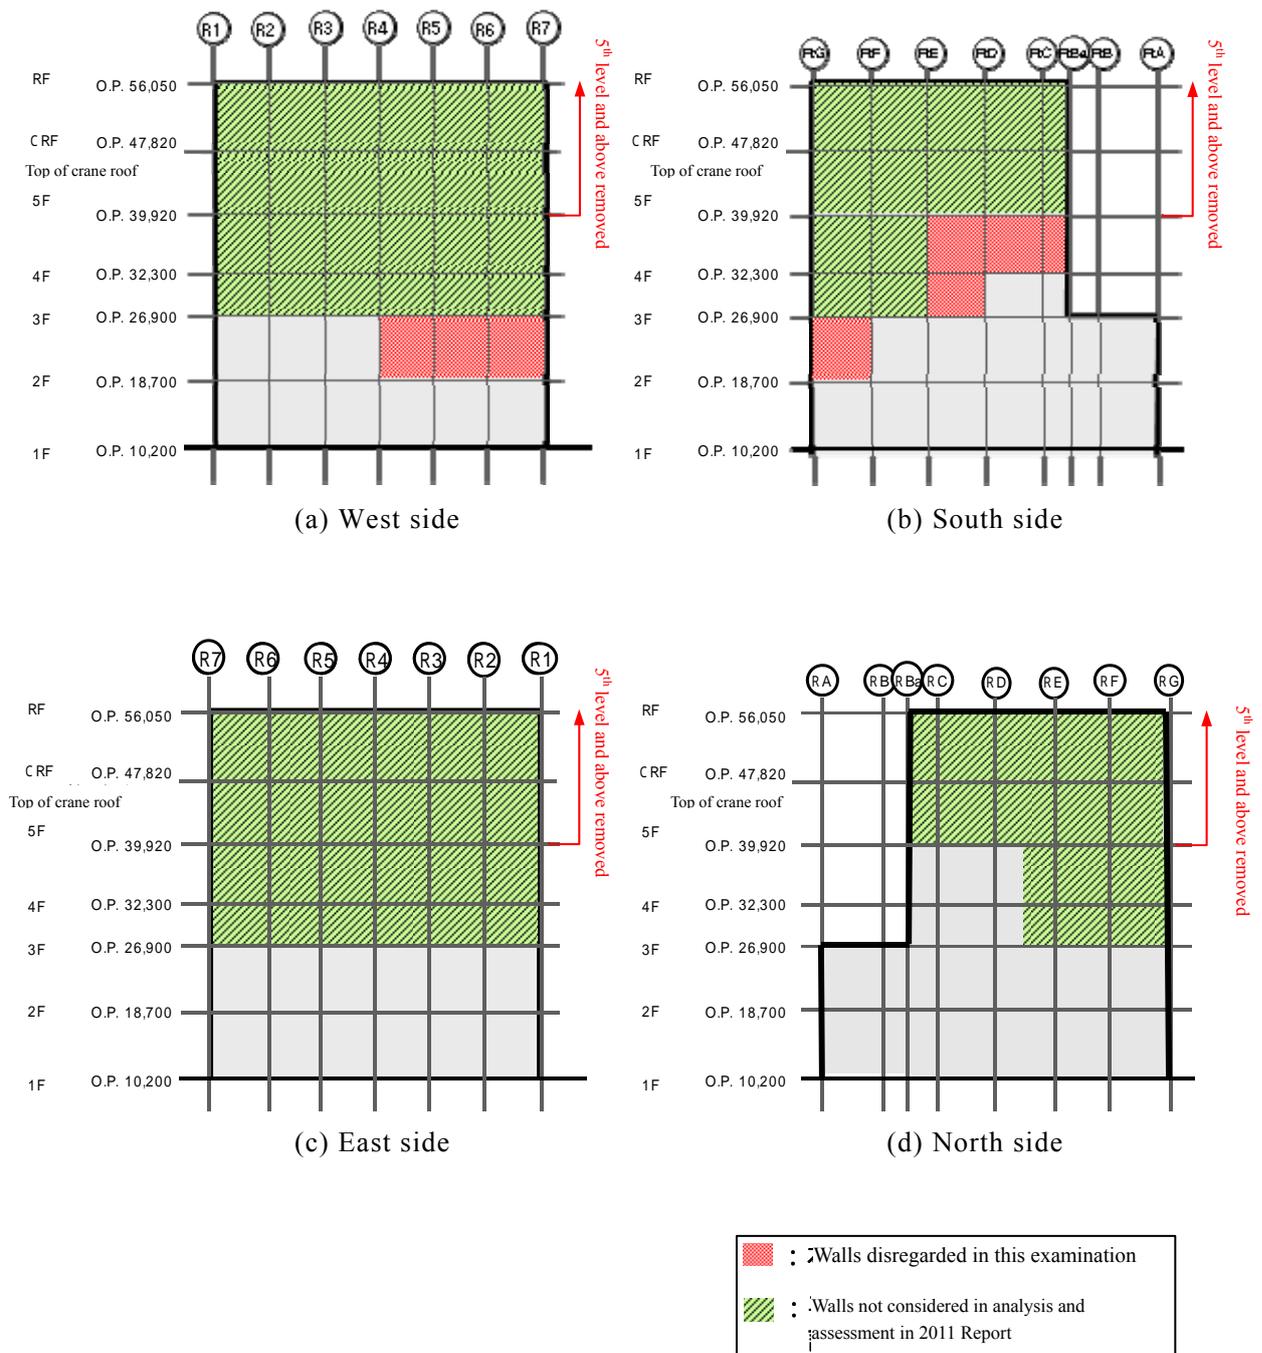
Figure-3.2.1 Exterior walls disregarding rigidity

In estimating the damage conditions, a new model for seismic response analysis based on the seismic response analytical model prepared in the 2011 Report is constructed, disregarding the areas confirmed to have damage (partial damage or total collapse) in Attachment-2 and the rigidity of areas where partial bulging of the exterior walls was confirmed in the June 2012 Report. The exterior walls disregarding rigidity are shown in Figure-3.2.1.

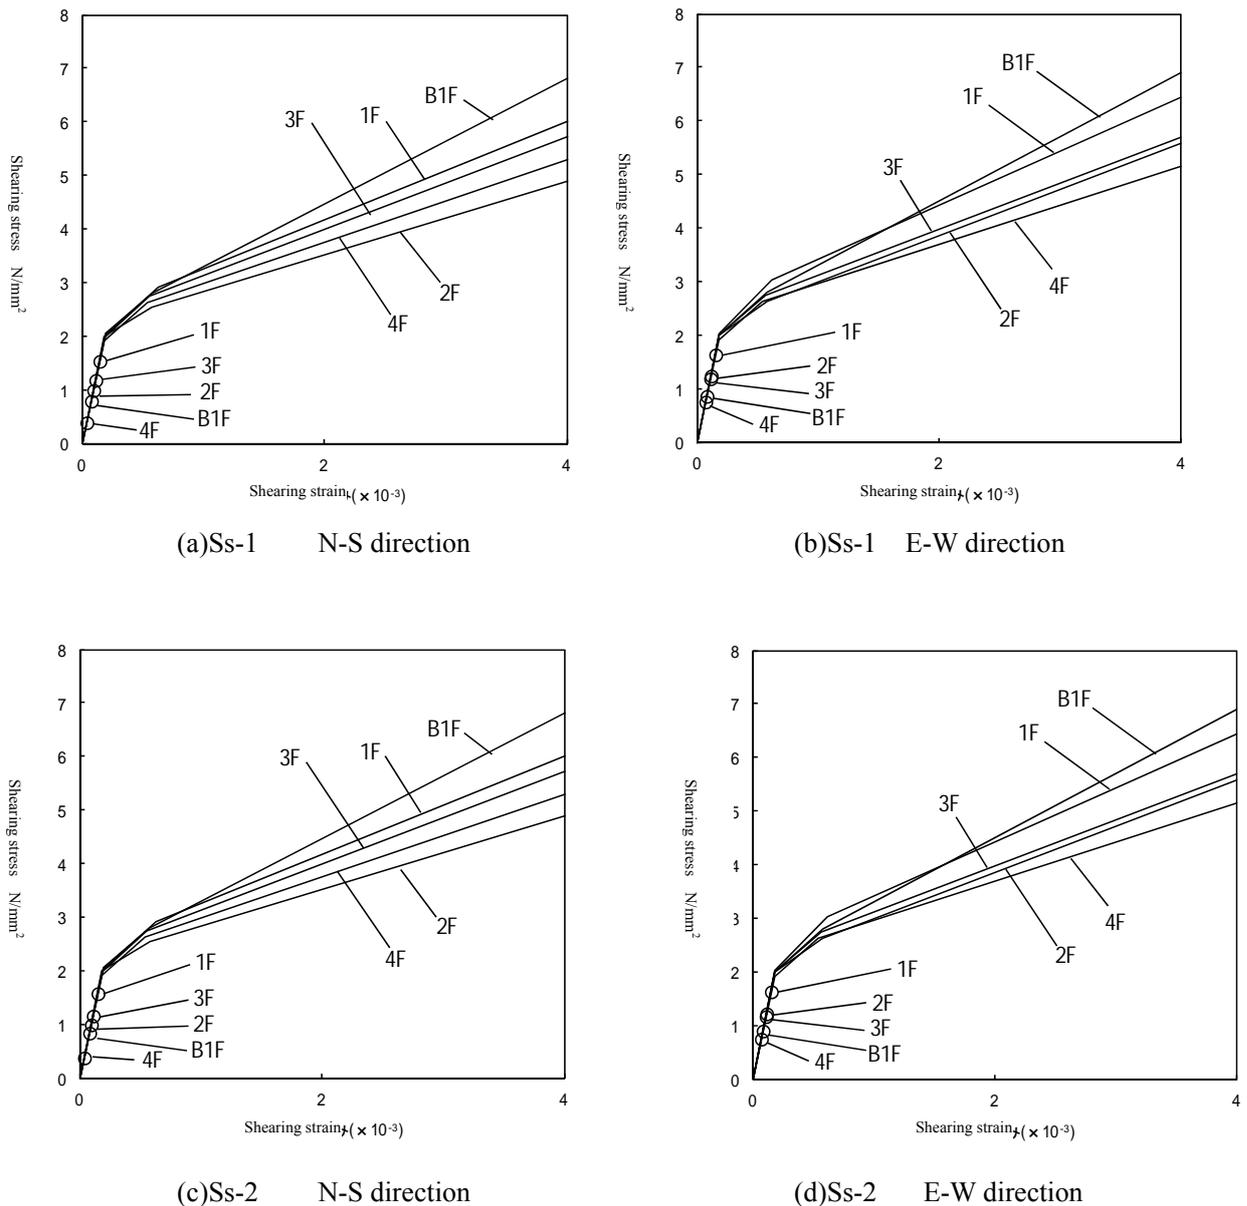
Figure-3.7.1 Maximum Response Value on Shearing Skeleton Curved Line

The maximum response values in relation to reference seismic motion Ss-1 and Ss-2 are shown on the shearing skeleton curve for earthquake-resisting walls in Figure-3.7.1. Shear strain is 0.16×10^{-3} (Ss-1, 2H, E-W direction, 1F) at a maximum, and there is sufficient allowance in relation to the assessment reference value (4.0×10^{-3}). Based on this, the reactor building, assuming the condition when spent fuel is removed, was assessed to have sufficient seismic safety even when disregarding rigidity of locations where partial bulging of the exterior walls was confirmed and walls where damage was confirmed.

Therefore, it is believed that the building will not collapse even if struck by reference seismic motion Ss.

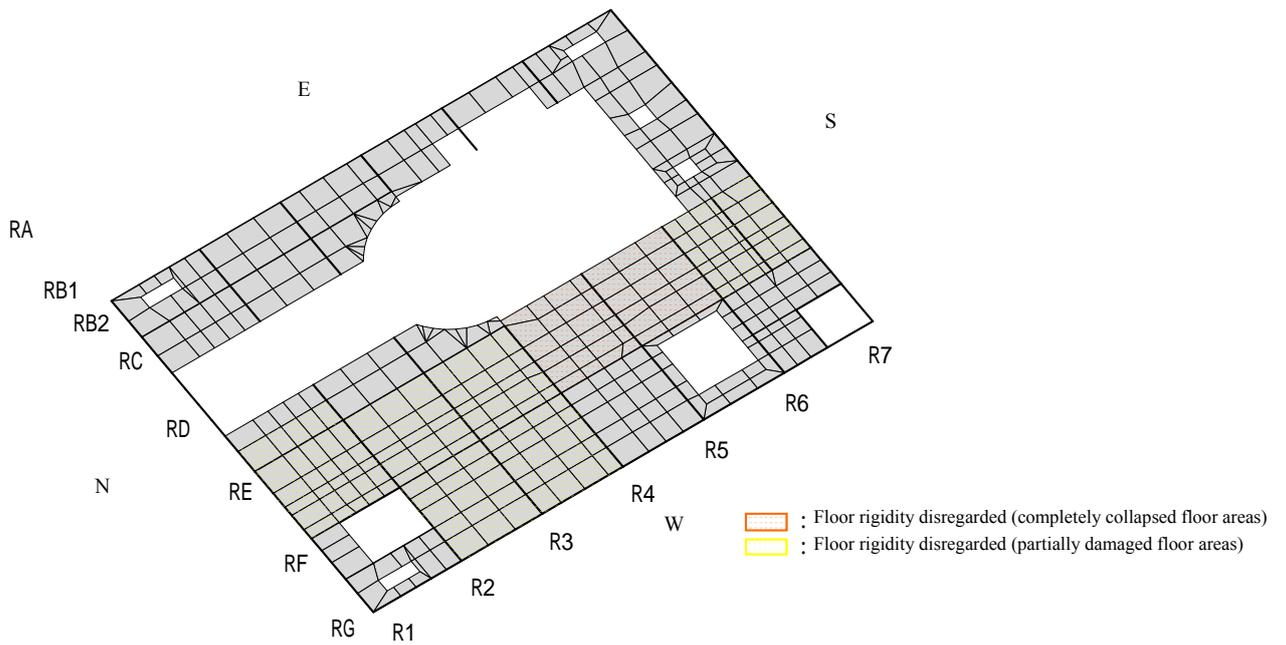
Figure 4.3.1 Damage Model: Isometric Drawing of 5th Level (O.P.39.92m)

In assuming the damage conditions, a three-dimensional analytical model was prepared which newly disregards the rigidity of the following damaged areas in accordance with the 2011 Report and is based on the areas where partial bulging of the exterior walls was confirmed in the June 2012 Report and areas where damage (partial damage and total collapse) was confirmed in Attachment-2. The damage model is shown in Figures-4.3.1~4.3.4.

As for floor slabs, the rigidity was disregarded for parts of the 3rd level (O.P.26.9m) to 5th level (O.P.39.92m) as well as all of the partially damages areas of the floors and the areas which completely collapsed.

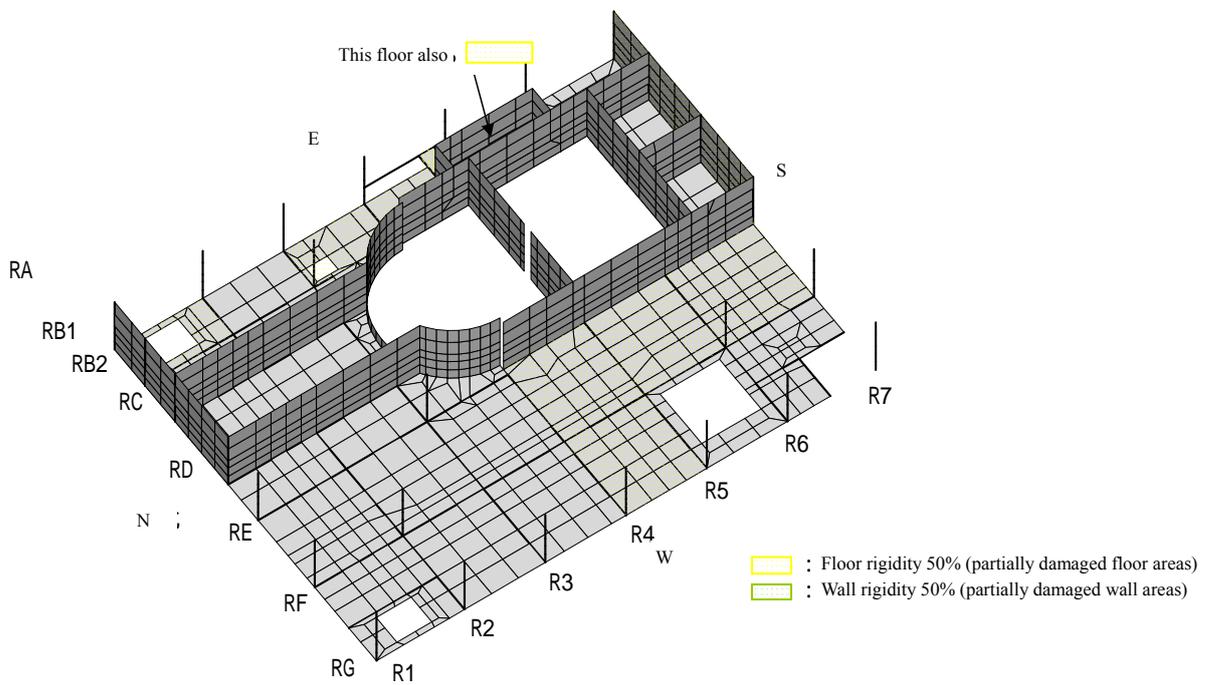
Figure-2 Damage Model: Isometric Drawing of 4th Level (O.P. 32.3m) (Parameter Case)

For the exterior walls, the actual condition of rigidity of part of the south side and west side, where there is bulging in the exterior wall as described in the June 2012 Report, and the south side of the 3rd level (O.P.26.9m) and 4th level (O.P.32.3m) according to Attachment-2, are taken into consideration and set at 50%.

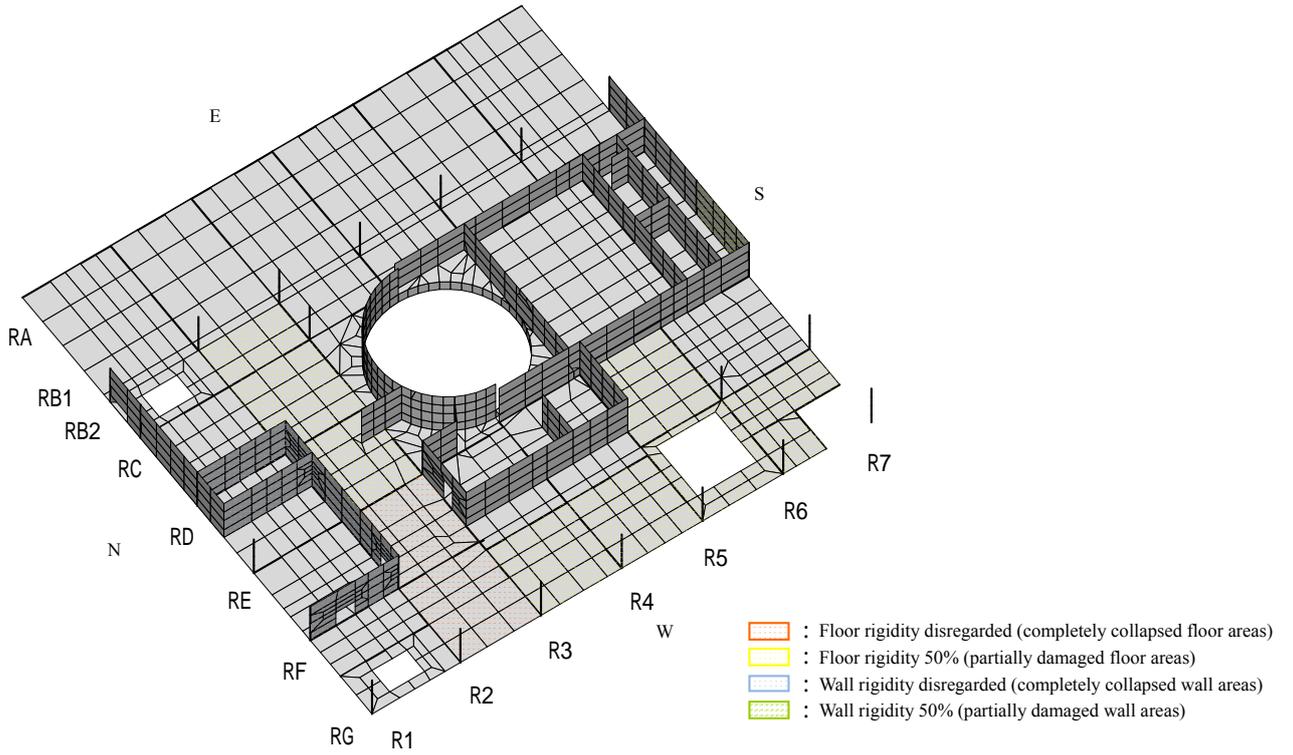
Figure-3 Damage Model: Isometric Drawing of 3rd Level (O.P. 26.9m) (Parameter Case)

For the floor slabs, the actual condition of rigidity of locations determined to be partially damaged floor are taken into consideration for parts of the 5th level (O.P.39.92m) to 3rd level (O.P.26.9m), and set at 50%.

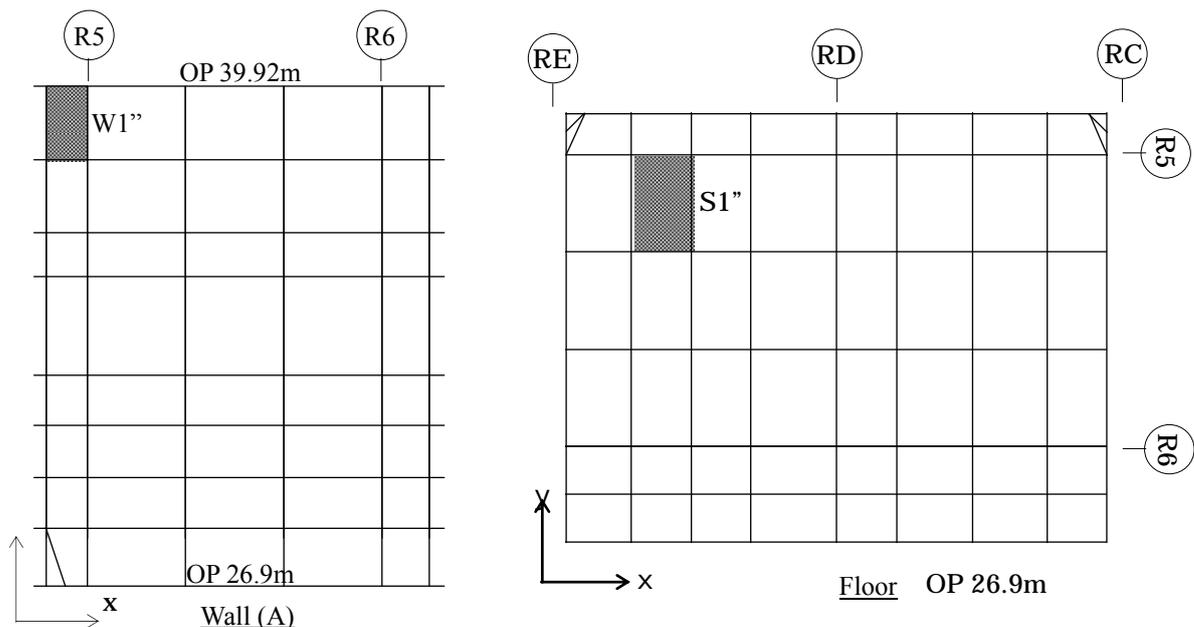
Figure-5 Locations where Testing Ratio of Strain is Maximum in Parameter Case (W1'' and S1'')

*2 : Strain in the pool walls and pool floor differs in the parameter case and basic case for locations where the ratio of the occurring strain and occurring stress in relation to the assessment reference value (testing ratio) is maximized, and the strain in the parameter case in the above table is not the value of a location where the testing ratio is the maximum, and the value of the location is the same as in the basic case. Locations where the testing ratio is the maximum in the parameter case are S1'' in the floor and W1'' in wall (A) shown in Figure-5, and the testing ratio is 0.24 for the reinforcing bar strain of W1'' and 0.13 for the concrete strain of S1''.

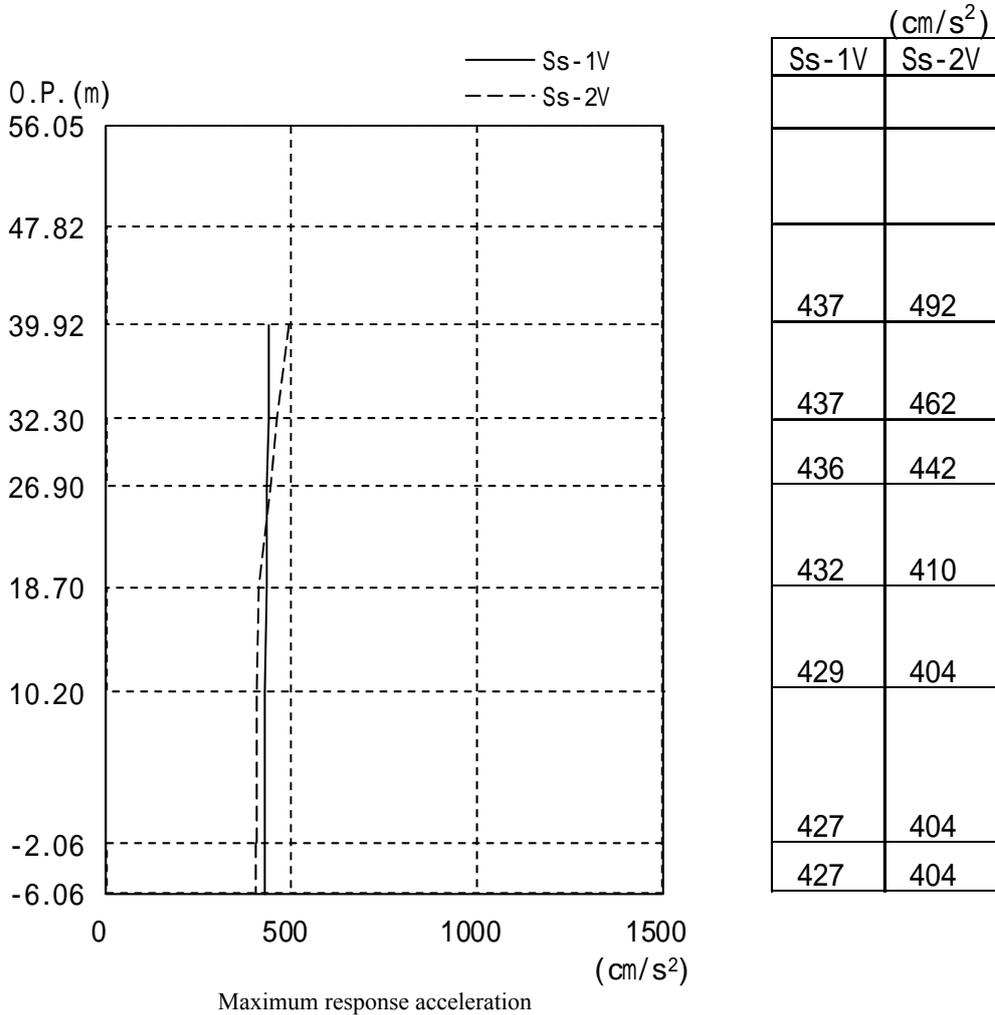
Figure-2 Maximum Response Acceleration (Vertical Direction)

The maximum response acceleration and maximum response axial force for the vertical direction found using seismic response analysis are shown in Figure-2 and Figure-3.
