The seismic response analysis results based on the observation record of the Tohoku-Chihou-Taiheiyou-Oki Earthquake in 2011 indicate that the structures inside Units 1-4 RPV were evaluated to maintain sufficient safety functions. (Previously announced on August 18, 2011) From November 27 to December 12, 2012, the structures and equipment inside Unit 4 reactor (representative unit) for which opening of the reactor and fuel removal have been completed were visually inspected utilizing an underwater camera for the purpose of obtaining more information. As a result, no abnormality which may affect the reactor's function was found. (Previously announced on December 13, 2012)

Equipment inspected and results of inspection (Photos)

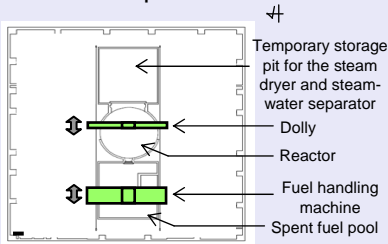
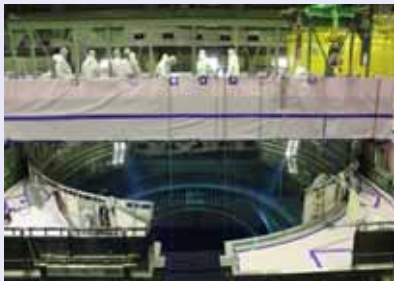
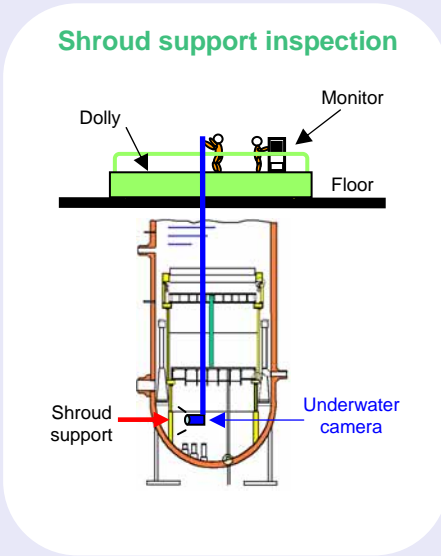
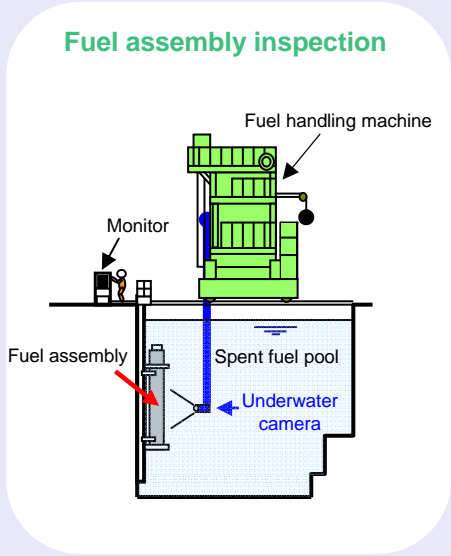
Inspection conducted on the dolly (Photo taken on November 30, 2012)

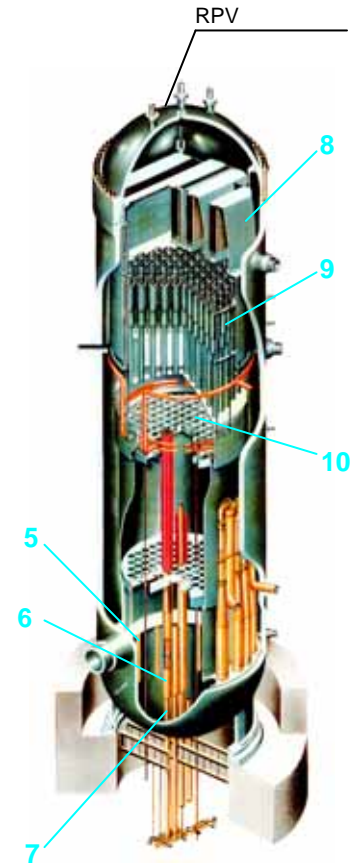
Problem found at the inspection

During inspection of the inside of reactor, a small damage (crack) was found on the upper part of the steam dryer support bracket (installed at 184 °). (Announced on our home page on December 5, 2012 [Discussed at the Noncompliance Management Committee on December 4]) It was judged that the damage (crack) found has no impact on equipment soundness. The damage is assumed to have occurred at the steam dryer installation (when the bracket contacted the anti-seismic block) which took place after the 16th regular inspection (June-October 2011), not due to the earthquake.

* In response to this incident, the steam dryer support brackets (installed at 4 °, 94 ° and 274 °) and anti-seismic blocks (at 4 locations) in other areas. As a result, no problem was found.
