**Fukushima Daiichi Nuclear Power Station  
Leakage from the Contaminated Water Storage Facility RO Concentrated  
Water Reservoir  
(Final Report)**

Filed, June 2014  
Revised, October 2014  
Tokyo Electric Power Co., Inc.

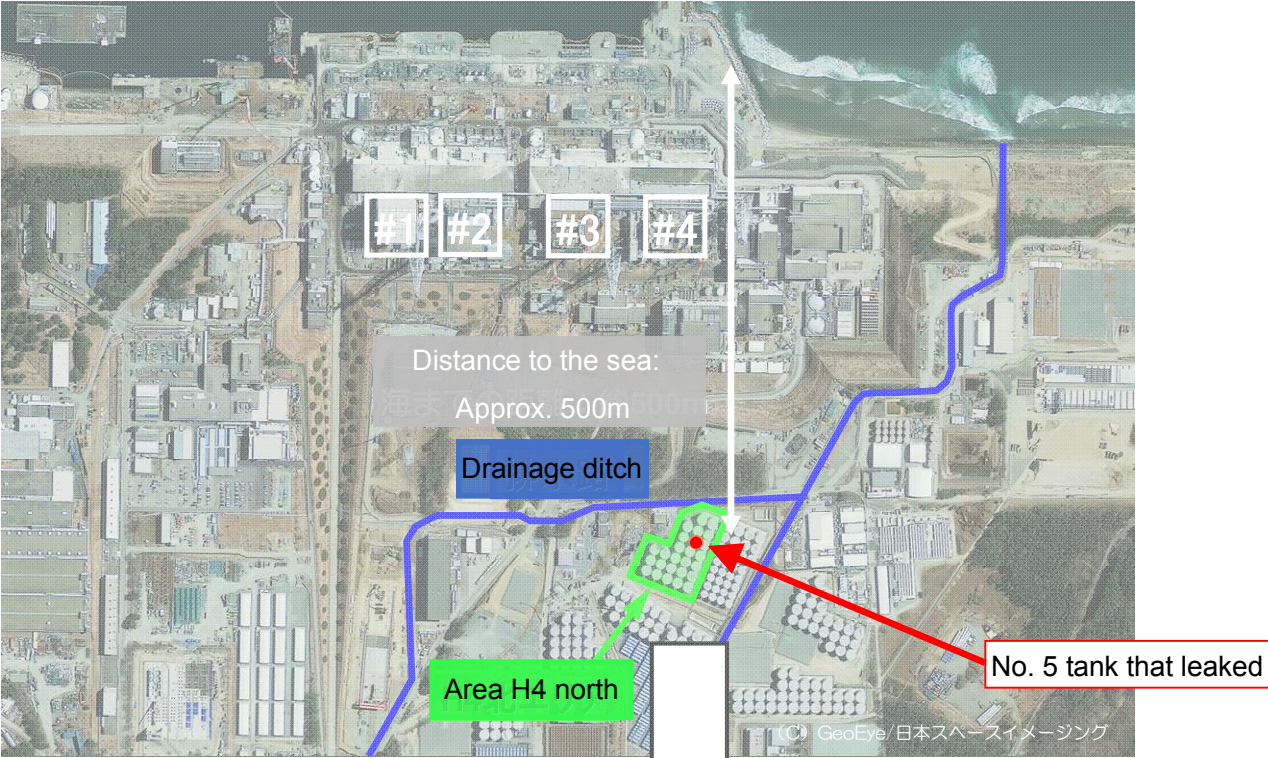
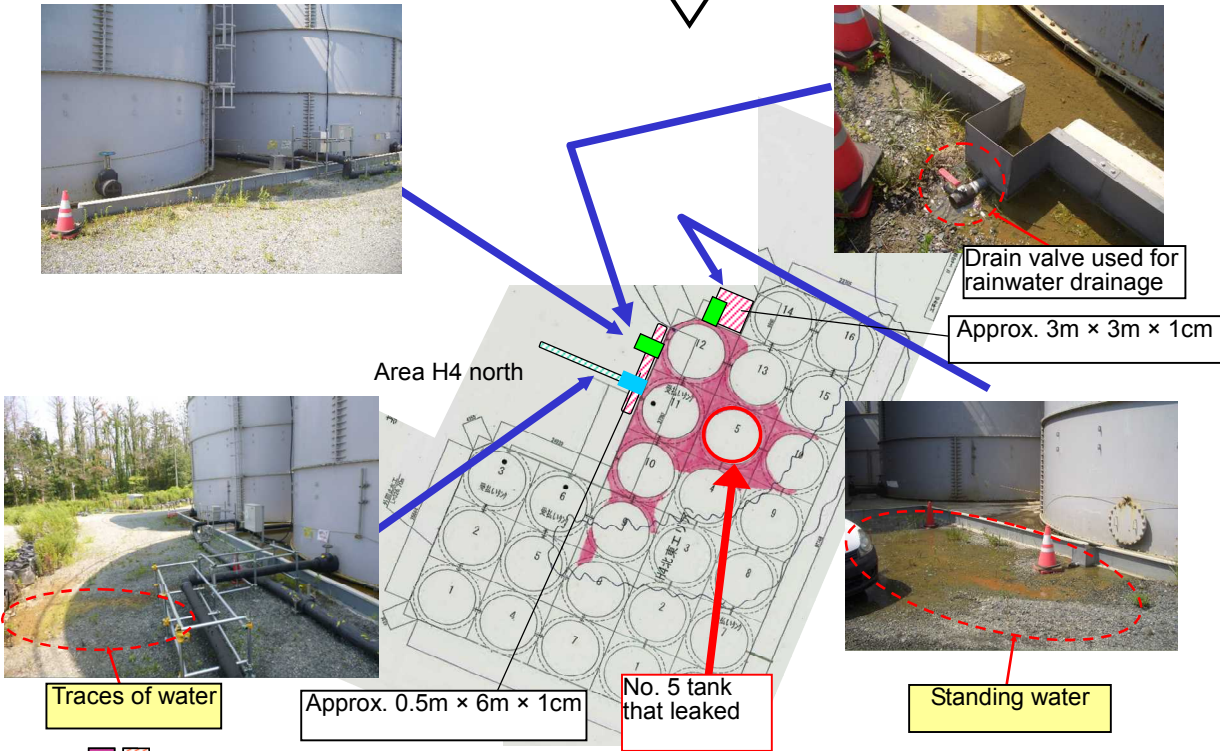
**Fig. 1 Water leak locations**

- : Areas with standing water (as of 8/19 4:00 p.m.)
- : Drain valve and catch basin where an outflow was confirmed
- : Nearby drain valve that was closed and its catch basin

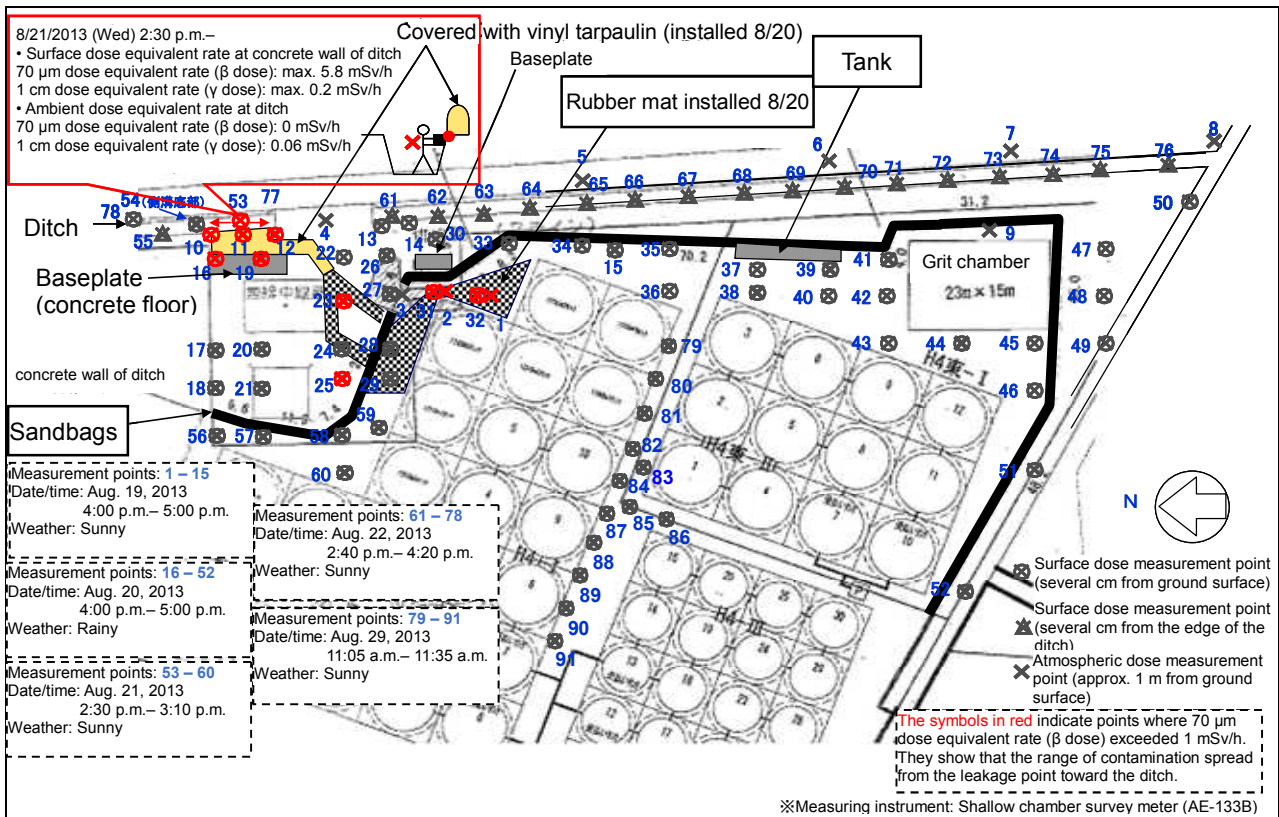
Fig. 1 Investigation of radiation dose on ground surface (measurement points)

Measurement points: 1 – 15 Date/time: Aug. 19, 2013 4:00 p.m. – 5:00 p.m.					Measurement points: 16 – 30 Date/time: Aug. 20, 2013 4:00 p.m. – 5:00 p.m.						
Measurement point	Date	Dose rate		Weather	Remarks	Measurement point	Date	Dose rate		Weather	Remarks
		70 μm dose equivalent rate (β dose)	1 cm dose equivalent rate (γ dose)					70 μm dose equivalent rate (β dose)	1 cm dose equivalent rate (γ dose)		
1	8/19	>98.5	1.5	Sunny	No rubber mat; height: approx. 50 cm	16	8/20	8.96	0.04	Rainy	On concrete
2	8/19	5.4	0.1	Sunny	No rubber mat	17	8/20	0.03	0.10	Rainy	
3	8/19	0.03	0.05	Sunny	No rubber mat	18	8/20	0.02	0.08	Rainy	
4	8/19	0	0.04	Sunny		19	8/20	1.96	0.04	Rainy	On concrete
5	8/19	0	0.06	Sunny		20	8/20	0.02	0.08	Rainy	
6	8/19	0	0.06	Sunny		21	8/20	0.09	0.08	Rainy	
7	8/19	0	0.045	Sunny		22	8/20	0.12	0.03	Rainy	
8	8/19	0	0.06	Sunny		23	8/20	2.90	0.10	Rainy	
9	8/19	0.135	0.015	Sunny		24	8/20	0.04	0.16	Rainy	On rubber mat

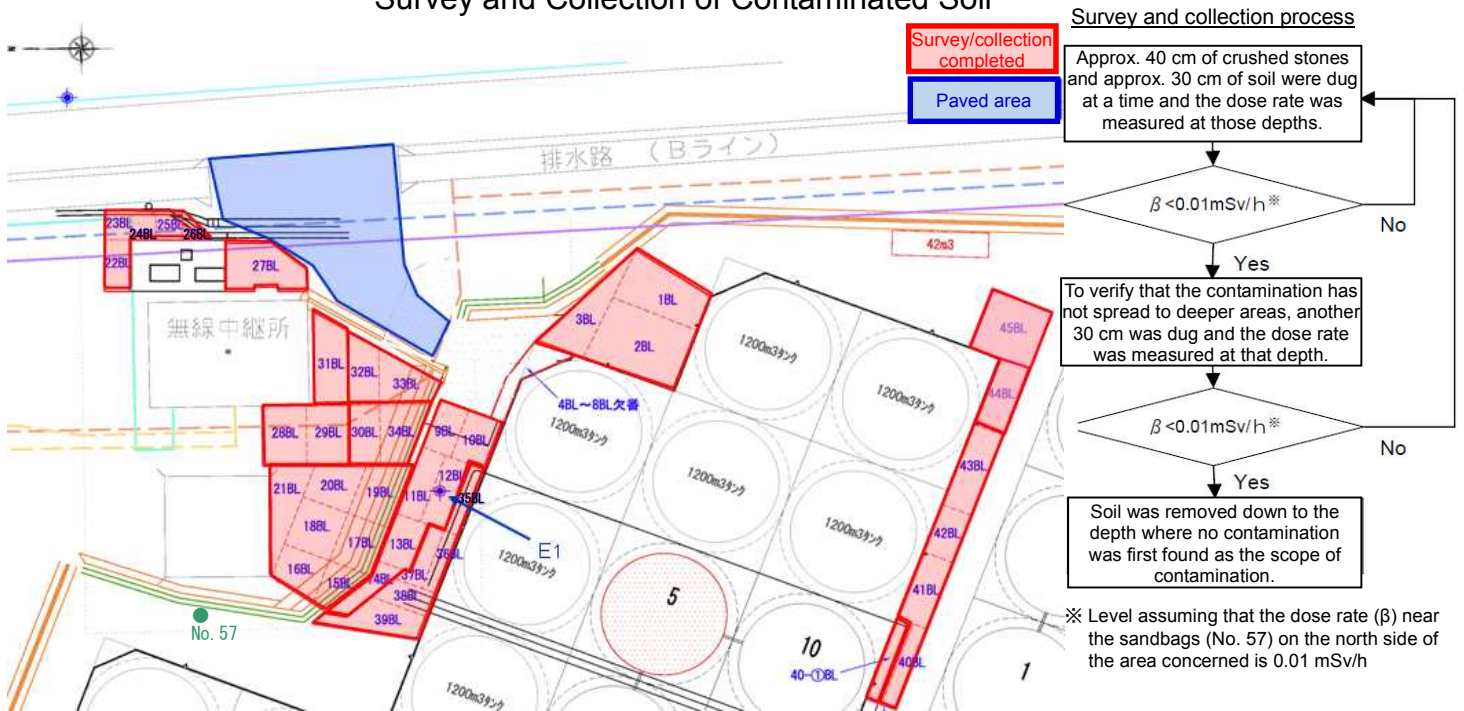
Fig. 1 Survey and collection of contaminated soil—Overall ground view and process

Block	Dose rate measurement depth	Dose rate (mSv/h)	Amount of soil removed (m <sup>3</sup> )	Remarks	Block	Dose rate measurement depth	Dose rate (mSv/h)	Amount of soil removed (m <sup>3</sup> )	Remarks
1	GL-3000	0.009	60		27	GL-1000	0.008	29	
2	GL-3000	0.009	96		28	GL-2500	0.040	26	In consideration of safety
3	GL-3000	0.009	64		29	GL-2500	0.10	17	In consideration of safety
9	GL-1080	0.005	16		30	GL-1000	0.008	18	
10	GL-1480	0.008	24		31	GL-2500	0.110	23	In consideration of safety
11	GL-840	0.008	15		32	GL-3000	0.007	30	
12	GL-860	0.008	16		33	GL-3000	0.130	10	In consideration of safety
13	GL-550	0.009	10		34	GL-1500	0.006	6	
14	GL-400	0.006	3		35-1	GL-2000	13.00	10	In consideration of safety
15	GL=1050	0.009	17		35-2	GL-2000	1.70	9	In consideration of safety
16	GL-900	0.004	21		36	GL-2000	0.80	19	In consideration of safety
17	GL-600	0.006	10		37	GL-2000	2.20	15	In consideration of safety
18	GL-600	0.007	15		38	GL-800	0.007	25

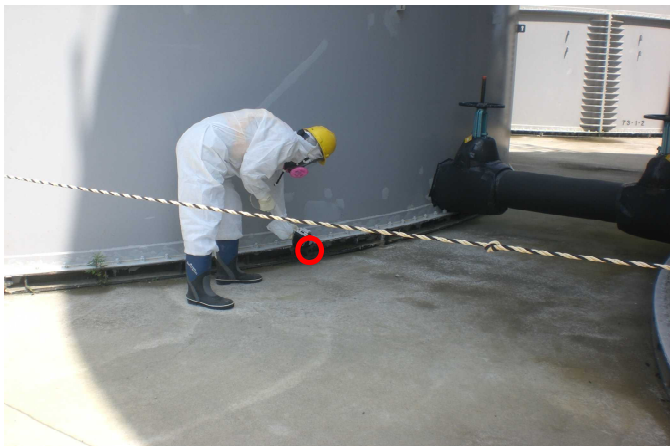
Fig. 2 High-dose area in tank No. 4

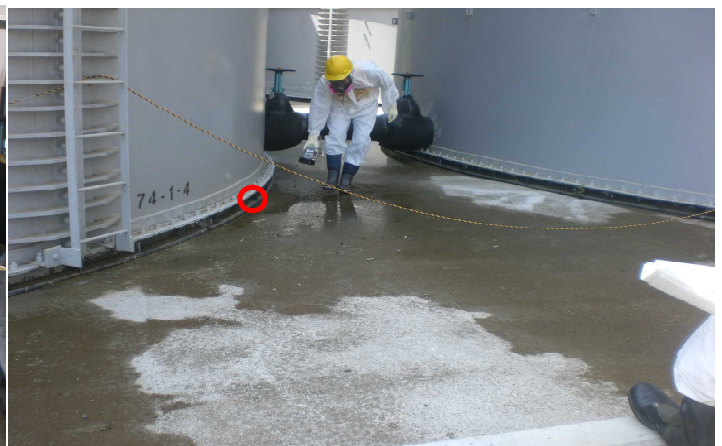
Fig. 3 High-dose area in tank No. 10

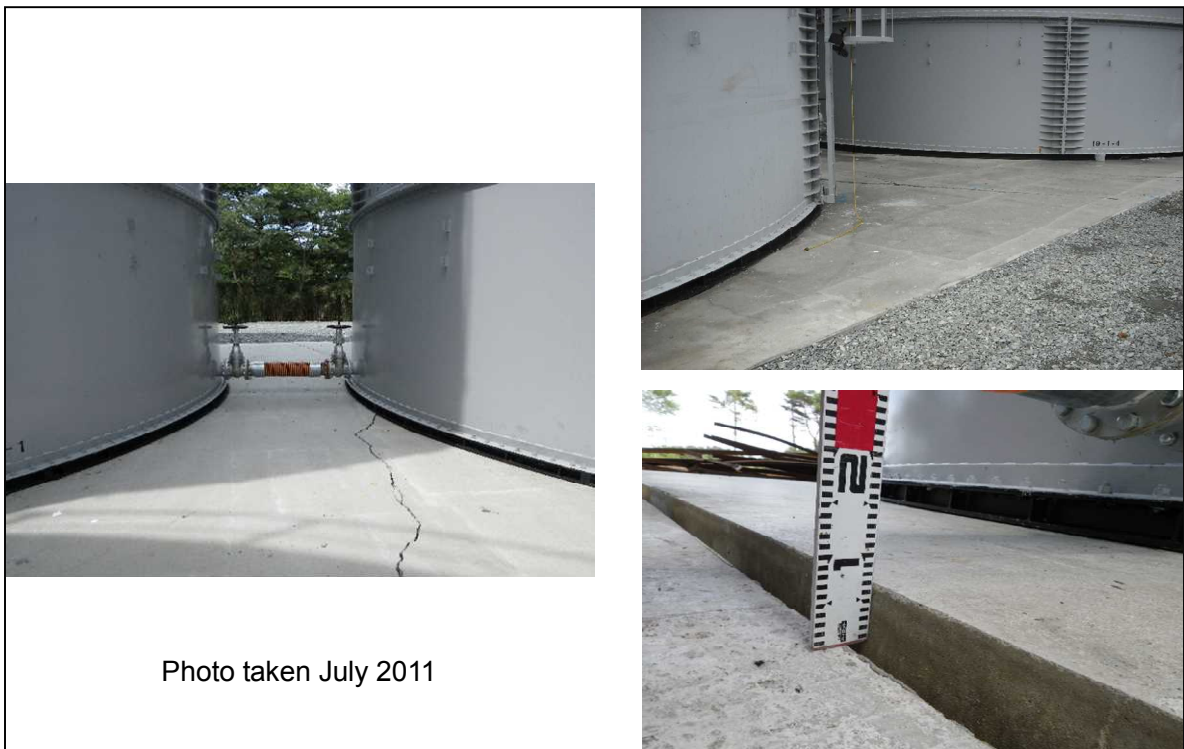
Fig. 2 Condition of the foundation in area H1 east

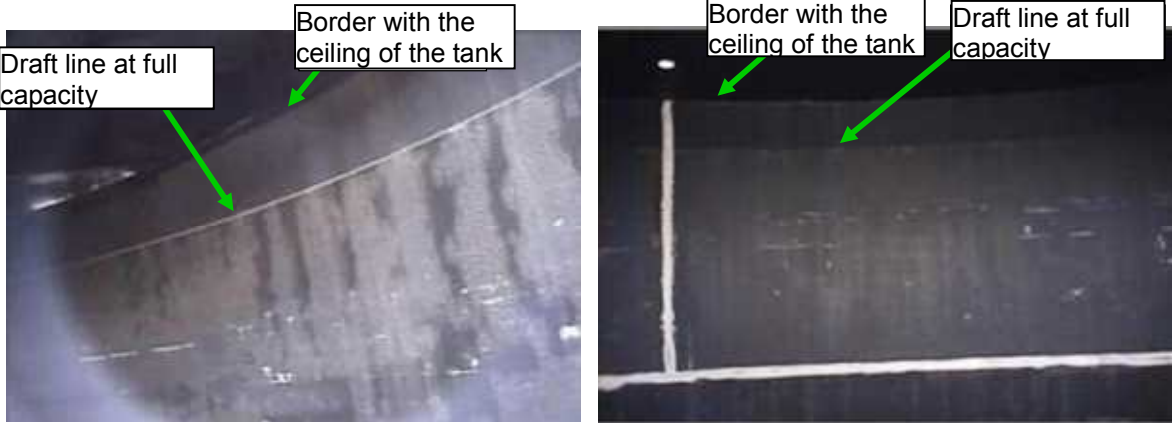
Fig. 3 Draft line inside tank No. 5

- The results of a nuclide analysis of water in tank No. 5 and assessment of leakage amount are as shown in the table below. The leaked amounts were obtained by multiplying the leaked volume of 300m<sup>3</sup> to the concentration of each nuclide.
- The leaked volume of Sr-90—which is thought to have the highest concentration and the greatest impact on the environment—was calculated as 4.5E + 13 Bq.
- With regard to other nuclides, the concentration of tritium was high, but fell below 1/50 that of Sr-90, and cesium and other nuclides fell below 1/10 that of tritium.
- There were no large differences between the water in the tank concerned and the leaked water when considering the fact that the analysis results of the leaked water also show measurement fluctuations and do not necessarily indicate a completely uniform state of radioactive material in the water.

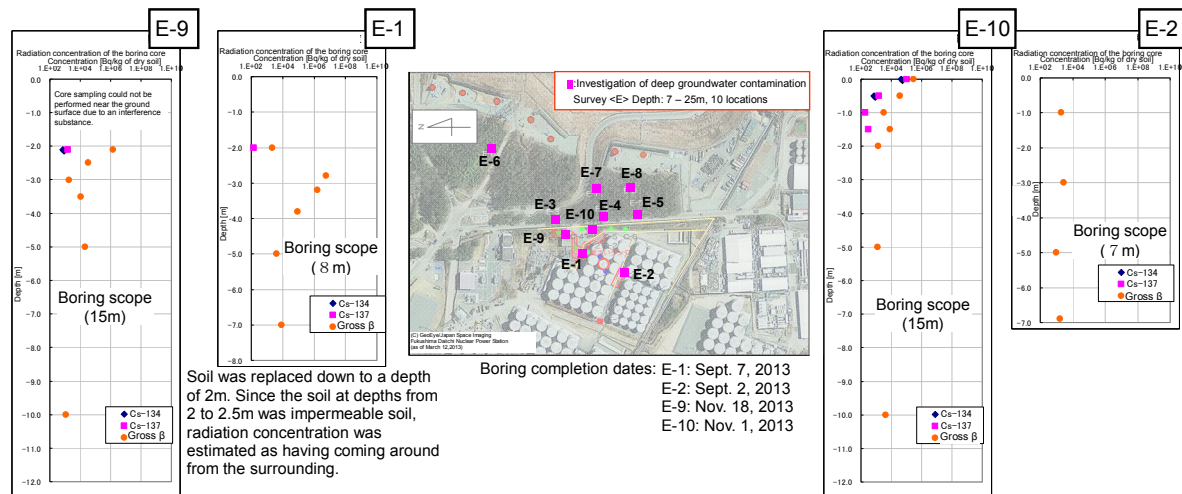
**Fig. 1 Survey of contamination of the boring core for investigation of deep groundwater contamination (E-1, 2, 9, 10)**

- At locations E-1 and E-9 on the northeast side of the tanks in area H4, high concentrations of gross  $\beta$  radiation were detected. Particularly at E-1 near the tank area, a high concentration was detected even at a depth of 3m.
- At location E-2 on the south side, gross  $\beta$  radiation was detected, but at a low concentration.
- At location E-10 on the east side, contamination was observed near the ground surface, but there was no large difference with the concentration of cesium.
- At locations E-3 to E-5 on the east side of drainage ditch B, surface dose equivalent rate was measured with the result that no radiation dose was measured, when excluding the ground surface that is thought to have been affected by the cesium that adhered near the ground surface after the accident.

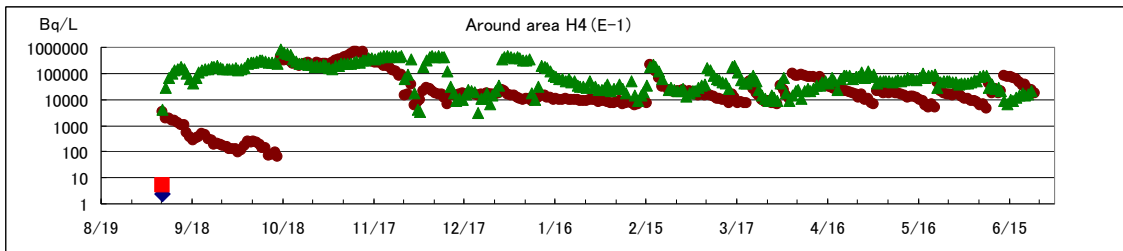
**Fig. 1 Results of boring (E-1) radioactivity analysis**

- There is an apparent tendency with regard to groundwater at E-1 for gross beta concentrations in particular to rise when the level of the groundwater rises due to rainfall.
- Radioactive materials remaining below the concrete foundations (thought to be mainly strontium-90) are thought to have been transported by rain and groundwaters to flow temporarily into the vicinity of the observation hole.

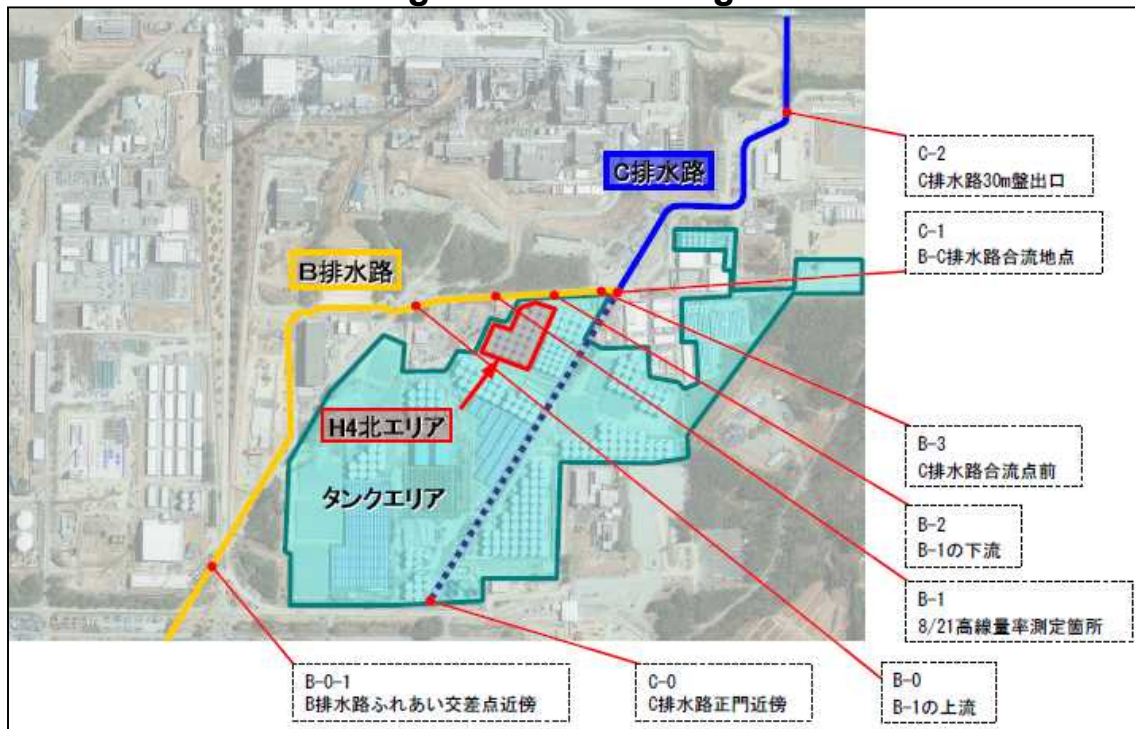
Fig. 1 Points where samples collected from drainage ditches B and C

- Spots were confirmed on the walls of drainage ditch B where high doses of radiation were measured that were thought to be the result of an influx of contaminated water. The dosage rates of the mud in drainage ditch B were measured and a nuclide analysis of the water performed, showing the amounts of beta radiation and gross beta radiation concentration to be high. For these reasons, the drainage ditch was closed off with sandbags, mud and water were collected, and the ditch was cleaned and covered.

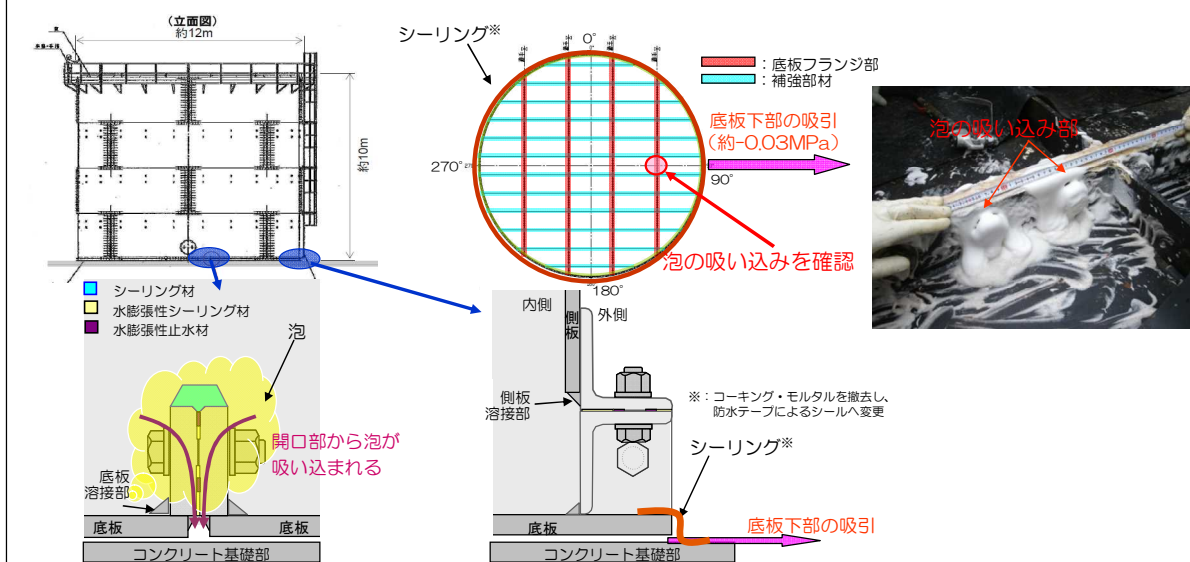
Fig. 3 Investigation Results (2) (vacuum test on baseplate bottom part)

- Foam was applied to the baseplate flange sections, etc., and then the bottom part of the baseplate suctioned, confirming that bubbles were suctioned in from 2 adjacent bolts.

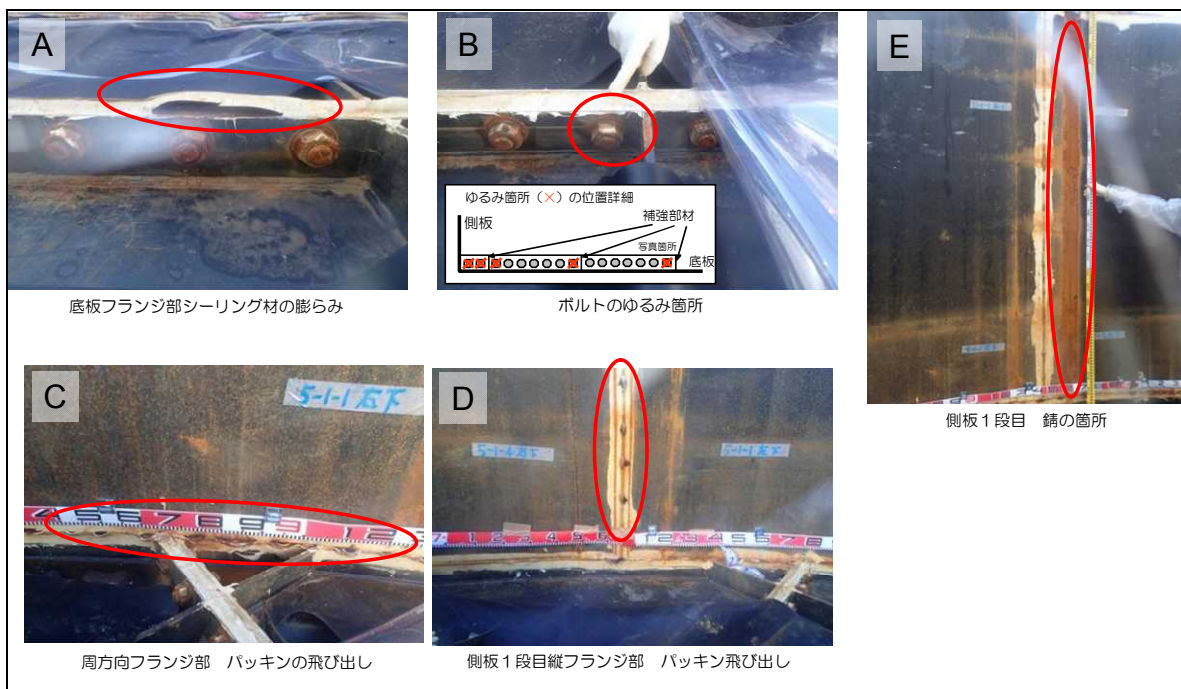
Fig. 6 Investigation Results (4) (photos of tank inner surfaces)

- A visual check of inside the tank was performed, confirming there were deformations and damage in the sealing material on the flanged section between the sideplate bottom part and baseplate, as well as that on the flanged section of the baseplate (confirmed also at tank No. 10 where there was no leakage).
- The state of fastening was checked through a bolt tapping test, confirming looseness in 5 bolts.
- Rust was confirmed running vertical on one sheet on the inner surface of the sideplate's first layer.

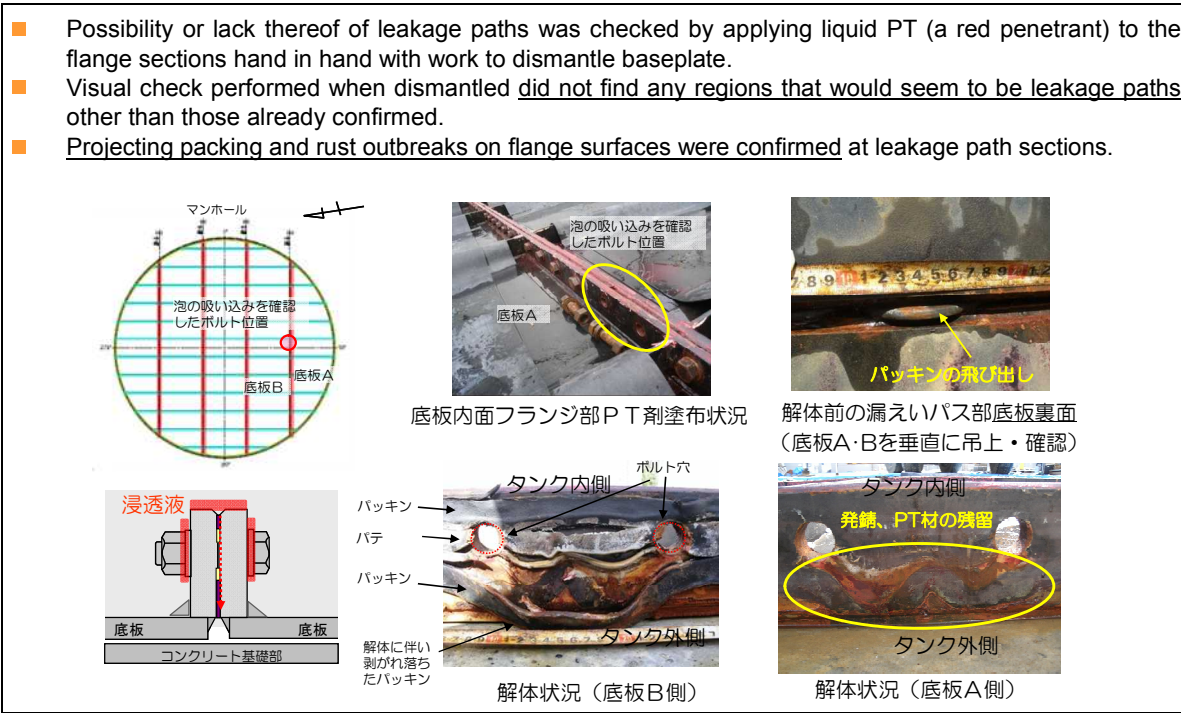
Fig. 9 Investigation Results (8) (visual checks of baseplate flange surfaces)

- A check of the flange surfaces found that the surfaces at the point of contact with packing at leakage path locations were considerably askew, and that the upper edge of packing traces was penetrating through the lower edge of the flange surface.
- Rust outbreaks were discovered between the putty and upper edge of the packing traces on the flange surface, as well as on the outer surface of the tank baseplate.
- The rust outbreaks on the flange surface and outer surface of the baseplate are thought to be corrosion produced by water that got into the gap that emerged between the putty and upper edge of the packing and went through to the bottom.

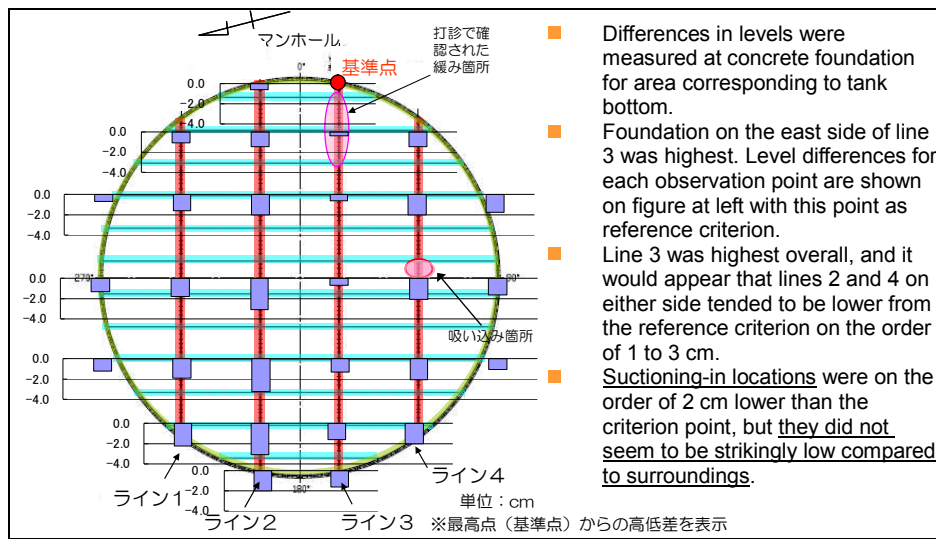
Fig. 12 Investigation Results (10) (measurements of level differences for concrete foundation)

Impact of level differences in concrete foundation	Measurements of concrete foundation (Attachment-21, Figure 12)	While level differences on order of 1 to 3 cm exist, confirmed that situation not such that the levels are strikingly different between the locations of leaks and surrounding areas	x
	Poor linkages in baseplate flanges	Measurement results (Attachment-21, Figures 4 and 5)	Confirmed that there were no striking discrepancies with other areas when it came to the spaces between baseplate flanges in vicinity of leaks, and that there were no level differences in the flange baseplates at the leak sites.	x
Deterioration of materials during operation	Corrosion of components such as steel plates and bolts	Visual check of external appearance (Attachment-20, Figure 7)	Confirmed that progress of rust did not seem to be striking and did not seem be anomalies such as deformation	x
	Damage and deterioration in sealing materials and in waterproofing materials between flanges	Visual observation of flange joint surfaces (Attachment-21, Figure 10)	Checked to see if packing had come off from flange bottoms, based on packing traces at flange joint areas and rust outbreak situation	O

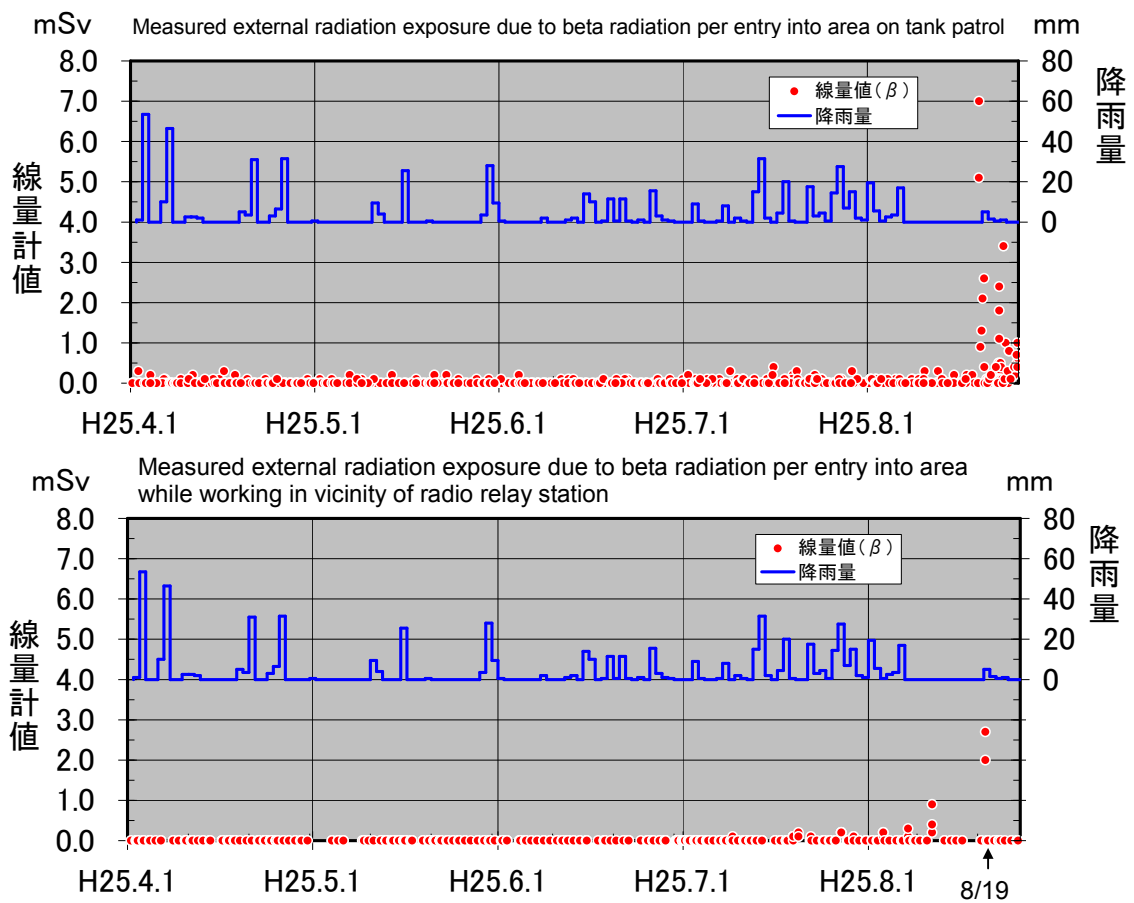
Fig. 1 Amount of external radiation exposure due to beta radiation for workers around area H4 north and amounts of rainfall (As measured by alarmed portable dosimeters)

While no changes in exposure while on tank patrol were apparent, external radiation exposure while working at the radio relay station due to previously undetected beta radiation was confirmed in July.

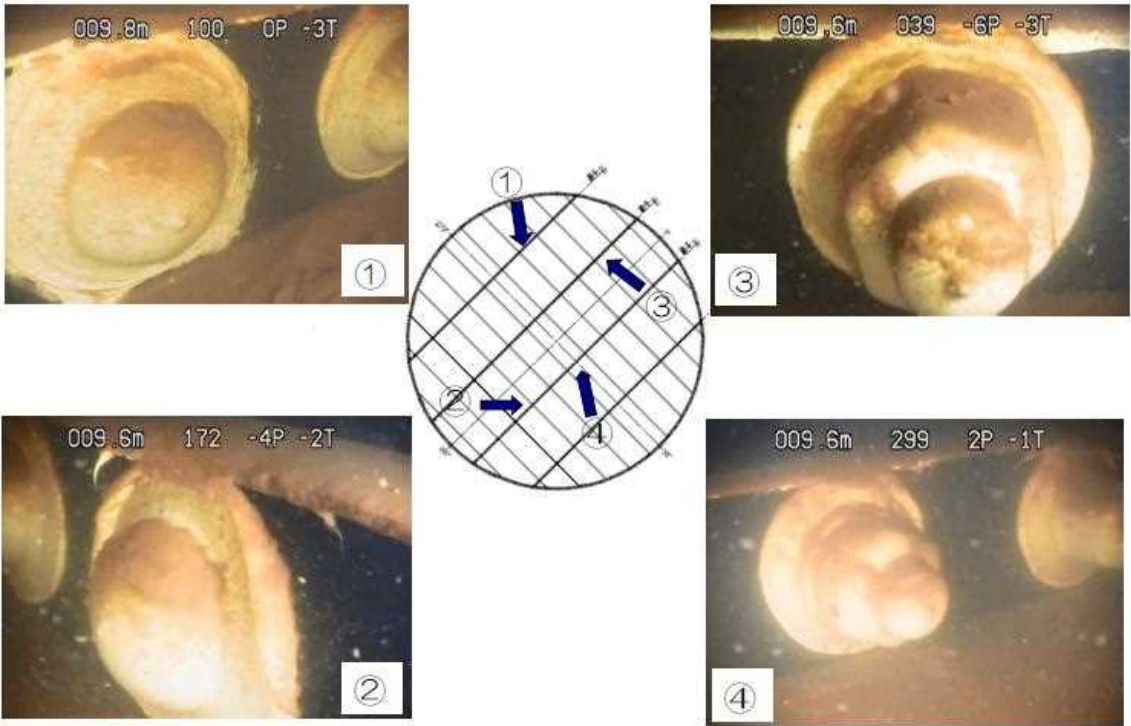
Photo 2 Example of Type 5 tank, showing coupler at bottom of area H2 tank

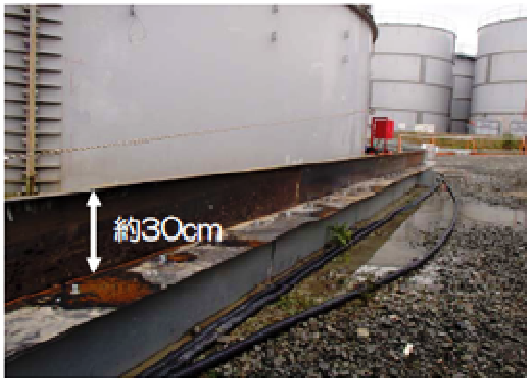
Photo 3 Status of building floodgate embankments using steel plates (area H4 north)

■ **Further embankments on floodgates using concrete and similar materials (improve reliability)**

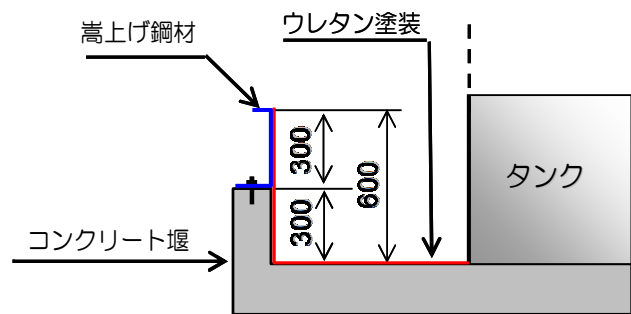
Fig. 5 Status of embankments using steel plates

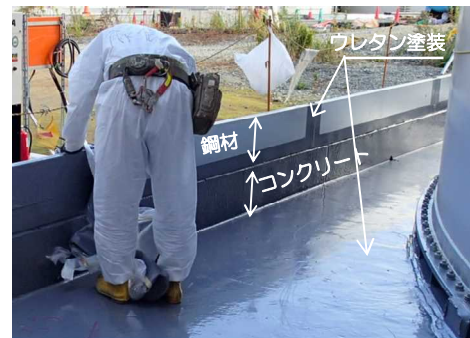
Photo 4 Status of covering surfaces

■ **Cover concrete surfaces inside dikes, prevent seepage through surface of grounds within outer dikes**

- Cover concrete surfaces inside the floodgates and improve waterproofing
- Lay concrete for preventing seepage so as to keep rainwater from soaking into the ground between the outer and concrete dikes

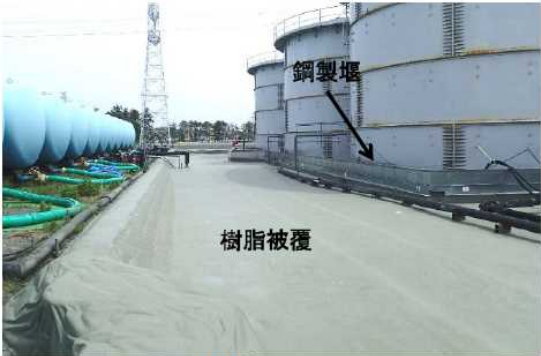
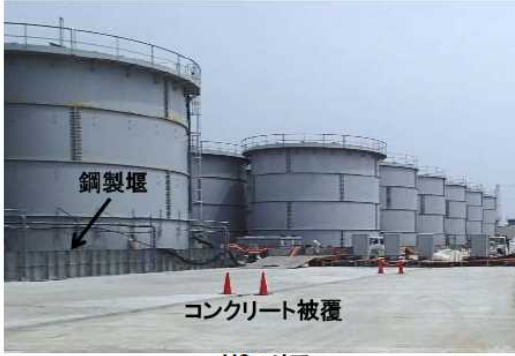
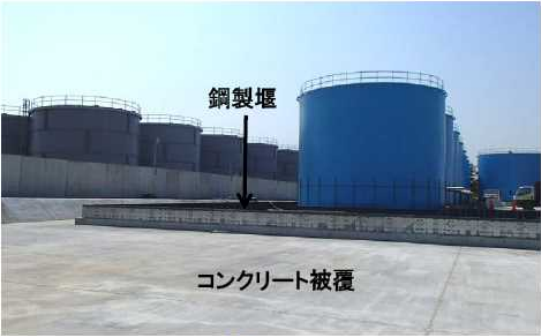
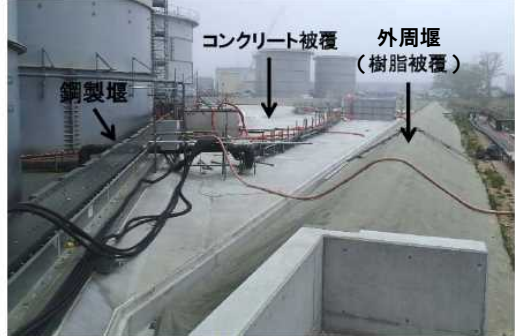
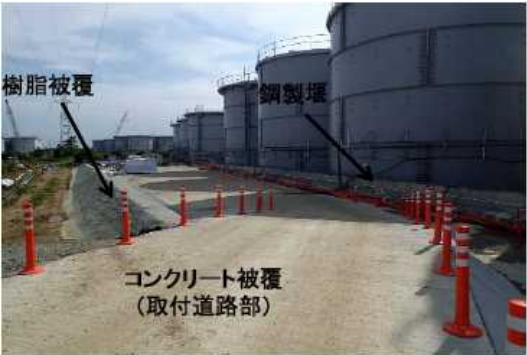
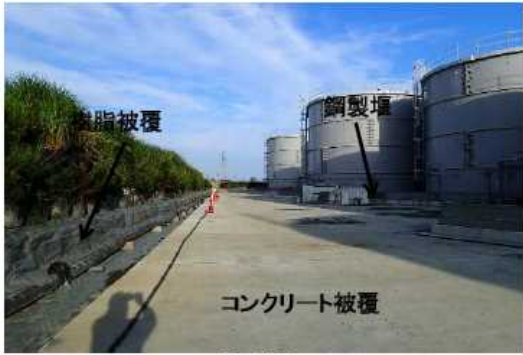
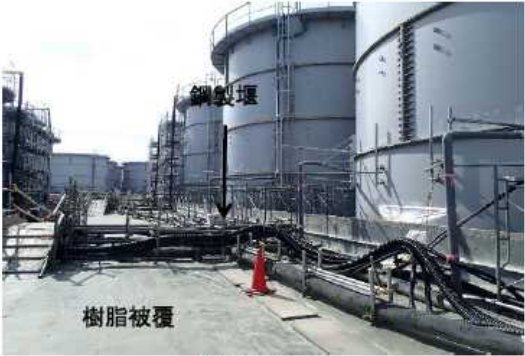
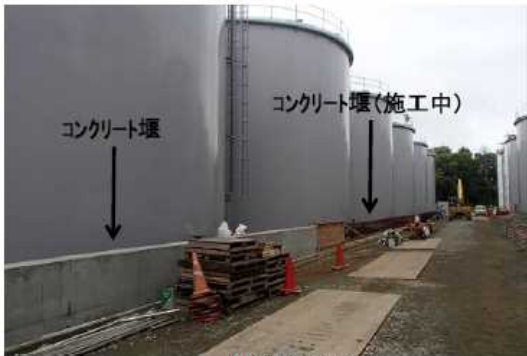
Photo 5 Photo showing current conditions

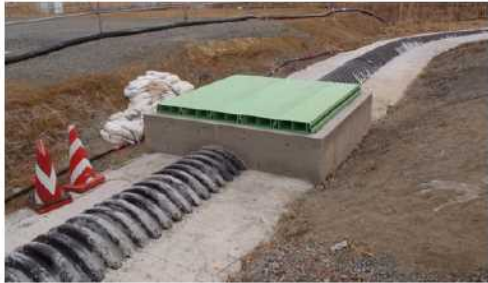
①ダブルプレスト管施工完了（撮影日H26.1.15）

■ Covering of drainage ditches B and C

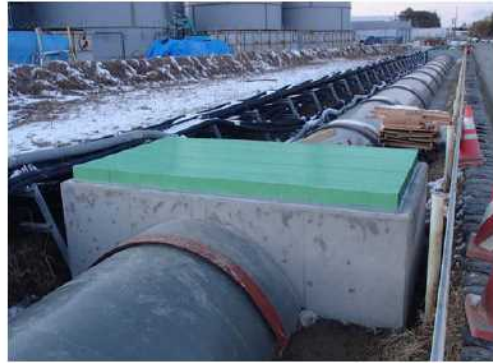
③FRP管施工完了（撮影日H26.2.7）

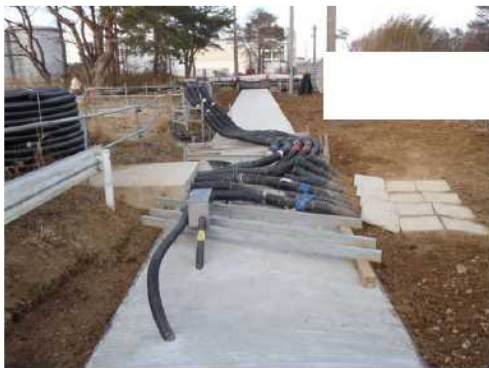
②コンクリート蓋施工完了（撮影日H26.1.22）

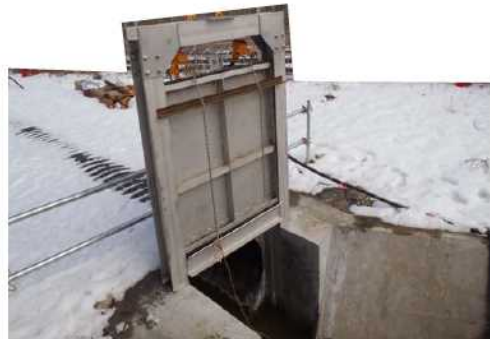
④止水ゲート施工状況（撮影日H26.2.12）

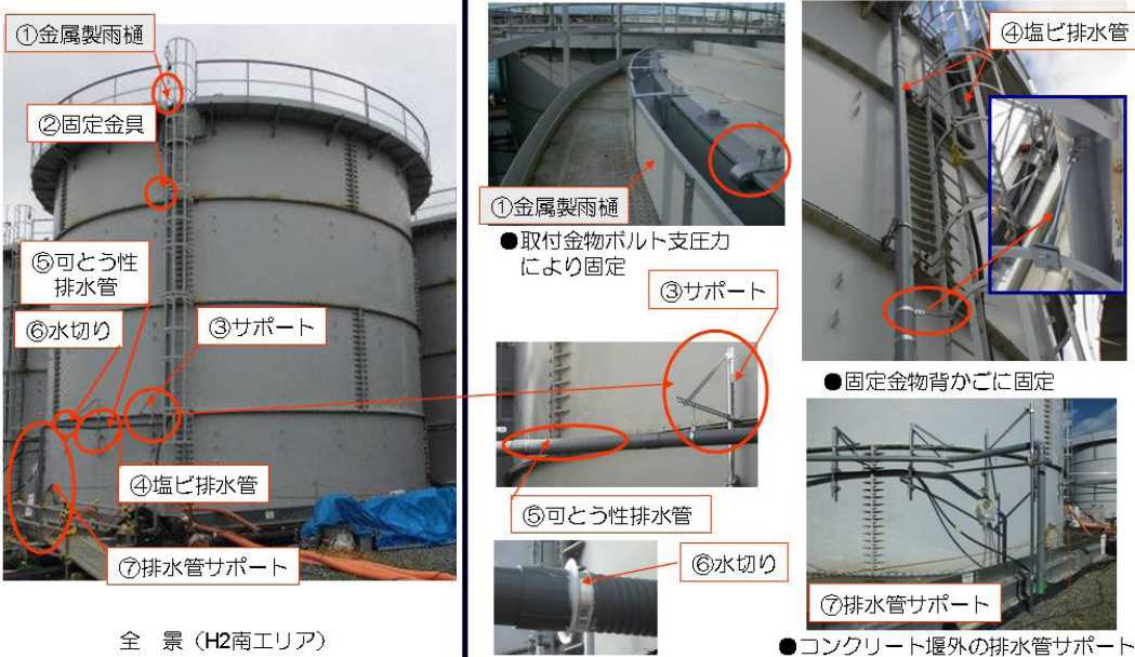
Photo 7 Installation of rain gutters to tank top plate

○Control rainwater influx

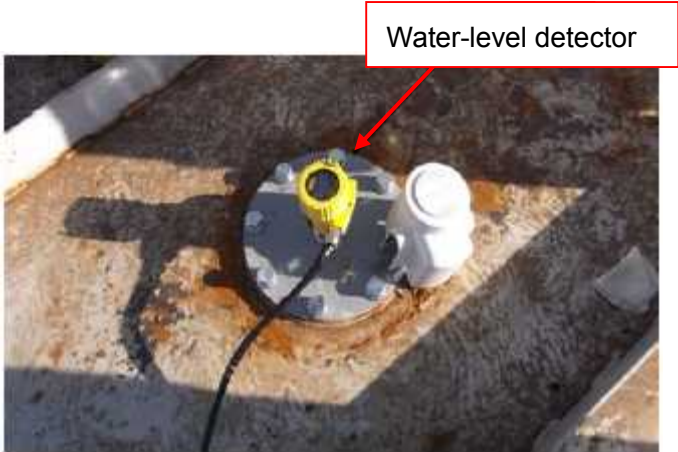
Photo 8 Water gauge installation

○Install water gauges at each individual tank

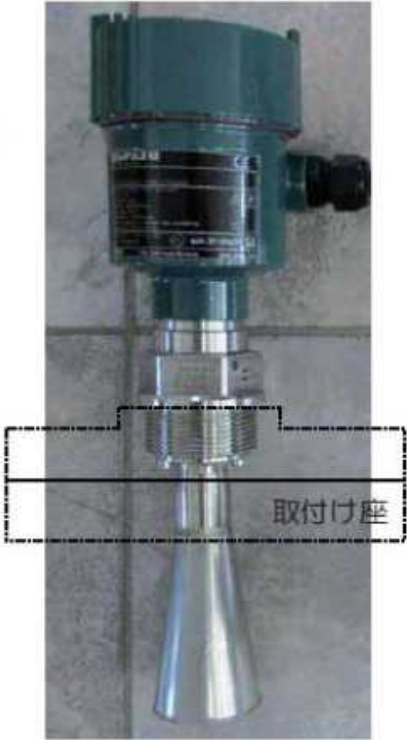
Photo 9 Radar-type water gauge

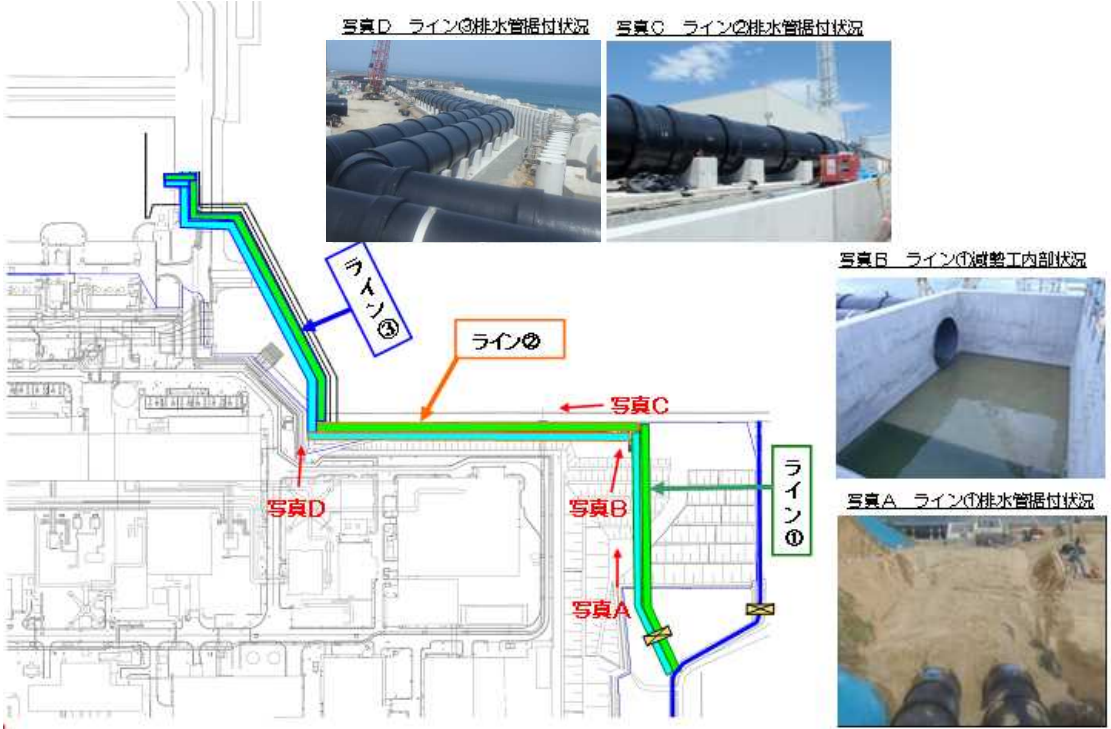
Fig. 10 Status of construction underway

○Create route for water from drainage ditch network C to drain to harbor
