Evaluation of the situation of
cores and containment vessels of
Fukushima Daiichi Nuclear Power Station
Units-1 to 3 and examination into unsolved
issues in the accident progression

Progress Report No. 3

May 20, 2015

Tokyo Electric Power Company, Inc.

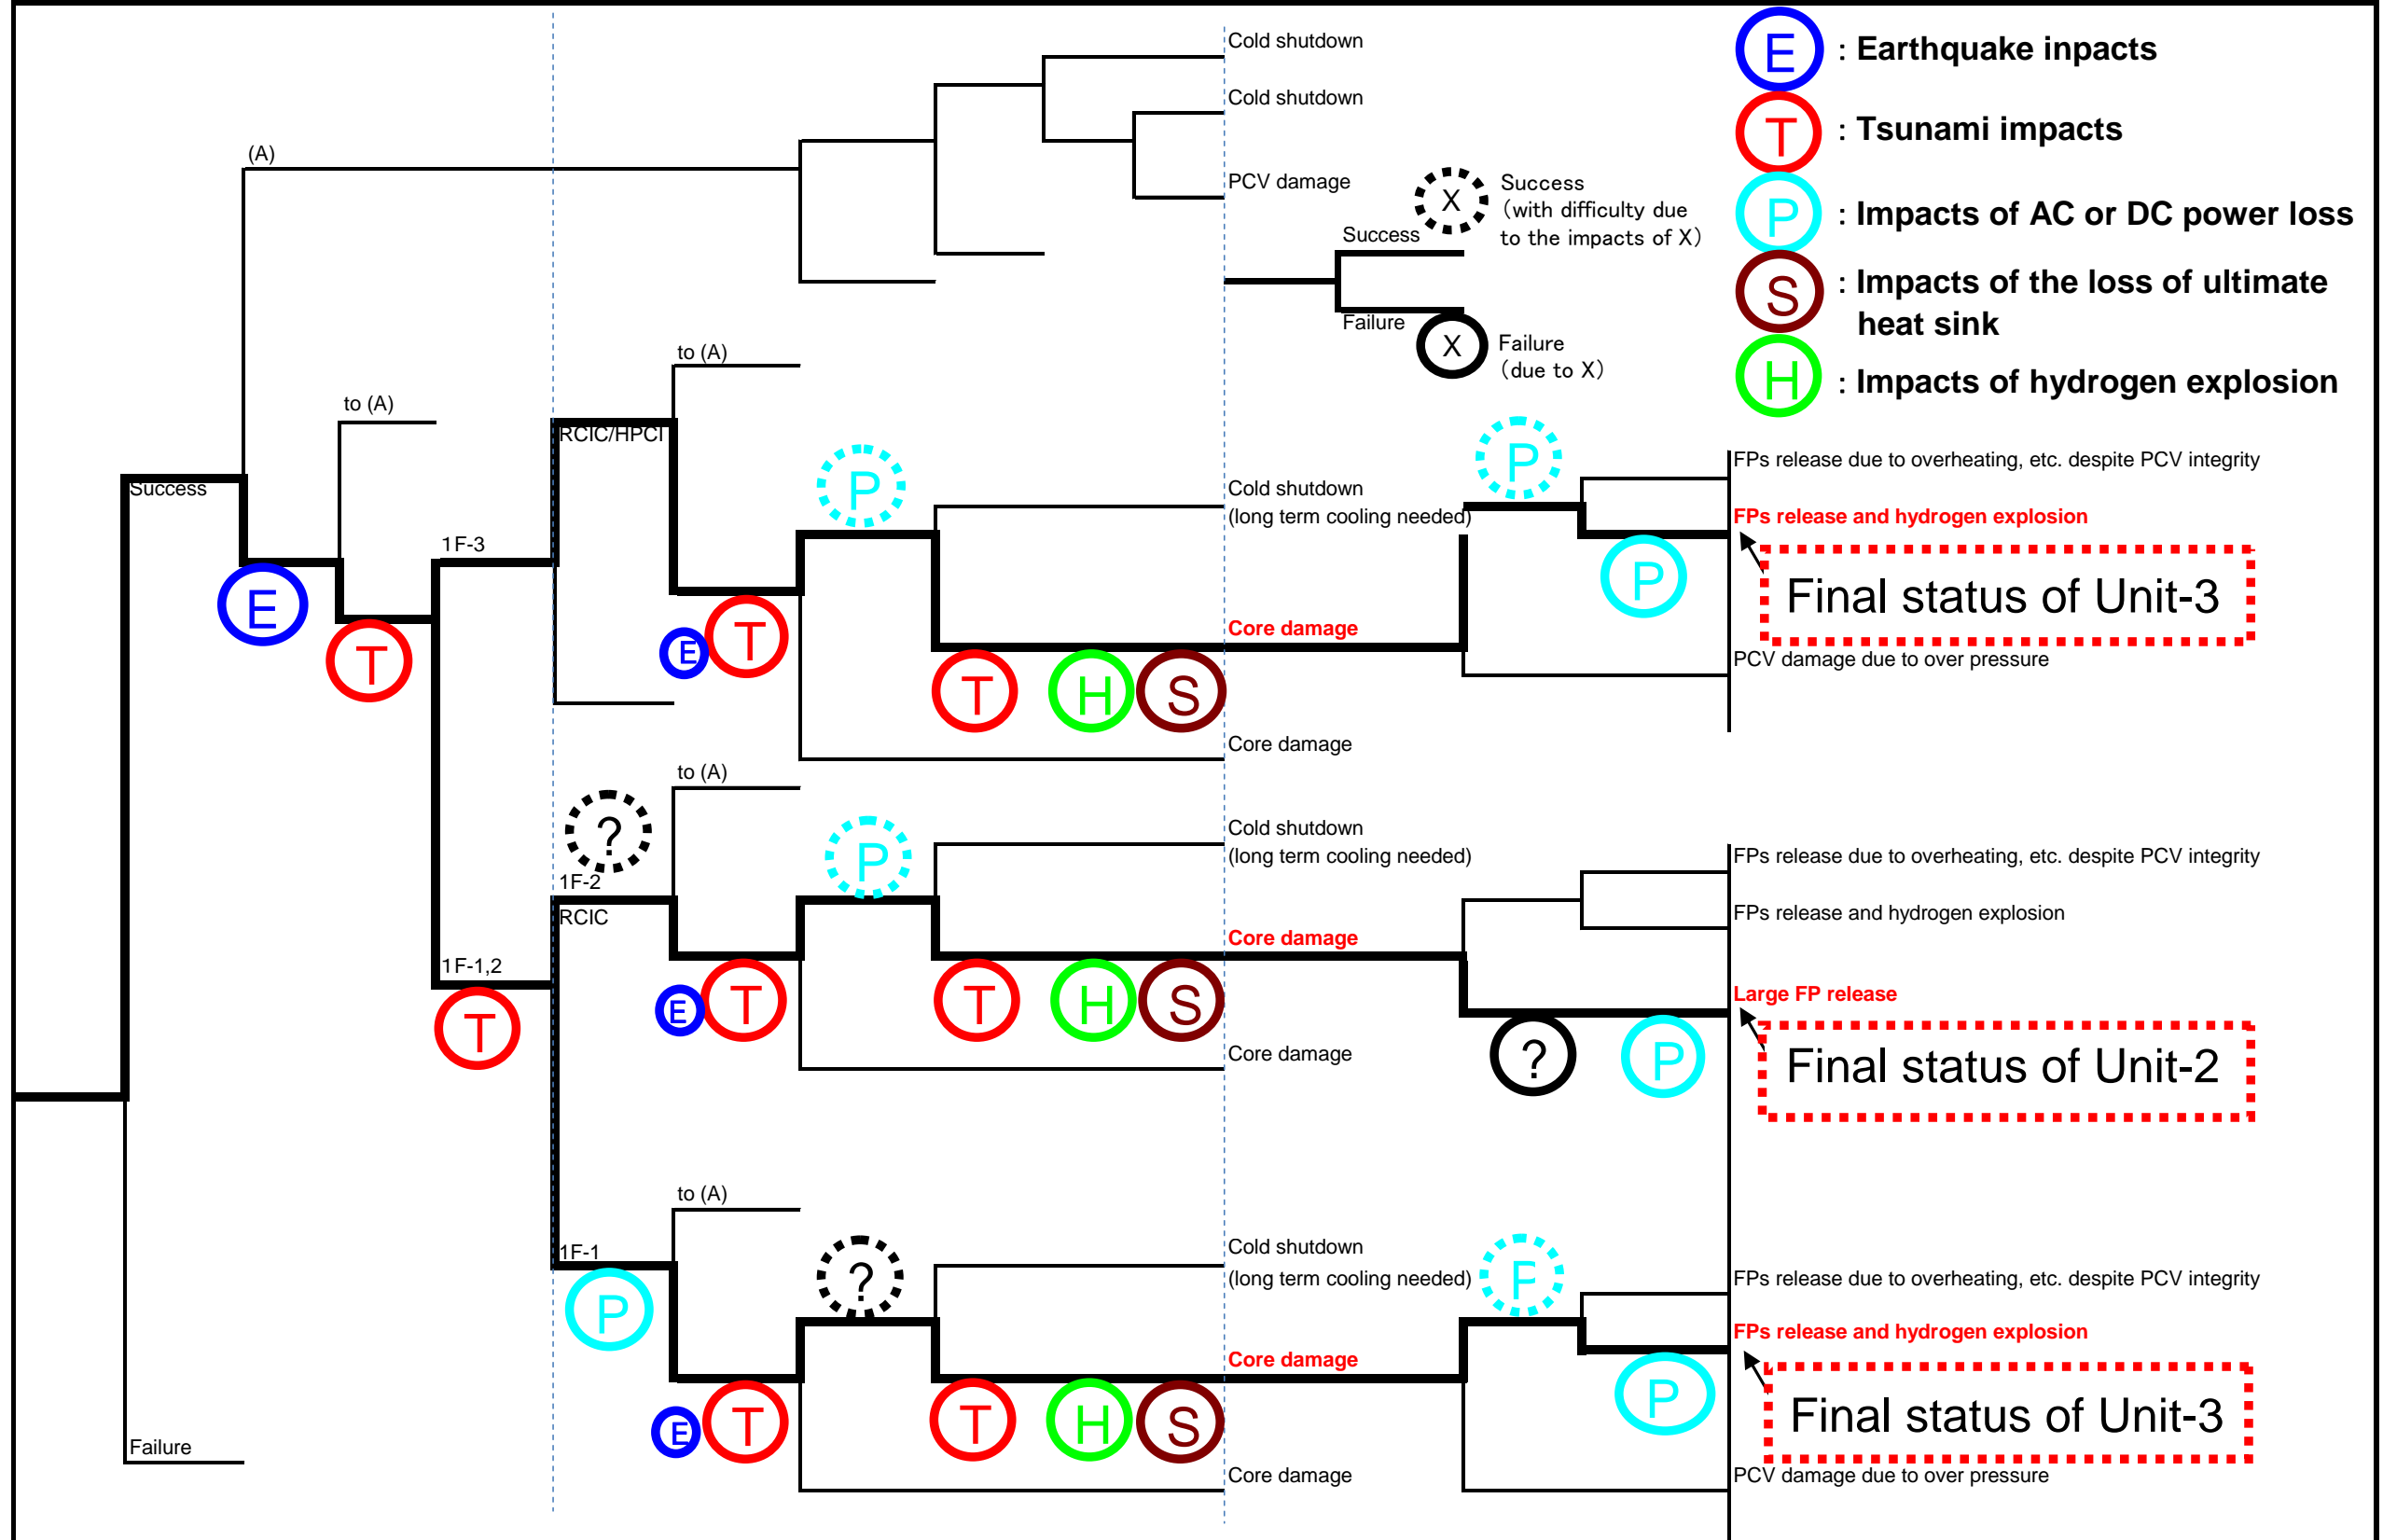
The accident progression processes to the ultimate severe accidents have been interpreted in the response actions to the accident^{†1)} taken so far and the knowledge obtained therefrom has been integrated in safety enhancement measures of the Kashaiwazaki-Kariwa Nuclear Power Plant. (Refer to Fig. 1 Examinations of accident progression at Units-1 to 3 by event-tree analysis. ^{†2)} See 7.1 for further details.)

Fig. 1 Event-tree analysis results of Units-1 to 3 of Fukushima Daiichi Nuclear Power Station

Below are detailed explanatory remarks about the event-tree analysis illustrated in Figure 1 of the first chapter. An event-tree analysis is a means to analyze what sequences a system follows starting at an initiating event to the ultimate status via junctions such as a loss of function of safety-related equipment. Generally at a junction, a branch above (success) leads an accident progression in the direction of cold shutdown, while a branch below (failure) leads in the direction to a severe accident. The more outcomes going to branches below, the more dangerous the ultimate plant conditions would be. Junctions are defined as a success or failure of functions of safety-related systems or equipment, etc. in an accident progression. Basically a junction follows a junction at its left, but the time difference between the two is not fixed, and varies according to the accident progression features at each unit.
