Report on the Investigation and Study of
Unconfirmed/Unclear Matters
in the Fukushima Nuclear Accident
Progress Report No.3

May 20, 2015

Tokyo Electric Power Company, Inc.

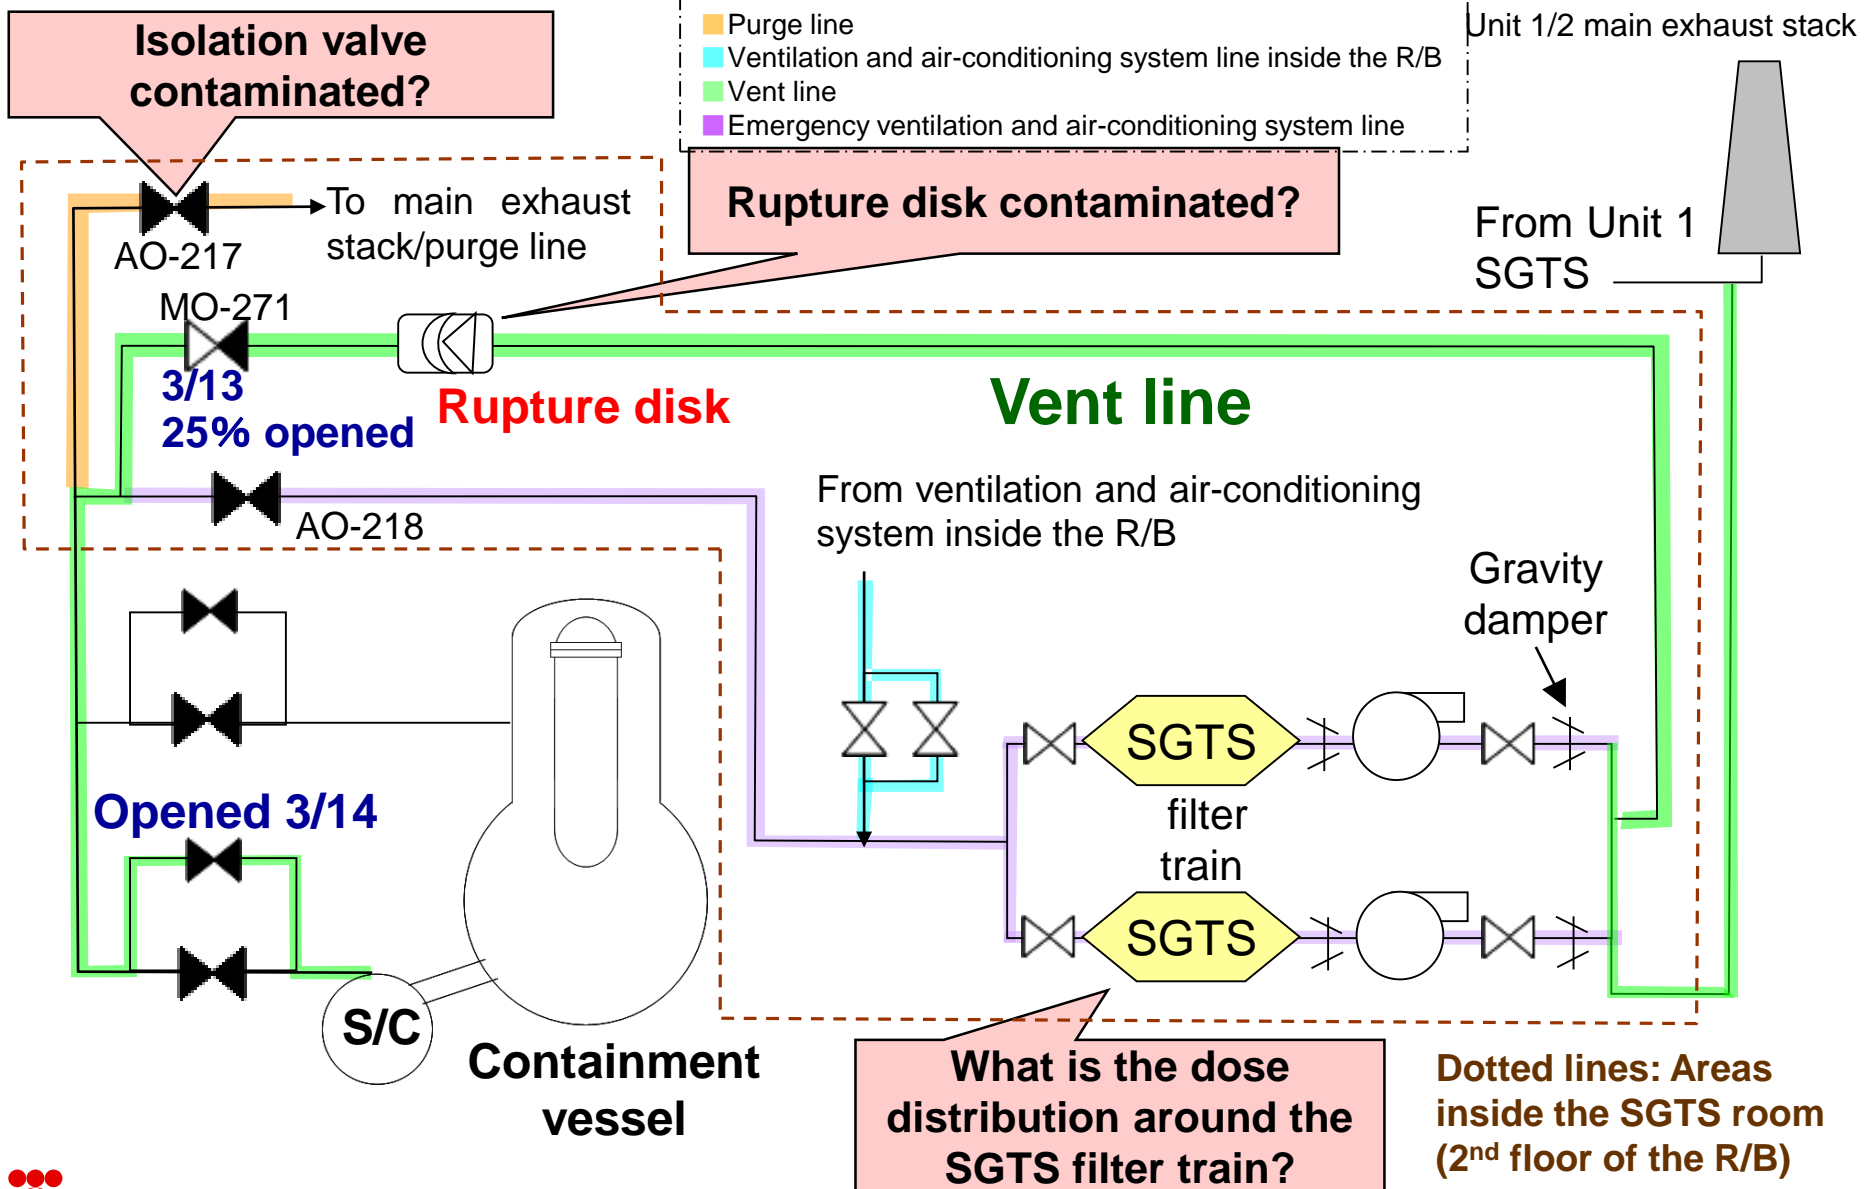
(2) Unit 2 SGTS system schematic and survey location

The SGTS filters (downstream side) were highly contaminated even though contamination was not found on the piping around the rupture disks

High levels of contamination were found on the SGTS filter (downstream side)
⇒ It is possible that gases containing radioactive materials flowed back into the SGTS. This may have been caused by the following factors.

No contamination was found near the rupture discs.

⇒ It is highly likely that the rupture discs did not function

The condition of the rupture disks shall be checked in order to shed light on issue Unit 2-9 (whether or not the Unit 2 rupture disks worked) and the cause of contamination of the STGS filters, and the examination of radioactive substance release routes shall continue

Further investigation into success and failure of Unit 2 containment vessel venting will be continued

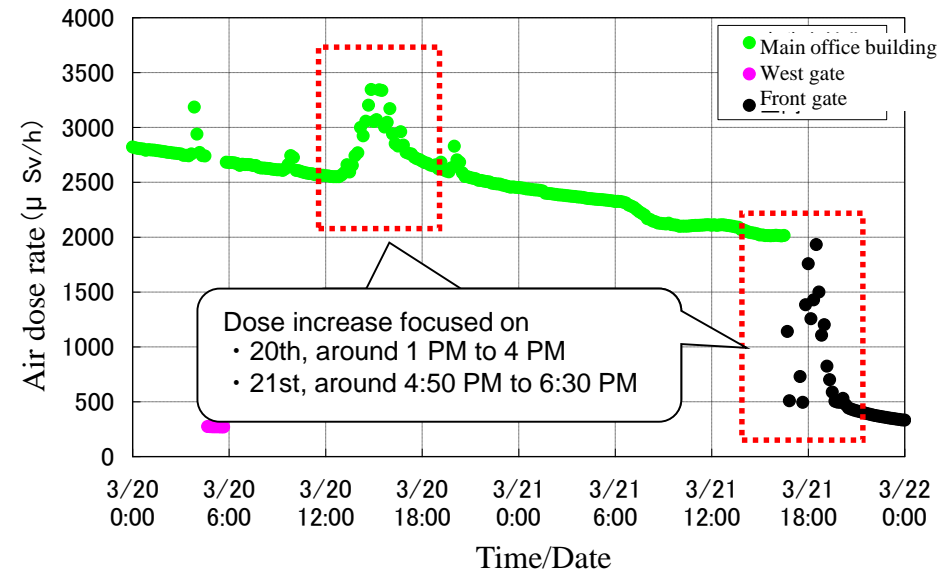
Fukushima Daiichi NPS site dose measurement results

On or around March 28 an increase in dose rate is on site at the Fukushima Daiichi NPS were measured. However, the cause of the aforementioned dose rate increase has yet to be identified

There are two possible causes of the dose increase.

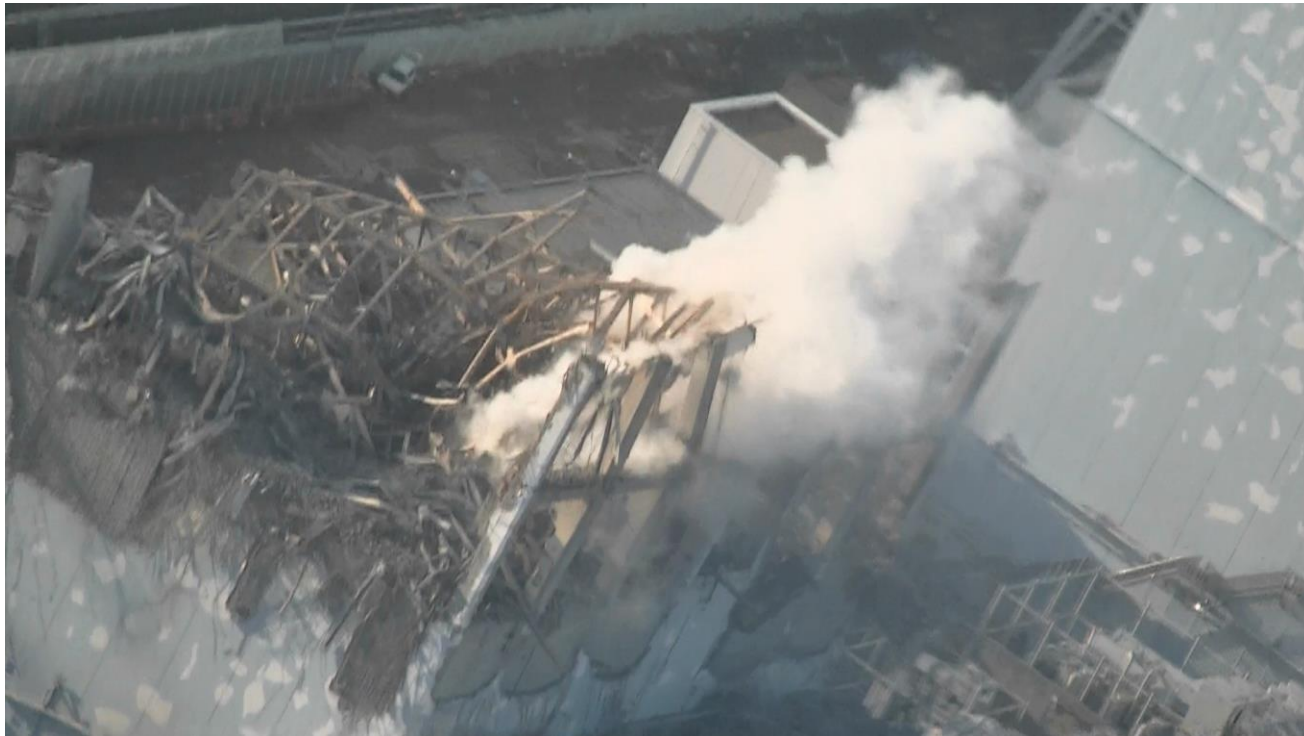
Aerial photo of Unit 3 (March 16, 2011)

During the course of the accident the containment vessels for Fukushima Daiichi NPS Units 1~3 loss containment function and reactive substances were steadily being discharged outside the building. (Photo) The site dose rate increase measured around March 20 was most likely due to a change in wind direction that blew the steadily escaping radioactive substances the opposite way.
