Leaks from Unit-3 PCV and steam release in a large amount

1. Background

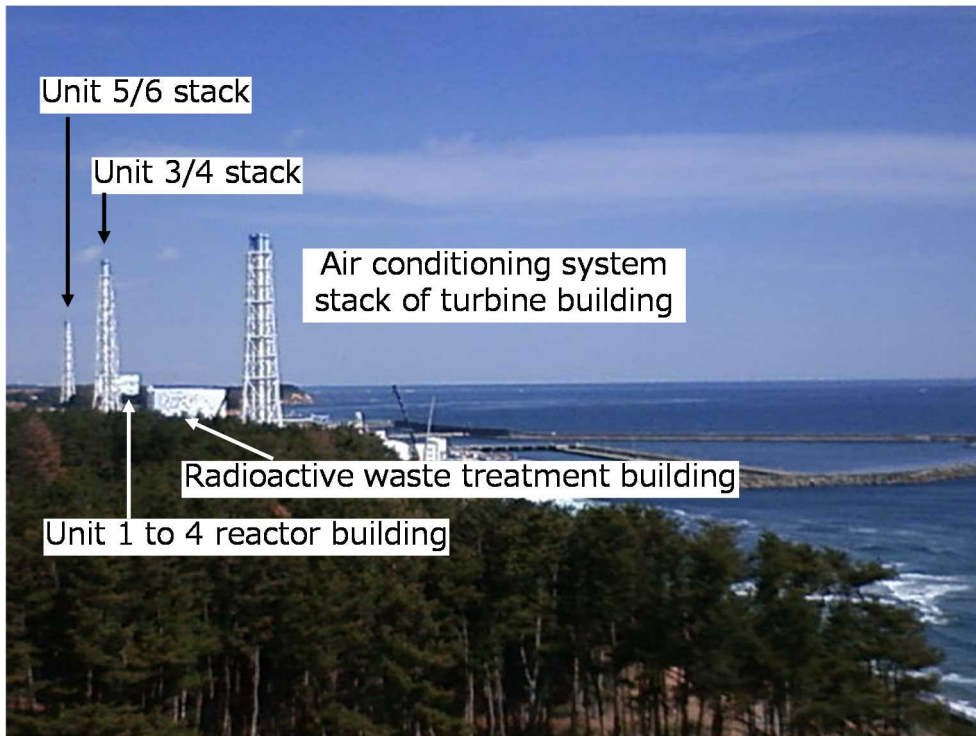
Figure 1 shows the photo recorded by the live camera at 10:00 on March 11th. This photo shows the Fukushima Daiichi NPS in sound conditions before the earthquake. A chimney type structure seen in the far left is the Unit-5/6 stack, a chimney type structure to its right is the Unit-3/4 stack and the last chimney type structure is the stack of the turbine building (T/B) ventilation system. The Unit-1/2 stack stands just behind the Unit-3/4 stack and is not visible in this photo. Occasionally the Unit-1/2 stack is visible in later live camera feed, because the live camera photo angle changes perhaps due to aftershocks.

Figure 1 Photos by the live camera at the Fukushima Daiichi NPS (taken at 10:00 on March 11th) (Top: Full screen view of the live camera, Bottom: Enlarged R/B surroundings)
