List of issues to be investigated

List of issues

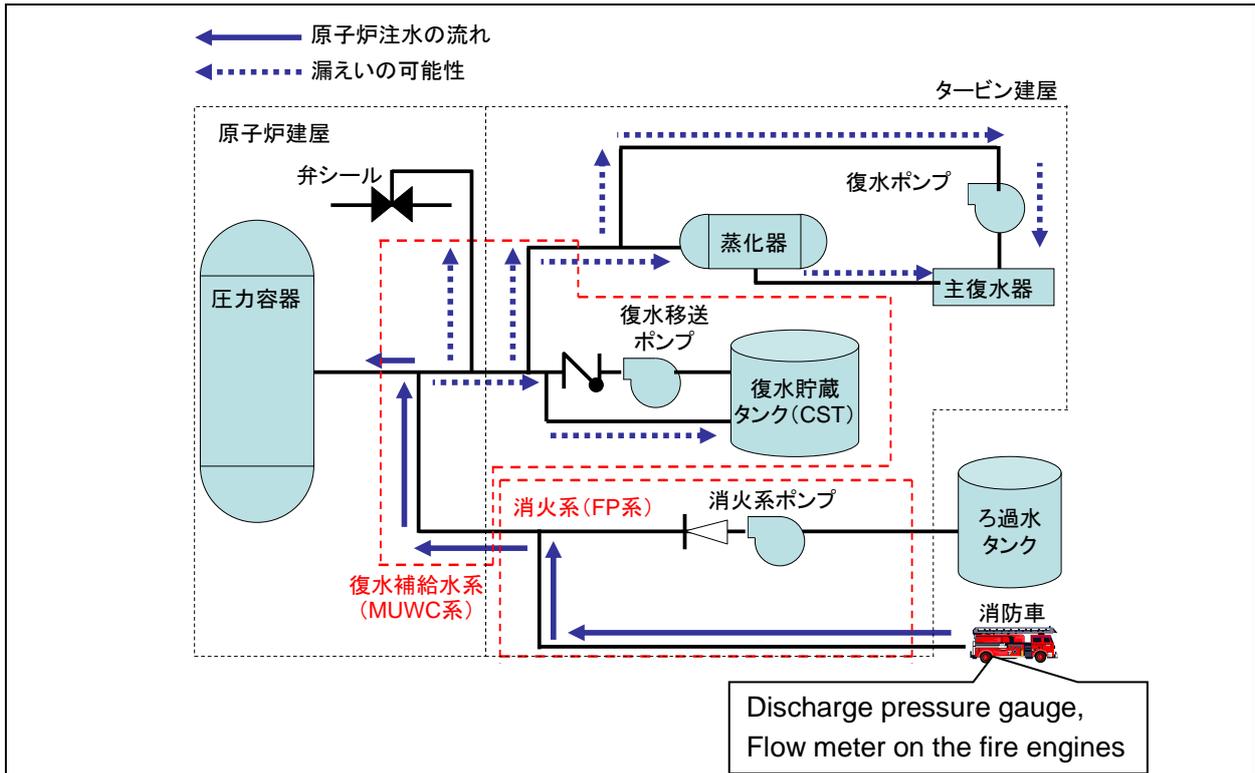
Common/Issue-2	Common	Category A③	Class (1)	Safety measures in [1]: p36
Amounts of water injected to the reactor by fire engines			Results: Attachment 1-4, 1-5, 2-14	
<p>Ultimately, Unit-1 to Unit-3 lost all their water injection functions which had been expected to work in an accident, and fire engines were alternatively used for the emergency water injection.</p> <p>The information relevant to the amount of water injected was compiled as the estimated amount (daily average of the amount injected) based on the discharge pressure of fire engines and flow rate indicator readings at the time of the accident. But their accuracies are not satisfactory, and part of the water injected is considered to have flowed to other systems and equipment, bypassing the water injection line to each reactor unit.</p> <p>At Unit-1, for instance, water injection was interrupted at 01:10 on March 14th. At 20:00 on the same day, water injection was resumed (via the reactor core spray system), but no reactor pressure increase was observed, indicating a possibility of no water, or only a small amount, being injected. At 02:33 on March 23rd, when the reactor feedwater system started to inject water, the reactor and PCV pressure increased, probably due to steam generation. This indicates a possibility of no water, or only a small amount, having been injected before.</p> <p>In the MAAP analysis, the amount of water injected to the reactor was set substantially less than the amount of water injected by fire engines, in order to simulate the observed PCV pressure changes. The amount of water injected to the reactor is of critical importance in examining the accident progression. Therefore, the actual amount of water injected to the reactor needs to be clarified because it has a big uncertainty.</p>

Figure Schematics of alternative water injection lines using fire engine pumps

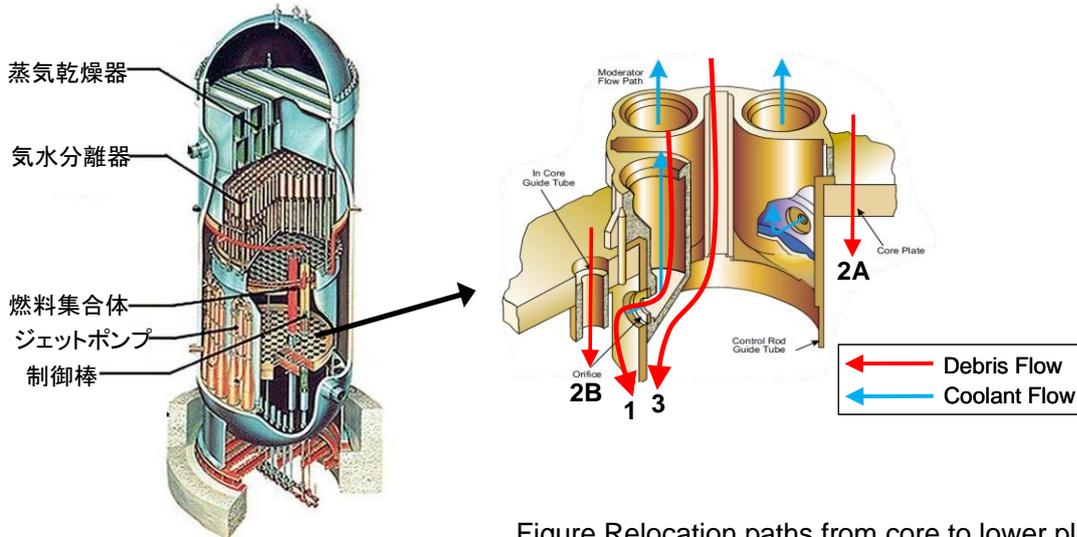
Common/Issue-6	Common	Category B②	Class (2)	Safety measures in [1] -
Molten core behavior on falling to the lower plenum				Results: Attachment 1-8
<p>MAAP employs basically Three Mile Island (TMI) knowledge in simulating the molten fuel relocation mechanism to the lower plenum, in which molten fuel destructs the core support plate and reaches the lower plenum. On the other hand, BWRs have complex lower structures, which could configure other molten fuel relocation paths to the lower plenum: via the coolant flow paths through a side entry orifice at the fuel support; or via the surrounding bypass region (whereto the molten fuel could migrate in the radial direction from the core) and, by damaging the shroud, further through the outer shroud region (downcomer region).</p> <p>In the MAAP analysis of Unit-1 to date, the reactor pressure showed a sharp peak at around 22:00 on March 11th. This comes from the model in the analysis that the molten fuel stayed temporarily on the core support plate for a while and, as soon as the core support plate was damaged, the molten fuel dropped instantaneously to the lower plenum, generating a large amount of hydrogen gas.</p> <p>It is necessary to clarify the molten fuel behavior during relocation to the lower plenum in order to contribute to understanding of the accident progression and estimation of the situation in the core and PCV.</p>

Figure Relocation paths from core to lower plenum

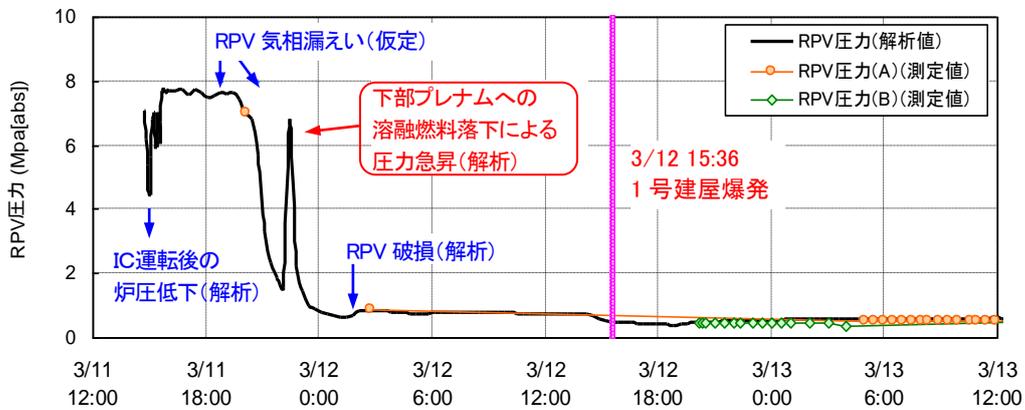
RPV 気相漏えい(仮定)	Gaseous leak from RPV (assumed)
下部プレナムへの溶融燃料落下による圧力急昇(解析)...	Sharp pressure increase due to debris slumping to lower plenum
IC運転後の炉圧低下(解析)	Pressure decrease after IC operation (anal.)
RPV 破損(解析)	RPV failure (anal.)
3/12 15:36 1号建屋爆発	At 15:36 March 12 th Unit-1 R/B exploded

Figure Reactor water level and PCV pressure changes in Unit-1

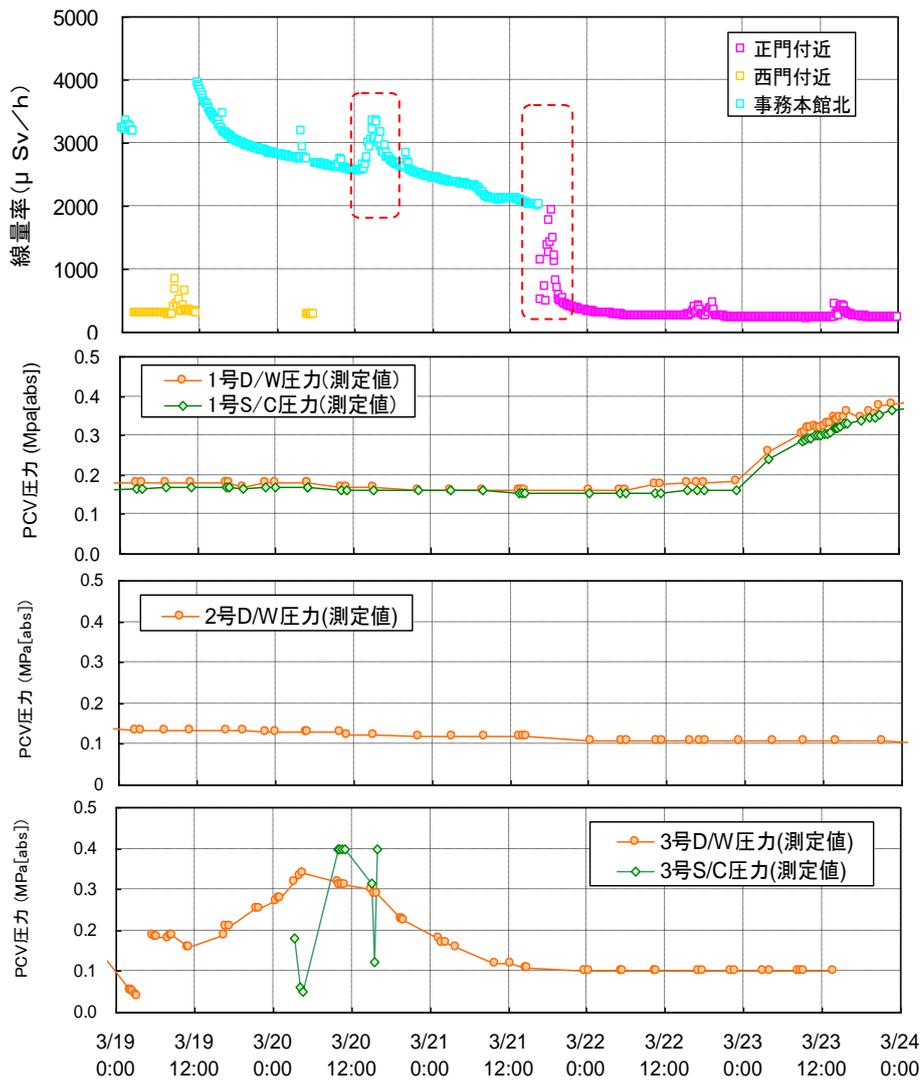
Common/Issue-9	Common	Category B⑤	Class (2)	Safety measures in [1]: -
Air dose increases on around March 20 th				Results: Attachment: 3-6
<p>At Unit-1 and Unit-3, the water injection rate observed on the Accident Management (AM) panel showed a big decrease from March 20th and 21st for several days. This may indicate that the reactor cooling was not sufficient to prevent the release of radioactive materials. Further, at about 16:00 on March 21st when black smoke rose at Unit-3, a sharp increase was observed in the air dose rate near the main gate, although no significant changes were noticed in the DW pressures and the RPV pressures.</p> <p>The analysis using MAAP is terminated in about a week at the maximum after the earthquake. This is because the uncertainties of the analysis become larger with the extended time of analysis and the reliabilities of the results are significantly lowered.</p> <p>Fission products released around March 20th and 21st from the Fukushima Daiichi NPS might have caused radiation dose increases in parts of the Kanto region, depending on the wind directions, and might have led to some recommendations to refrain from tap water intake due to increased radioiodine concentration levels. Details of radioactive materials release behavior need to be clarified.</p>

Figure Air dose rates at the Fukushima Daiichi NPS from March 19th to 23rd

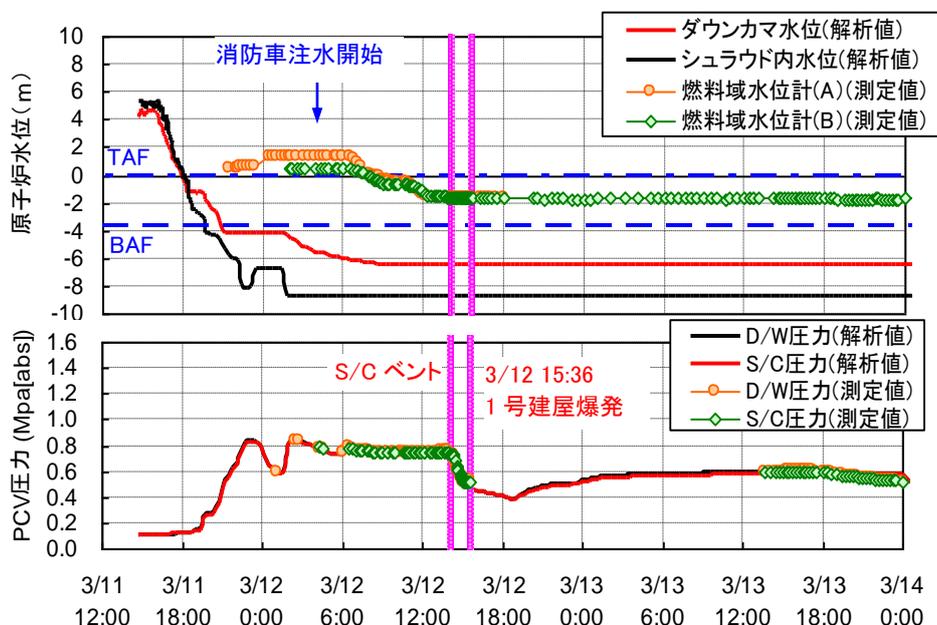
At Unit-1, the D/W pressure decrease was confirmed from 14:30 through around 14:50 on March 12th following the large S/C vent valve opening operation. At 15:36 on that day, hydrogen exploded in this reactor building and the roof and the outer walls of the top floor were heavily damaged.

These hydrogen explosions are considered to have been caused by hydrogen gas generated mainly by zirconium-water reactions which leaked out with steam to the reactor buildings. It is necessary to clarify the amounts of hydrogen gas generated and leak paths.

Figure RPV water level and PCV pressure changes at Unit-1 until the hydrogen explosion occurred

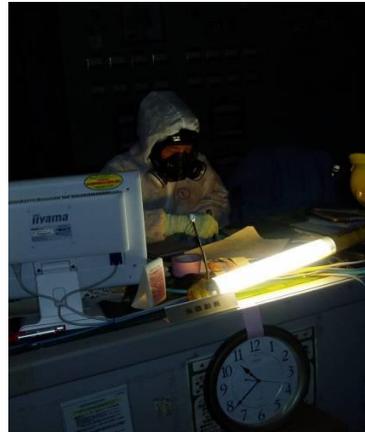
In the MCRs for Units-1 to 4, most instrumentation and control power supplies were lost after the tsunami had arrived and nothing was available for operators to monitor plant conditions or to take operational actions.

There is also a reality, on the other hand, that operators in the MCRs were desperately struggling for any actions possible to take at that moment and situation, or later, by referring to, for example, system configuration diagrams. An example of such an attempt was that the operators in the Unit-1/2 MCR took an action around 17:00 on March 11th to prepare for water injection to the reactor via alternative water injection lines. It is important to verify the psychological conditions that operators and other personnel encountered under such situations in order to extract lessons for implementation to future development of emergency response, from the viewpoint of software.

Connecting employees' private car batteries to power necessary instrumentations

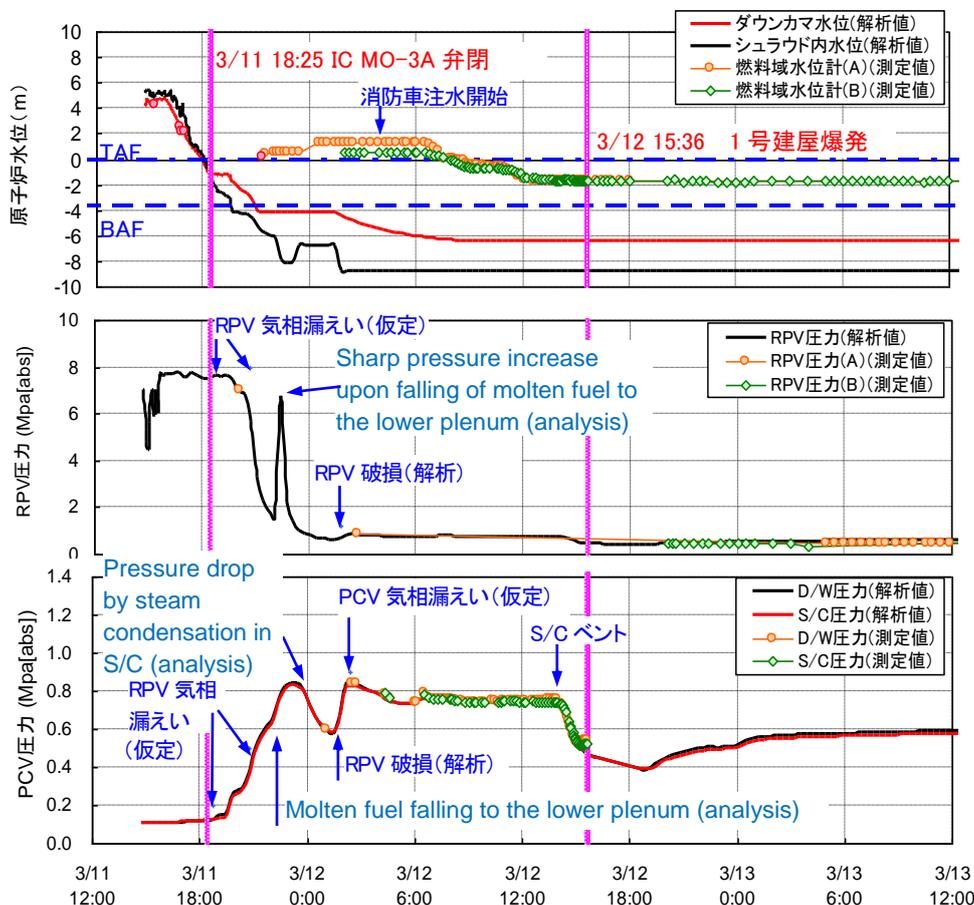
Unit-1/Issue-2	Unit-1	Category A⑤	Class (2)	Safety measures in [1]: -
Plant behavior if the Unit-1 ICs had functioned				Results: Attachment 1-7
<p>At Unit-1, the reactor pressure was being controlled after the earthquake by intermittent operation of the emergency isolation condensers (ICs). Immediately before all power supplies were lost due to tsunami, the IC operation had been incidentally in a halted situation. In the station blackout condition, the shift operators in the MCR noticed the display lamps indicating the IC (Sub-system A) isolation valves (MO-2A, MO-3A) as “Closed” outside the PCV at around 18:00 on March 11th. They took action to open the valves at 18:18 on March 11th, and confirmed the steam generating sounds and saw the steam when looking above the reactor building, but the amount of steam was limited and it stopped a while later. Concerned about the water inventory left in the IC shell side tank, at 18:25 the operators closed the isolation valve (MO-3A) on the return line.</p> <p>Post-accident surveys of the water level in the IC shell side tank showed that the water level of Sub-system A had been 65% (normal level was 80%) and the water in the tank had been sufficient. If the isolation valve (MO-3A) on the return line had not been closed at 18:25 on March 11th, the reactor cooling by the IC might have been continued.</p> <p>Therefore, the reason why the amount of steam generation was limited upon the opening of the IC Sub-system A isolation valves outside the PCV and why it stopped after a while (Unit-1/Issue-1) will be investigated. In addition the effect on the accident progression will be investigated, if the isolation valve of IC (Sub-system A) outside the PCV had been kept open after 18:25 on March 11th.</p>

Figure Changes of Unit-1RPV water level, RPV pressure and PCV pressures

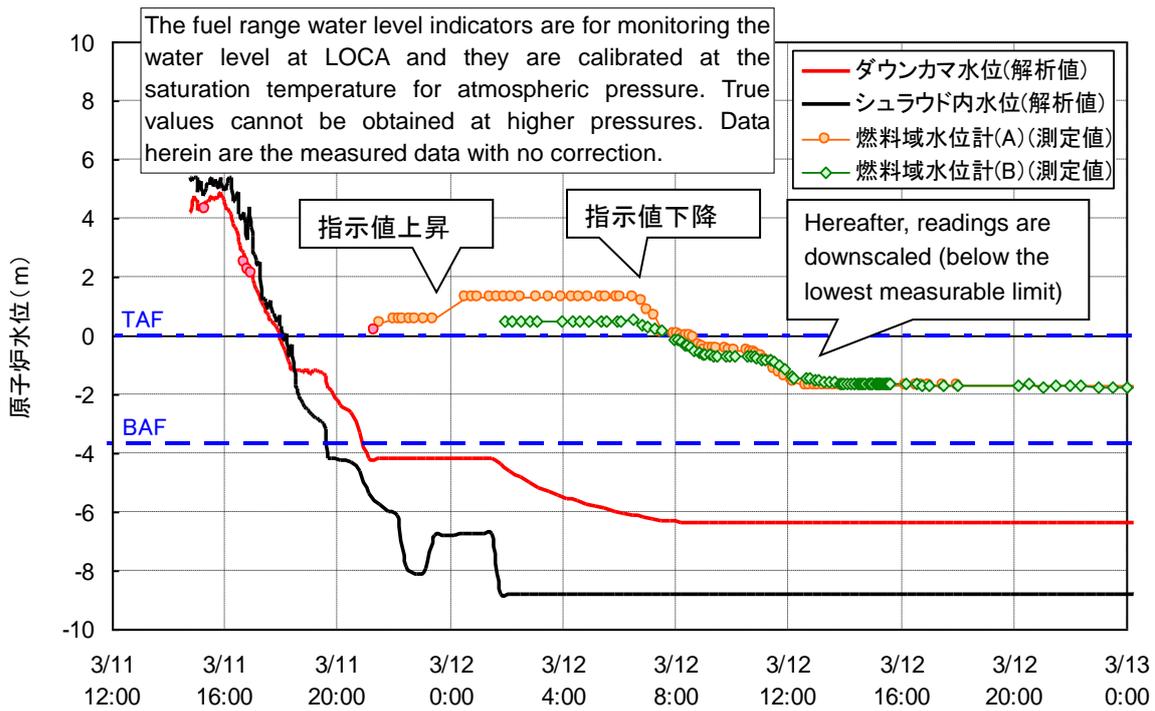
The fuel range water level indicators of the condensing water chamber type cannot show true values when the PCV temperature rises or the reactor pressure decreases, because the water in the piping in the condensation chamber evaporates. Therefore, the fuel range reactor water level indicators seem to have been already malfunctioning when restored by the temporary power supply.

But the water levels indicator readings tell the pressure difference between the reference leg and variable leg. It is possible that some information might be obtained on the reactor depressurization timings or reactor water levels.

Figure Reactor water level changes at Unit-1

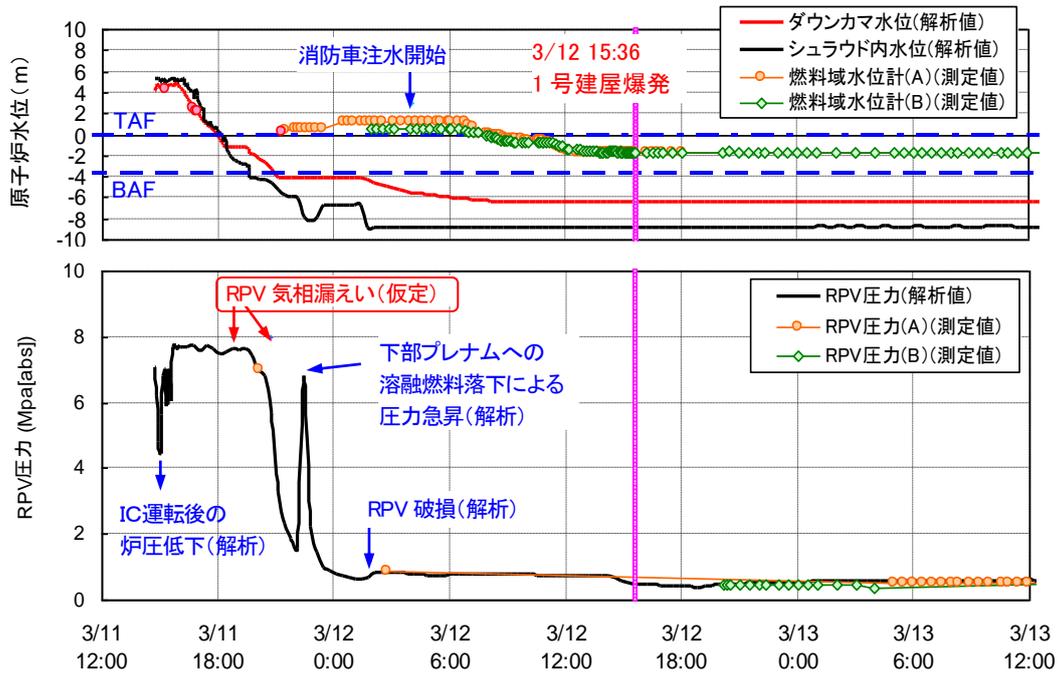
Unit-1/Issue-5	Unit-1	Category B③	Class (2)	Safety measures in [1]: pp27-36
Leaks in gaseous phase from Unit-1 RPV				Results: -
<p>At Unit-1, the RPV pressure measured 7.0MPa[abs] at 20:07 and the D/W pressure measured 0.6MPa[abs] at about 23:50 on March 11th, while the D/W pressure was 0.84MPa[abs] at 02:30 and the RPV pressure was 0.9MPa[abs] at 02:45 on March 12th. Although the exact timings are unclear, it was confirmed that the PCV pressure showed a big increase. And the RPV pressure decreased despite no depressurization operation.</p> <p>If the reactor water level drops and the core starts to be uncovered, the heat transfer from the overheated core and the overheated steam heat up the RPV pressure boundary above its normal temperatures. There may be a possibility that leak holes form for leaks in the gaseous phase at some of these upper locations before the molten fuel penetrates the RPV bottom, and the RPV pressure may decrease if the leak holes are big enough. Should that have occurred, it would affect the timings of RPV damage and the thermal and mechanical loads to the PCV after the RPV damage.</p> <p>The MAAP analysis assumed that the core temperatures were elevated by the overheating of the uncovered core and molten fuel, resulting in gaseous leaks from the RPV to the D/W through the in-core instrumentation dry tubes or the SRV flanges on the main steam line.</p> <p>But there is no direct evidence of measured plant parameters or observations that confirms leaks through these leak paths. Clarification is needed for grasping the core and PCV conditions.</p>

Figure RPV and PCV pressure changes at Unit-1

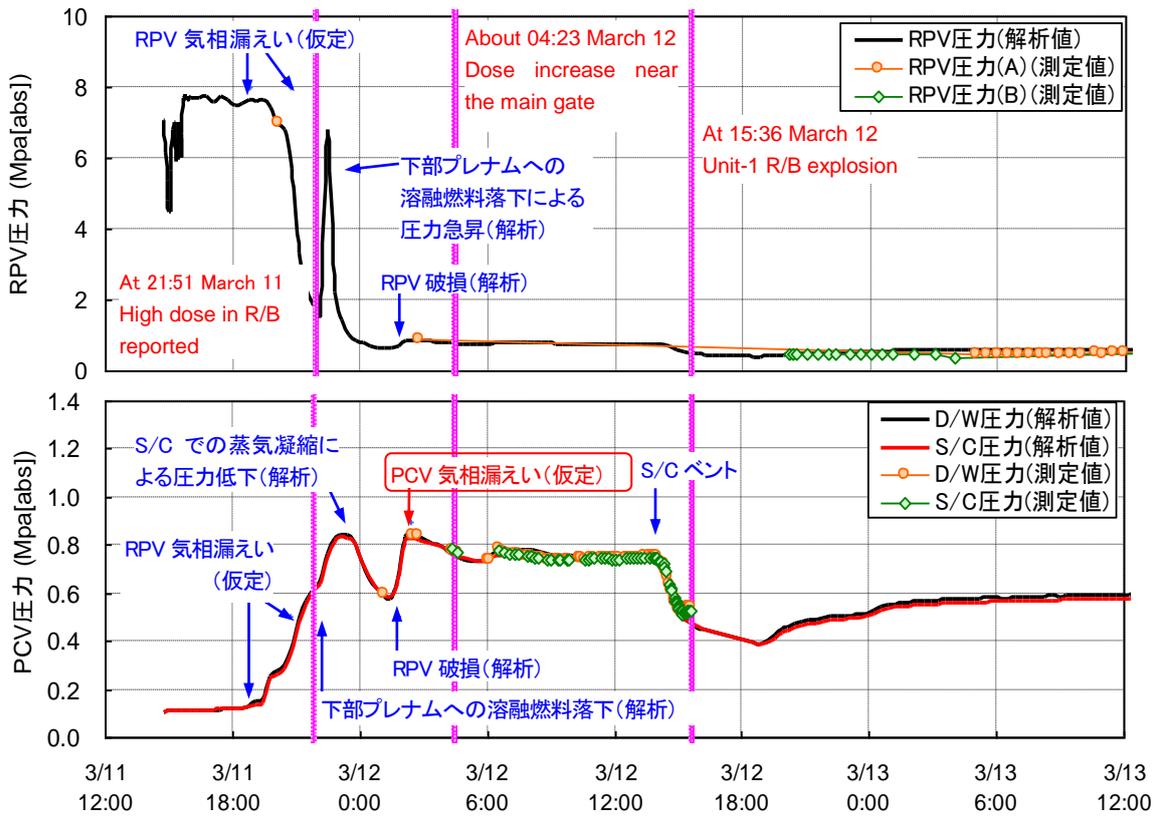
Unit-1/Issue-6	Unit-1	Category B④	Class (1)	Safety measures in [1]: pp.27-43
Leaks in gaseous phase from Unit-1 PCV				Results: -
<p>The Unit-1 DW pressure measured 0.6MPa[abs] at about 23:50 on March 11th, 0.84MPa[abs] at about 02:30 on March 12th and then stayed between 0.7MPa[abs] and 0.8MPa[abs] until it decreased at about 14:30 by the venting operation.</p> <p>Steam generation by water injection, the PCV temperature increases, the gas production by core-concrete reactions, etc. are likely to increase the PCV pressures. Nevertheless, it remained at a level which may indicate possible leaks from the PCV.</p> <p>In the meantime, shift operators entered the reactor building at about 21:00 on March 11th, when their APDs measured 0.8mSv instantaneously. They reported it upon return to the MCR at 21:51. At about 04:00 on March 12th and onward, the dose rates increased in wide areas near the main gate.</p> <p>The MAAP analysis assumed gaseous leaks from the PCV to the reactor building at about 03:10 on March 12th, about 12 hours after the earthquake. It was so assumed to roughly simulate the measured PCV pressure changes. But there is no direct evidence of measured plant parameters or observations that confirms the timing of leaks and their paths.</p> <p>Clarification is needed for grasping the PCV conditions.</p>

Figure RPV and PCV pressure changes at Unit-1

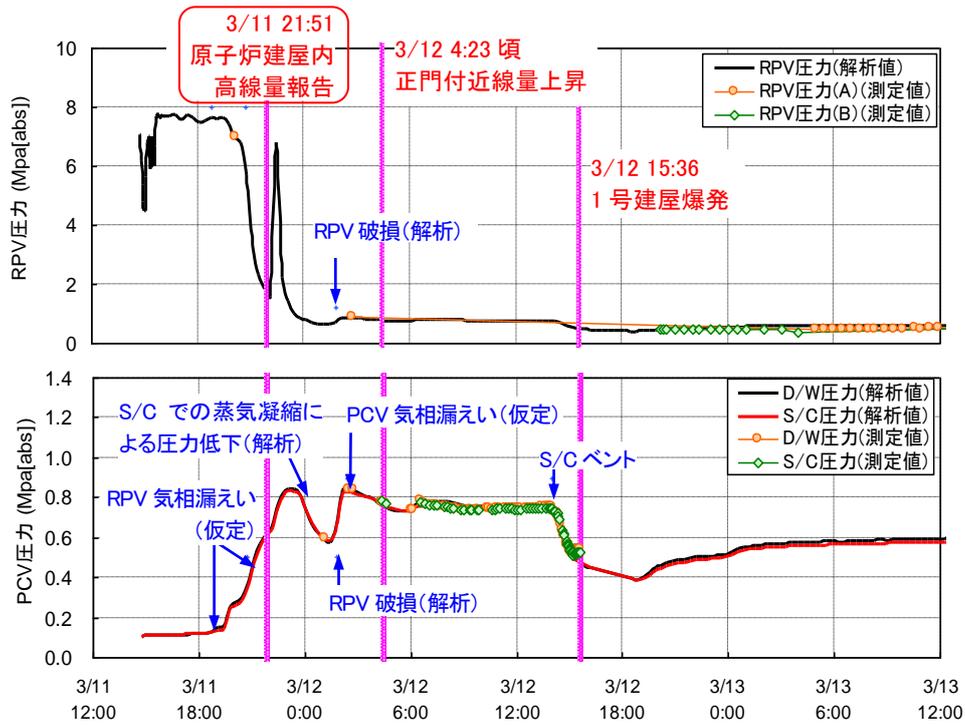
Unit-1/Issue-7	Unit-1	Category B⑤	Class (2)	Safety measures in [1]: pp.27-36 (strengthening of water injection means)
Dose rate increase in Unit-1 reactor building on March 11 th				Results: -
<p>At 17:19 on March 11th, shift operators approached the Unit-1 reactor building, carrying a GM survey meter for contamination inspections, in order to check the RPV pressure indicators and the IC shell side remaining water levels. When they opened an outer airlock door, their GM survey meter gave a value higher than normal (recording 300cpm, about three time the usual background). They returned to the MCR to report this at 17:50.</p> <p>There is a further record that at about 21:00 on March 11th, when shift operators entered the reactor building, their APDs measured 0.8mSv instantaneously and they reported it upon return to the MCR at 21:51.</p> <p>By referring to the written records on the MCR whiteboard for consideration, the dose rate at the spot could be 288mSv/h, <i>if</i> "instantaneously" were assumed as 10 seconds. When compared to the dose limit 100mSv for emergency operations, this dose rate (288mSv/h) is high enough to impede the accident management operations.</p> <p>It is not clear whether the dose rates in the reactor building were high, when shift operators entered the reactor building at 20:07 on March 11th to check the RPV pressure indicators. It has been confirmed that, later at 23:00, the dose rates before the airlock doors of the reactor building were high (1.2mSv/h in front of the outside of the north airlock door, and 0.52mSv/h in front of the outside of the south airlock door).</p> <p>Thus, the high dose rates are recognized at an early stage of the accident at Unit-1, but there is no direct evidence which shows the exact timings and paths of fission product leaks. It is necessary to clarify them, in combination with the Unit-1/issue-8 and 9, in order to assess the accessibility to the reactor building for accident management operations as well as to estimate the conditions of the core and the PCV.</p>

Figure RPV and PCV pressure changes at Unit-1

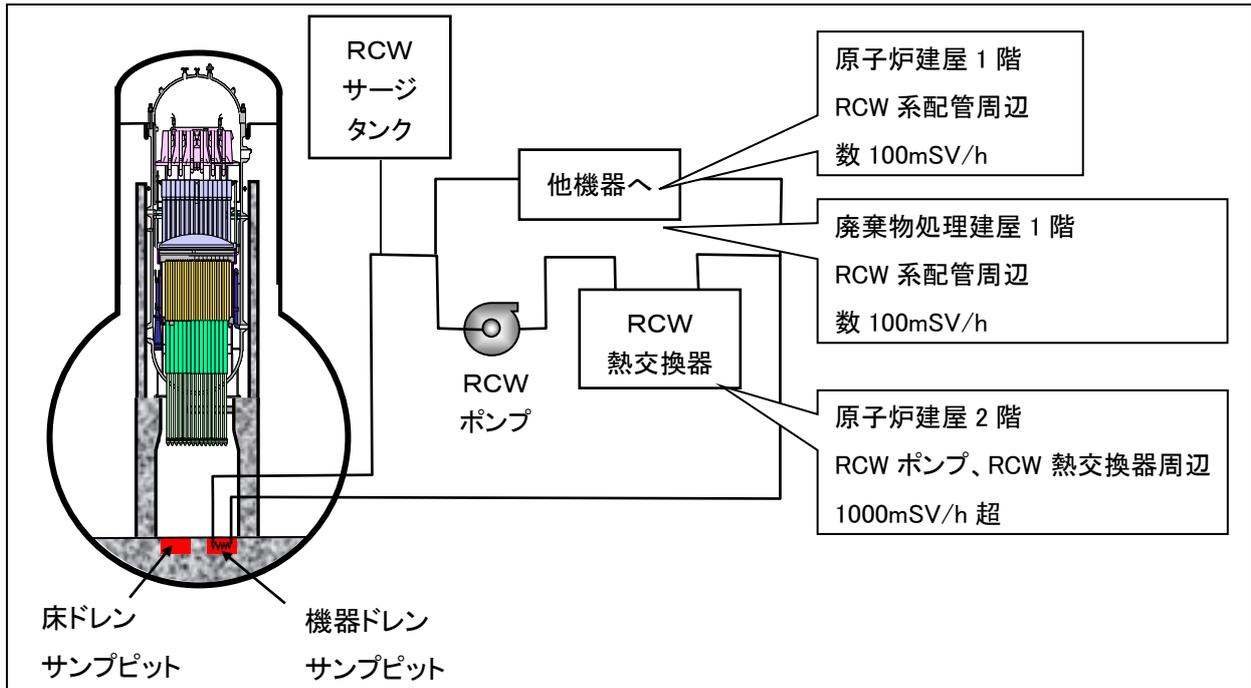
Unit-1/Issue-9	Unit-1	Category B⑤	Class (2)	Safety measures in [1]: pp.40, 43, 44 (strengthening of venting means)
Causes of high dose contamination around the Unit-1 RCW piping				Results: Attachment 1-9
<p>The investigation of Unit-1 in May 2011 confirmed high dose rate contamination of several hundred to several thousand mSv/h near the RCW piping. No such high dose rate has been noticed near the RCW piping at Unit-2 and Unit-3.</p> <p>The RCW is a closed-loop system to cool auxiliary equipment and is unlikely to experience such high contamination in normal situations. However, the RCW also has a role to cool the equipment inside the PCV and it has piping to cool the drain in the equipment drain sump at the bottom of the pedestal.</p> <p>Therefore, there may be a possibility that part of the molten fuel fell into the equipment drain sump and damaged the RCW piping, allowing the transfer of high dose rate steam or water containing radioactive materials into the RCW piping. Identification of the causes of high dose rates in the RCW piping may help to estimate the conditions of the core and the PCV.</p>

RCWサージタンク	RCW surge tank
他機器へ	To other systems/equipment
RCW熱交換器	RCW heat exchanger
RCWポンプ	RCW pump
原子炉建屋 1 階 RCW 系配管周辺数 100mSV/h	R/B first floor Several hundred mSv/h around RCW piping
廃棄物処理建屋 1 階 RCW 系配管周辺数 100mSV/h	RW/B first floor Several hundred mSv/h around RCW piping
原子炉建屋 2 階 RCW ポンプ、RCW 熱交換器周辺 1000mSV/h 超	R/B 2nd floor More than several hundred mSv/h around RCW pump and heat exchanger
床ドレンサンプピット	Floor drain sump pit
機器ドレンサンプピット	Equipment drain sump pit

Figure Schematic diagram of RCW system

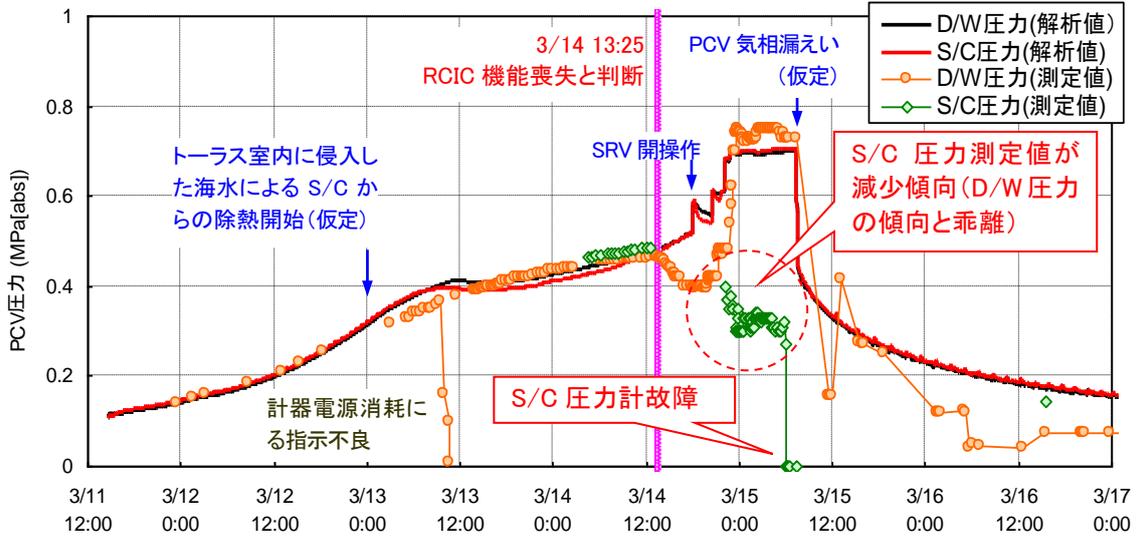
Unit-2/Issue-3	Unit-2	Category A⑤	Class (2)	Safety measures in [1]: -
Behavior of S/C pressure of Unit-2 after 21:00 on March 14 th				Results: -
<p>The D/W pressure of Unit-2 gradually increased while the RCIC was in operation, and after the RCIC was shut down it began to decrease at about 13:00 on March 14th. Thereafter it increased at about 20:00, about 21:00, about 23:00 and reached about 0.75MPa[abs] probably due to incondensable gas accumulation in the D/W because of hydrogen generation and the SRV opening.</p> <p>In the meantime, the S/C pressure measured about the same value as that of the D/W from 04:30 to about 12:30 on March 14th by the pressure indicator originally installed to this plant. The measurement was interrupted thereafter by defective readings. When the measurement was resumed at 22:10 by an S/C pressure indicator introduced for accident management (AM), it showed a lower value than that of the D/W. The S/C pressure indicator for AM was to measure the reference leg pressure of the S/C water level indicator mounted on a branch line off the S/C venting line.</p> <p>Such a discrepancy between the D/W and S/C pressures is very unrealistic for the PCV structural reasons. These pressure indicators should indicate consistent values. For this reason, the S/C pressure indicator is likely to have indicated wrong values. Eventually, the S/C pressure indicator downscaled at 06:00 on March 15th and the instrumentation system seems to have gone out of service. There is a possibility that the behavior of these pressure indicators and the timing of their failure may provide some meaningful information.</p>

Figure PCV pressure changes in Unit-2

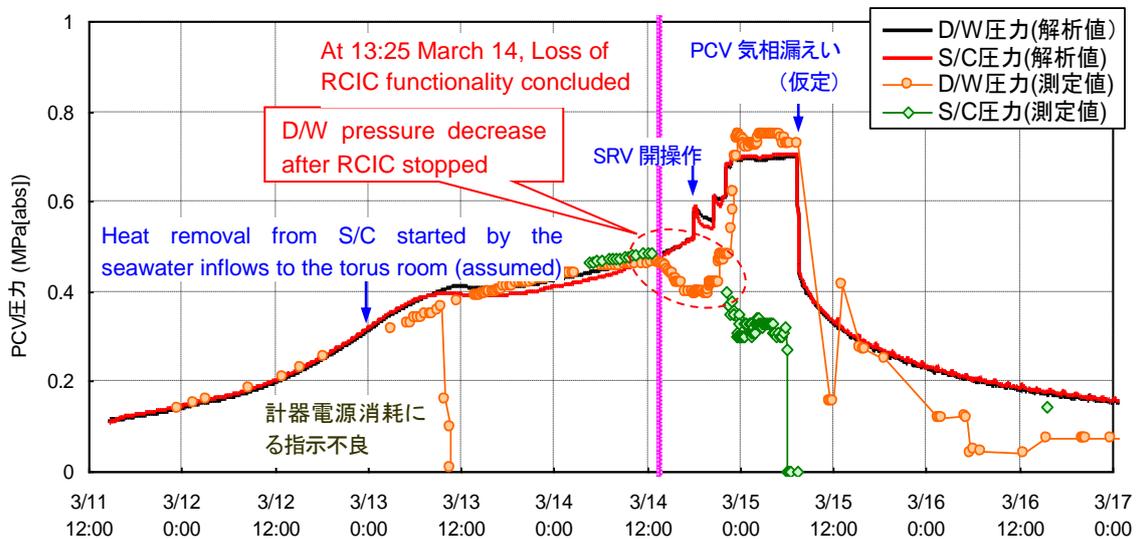
The D/W pressure of Unit-2 increased gradually while the RCIC was in operation. It began to decrease at about 13:00 on March 14th after the RCIC had been shut down. Theoretically, the decay heat in the RPV is transferred to the S/C by steam whether the RCIC is in operation or shutdown, and the D/W pressure is anticipated to increase gradually.

The above-mentioned D/W pressure decrease could be explained by possible leaks from the PCV. But it cannot explain the pressure increase afterward. Another possible interpretation was that the D/W pressure decrease was due to the continued total S/C energy inventory decrease by the heat removal by the water accumulated in the torus room, because the energy could not be transferred to the PCV (D/W) via the S/C by the RCIC turbine until starting energy transfer via SRV. However, the latest MAAP analysis could not reproduce the phenomena of the PCV pressure decrease. There is another inconsistency: the PCV pressure decrease started more than 1 hour later than 12:00 noon when the RCIC is estimated, from the RPV pressure increasing trend, to have completely stopped. This timing almost coincides with the timing when the energy transfer from the SRV to the S/C started; therefore, the scenario of continued heat removal through the S/C walls combined with the energy flow (to the S/C from the RCIC turbine) termination cannot be explained.

Figure PCV pressure changes in Unit-2

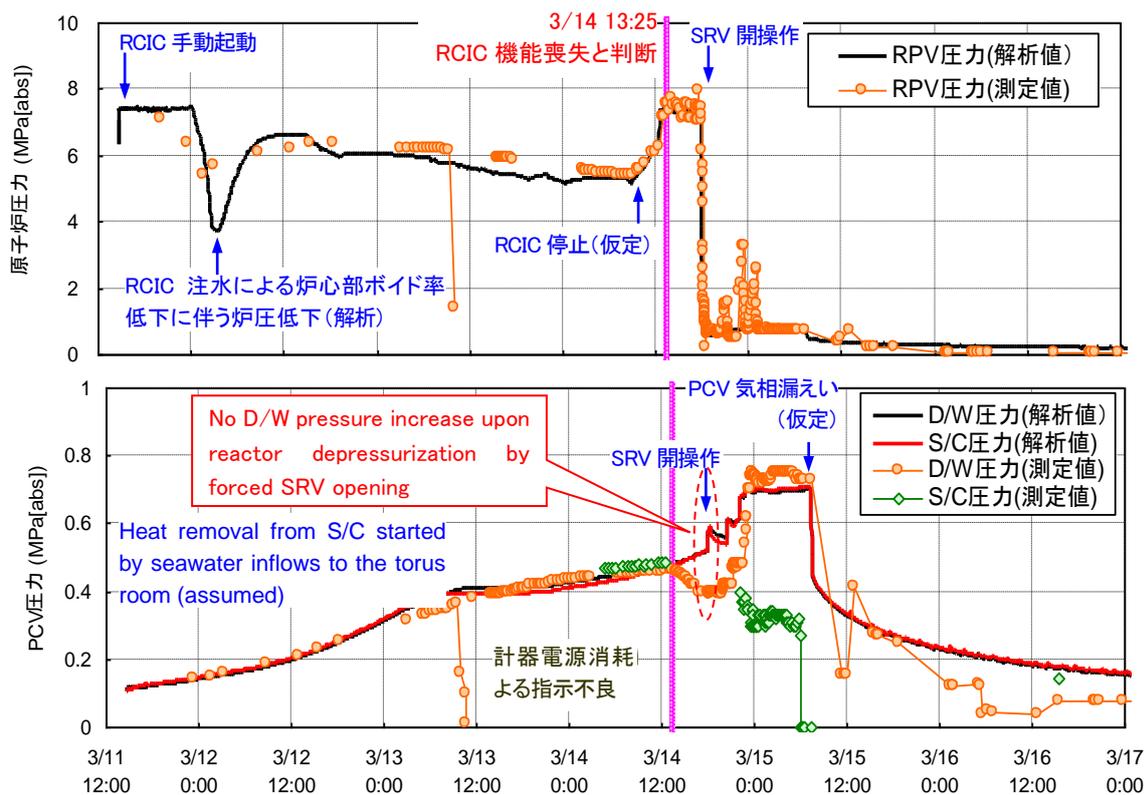
Unit-2/Issue-6	Unit-2	Category B①	Class (2)	Safety measures in [1]: -
PCV pressure behavior upon forced SRV opening at Unit-2				Results: Attachment 2-6
<p>At Unit-2 the manual forced depressurization of the reactor was successfully completed at 18:02 on March 14th by the opening operation of the SRV(s). Theoretically, the D/W pressure should increase by a large amount of steam (energy) flow into the S/C upon forced depressurization by the SRV(s). Nevertheless, it remained at about 0.4MPa[abs] from 17:00 through 20:00.</p> <p>It should be noted that, thereafter at about 20:00, 21:00 and 23:00 on March 14th, the D/W pressure showed an increase and reached about 0.75MPa[abs], probably due to the accumulation of the incondensable gases.</p> <p>The MAAP analysis predicted the pressure increase upon forced depressurization. It is necessary to clarify the pressure change behavior upon forced depressurization by the SRV(s).</p>

Figure Pressure changes of RPV and PCV at Unit-2

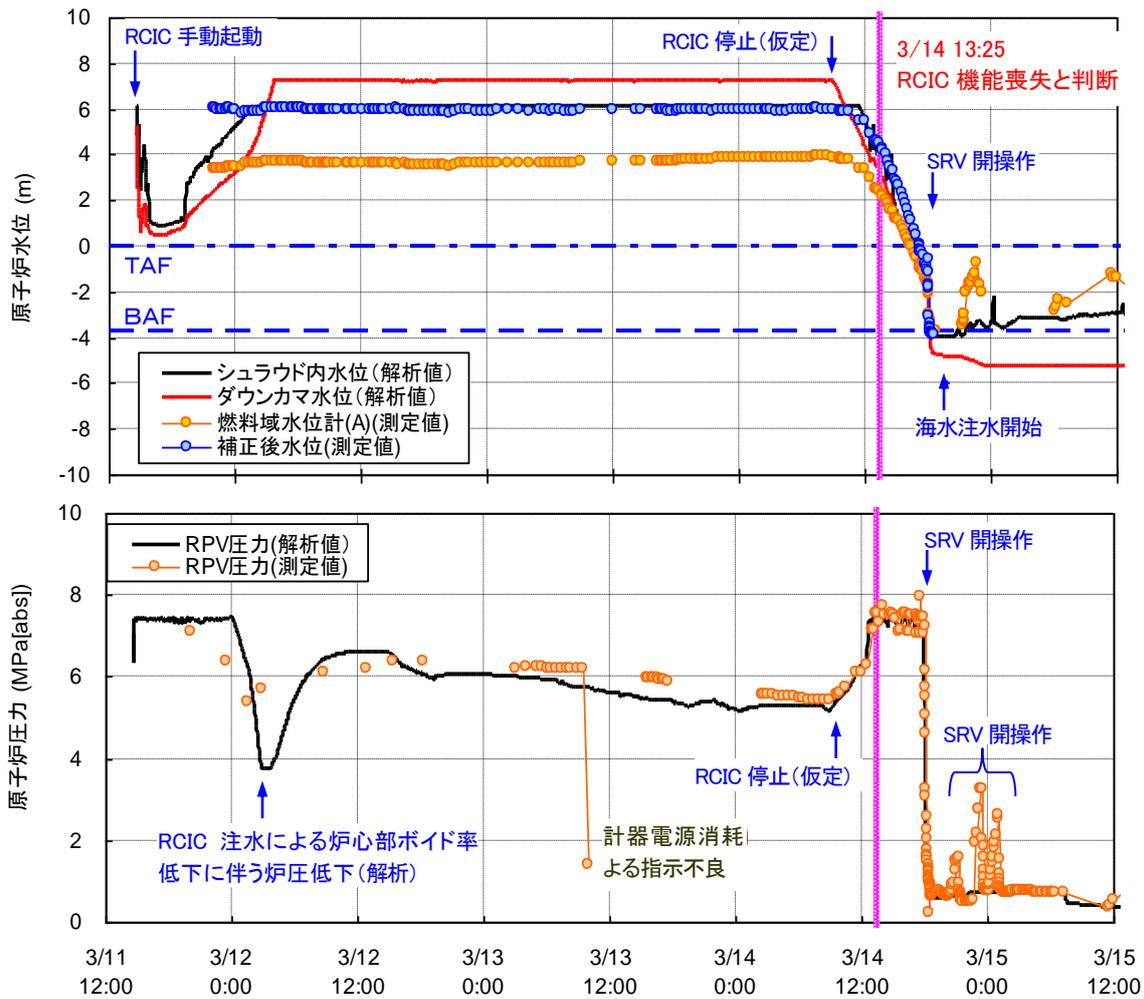
Unit-2/Issue-8	Unit-2	Category B③	Class (1)	Safety measures in [1]: pp.27~36
Leaks in gaseous phase from Unit-2 RPV				Results: Attachment 2-10
<p>At Unit-2 the forced depressurization of the reactor was successfully completed at 18:02 on March 14th by the opening operation of the SRV(s).</p> <p>The SRV(s) were repeatedly opened thereafter in order to control the intermittent reactor pressure increase. But the operation records of SRV opening and the RPV pressure decrease do not always coincide. For instance, the operations of manual opening are recorded twice at 21:20 on March 14th and at 01:10 on March 15th, but no record of confirming the SRV manual opening exists at the time of reactor pressure increase and decrease at about 23:00 on March 14th.</p> <p>The reactor water level indicator readings showed about the BAF level at the time of the forced depressurization, and the core melting progressed thereafter. In view of this, gaseous leaks might have occurred from the reactor vessel, due to, for example, damage of TIP tubes, which composed the pressure boundary. In addition, no further operations of SRV opening for depressurization were taken after a certain time.</p> <p>But there is no direct evidence in the measured plant parameters or observed events which shows when and from where the leaks actually occurred. Clarification is needed.</p>

Figure RPV water level and pressure changes at Unit-2

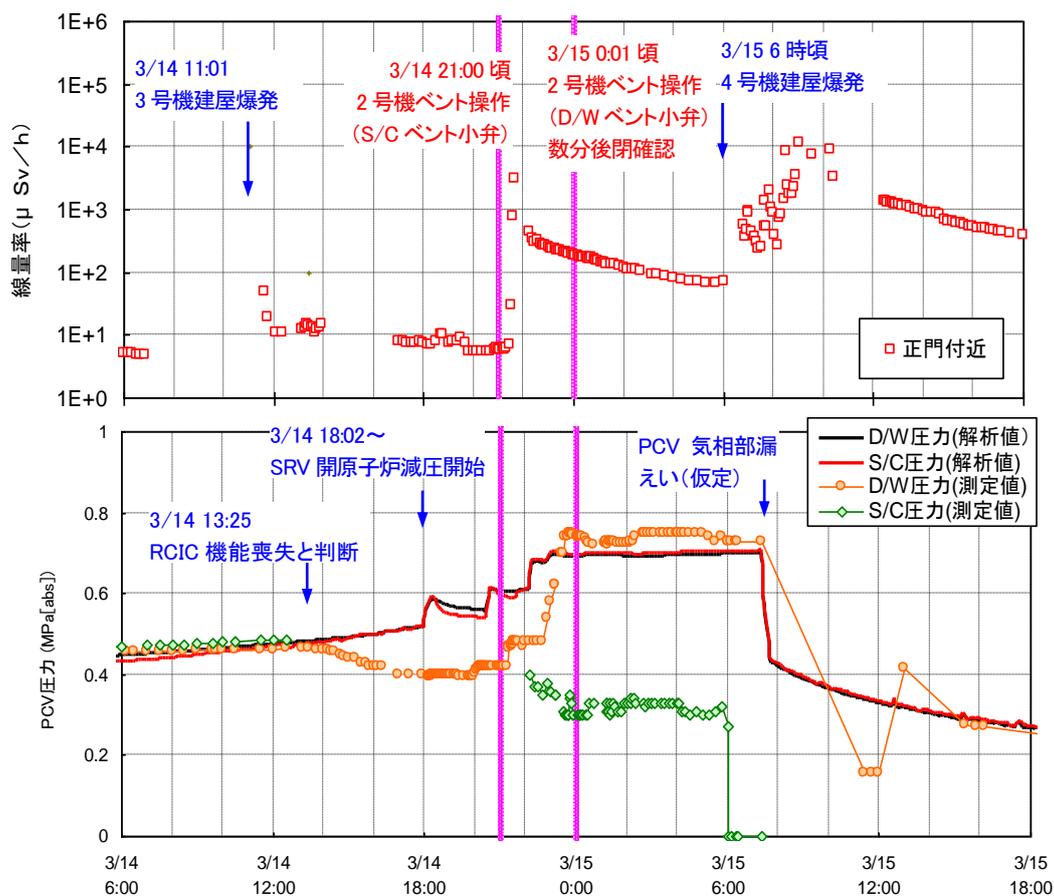
Unit-2/Issue-9	Unit-2	Category B①	Class (2)	Safety measures in [1]: p.40
Consideration of possible rupture disc actuation at Unit-2				Results: Attachment 4
<p>At Unit-2 the RCIC could continue injecting water with no power source for control, which had been lost due to the tsunami. But, since the need to vent the PCV was foreseen in due course, the venting line was configured by 11:00 on March 13th except for the rupture disc actuation.</p> <p>However, the large S/C vent valve (AO-valve) was confirmed to have been closed by the impacts of the explosion of the Unit-3 reactor building. Finally, the valve is considered to have become inoperable for opening actions due to the defective solenoid valve.</p> <p>At about 21:00 on March 14th, the small S/C vent valve was slightly opened by activating its solenoid valve. The venting line configuration was completed again except for the rupture disc actuation, but it was reported that the small S/C valve had been in the “Closed” position at 23:35 on March 14th.</p> <p>The S/C venting was thus being prepared for, but no clear evidence exists whether it actually was successful. Even if the S/C pressure indicators did not provide true values, the measured D/W pressure exceeded the rupture disc working pressure (528kPa[abs]) at about 23:00 on March 14th (540kPa[abs]). The S/C venting flow rate with the opened small S/C vent valve is limited, and so the D/W pressure decrease also will be limited. On the other hand, the monitoring car measured a sharp radiation dose increase near the main gate at about 21:20 on March 14th when the SRV opening was recorded.</p> <p>Clarification is needed to interpret the causes of the radiation dose increase, including the possibilities of PCV venting being implemented and the rupture disc actuation.</p>

Figure Radiation dose near the main gate and PCV pressure changes upon Unit-2 venting
[Back to List of Issues/Unit-2](#)

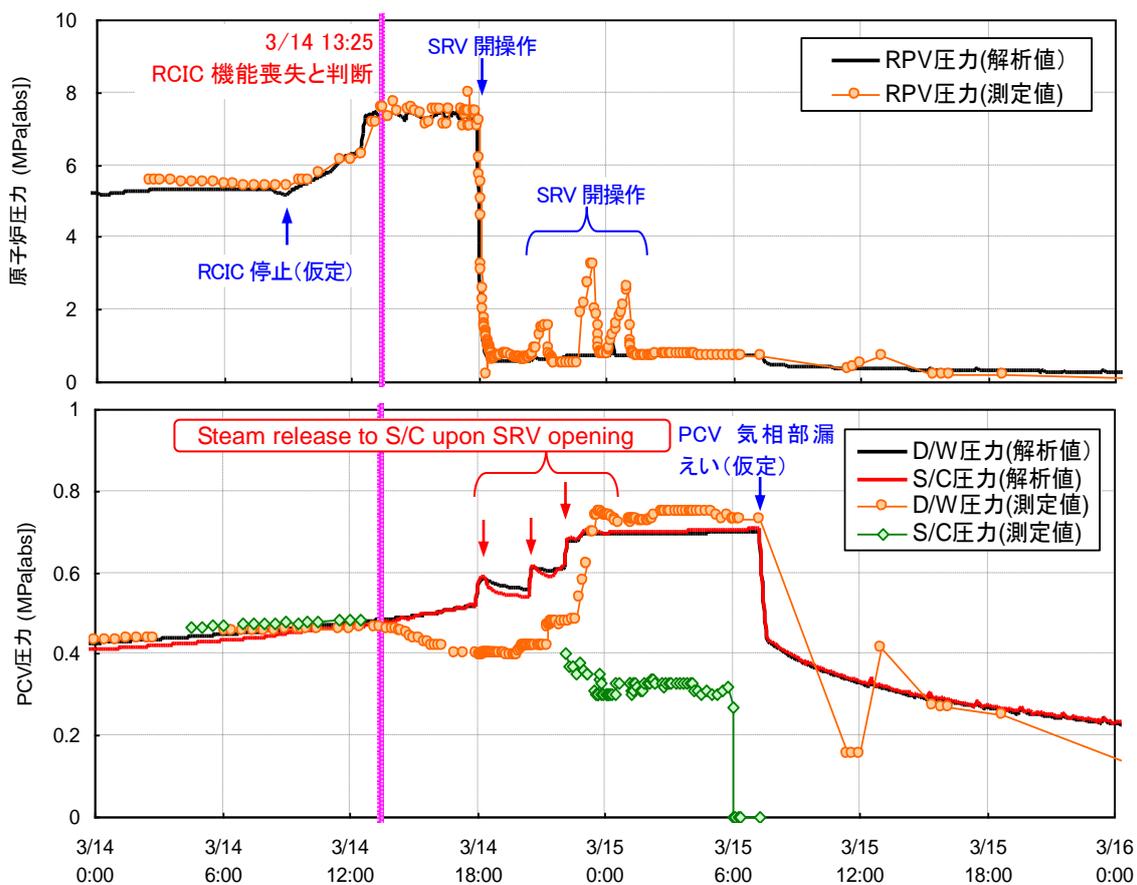
Figure RPV and PCV pressure changes at Unit-2

At Unit-2 the forced depressurization of the reactor was successfully completed at 18:02 on March 14th by the opening operation of the SRV. Further at about 21:00 on March 14th, an attempt was made to open another SRV because the reactor pressure had increased, but the pressure did not decrease. Further a third SRV was then actuated and the reactor pressure decreased at 21:20.

The reactor pressure was about 1.5MPa when it increased at about 21:00, when the core melting is considered to have been already progressing. Therefore, the exhaust upon reactor depressurization would have contained a large amount of hydrogen gas, a non-condensable gas. The non-condensable gas in the exhaust will cause pressure increase behavior different from that due to only steam in the exhaust. Clarification is needed concerning possible impacts on the S/C integrity due to hydrogen-rich steam release.

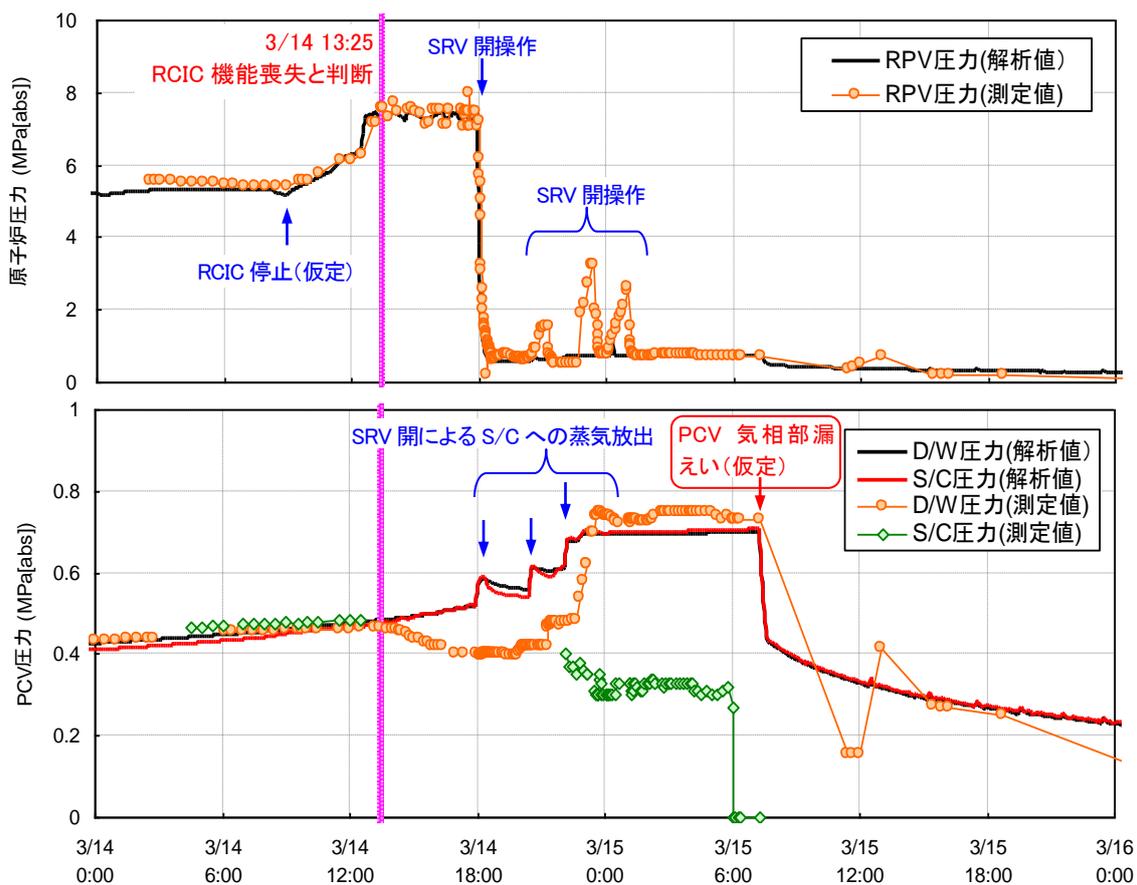
Figure RPV and PCV pressure changes at Unit-2

It can be further considered that the leaks had started sometime between about 23:30 on March 14th, when the PCV pressure had changed above 0.7MPa[abs], and about 07:20 on March 15th.

But no direct evidence has been identified from the measured plant parameters or observed facts concerning at what time and at what point the leaks actually occurred. Clarification is needed.
