List of issues to be investigated

List of issues

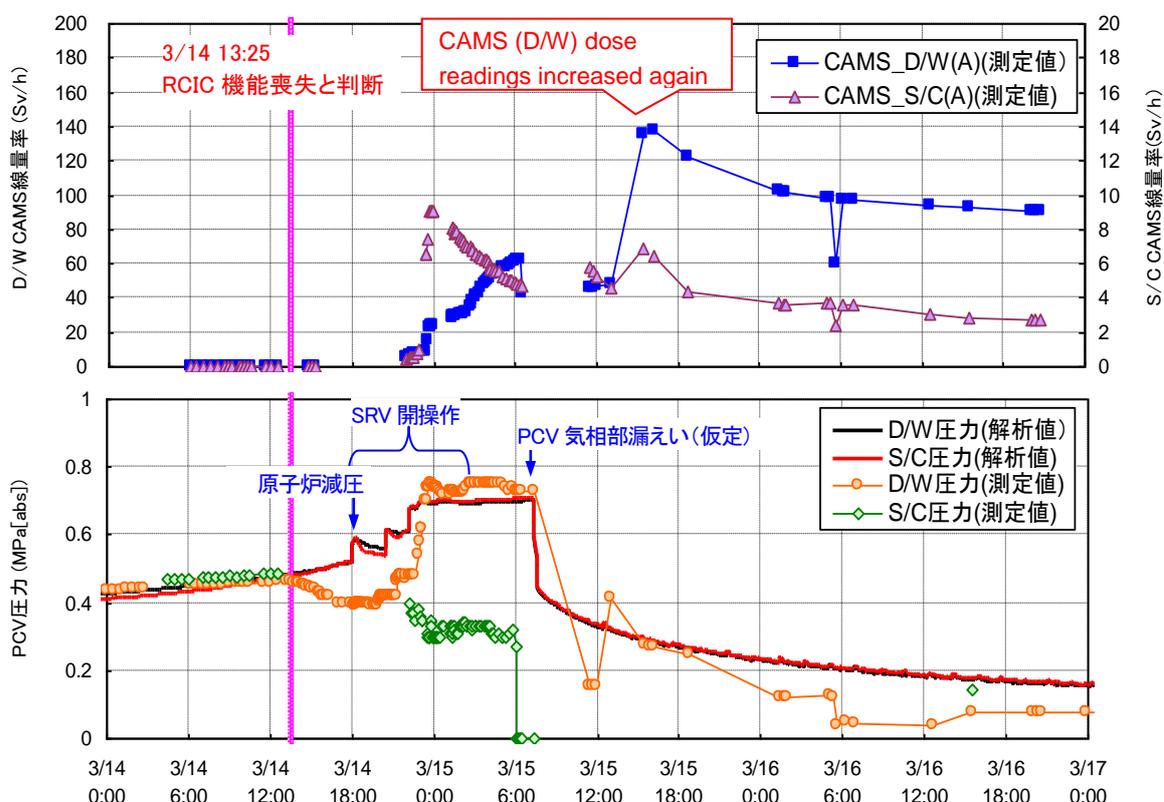
Figure Changes of CAMS readings and PCV pressures at Unit-2

The CAMS (D/W) readings of Unit-2 recorded from the morning of March 15th were monotonically increasing before around 06:00 (63Sv/h at 06:20). After about a 6-hour blank period, it read 46Sv/h at 11:25. This can be interpreted as having reflected the dose rate decrease in the PCV as the result of FP release to the environment.

Thereafter, the CAMS (D/W) recorded a rapid increase to 135Sv/h at 15:25 on March 15th. This rapid increase may have been caused by some unknown changes of the situation in the RPV and PCV. It will be investigated what phenomena could have occurred around this time period.

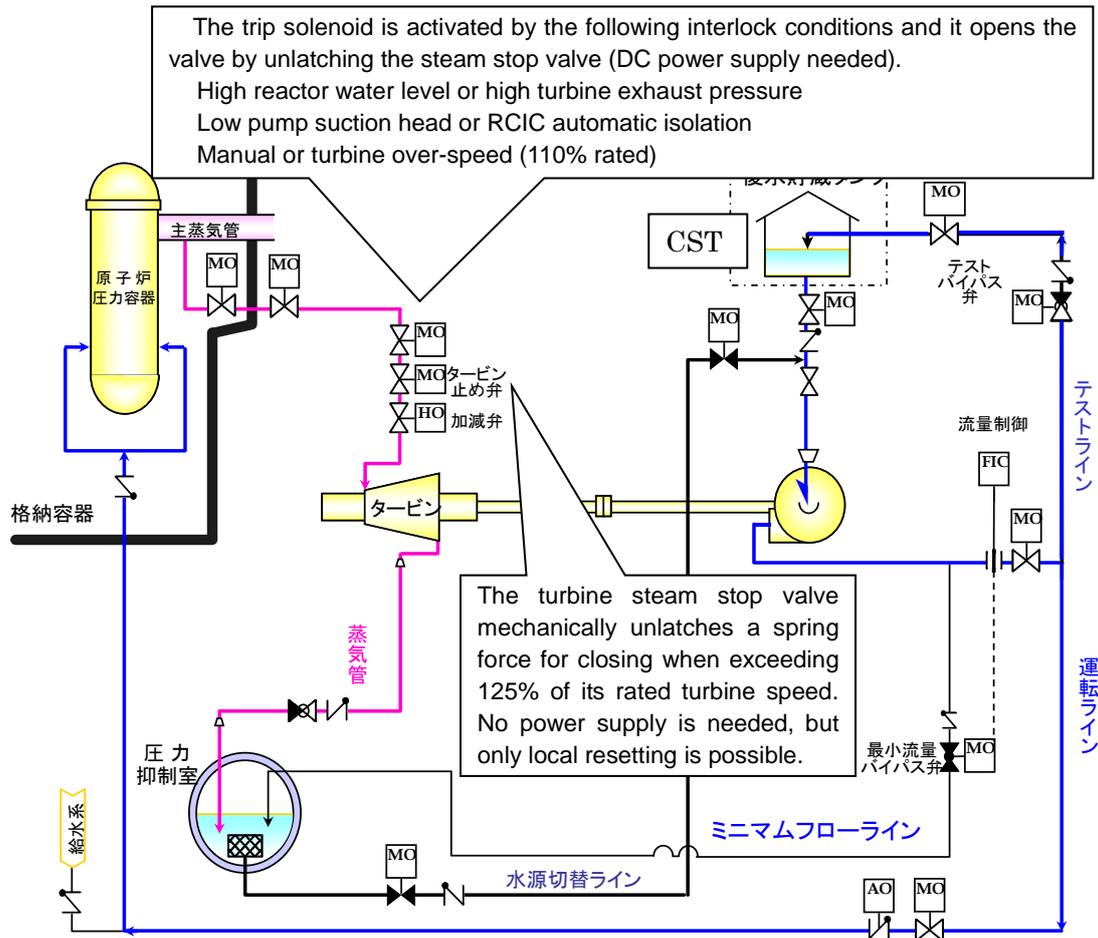
Figure Schematic RCIC line configuration

At 11:36 on March 12th, the status indicator lamp on the MCR control panel showed shutdown of the RCIC, and the flow meter and discharge pressure indicator readings all became zero. The RCIC was thus confirmed to have shut down. The shutdown condition was locally confirmed in the RCIC room, too, afterward. It was attempted to restart the RCIC after resetting it from the MCR control panel, but immediately after attempting the restart, the steam stop valve trip mechanism was unlatched, the steam stop valve was closed and the RCIC was shut down.

On the next day after the HPCI stopped operating, it was attempted to restart the RCIC again at 05:08 on March 13th after the steam stop valve mechanism had been properly latched, adjusted, and the pre-service status had been checked, but again the steam stop valve was closed and the RCIC restart attempt failed.

The RCIC could continue working beyond its design condition of 8 hours, but, in order to increase the RCIC system reliability, it is necessary to clarify the battery capacities and real loads, and the reason why the stop valve mechanism was unlatched.

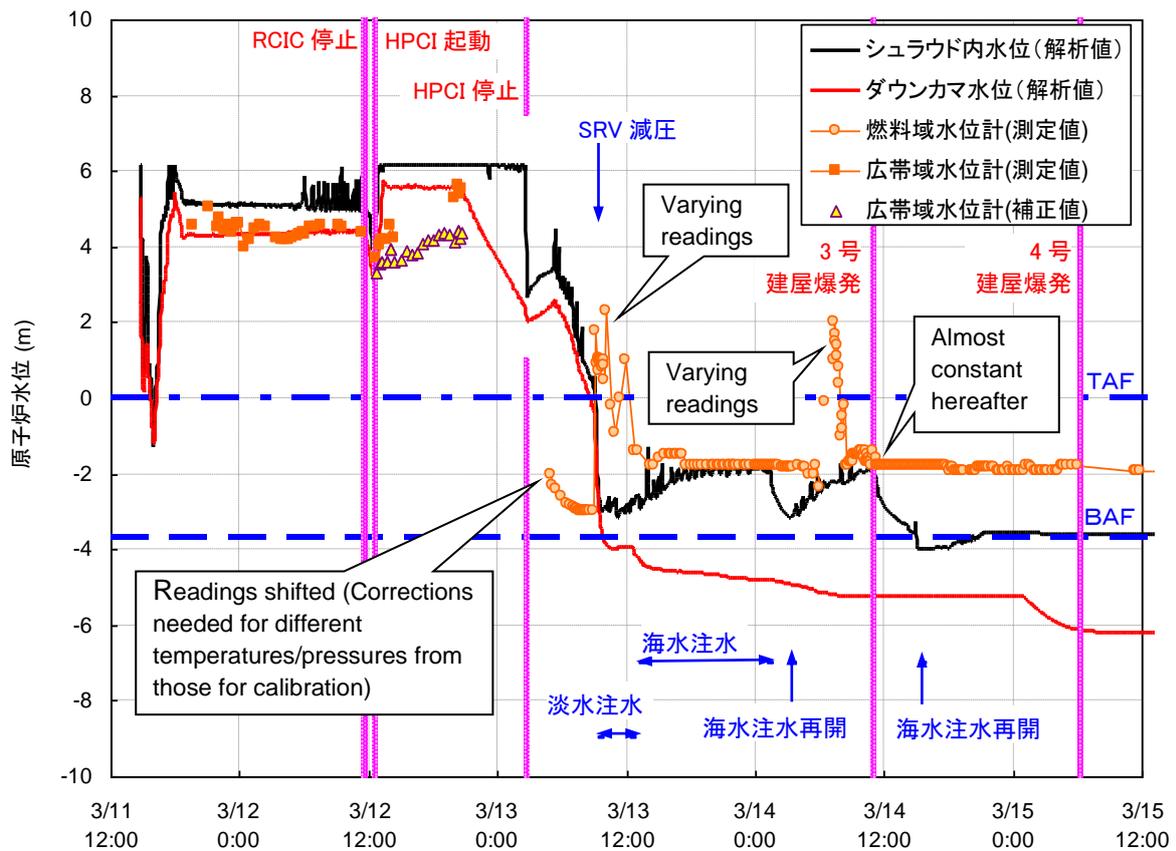
Figure Reactor water level changes at Unit-3

Unit-3/Issue-2	Unit-3	Category A⑤	Class (2)	Safety measures in [1]: P.27~36
RPV water level indicator readings at Unit-3 after loss of true value indications				Results: Attachment 3-9
<p>The reactor water level indicators of Unit-3 showed roughly constant values after about 12:00 on March 13th, irrespective of the water injection conditions. It can be considered that the water level indicators were out of order, like those of Unit-1, because of the water level decrease both in their reference leg and variable leg.</p> <p>The condensing chamber type water level indicators installed in the Fukushima Daiichi NPS reactors lose their water in their internal piping (reference leg and variable leg) by evaporation, causing them to show wrong values, when the PCV temperatures increase or the reactor pressures decrease.</p> <p>But, the water level indicator readings represent the pressure difference between the reference leg and the variable leg. This may provide some relevant information concerning the timing of reactor pressure decrease and/or reactor water level</p>

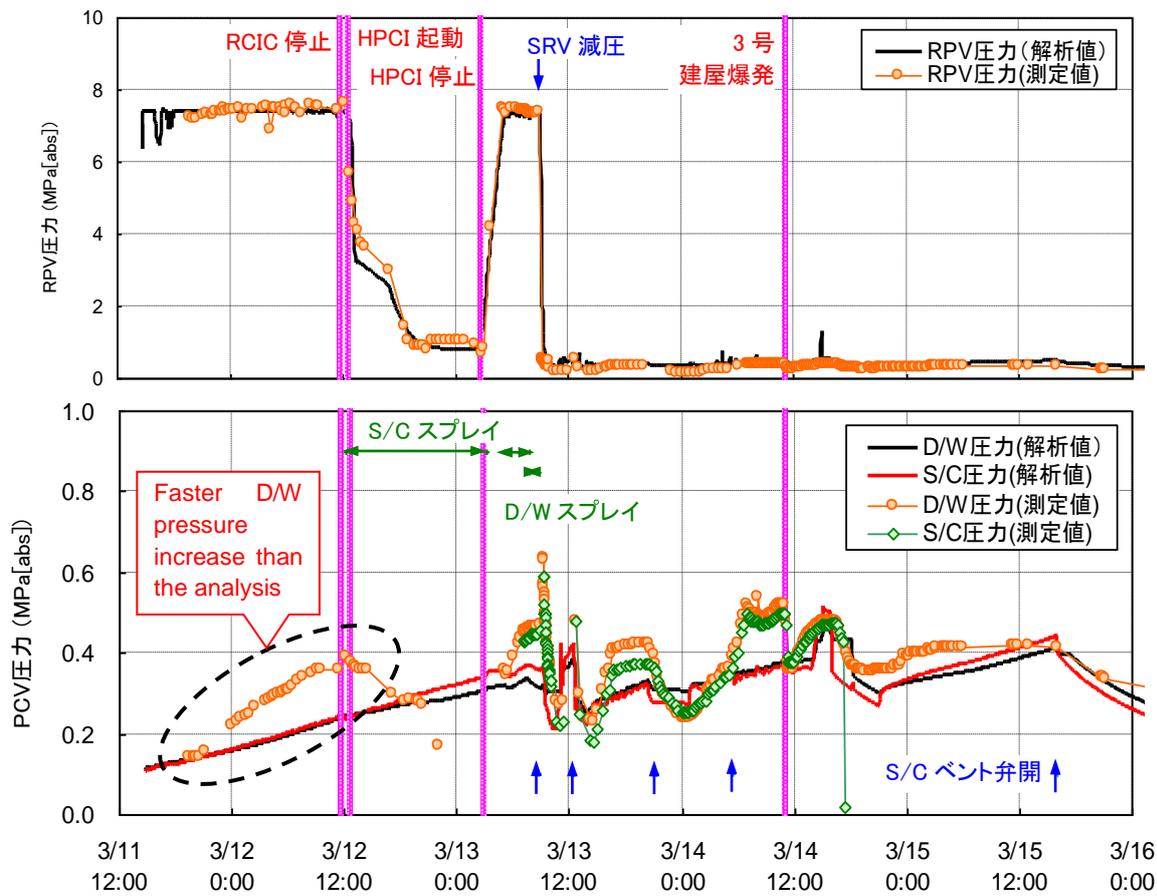
Figure Pressure changes of RPV and D/W of Unit-3

Unit-3/Issue-3	Unit-3	Category B①	Class (1)	Safety measures in [1]: pp. 17, 18, 39, 40
Thermal stratification in the S/C of Unit-3				Results: Attachment 3-7
<p>The D/W pressure of Unit-3 was in an increasing trend due to the exhaust steam from the RCIC and SRV(s), while the RCIC was in operation after the tsunami arrival.</p> <p>When compared with the MAAP analysis results with the use of design conditions, the observed pressures until about 22:00 of March 12th showed a larger and faster increase. The MAAP analysis could not simulate this pressure behavior (the D/W pressures increases were much larger as compared with the MAAP results until about 12:00 when the HPCI started operation, and the analysis pressures by MAAP continued to increase afterward while the observed pressures decreased rapidly).</p> <p>JNES suggested a possibility (*) of thermal stratification in the upper part of the S/C pool water causing a local temperature rise which led to the larger D/W pressure increase as compared with the uniform temperature rise of the S/C pool water. The thermal stratification would have been generated by the high temperature exhaust steam from the RCIC turbine only heating the S/C pool surface water.</p> <p>Further examination is due into the D/W pressure changes until about 22:00 on March 12th.</p> <p>(*) “Examinations into the impacts of thermal stratification in the suppression chamber water on the containment vessel pressures, and other parameters”, issued Feb. 1st, 2012, by the Japan Nuclear Energy Safety Organization (in Japanese)</p>

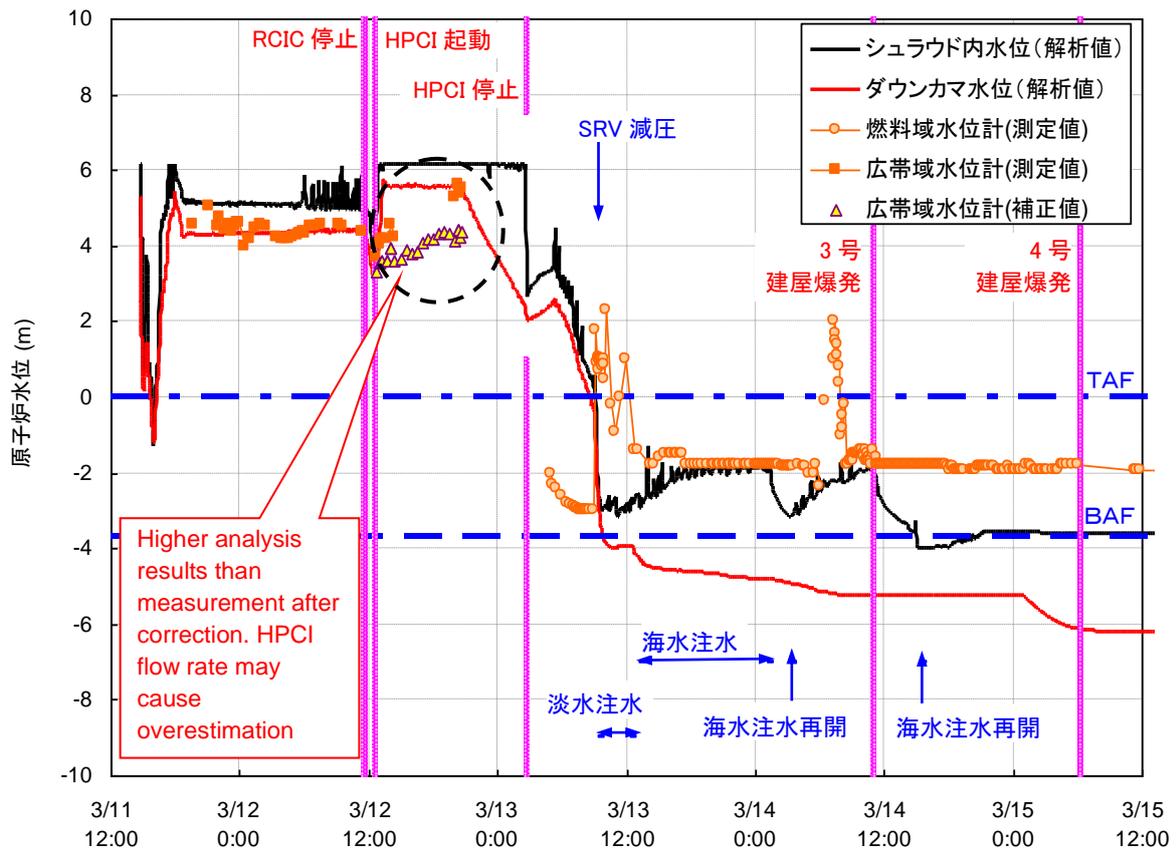
Figure Reactor water level changes at Unit-3

Unit-3/Issue-4	Unit-3	Category B①	Class (2)	Safety measures in [1]: p. 26 (for strengthened monitoring)
Reactor water level behavior during HPCI operation at Unit-3				Results: Attachment 3-3
<p>At Unit-3, the HPCI was adjusting the amount of water injection into the reactor by both using its return line to the CST water source and adjusting the set points of the flow controller while confirming the water level indicator to prevent the HPCI from being shut down by the high reactor water level signal (L-8). At 20:36 on March 12th, while the HPCI was in operation, the power supply to the reactor water level indicators was lost preventing the reactor water level from being monitored. The HPCI water injection flow rate of the flow controller was reset at a slightly increased level, and the reactor pressures, the HPCI discharge pressures, etc. were used to monitor the HPCI operation status.</p> <p>In the earlier MAAP analysis results, which TEPCO had disclosed in March 2012, the amount of water injection by the HPCI had been set to simulate the reactor water levels observed by the water level indicators (wide range). In the simulation, the reactor water levels measured until 20:36 on March 12th were used without corrections corresponding to the reactor pressures and PCV pressures. This caused the overestimation of the amount of water injected to the reactor in the MAAP analysis (The water level in the analysis is about 1m higher than that of measurement after such corrections). In consequence, it is likely that the amount of water actually injected by the HPCI was less than that assumed in the MAAP analysis.</p> <p>The amount of HPCI water injection will be reviewed and the real progression of the accident will be examined for estimating the core and PCV status.</p>

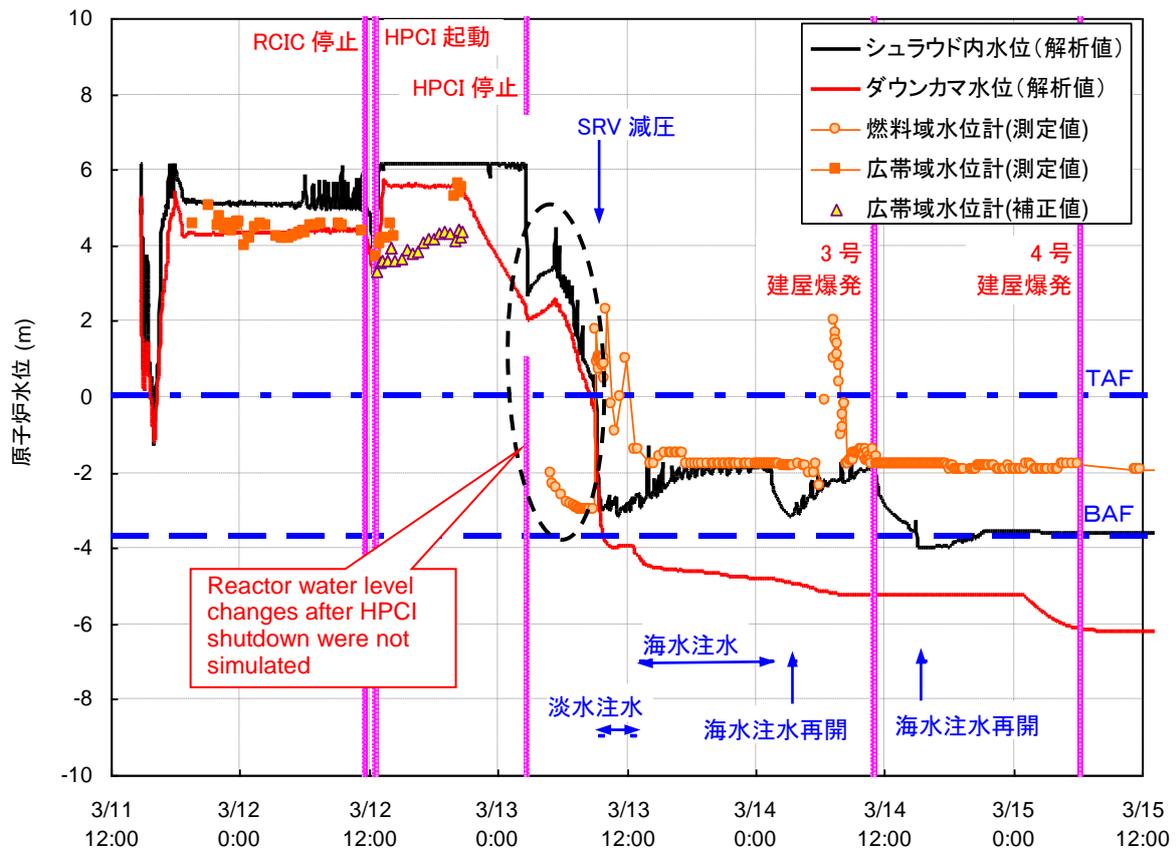
Figure Reactor water level changes at Unit-3

Unit-3/Issue-5	Unit-3	Category B①	Class (2)	Safety measures in [1]: -
Reactor water level behavior after the loss of function of HPCI at Unit-3				Results: Attachment 3-3, 3-4, 3-9
<p>At Unit-3, the HPCI was adjusting the amount of water injection into the reactor by both using its return line to the CST water source and adjusting the set points of the flow controller while confirming the water level indicator to prevent the HPCI from being shut down by the high reactor water level signal (L-8). At 20:36 on March 12th, while the HPCI was in operation, the power supply to the reactor water level indicators was lost preventing the reactor water level from being monitored. The HPCI water injection flow rate of the flow controller was reset at a slightly increased level, and the reactor pressures, the HPCI discharge pressures, etc. were used to monitor the HPCI operation status.</p> <p>From 20:36 on March 12th to about 04:00 on March 13th the reactor water levels were not measured. When the reactor water level indicators were restored, the fuel range water level indicator read about TAF-2m. But, the MAAP analysis maintained the water level higher than the TAF level until about 09:00 on March 13th when the Unit-3 was depressurized, overestimating the water level.</p> <p>This discrepancy indicates that the water actually injected by the HPCI after 20:36 on March 12th was less than that assumed in the MAAP analysis. It further indicates a possibility that the water injection by HPCI had actually ended before the HPCI was manually shut down at 02:42 on March 13th.</p> <p>In view of a high likelihood of a smaller amount of water actually being injected than that assumed in the analysis, the overestimated amount of HPCI water injection will be reviewed and the actual progression of the accident will be investigated for estimating the core and PCV status.</p>

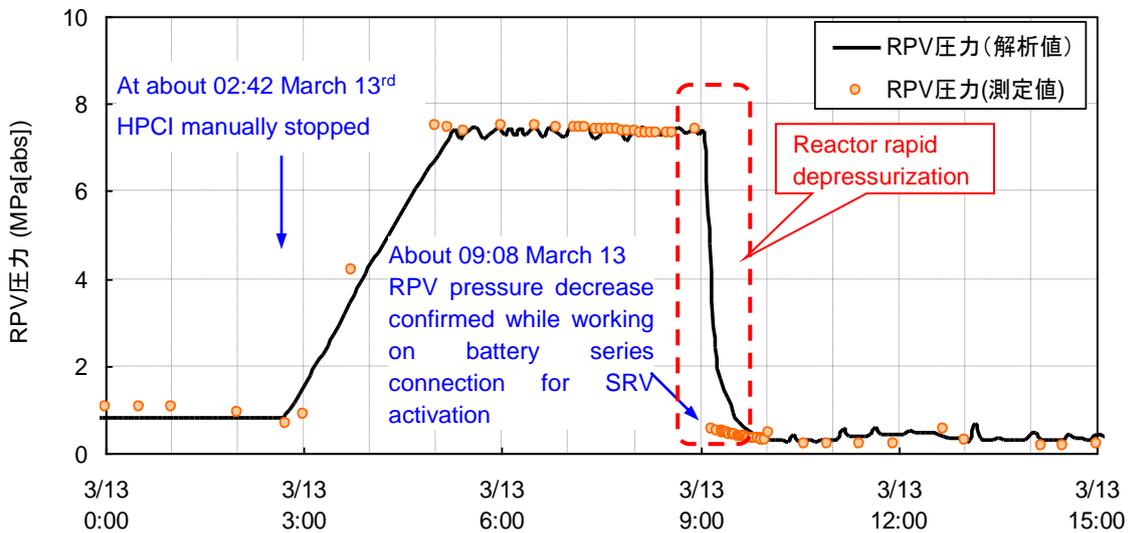
Figure Reactor pressure changes at Unit-3

This pressure decrease can be confirmed in two types of observed data: measured values recorded by the operators and the chart records. From the chart records, continuous transient behavior can be read, although the exact values are not known. The pressure decrease rate thus read is as large as about 7MPa[abs] down to about 1MPa[abs] in 2 to 3 minutes.

At this time, the battery connection work to the SRV control panel was not completed. The pressure decrease did not occur by the SRV manual actuation. It is necessary to investigate the depressurization mechanism.

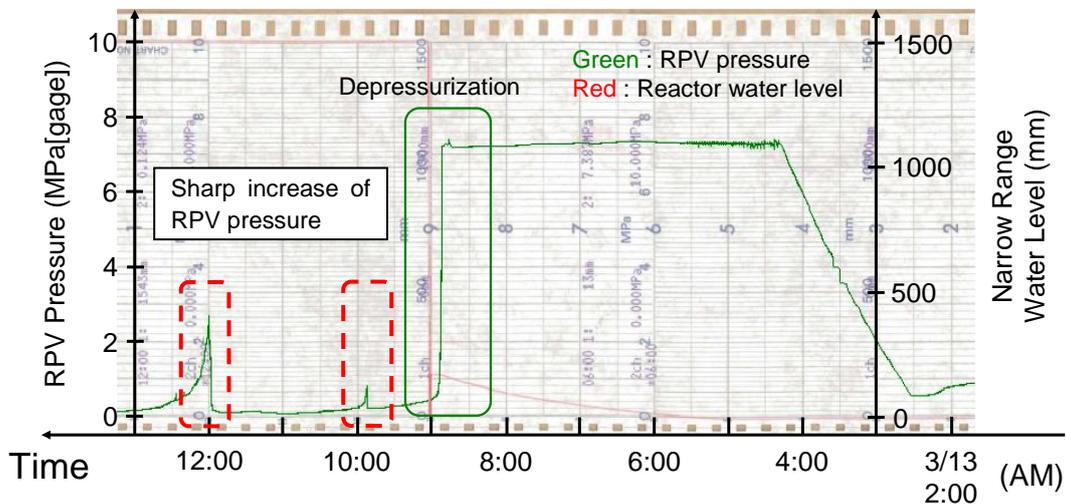
Figure Strip chart records (March 13th, 2011)

This pressure behavior, especially the pressure decrease, was considered and reported to be the responses to the SRV opening operations at 09:50 on March 13th upon the completion of battery connection and at about 12:00 upon the recovery from having found disconnected wiring. However, the pressure rise at these two times is very sharp as compared with the pressure increase at 02:42 on March 13th, when the HPCI had stopped operation.

The pressure behavior should be similar in the two cases, when the HPCI turbine steam regulator valve is closed upon the HPCI being shut down and when the SRV(s) are closed, because both cases are equivalent in having lost the steam discharge paths. But the observed pressure increase behavior is actually different. The sharp pressure increase might have been caused by the relocation of molten fuel down to the lower plenum or the generation of a large amount of hydrogen.

The pressure change mechanism and its relevance to the accident progression will be investigated.

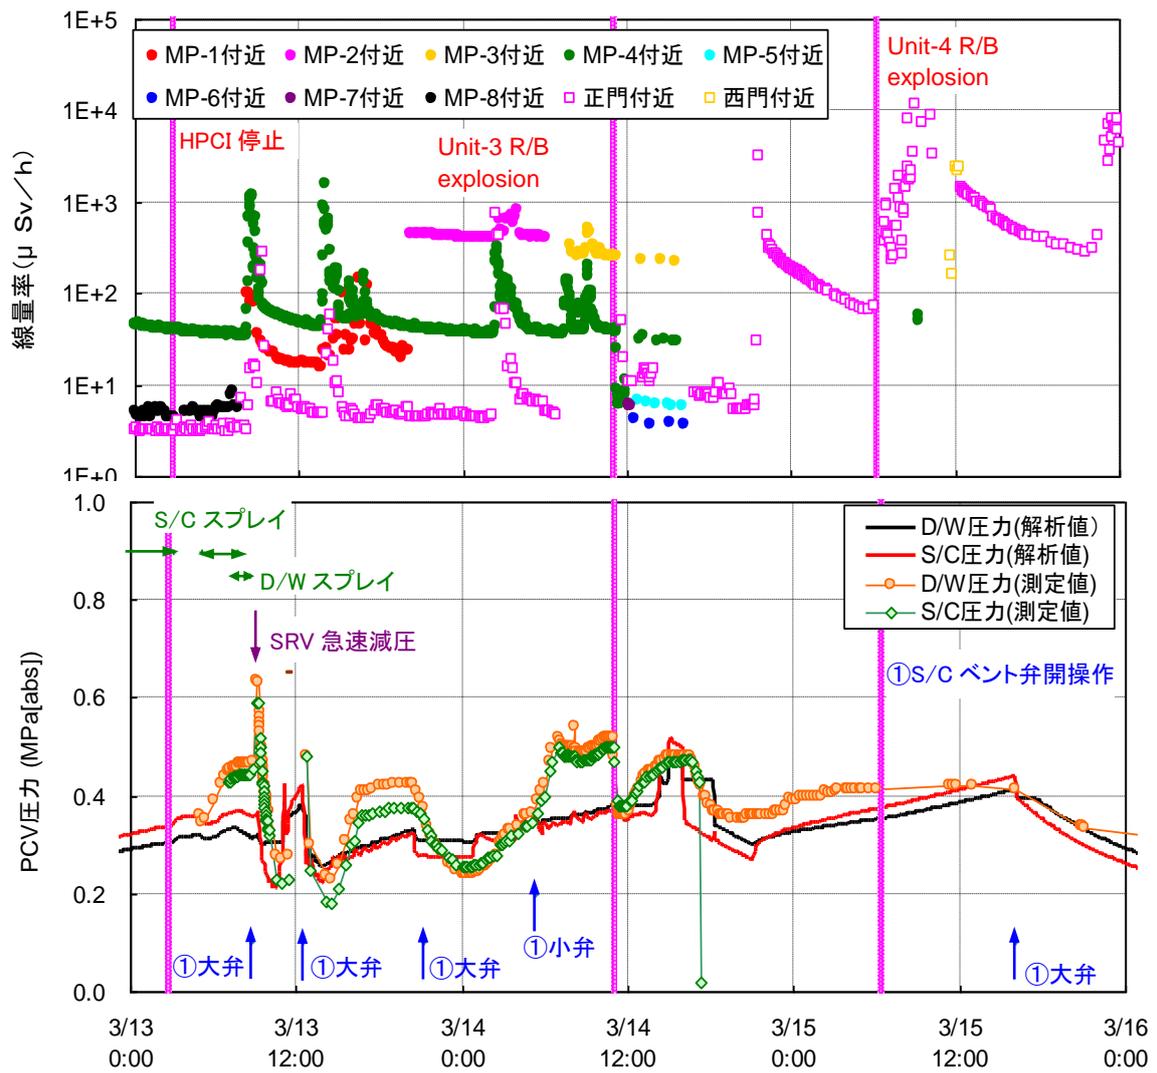
Figure Dose rate changes at the NPS (upper) and D/W pressure changes at Unit-3 (lower)

The Emergency Response Center at the Fukushima Daiichi NPS concluded that the PCV had been vented once at Unit-3 when the D/W pressure decrease had been observed at 09:24 on March 13th following the completion of S/C venting line configuration at 08:41 on March 13th. Thereafter, the large S/C vent valve (air-operated) was closed several times due to problems of driving air pressure or the actuation circuit using a temporary small generator. Each time it was attempted to open the large S/C vent valve by solving the problem causes.

The D/W pressures observed during this period repeatedly went up and down, but their timings were mostly not consistent with the timings of repeated opening operations of the large S/C vent valve. The flow rate changes anticipated by the small S/C vent valve opening operations seem too limited to explain the measured D/W pressure changes.

The causes of the D/W pressure changes during the series of venting operations will, therefore, be investigated.

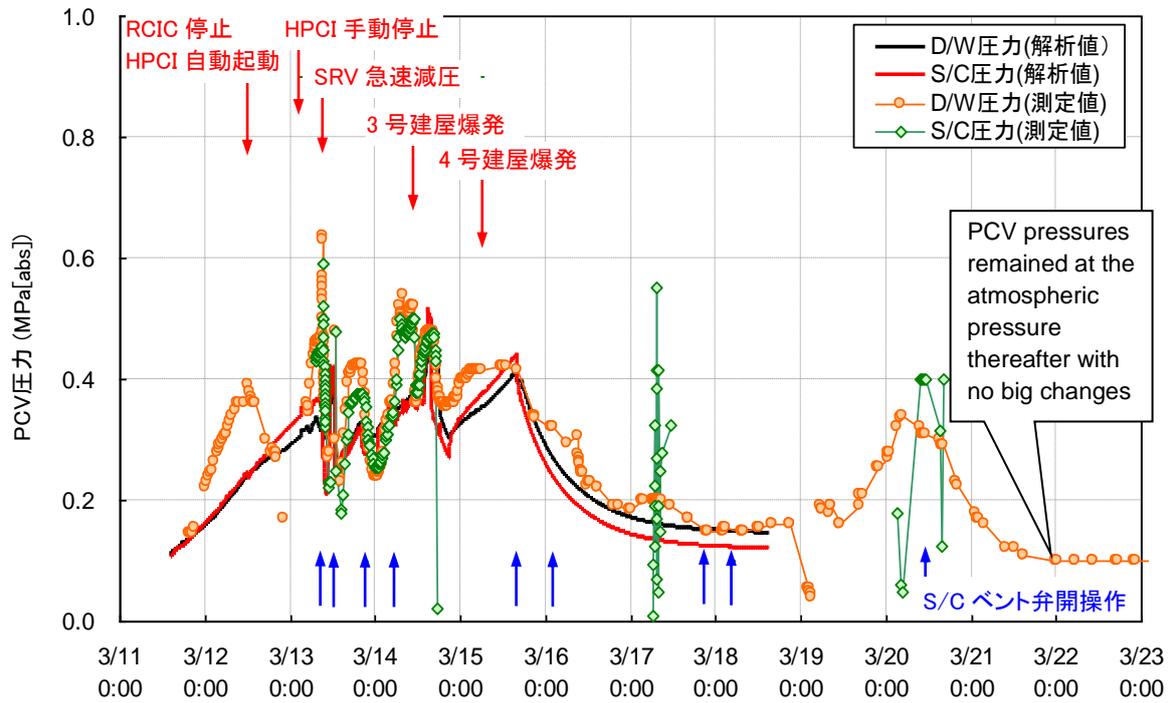
Figure PCV pressure changes at Unit-3

Unit-3/Issue-10	Unit-3	Category B③	Class (1)	Safety measures in [1]: pp.27-43
Leaks in gaseous phase from Unit-3 PCV				Results: Attachment 3-8
<p>At Unit-3, the D/W pressure increase due to the rapid reactor depressurization at about 09:00 on March 13th led to the S/C pressure increase big enough to exceed the rupture disk working pressures. Thereafter the D/W pressure decrease at 09:24 on March 13th was confirmed and the PCV venting was concluded to have been implemented.</p> <p>It was considered that the D/W pressure repeated thereafter ups and downs corresponding to the steam generation by water injection and to the venting operations. After it increased for a while on March 21st, it stayed at around atmospheric pressure, with no big changes.</p> <p>The MAAP analysis assumed no PCV leaks in Unit-3, but the steam leak from the PCV seems probable because the steam explosion occurred in the Unit-3 reactor building, steam release was observed near the reactor well in the reactor building, and the D/W pressure showed no big changes after March 21st at around atmospheric pressure.</p> <p>Adding to that, when nitrogen gas was injected into the PCV, Unit-3 showed no pressure changes in the PCV, while Unit-1 and -2 showed pressure increases in their PCVs. There is another relevant observation concerning the oxygen concentrations in the PCV air, when measured by the PCV gas control system, i.e., it was almost zero in Unit-1 and -2, while it was high in Unit-3, indicating the possibility of air inflow into the PCV.</p> <p>It is considered, therefore, Unit-3, for which the operators attempted to repeat venting operations, would have had the largest leaks in the gaseous phase. Further investigation is needed to clarify when and from where the leaks in the gaseous phase actually occurred.</p>

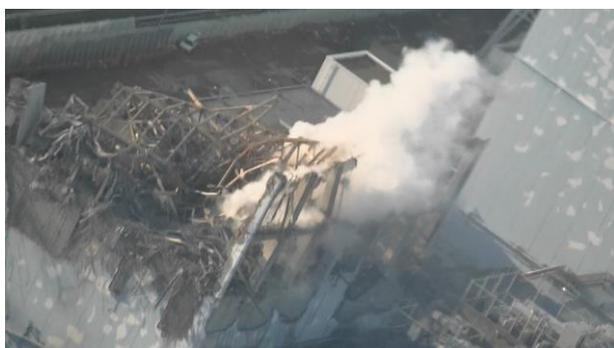
Photograph taken on March 16th, 2011

At Unit-3 a large amount of steam was observed to be blowing upward above the reactor building: dark smoke was observed on March 21st; and steam rising was observed on March 29th from the top and west side of the reactor building. Even after the spent fuel storage pool temperature was lowered sufficiently, steam release above the building was repeatedly observed.

Steam thus observed seems to be leaking from the PCV and it may provide some useful information to identify the leak locations.

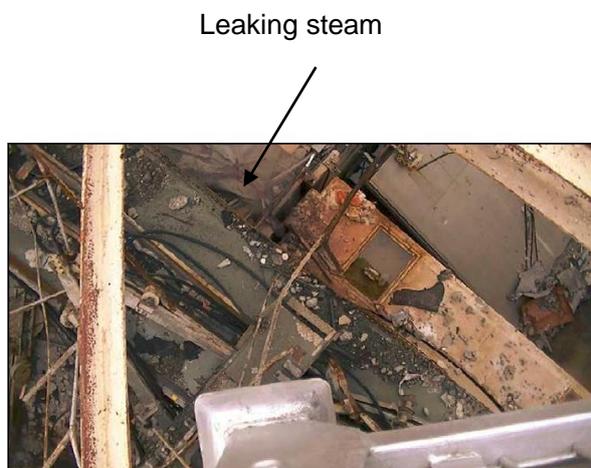
撮影者：東京電力株式会社
撮影日：平成23年8月24日

Movie sequences on August 24th, 2011, taken at the time of dust sampling above the reactor building, show steam leaking from the shield plug margin and the periphery of the deformed dryer separator (DS) pit gates.
