Investigation of the cause of hydrogen explosion at the Unit 4 Reactor Building

24th July 2012

Tokyo Electric Power Company, Inc.

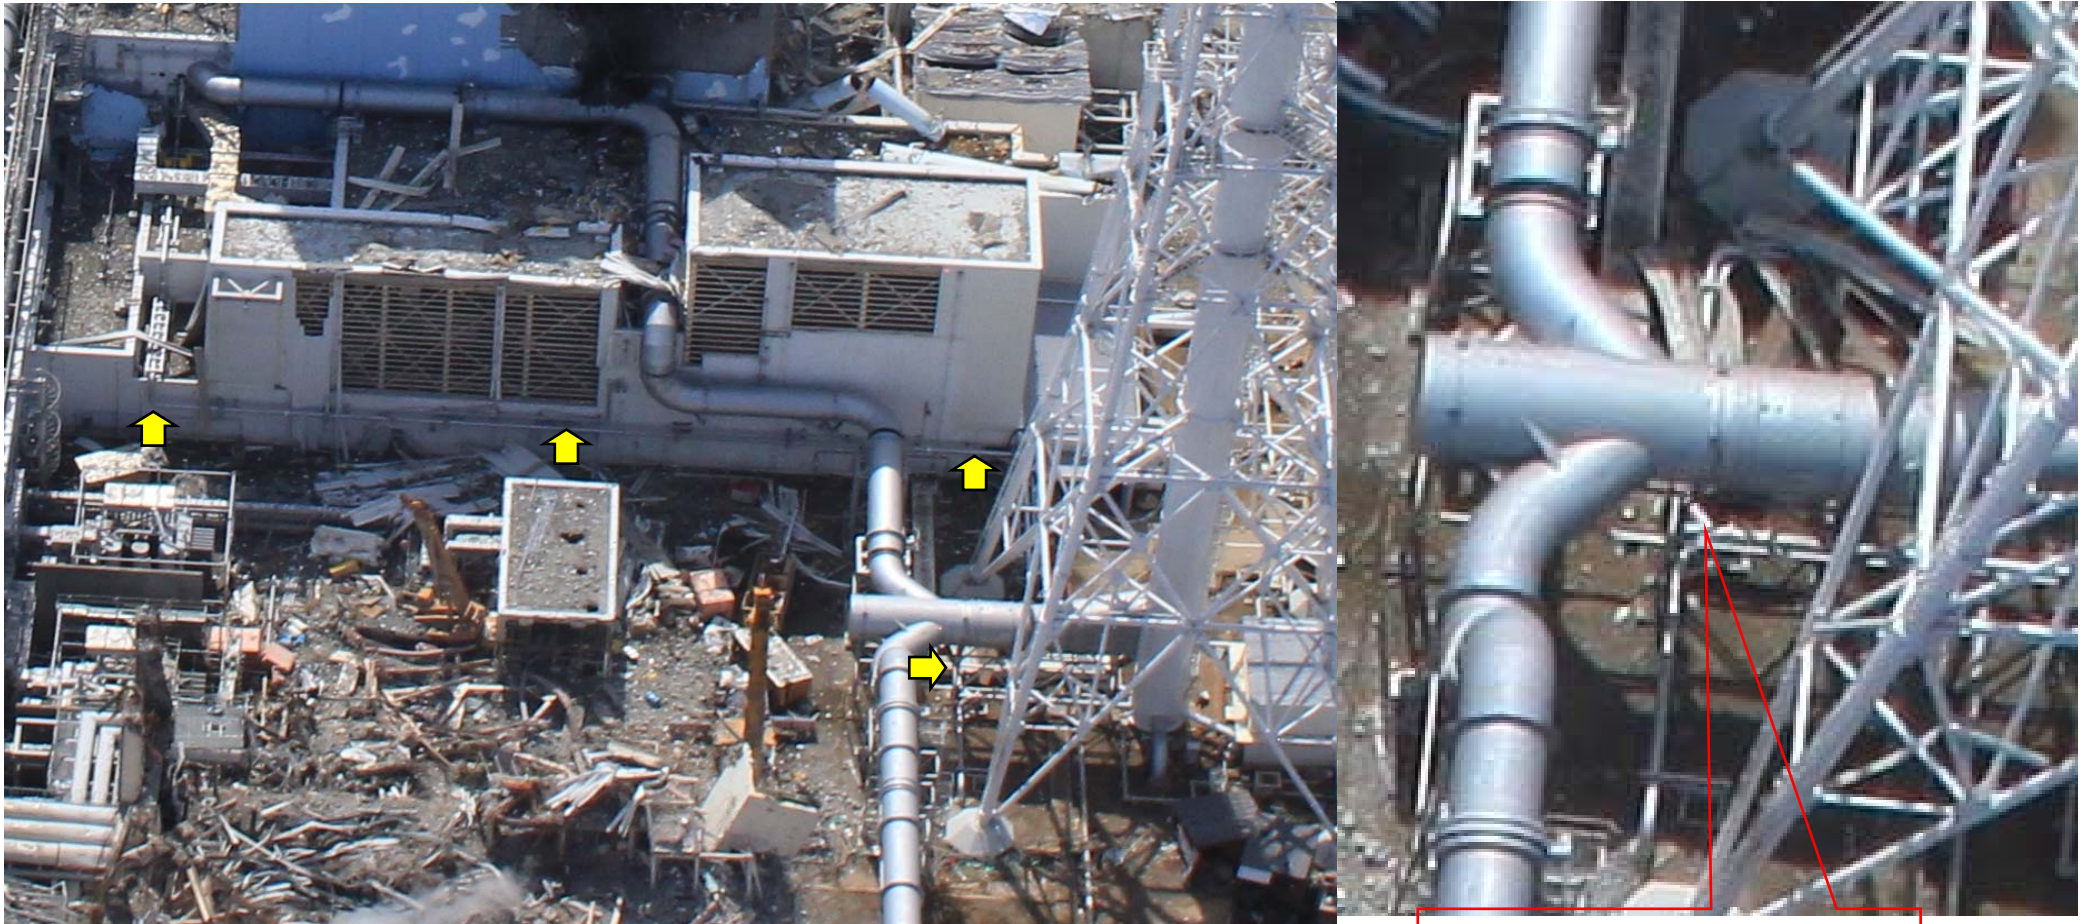
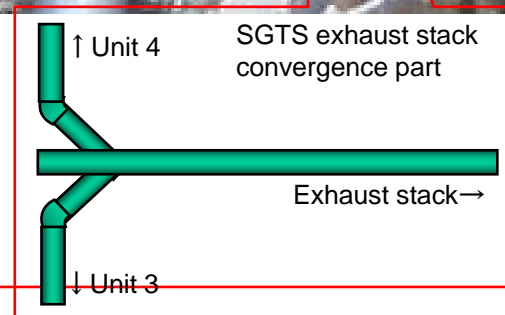
4. Hydrogen flow pass into the R/B (SGTS exhaust piping of Unit 3 and 4)

The SGTS exhaust pipe of Unit 4 joins the Unit 3 exhaust pipe at the main exhaust stack convergence part.
