Progress of Landside Impermeable Wall freezing: the Second Stage

January 26, 2016

TEPCO

- 1. About Landside Impermeable Wall 2
- 2. Soil temperatures 3-8
- 3. Auxiliary construction for further freezing the wall 9-13
- 4. Groundwater levels and hydraulic heads 14-17
- 5. Coolant leakage at 1BLK 18-22
- Reference 23-25

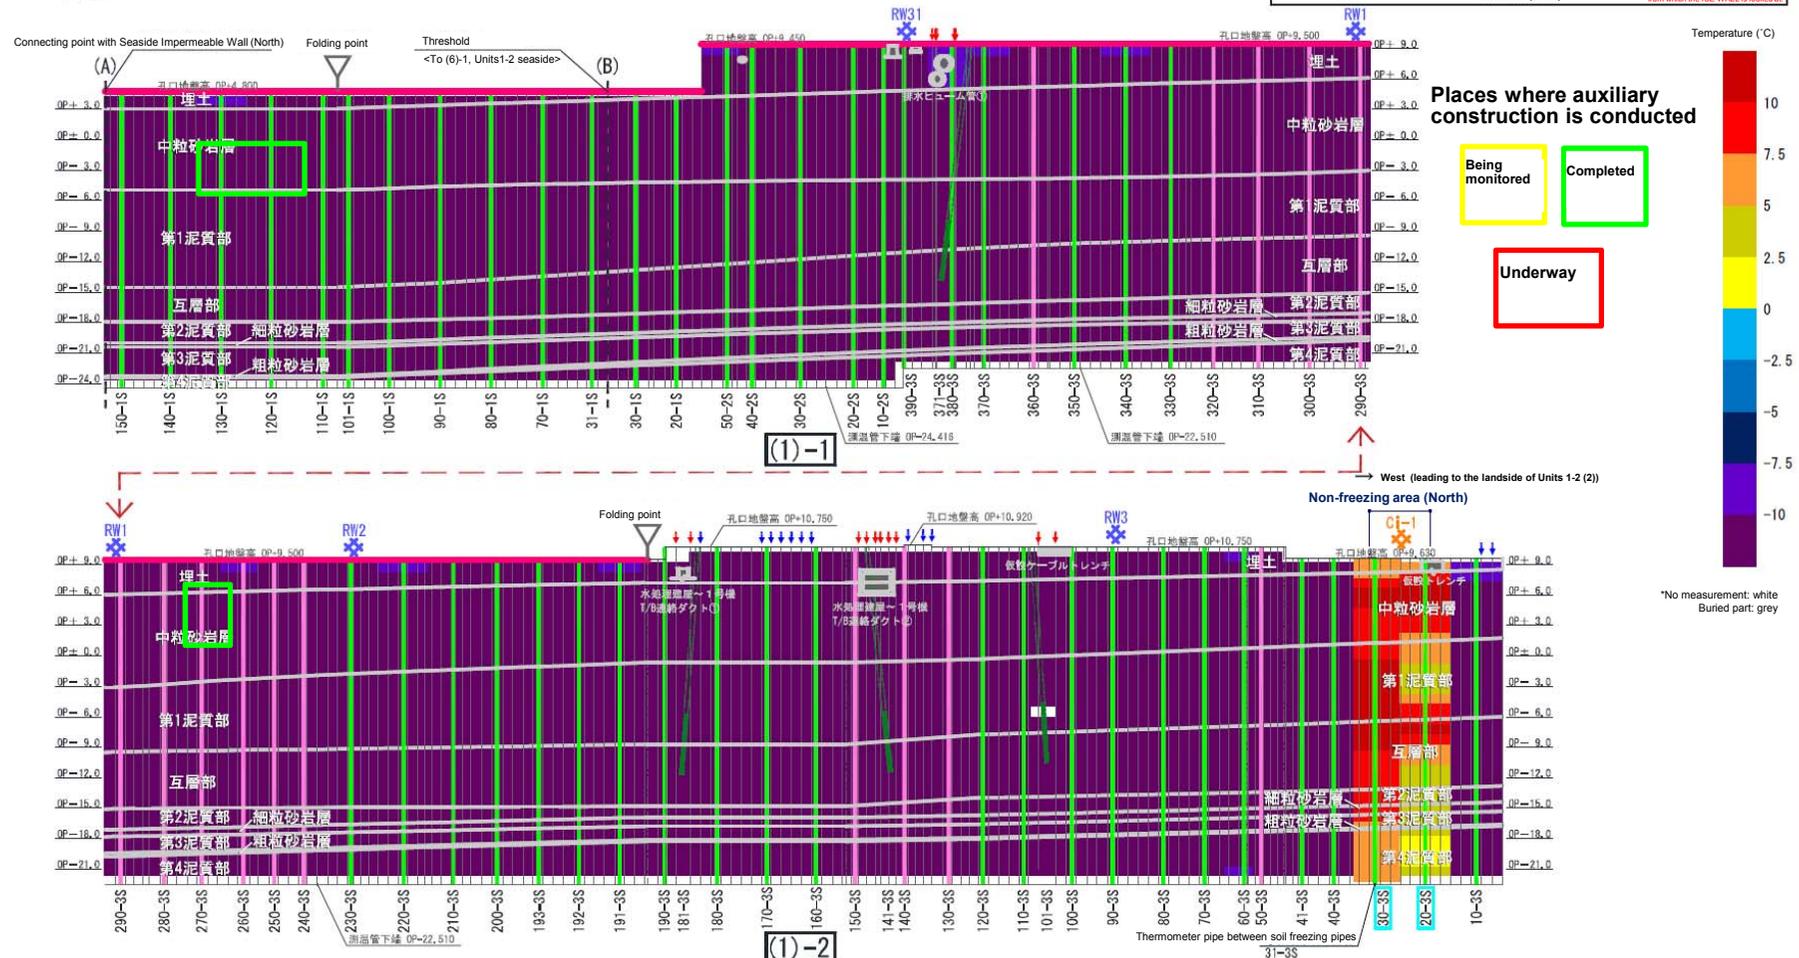
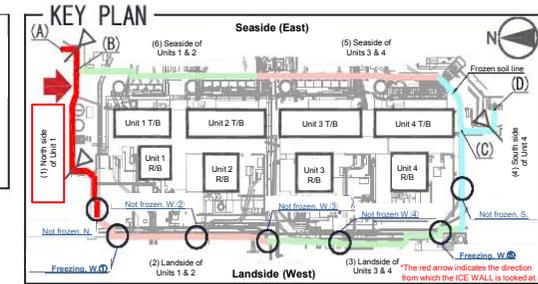
2-1 Distribution map of soil temperatures (north side of Unit 1)

Distribution map of soil temperatures

(1) North side of Unit 1 (a view from the north side)

(The temperature data as of 7 a.m. on January 24)

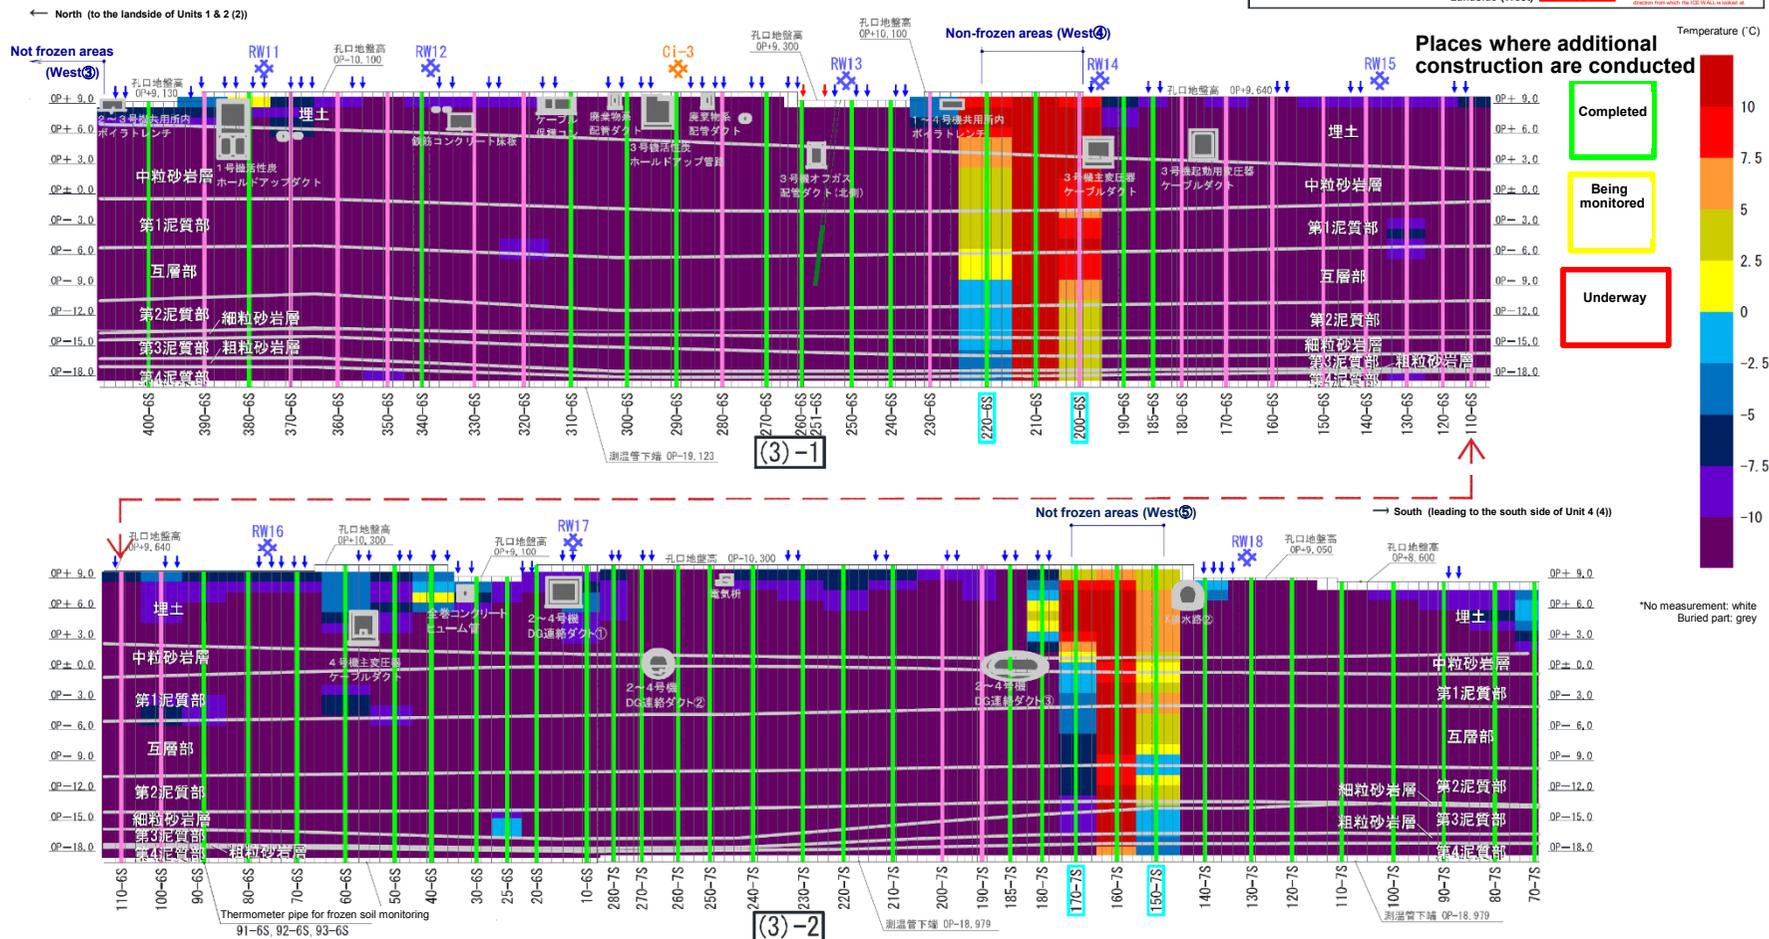
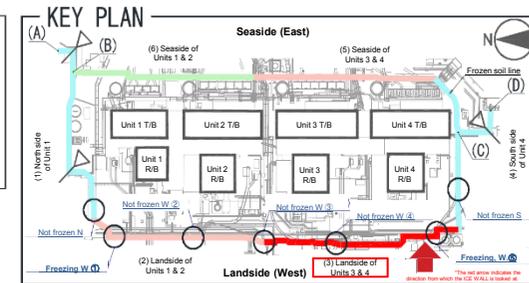
2-3 Distribution map of soil temperatures (west side of Units 3-4)

■ Distribution map of soil temperatures

(3) Landside of Units 3-4 (viewed from the west side)
 (Temperature data as of 7 a.m. on January 24)

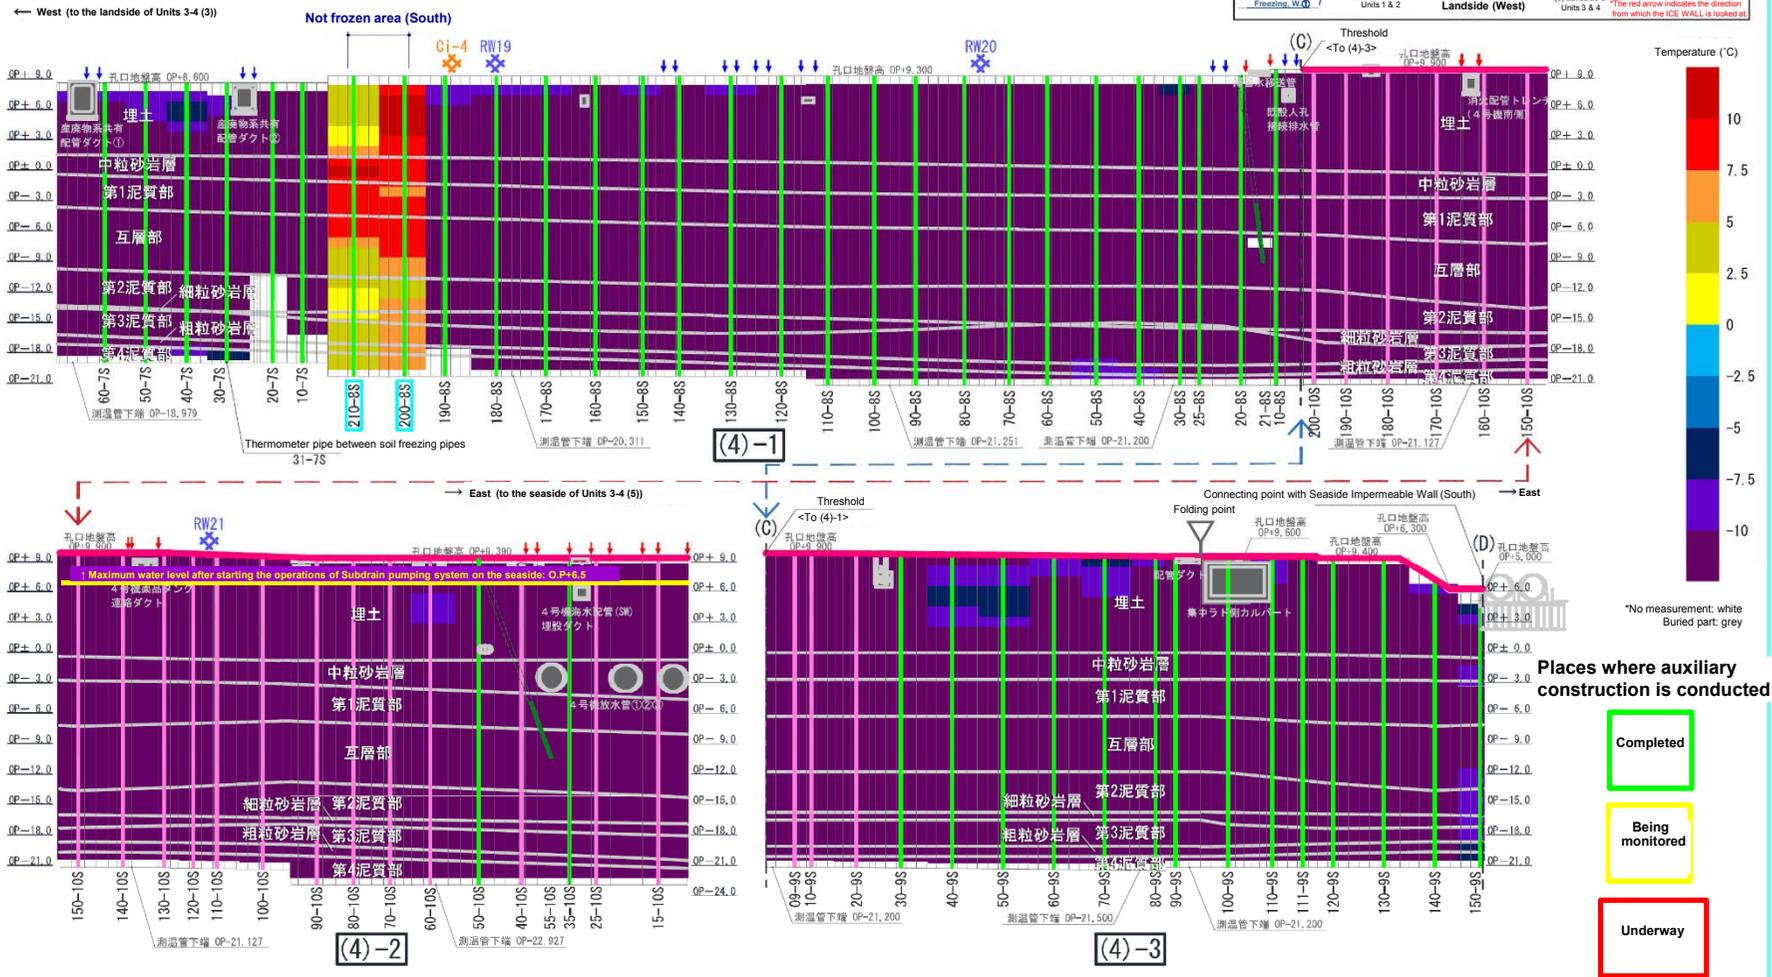
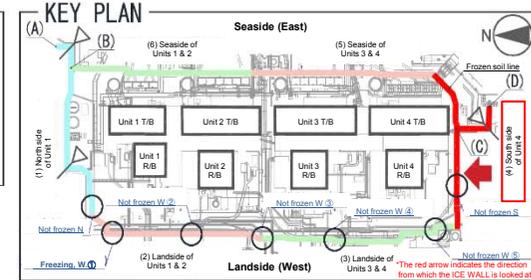
2-4 Distribution map of soil temperatures (south side of Unit 4)

Distribution map of soil temperatures

(4) South side of Unit 4 (a view from the south side)

(Temperature data as of 7 a.m. on January 24)

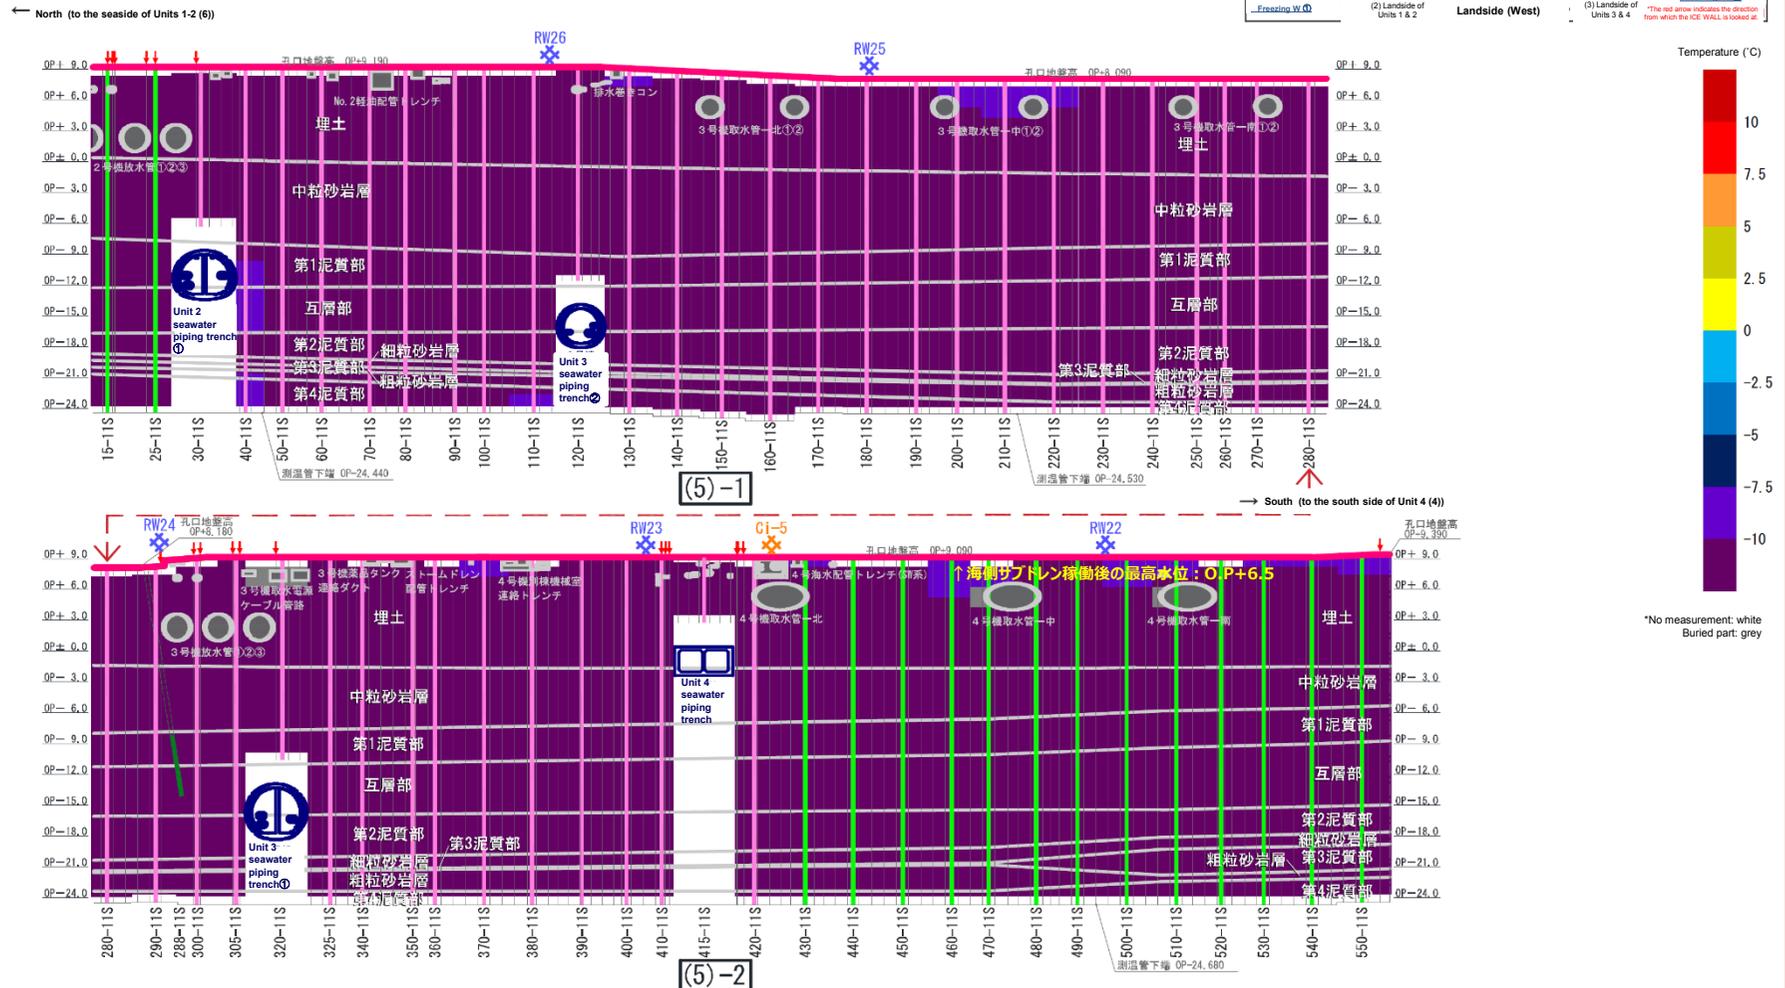
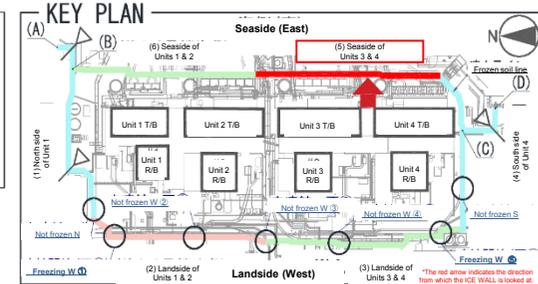
2-5 Distribution map of soil temperatures (east side of Units 3-4)

Distribution map of soil temperatures

Seaside of Units 3-4
(west side: a view from the inside of frozen soil)

(Temperature data as of 7 a.m. on January 24)

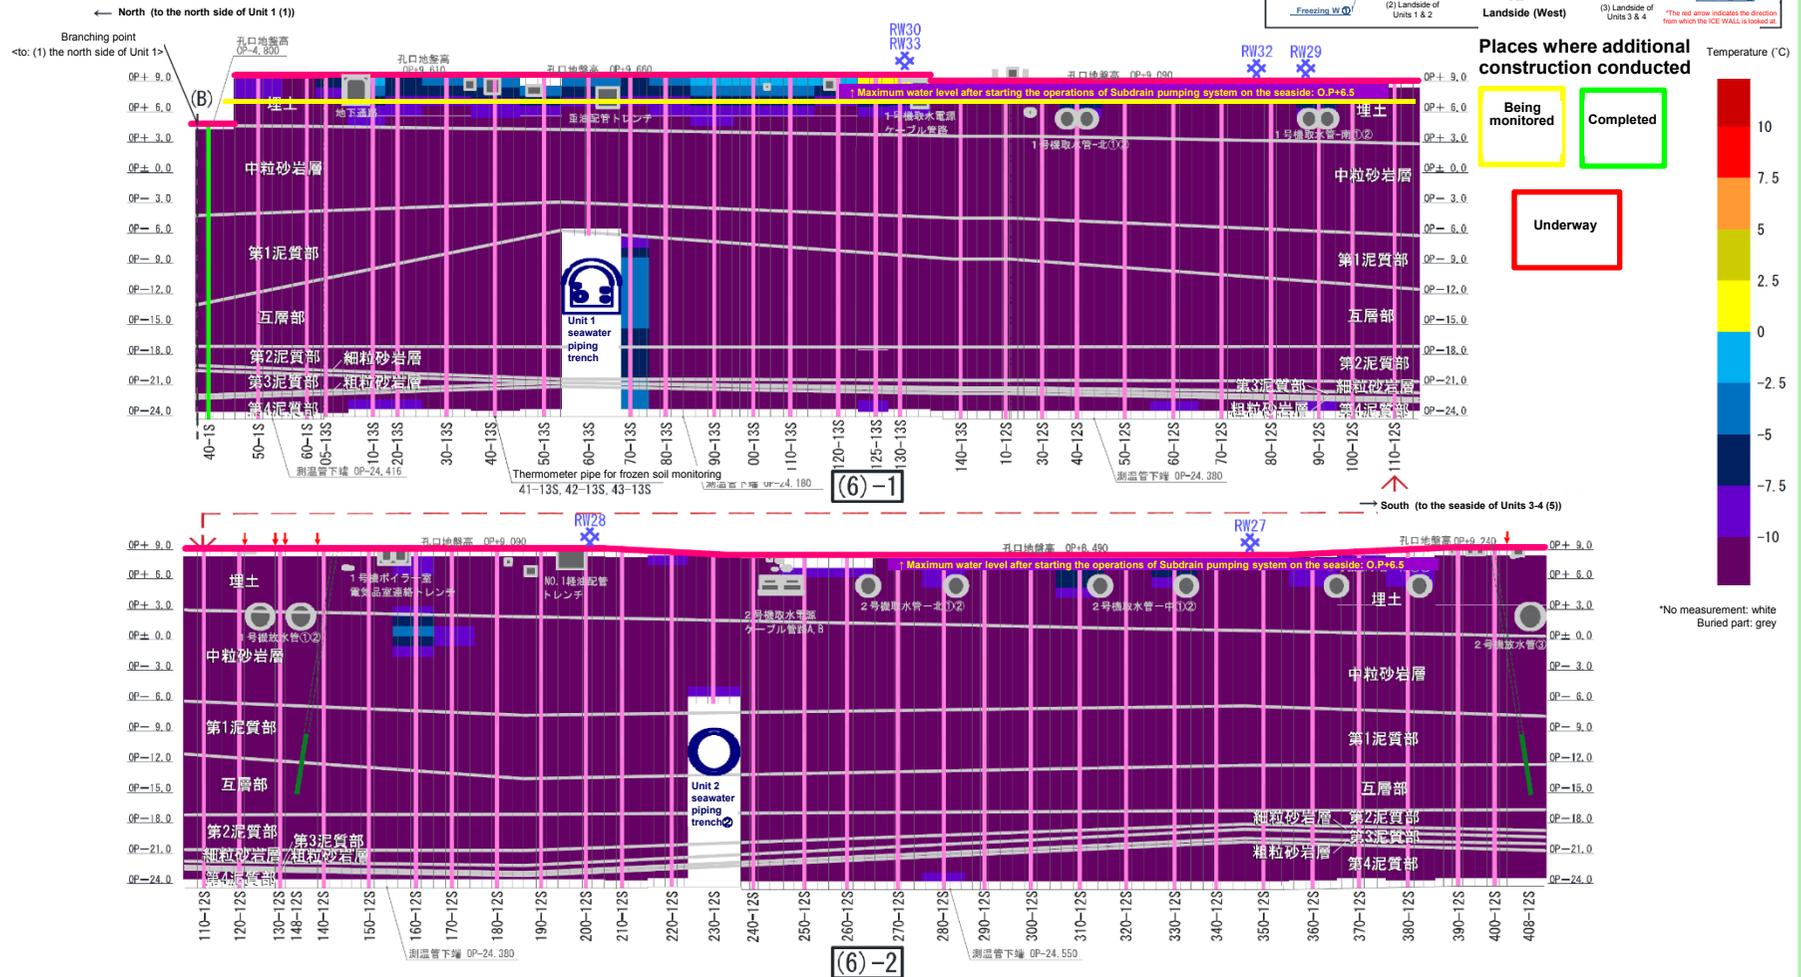
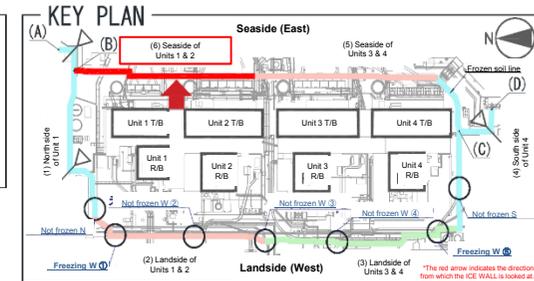
2-6 Distribution map of soil temperature (east side of Units 1-2)

Distribution map of soil temperatures

Seaside of Units 1-2
(west side: a view from the inside of frozen soil)

(Temperature data as of 7 a.m. on January 24)

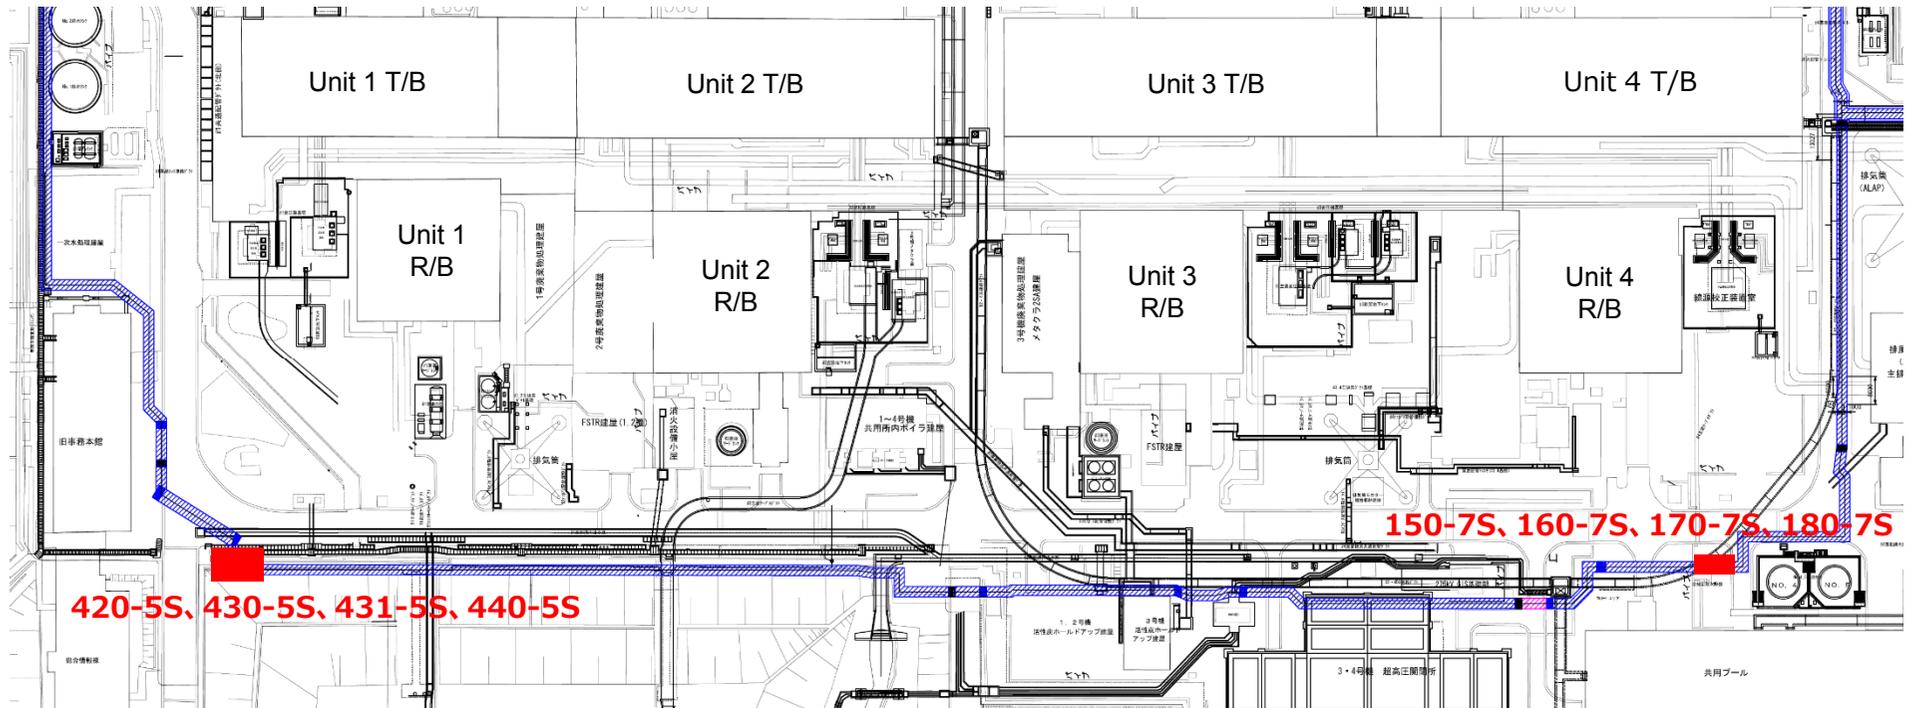
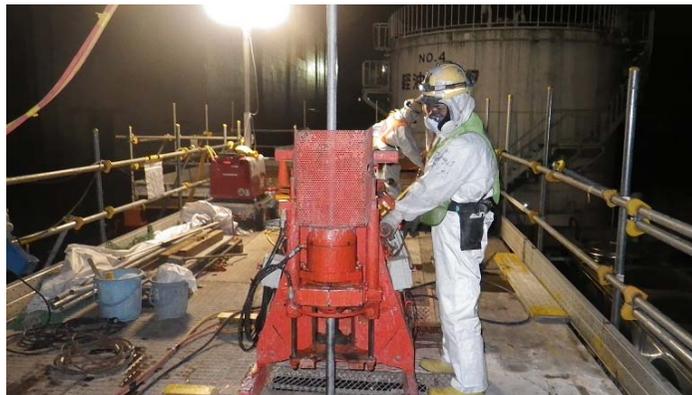
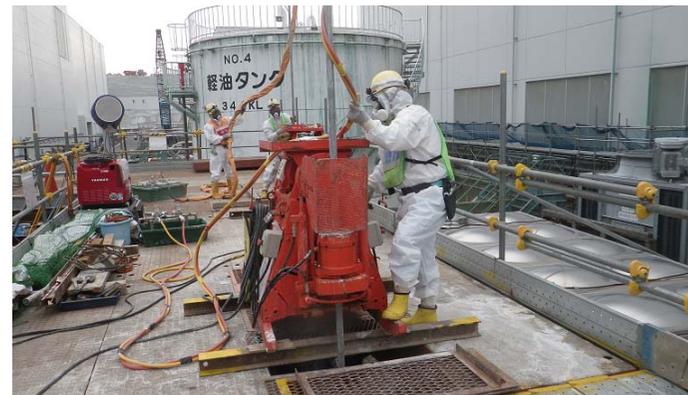
3-1 Additional construction to further freeze the areas where soil freezing began on December 3

To further freeze the areas where soil freezing began on Dec. 3, 2016, additional construction (chemical injection) will be applied to the points where soil temperatures are expected not to go below 0°C a month later.

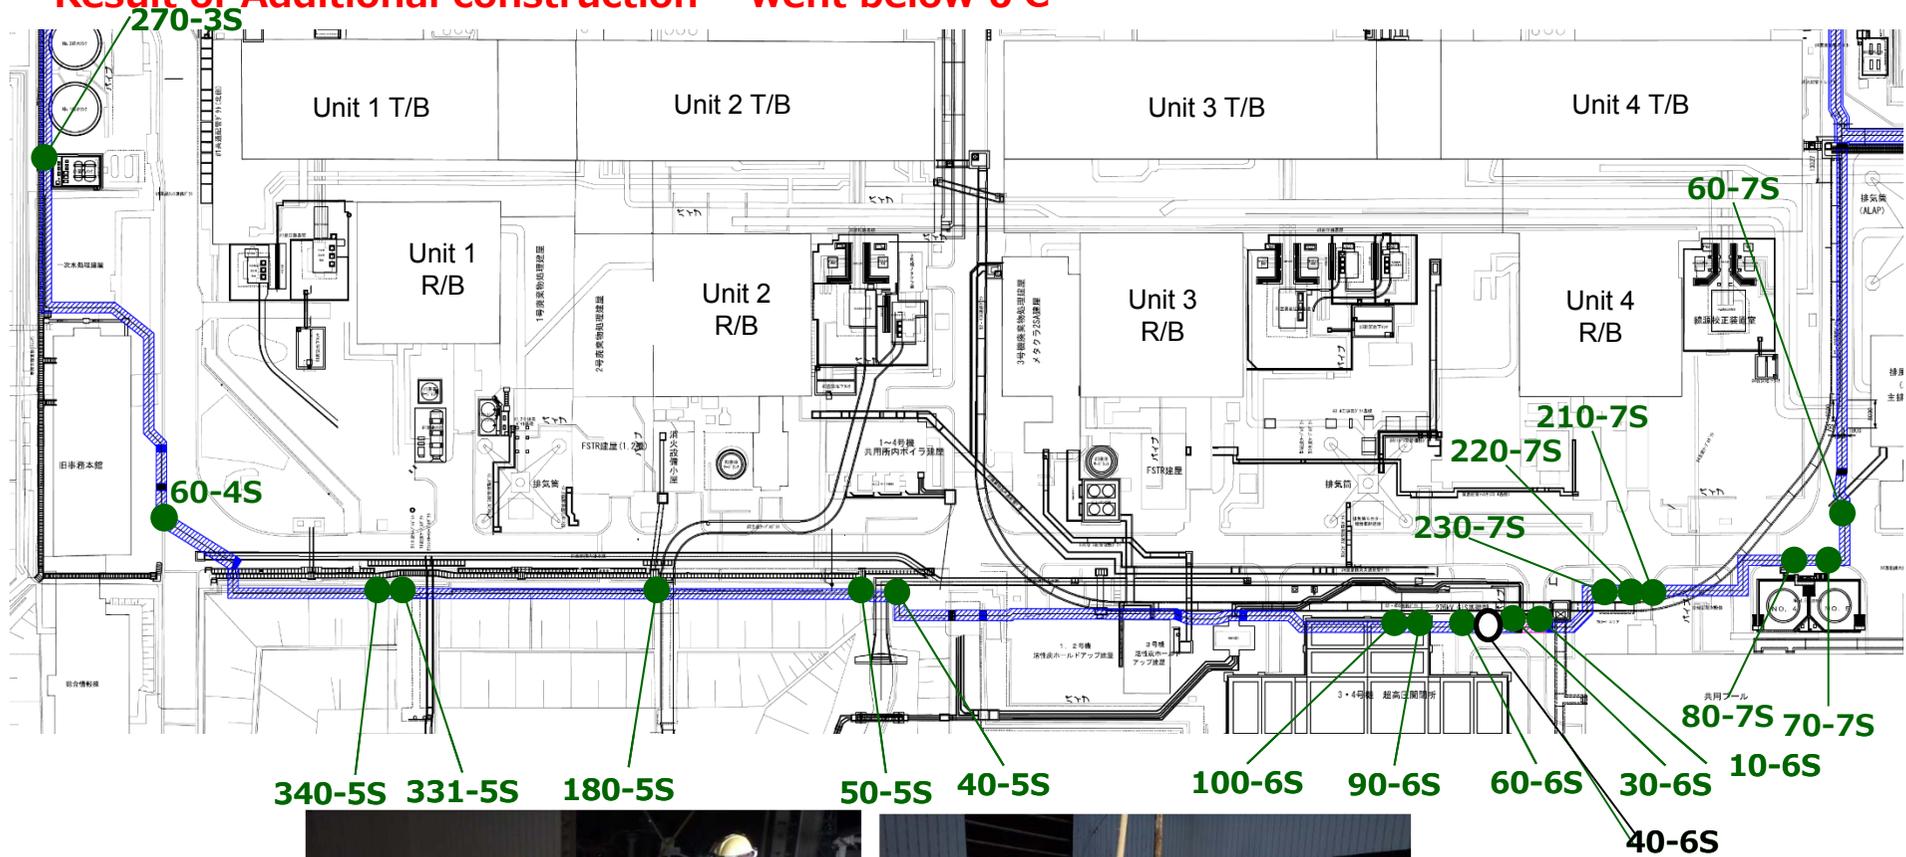
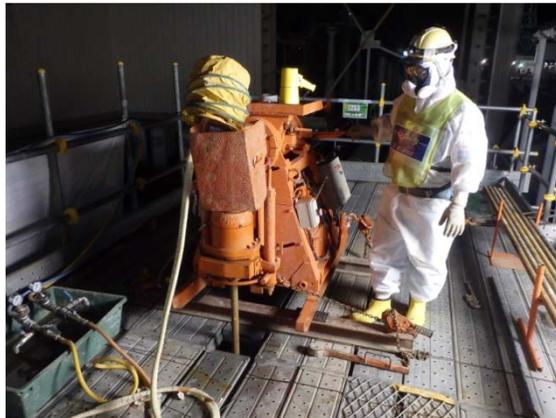
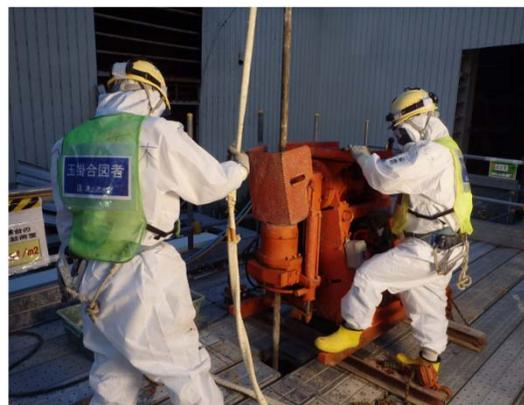
3-2 Additional construction on the landside except for the areas where soil freezing began on December 3 (as of Tuesday, January 24)

Result of Additional construction – went below 0°C

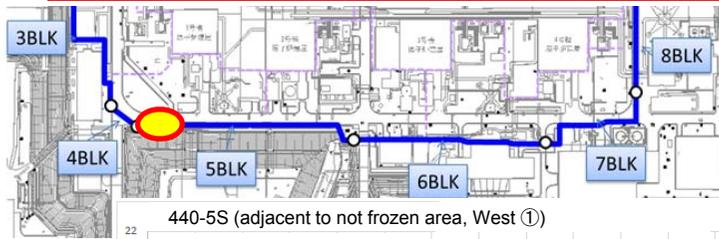
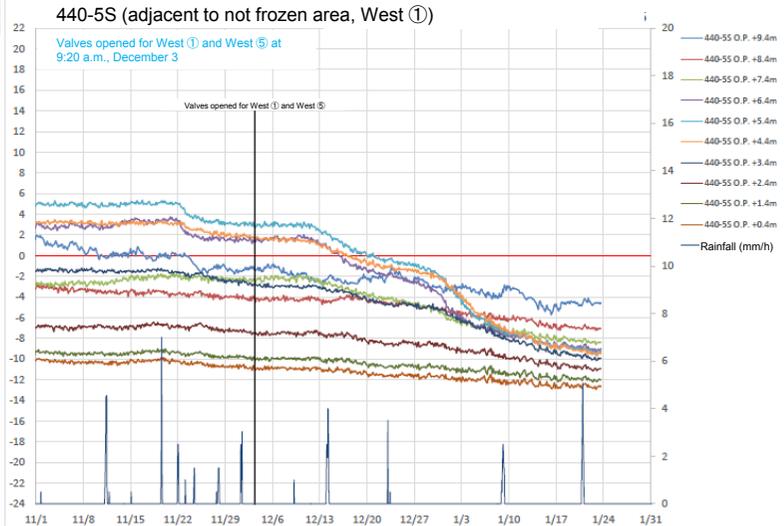
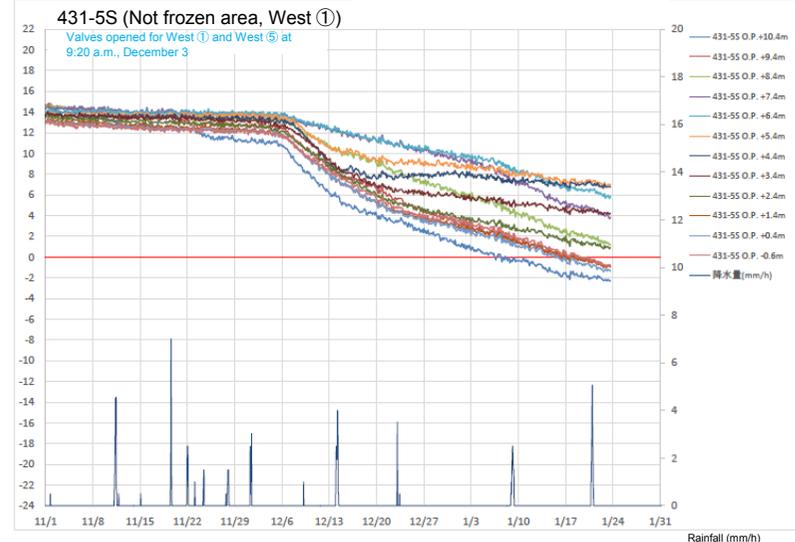
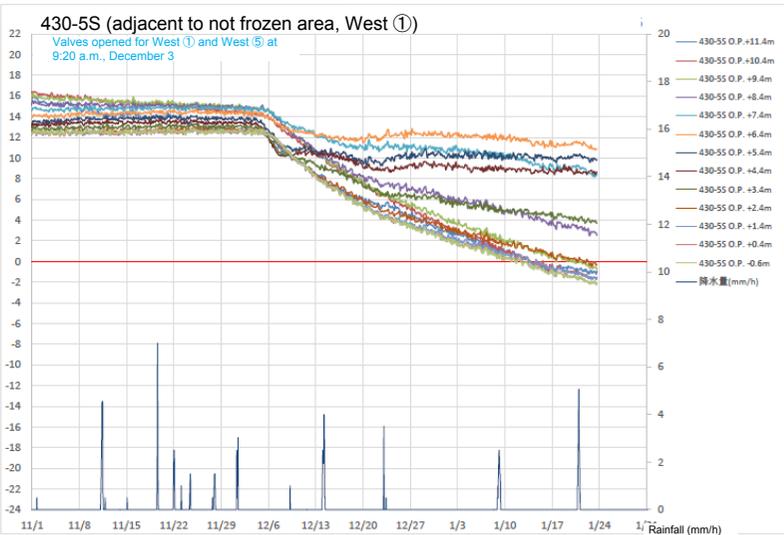
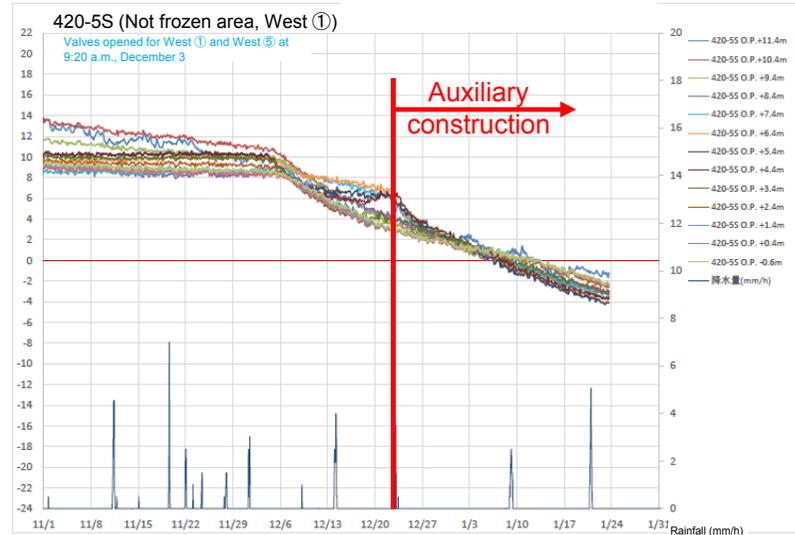
3-4 Auxiliary construction to further freezing the mountainside, soil temperature decrease

(Freezing began on December 3 West①)

- [440-5S] : Below 0°C
- [431-5S] : Auxiliary construction scheduled to be under way. Soil temperatures are decreasing relatively steadily.
- [430-5S] : Auxiliary construction scheduled to be under way.
- [420-5S] : Below 0°C

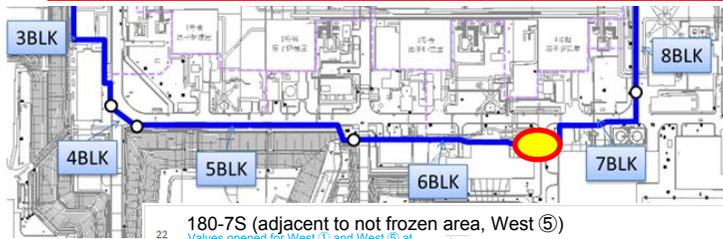
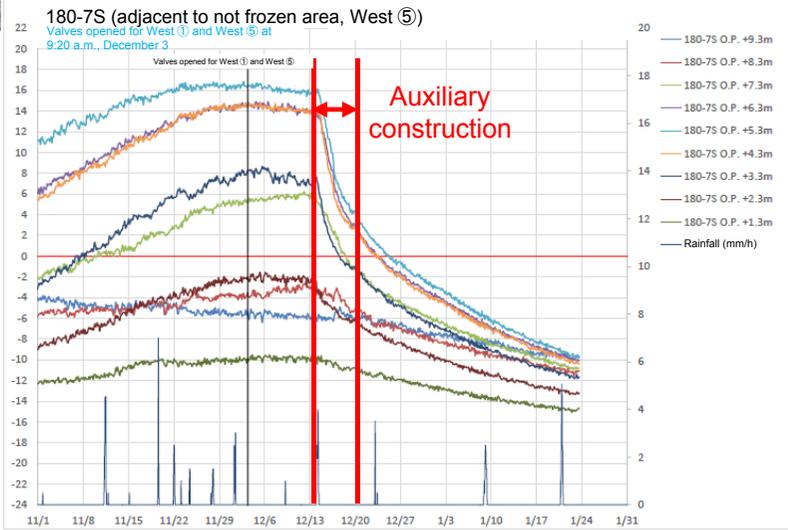
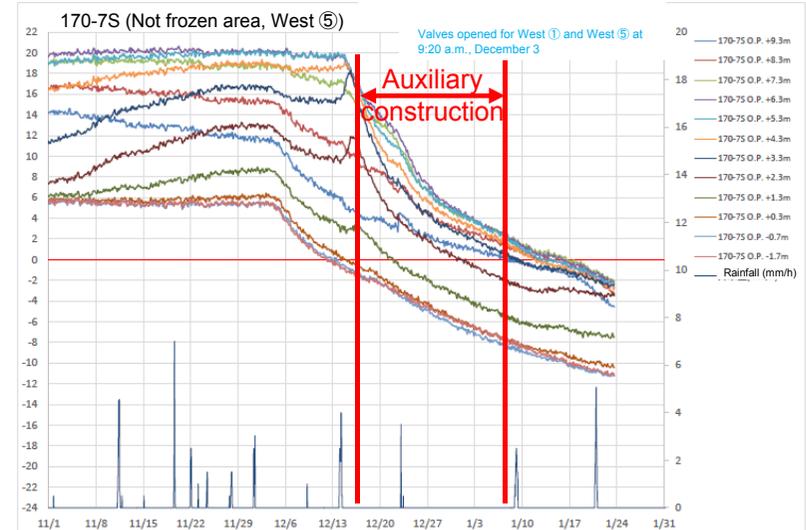
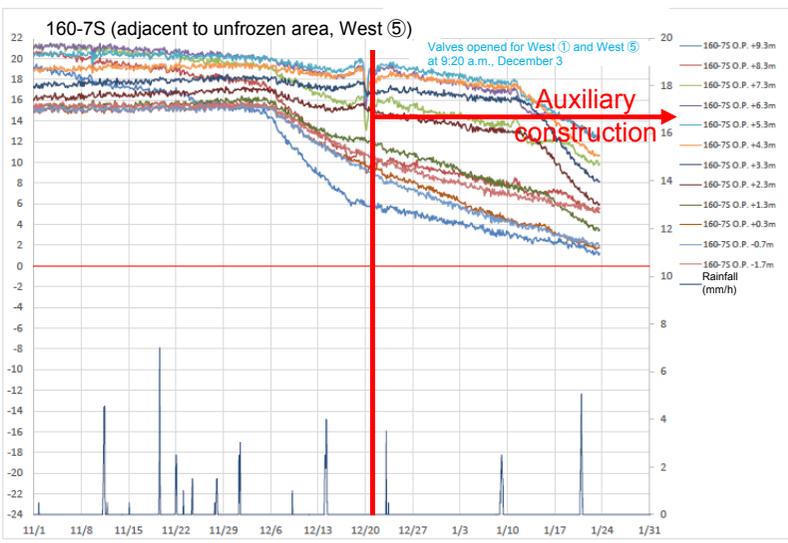
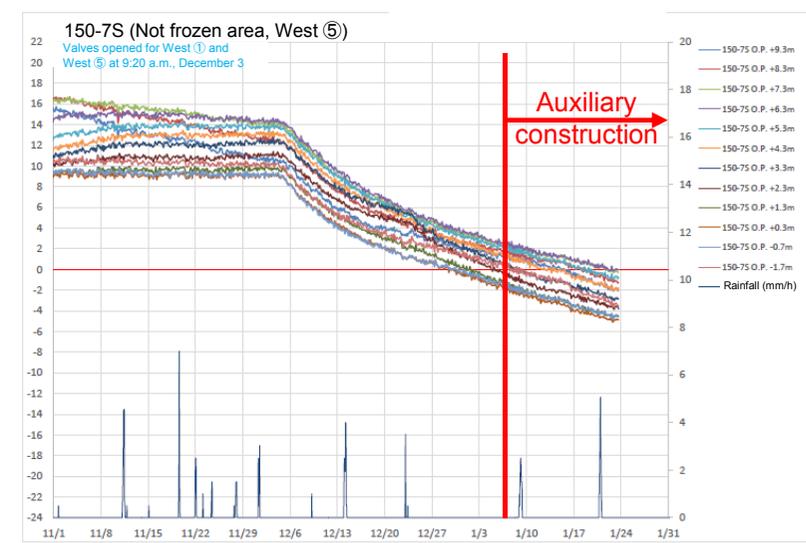
3-5 Auxiliary construction to further freezing the mountainside, soil temperature decrease

(Freezing began on December 3 West⑤)

- [180-7S] : Below 0°C
- [170-7S] : Below 0°C
- [160-7S] : Auxiliary construction is under way. Soil temperature tending to decrease.
- [150-7S] : Below 0°C

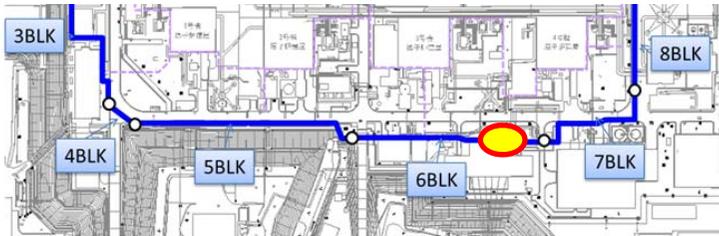
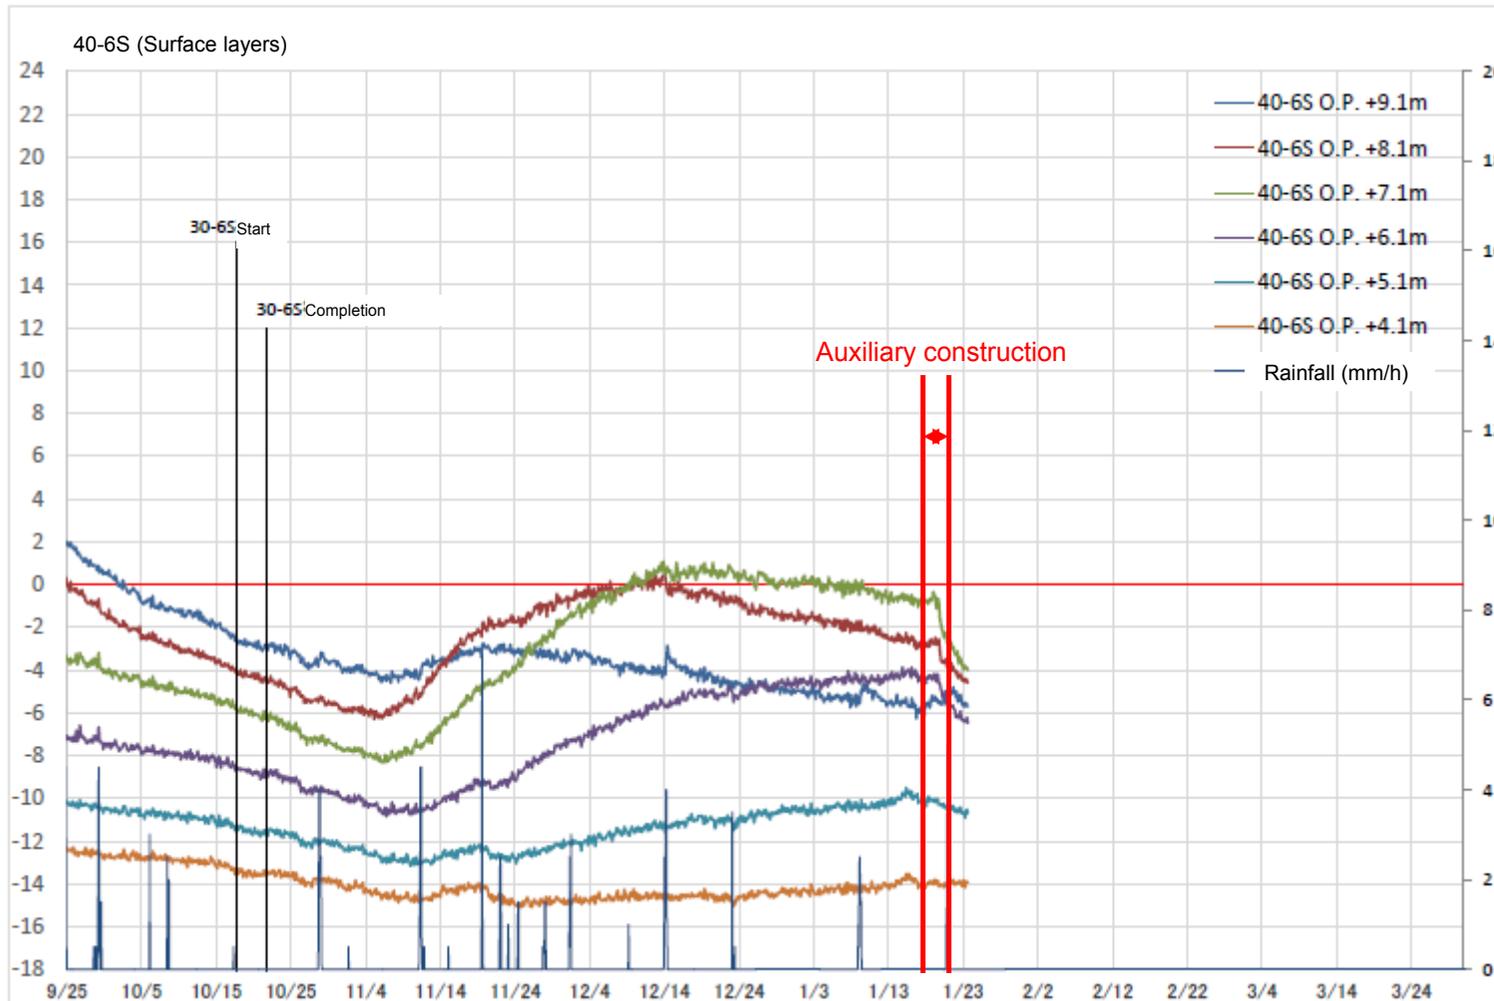
3-5 Auxiliary construction to further freezing the mountainside, soil temperature decrease (6BLK)

【40-6S】：Lower than around 0℃

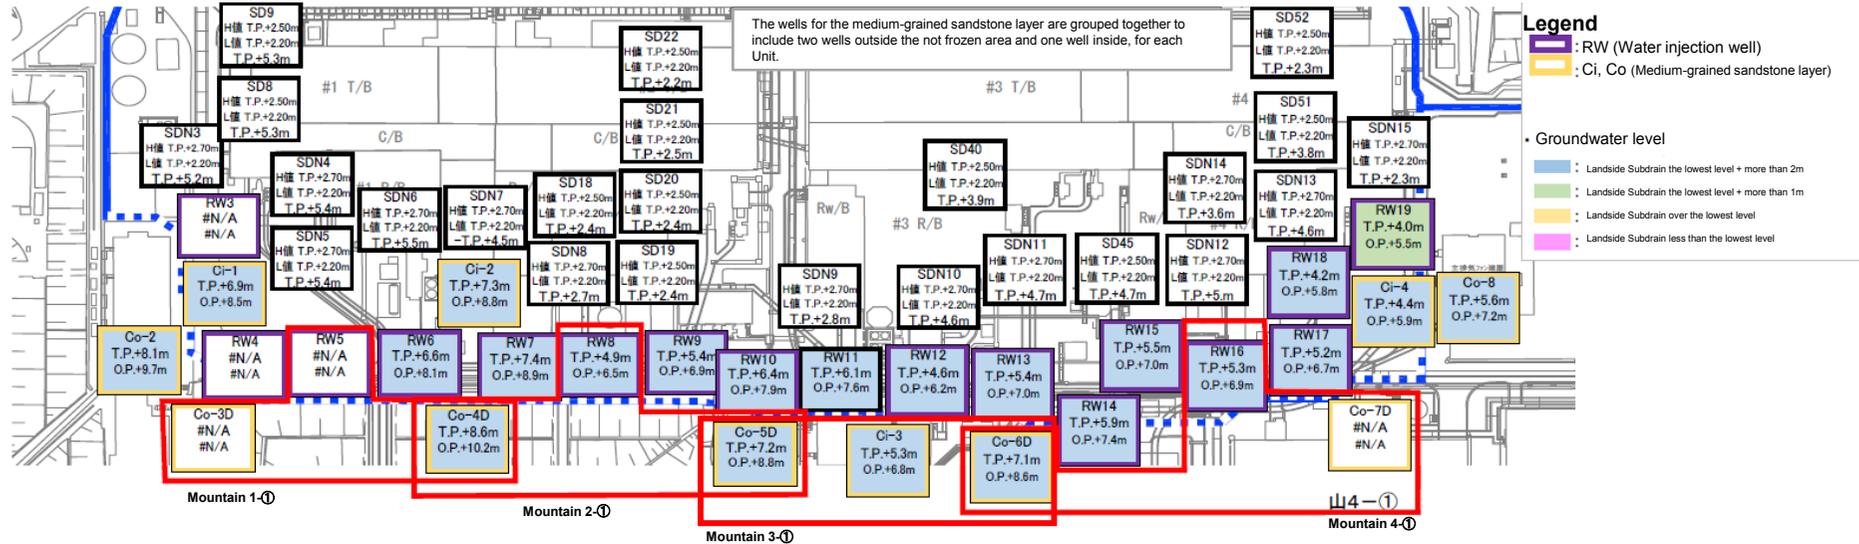
3. Landside Impermeable Wall (groundwater levels around the seaside and the operations of Subdrain pumping system)

Monitoring items in an early stage of the ice wall freezing (Second Stage, landside, water levels in the medium-grained sandstone layer)

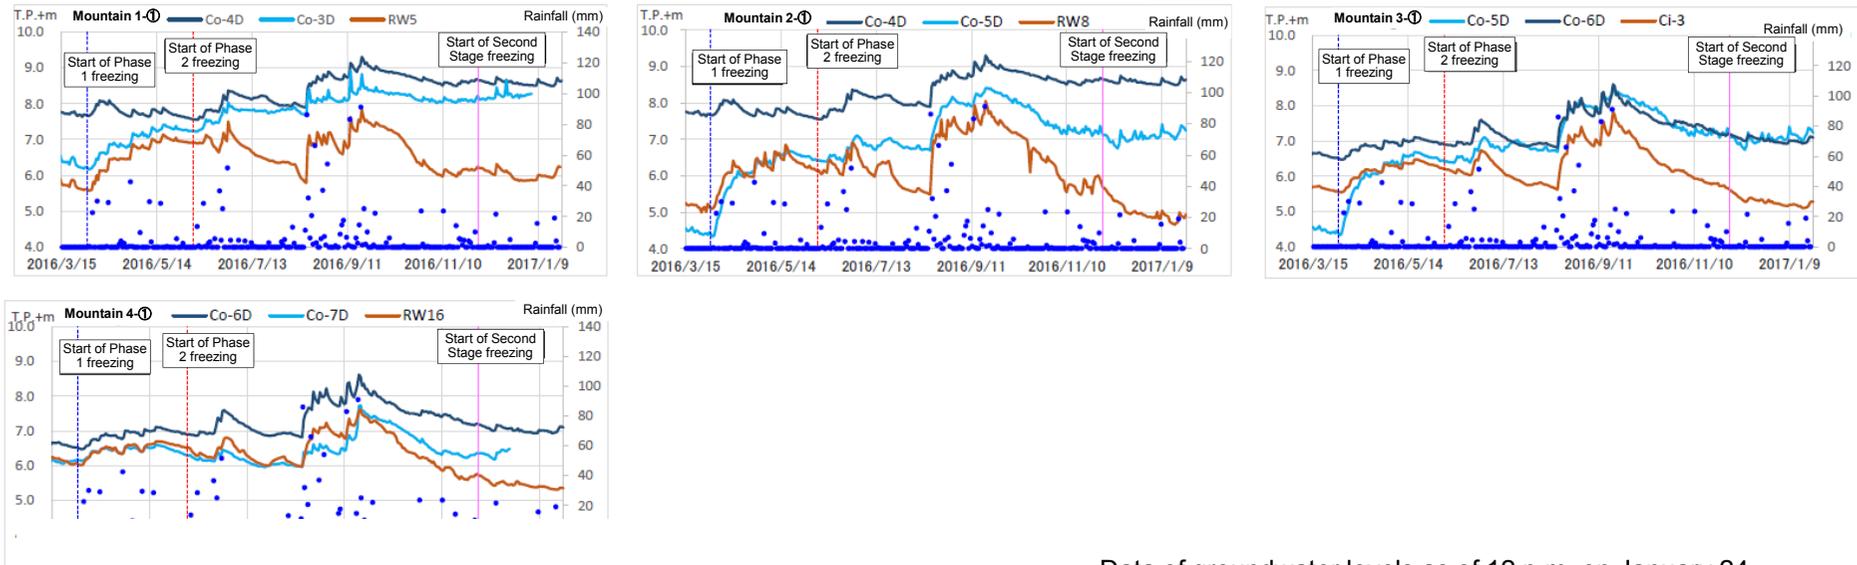
4. Groundwater levels inside and outside the Landside Impermeable Wall

Data of groundwater levels as of 12 p.m. on January 24

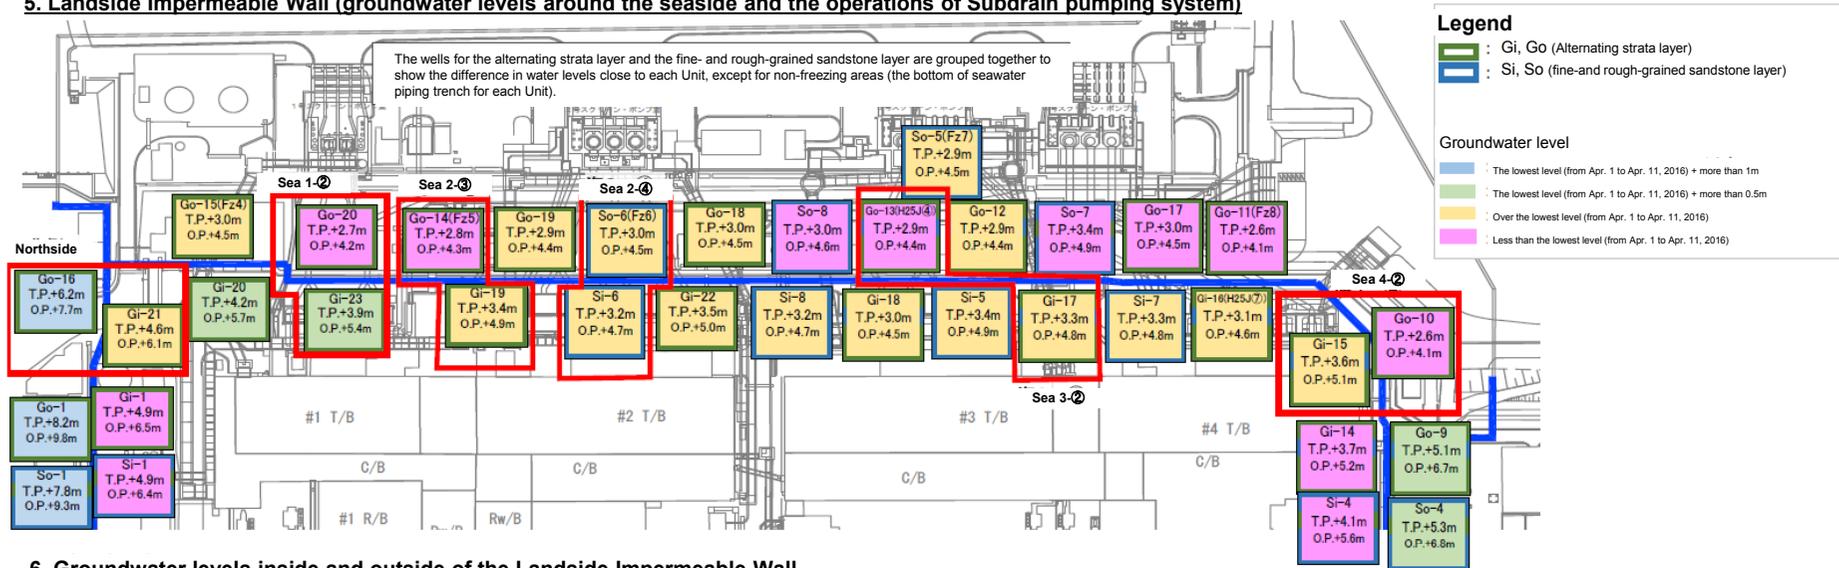
5. Landside Impermeable Wall (groundwater levels around the seaside and the operations of Subdrain pumping system)

Monitoring items in an early stage of the ice wall freezing (Phase 1 Stage 1, seaside, water levels in the middle-grained sandstone layer)
