Progress of Landside Impermeable Wall freezing: the Second Stage

January 26, 2016

TEPCO

- 1. About Landside Impermeable Wall 2
- 2. Soil temperatures 3-8
- 3. Auxiliary construction for further freezing the wall 9-13
- 4. Groundwater levels and hydraulic heads 14-17
- 5. Coolant leakage at 1BLK 18-22
- Reference 23-25

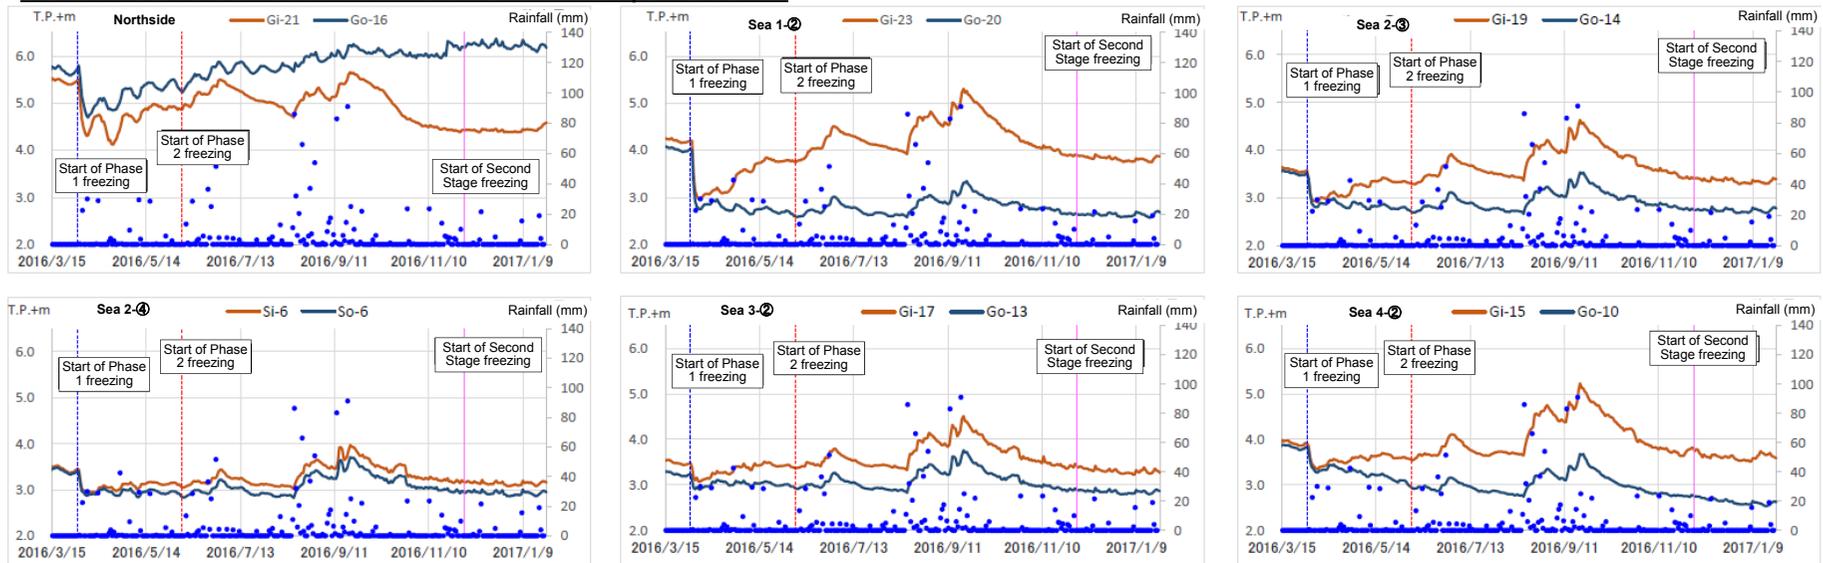
6. Groundwater levels inside and outside of the Landside Impermeable Wall

Data of groundwater levels as of 12 p.m. on January 24

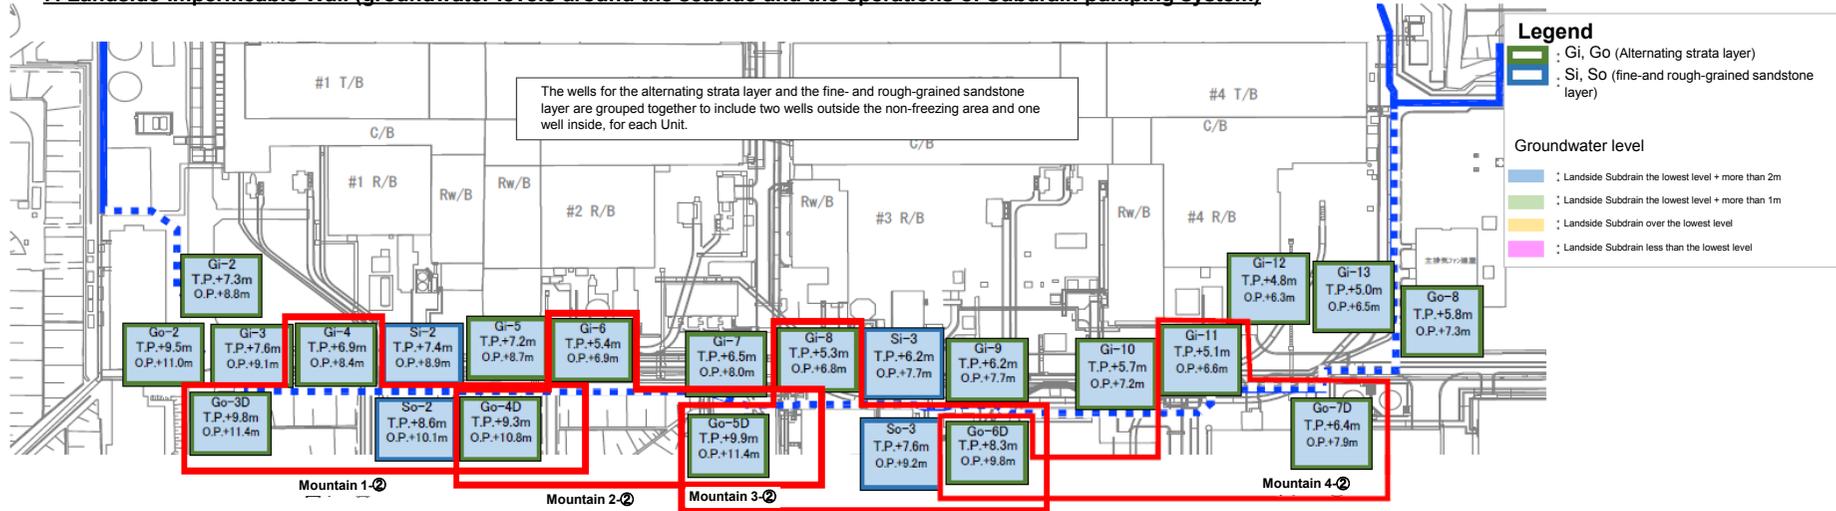
7. Landside Impermeable Wall (groundwater levels around the seaside and the operations of Subdrain pumping system)

Monitoring items in an early stage of the ice wall freezing (Phase 1 Stage 1, seaside, water levels in the middle-grained sandstone layer)

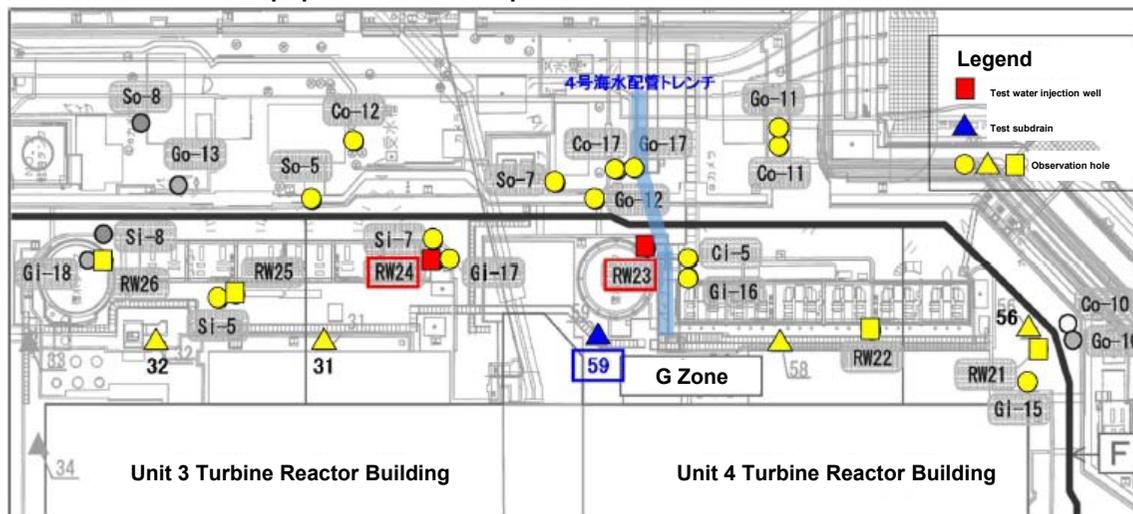
Relationship positions map

5-1 Water injection testing for RW23 and 24

- Test Time : approx. 38 hours
- injected water(total amount) : approx. 46m³ (cubic meters)
- effect of injected water : approx. 16cm (SD59)
- others : no abnormalities found for pumped-up and groundwater amounts entering the reactor buildings during the test period at 4m above sea level.
Also, no abnormal rise in temperatures found in temperature pipes.

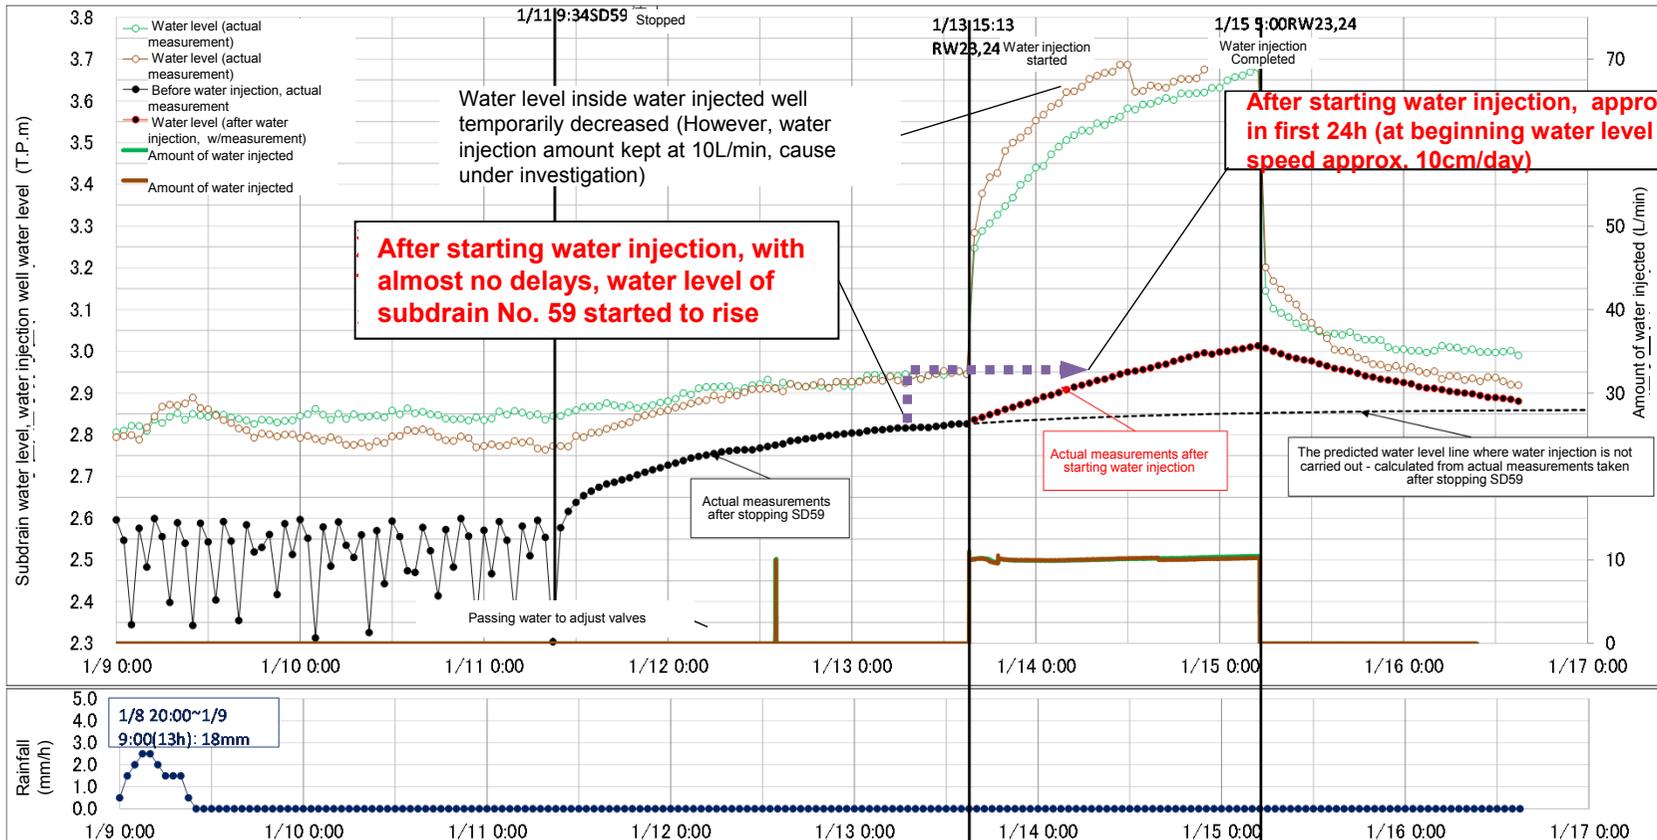
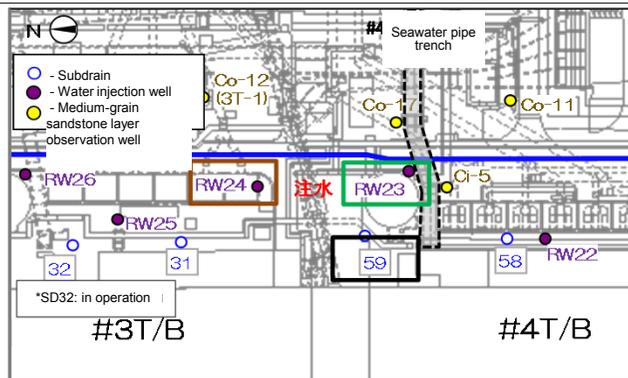
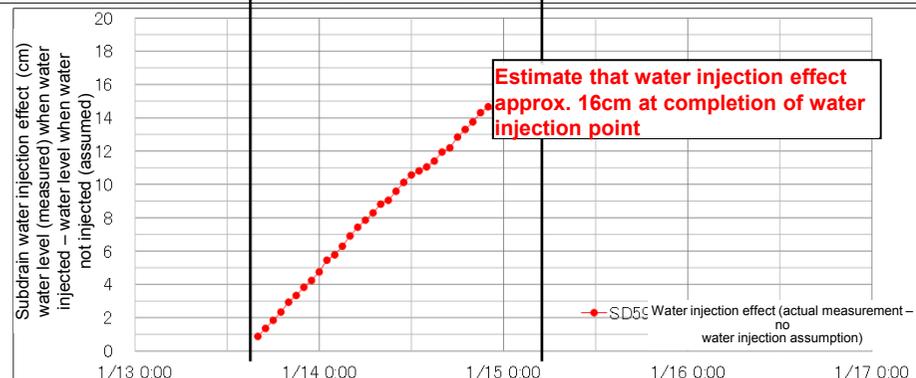
5-2 Water levels of related wells

- After water injection started, with no delay subdrain No. 59 water levels started to rise, approx. 10cm in the first 24 hours.
- When water injection completed, result was estimated to be approx. 16cm, taking into account actual amount of rising water level from prediction of subdrain No. 59
