Progress Status of “Drastic Countermeasures Preventing Groundwater Inflow into Reactor Buildings etc.”

① Progress Status of the Groundwater Bypass

② Progress Status of the Sub-drain Purification Test

Tokyo Electric Power Company

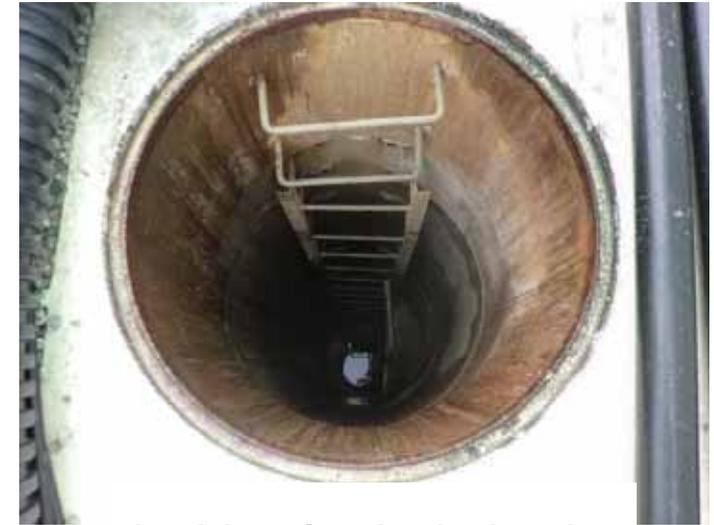
Inside of sub-drain pit

The purpose of sub-drain is to maintain the optimum groundwater level and prevent groundwater from flowing into the building by removing excess groundwater using the pump equipped in the sub-drain pit.
