I. Confirmation of Reactor Conditions

II. Progress Status by Field

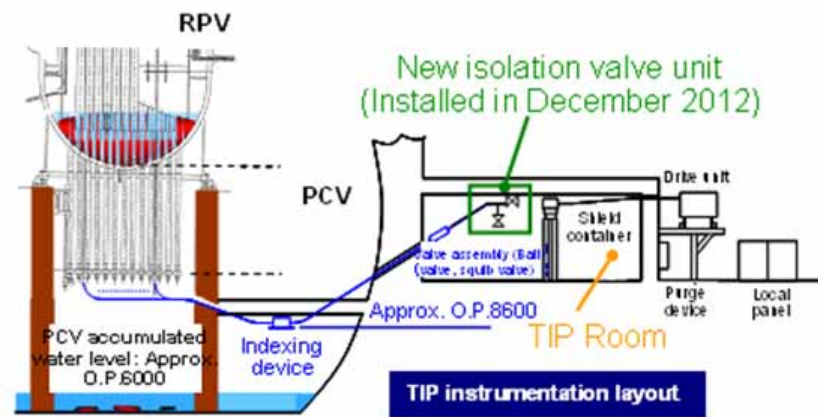
1. Inspection inside the TIP guide pipes

*Cable used for preliminary check before inserting the real TIP detector during construction.

The investigation of the inside of the reactor and permanent thermometer installation will be performed utilizing the TIP guide pipes. As a result of inspecting the inside of the TIP guide pipes (at 4 locations) by a fiberscope (February 25-28), it was confirmed that endoscope and thermocouple cannot be inserted into the guide pipes. Thus, work was terminated and countermeasures were considered. As a result, a method to push up the substances attached inside the guide pipes and obstacles (pushing up the roller with strong force utilizing a wire tip with a wedge attached) was selected. A validity test utilizing a mockup of the inner switch fixture is ongoing to examine the feasibility of the method (April 15-26) (See 1 below). Based on the test results, whether or not to proceed to the next process (manufacture of equipment, training, work at site, etc.) will be determined.

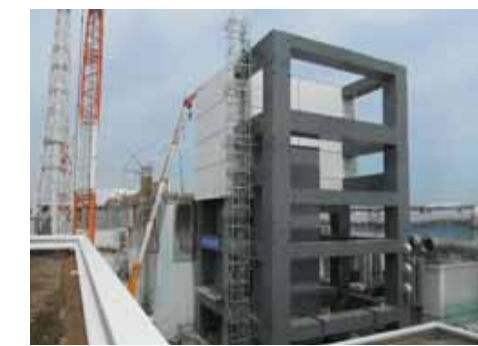
Progress of steel frame construction (Photo taken on April 23)

The cover installation for fuel removal is ongoing (to be completed around mid FY 2013). In addition to the foundation work, the steel frame construction was started on January 8. The steel frame except for the part which sticks out to the upper part of the fifth floor of the Reactor Building has been completed (April 10). The entire steel frame is planned to be completed around June 2013 (see Figure 4 below).

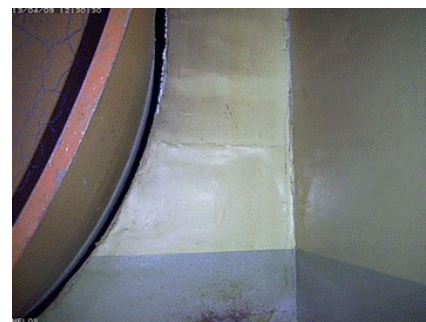
Investigation results ①

For the purpose of obtaining useful inputs for the investigation of the PCV and repair method, the access routes to the PCV are being investigated utilizing a robot. As for Unit 1, the personnel access lock (entrance to the PCV) on the first floor of the Reactor Building was investigated (April 9) (See 6 below). As for Unit 2, the MSIV Room (reactor main steam isolation valve room) in the Reactor Building was investigated (April 16).

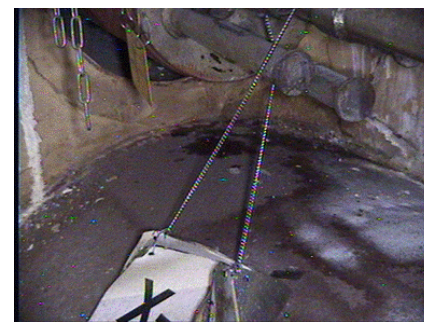
Investigation results ②
