Progress Status and Future Challenges of Mid-and-Long-Term Roadmap towards the Decommissioning of Units 1-4 of TEPCO's Fukushima Daiichi Nuclear Power Station (Outline)

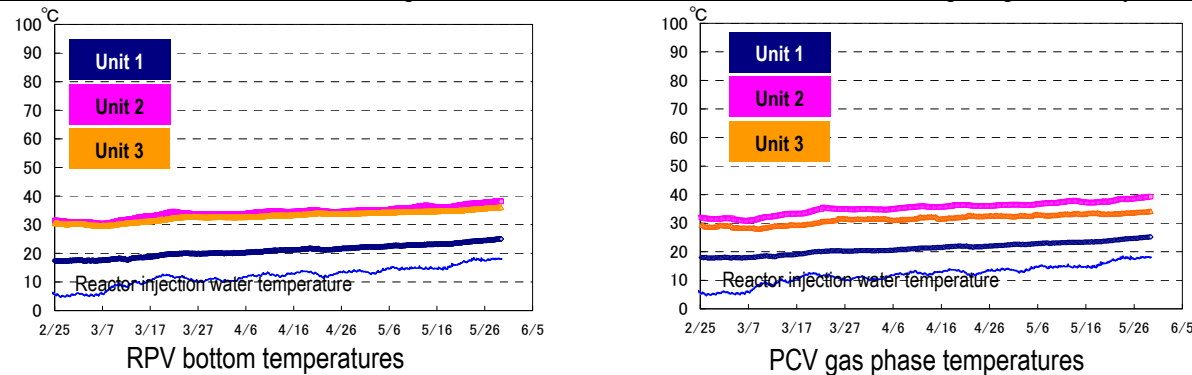
* The trend graphs show part of the temperature data measured at multiple points.

Through continuous reactor cooling by water injection, the temperatures of the RPV bottom and PCV gas phase have been maintained within the range of approx. 15 to 45°C for the past month, though they vary depending on the Unit and the thermometer location. The causes of temperature rise from the previous month include the rising temperature of injected water into the reactors due to rising air temperature. In addition, a temporary temperature rise of approximately 5 to 10°C was recorded by some thermometers inside the Unit 1 PCV. The causes of this temperature rise include nitrogen injection into the suppression chamber, which may change the gas flow inside the PCV and affect the instrument reading of the thermometers. We will continue investigating to identify the cause.

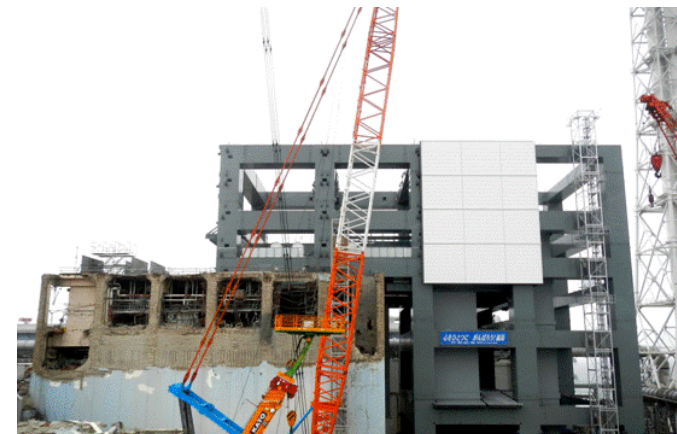
Figure 4: Installation of cover for Unit 4 spent fuel removal

Image of the completed steel frame

The steel frame was completed (Photo taken on May 29)

- Work towards removing spent fuel at Unit 4
 - The cover installation for fuel removal is ongoing (to be completed around mid-FY 2013). The steel frame construction was completed (May 29) (see Figure 4) and work on installing the ceiling crane is currently ongoing (from early June, to be completed in October).
