Main works and steps for the decommissioning

Fuel removal from Unit 4 SFP is underway. Preparatory works for fuel removal from Unit 1-3 SFP and fuel debris (Note 1) removal are ongoing.

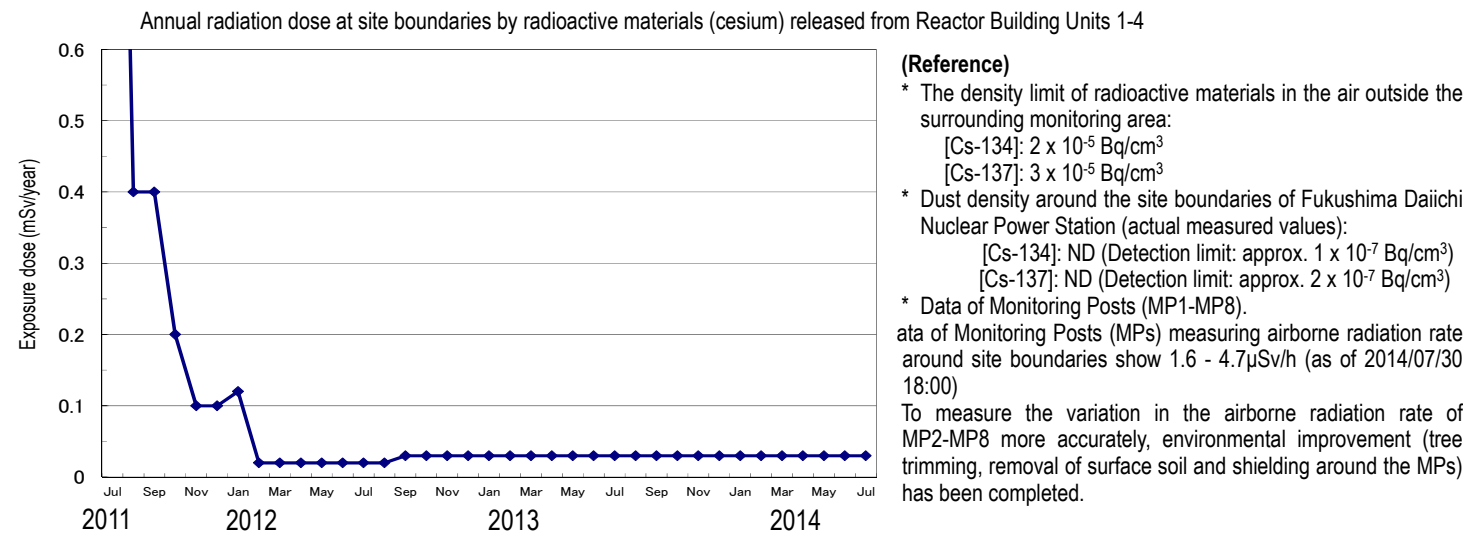
The density of radioactive materials newly released from Reactor Building Units 1-4 in the air measured at site boundaries was evaluated at approx. 1.3×10^{-9} Bq/cm³ for both Cs-134 and -137. The radiation exposure dose due to the release of radioactive materials was 0.03 mSv/year (equivalent to approx. 1/70 of the annual radiation dose by natural radiation (annual average in Japan: approx. 2.1 mSv/year)) at the site boundaries.

Note: Different formulas and coefficients were used to evaluate the radiation dose in the facility operation plan and monthly report. The evaluation methods were integrated in September 2012. As the fuel removal from the spent fuel pool (SFP) commenced for Unit 4, the radiation exposure dose from Unit 4 was added to the items subject to evaluation since November 2013.

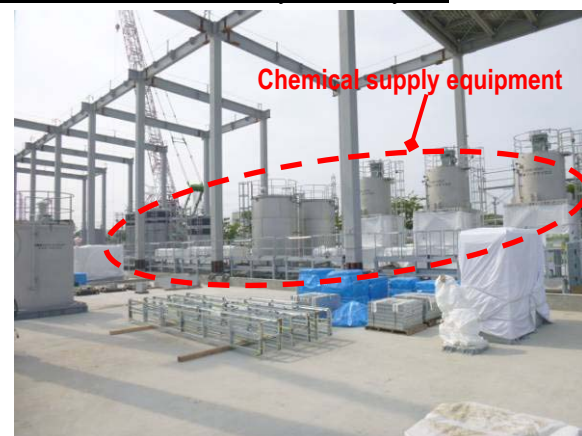
Figure 3: Installation status of additional multi-nuclide removal equipment

- Regarding the additional multi-nuclide removal equipment, foundation steel frame building (from June 12) and equipment installation (from June 21) are underway (see Figure 3). The foundation construction was completed on July 8.

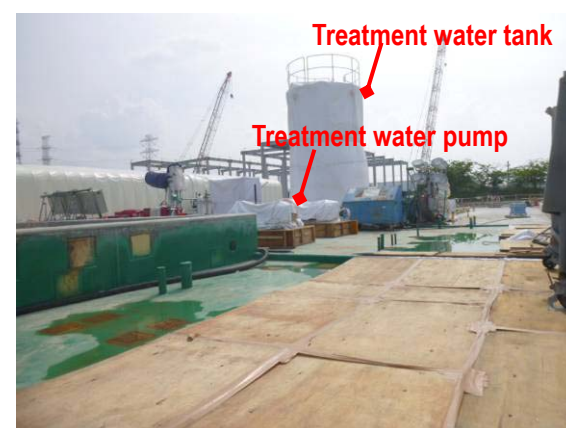
Figure 4: Installation status of high-performance multi-nuclide removal equipment

- To facilitate the installation of high-performance multi-nuclide removal equipment, a subsidy project of the Ministry of Economy, Trade and Industry, foundation construction is underway from May 10. In parallel, installation of equipment commenced from July 14 (see Figure 4).

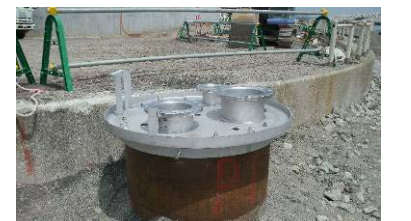
Installation status of groundwater drain pumping well (in front of Unit 1 intake)

- The water pumped from the groundwater drain, which is pumping groundwater inside the seaside impermeable walls, was analyzed. The result showed that it was at a level equivalent to the seawater density before the landfill.

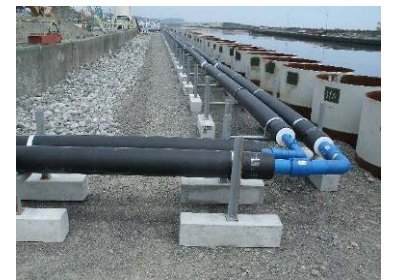
Installation status of groundwater drain pipes

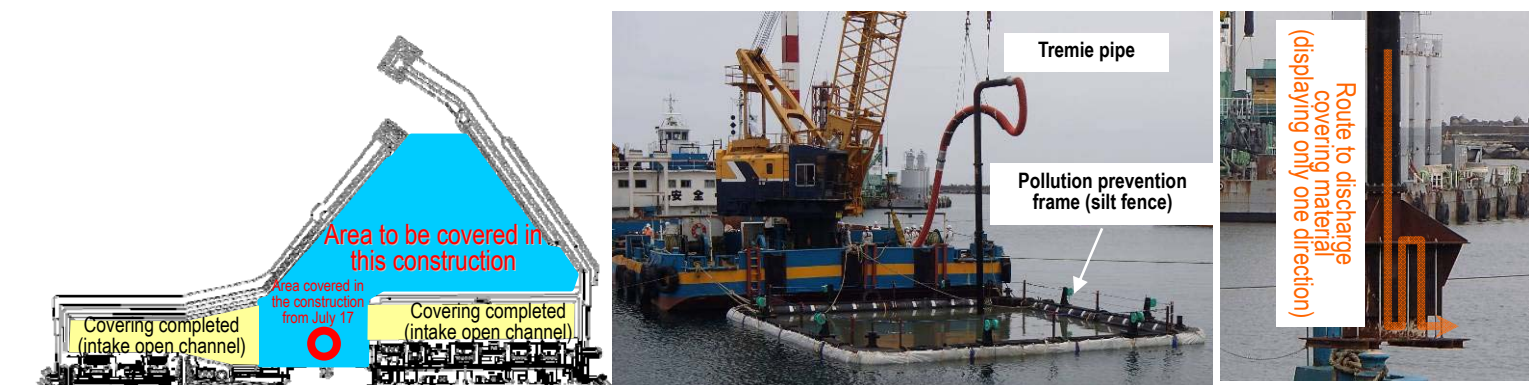
Figure 9: Status of covering over the sea bottom soil inside the port

To prevent contaminated soil from being stirred up, covering over the sea bottom soil inside the port commenced from July 17, with completion scheduled within this fiscal year.

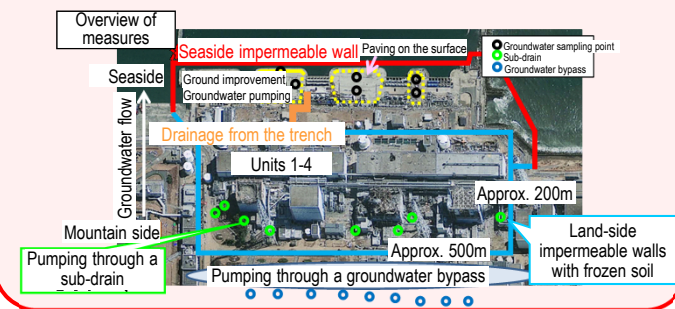
- Removing contaminated water in branch trenches and closing them (completed on September 19, 2013)
 - Treatment and removal of contaminated water in the main trench

- Unit 2: Treatment commenced on November 14, 2013, freezing toward water stoppage commenced on April 2
 - Unit 3: Treatment commenced on November 15, 2013
