## Main works and steps for decommissioning

Fuel removal from Unit 4 SFP is underway. Preparatory works to remove fuel from Unit 1-3 SFP and fuel debris (Note 1) removal are ongoing.

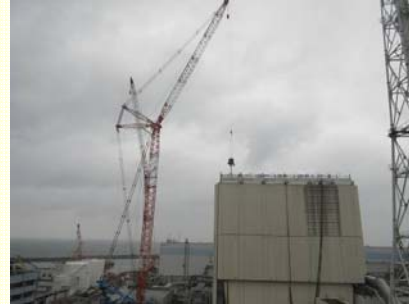
<Opening of roof panel holes and spraying of anti-scattering agents>

On October 28, though the nozzle tip used to spray anti-scattering agents moved due to the wind and expanded the hole of the roof panel, from which the nozzle is inserted to spray anti-scattering agents, no significant variation in monitoring posts and dust monitors was detected.

- On October 22, spraying of anti-scattering agents began from holes opened in the roof panels of the building cover.
- On October 28, while the anti-scattering agents were being sprayed, since the nozzle tip moved due to the wind, the opening of the hole expanded by approx. 1m x 2m into a triangular shape, whereupon spraying was suspended. No significant variation in the indicated values of dust monitors and monitoring posts was detected. The estimated cause of the nozzle-tip movement was a blast since the wind speed at the time was approx. 2m/s.

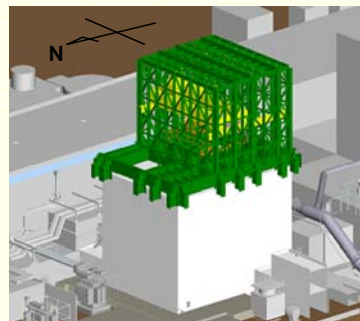
<Image of the Unit 1 fuel-removal facility>

Regarding Unit 1 where early fuel removal from the pool may reduce risks, facilities dedicated to fuel removal from the pool will be installed.

- Regarding Unit 1, there is a risk of rubble falling in the pool and influence the fuel. From the perspective of reducing risks throughout the power station by removing fuel early, a plan to build a structure dedicated to fuel removal inside the spent-fuel pool was selected (see Figure 12).

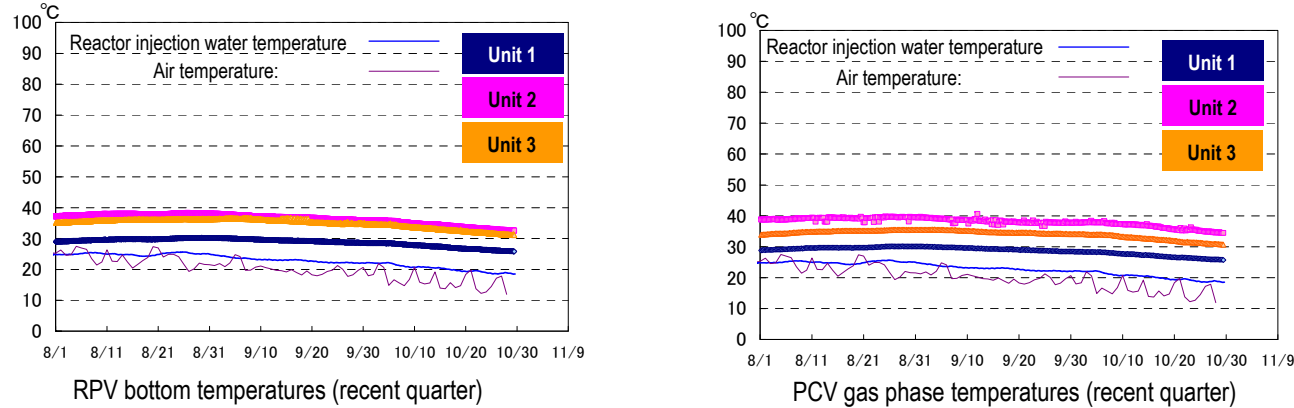
Through continuous reactor cooling by water injection, the temperatures of the Reactor Pressure Vessel (RPV) bottom and the Primary Containment Vessel (PCV) gas phase have been maintained within the range of approx. 25 to 45°C for the past month, though they vary depending on the unit and location of the thermometer.

\* The trend graphs show part of the temperature data measured at multiple points.

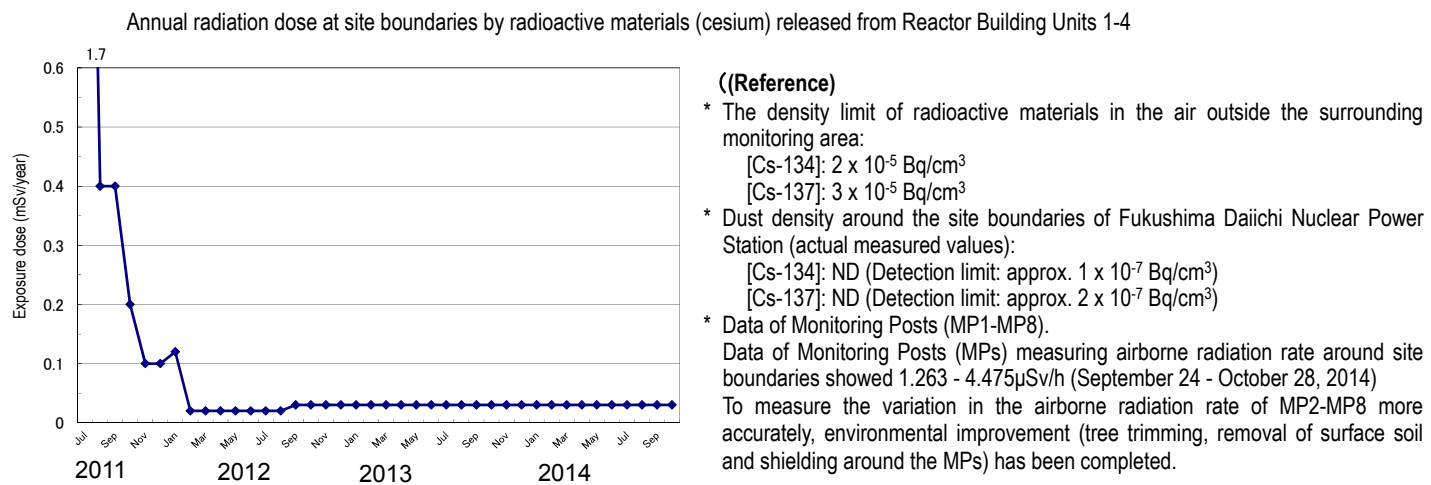
The density of radioactive materials newly released from Reactor Building Units 1-4 in the air measured at site boundaries was evaluated at approx.  $1.3 \times 10^{-9}$  Bq/cm<sup>3</sup> for both Cs-134 and -137. The radiation exposure dose due to the release of radioactive materials was 0.03 mSv/year (equivalent to approx. 1/70 of the annual radiation dose by natural radiation (annual average in Japan: approx. 2.1 mSv/year)) at the site boundaries.

Note: Different formulas and coefficients were used to evaluate the radiation dose in the facility operation plan and monthly report. The evaluation methods were integrated in September 2012. As the fuel removal from the spent fuel pool (SFP) commenced for Unit 4, the radiation exposure dose from Unit 4 was added to the items subject to evaluation since November 2013.

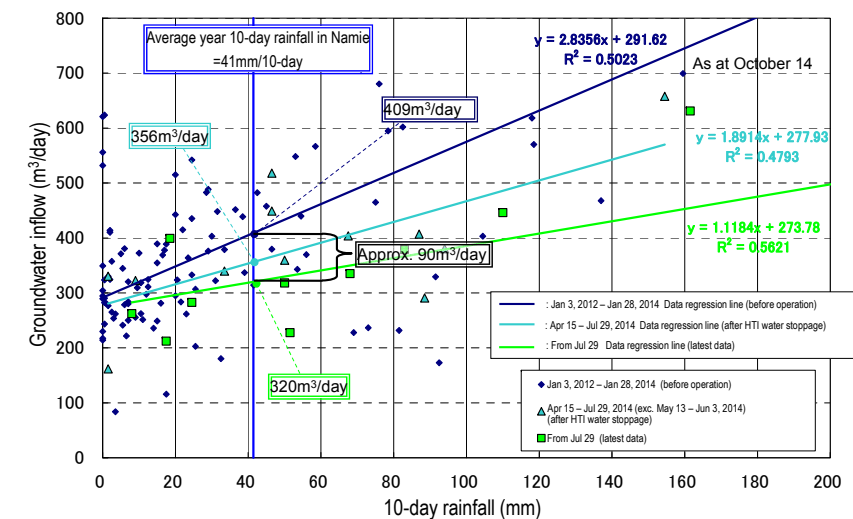
Figure 1: Analytical results of inflow into buildings

- It was confirmed that the groundwater inflow into the buildings had decreased by 90m<sup>3</sup>/day based on the evaluation data by now through measures such as the groundwater bypass and water stoppage of the High Temperature Incinerator Building (HTI) (see Figure 1).

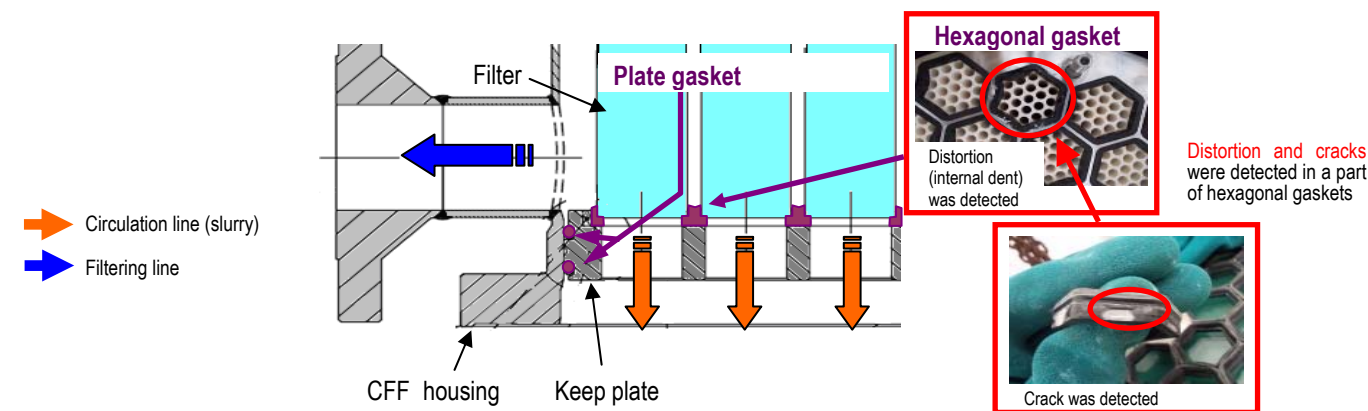
Figure 4: Filter damage to multi-nuclide removal equipment System B

- Regarding the existing System B, as the calcium density at the inlet of absorption vessels increased and carbonate outflow from a filter to downstream was detected, treatment was suspended on September 26. Distortion and cracks were also detected in part of the hexagonal gaskets of the filter (see Figure 4). The estimated cause of the distortion was pressure pulsation during operation of the equipment to resolve the filter clogging (back-pulse pot.) The filter causing the incident was replaced and treatment resumed on October. Regarding measures to reduce the operational pressure of the back-pulse pot, within a range not influencing operation, horizontal deployment to other systems and additional multi-nuclide removal equipment is underway.

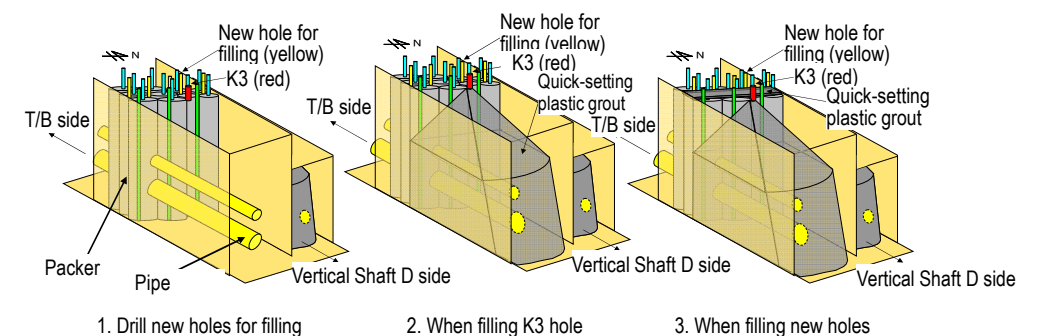
**Installation procedure**

- Drill new holes for filling on the top of the packer (to make holes for filling on the top)
- Using the packer as a side frame, install quick-setting plastic grout from K1 and K3 holes to fill around the pipes.
- Install quick-setting plastic grout from new holes to fill on the top of the packer.

Figure 6: Image of Unit 2 open-cut duct and space filling

- At the seawater-pipe trench Unit 2 open-cut duct, freezing started on June 13 and space filling has been conducted since October 16. As of October 29, filling on the Vertical Shaft D side was completed and preparation for filling the top of the packer is underway (see Figure 6).

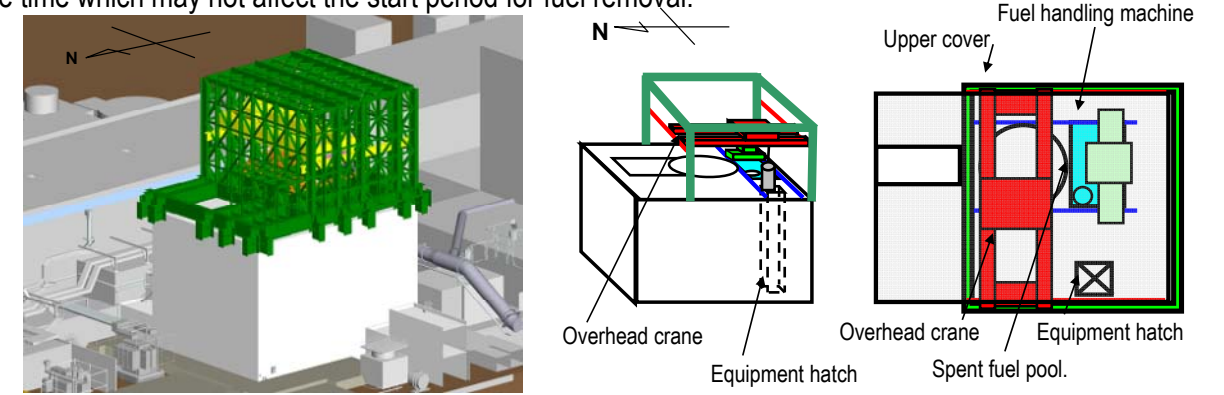
Figure 12: Plan image of Unit-1 fuel removal

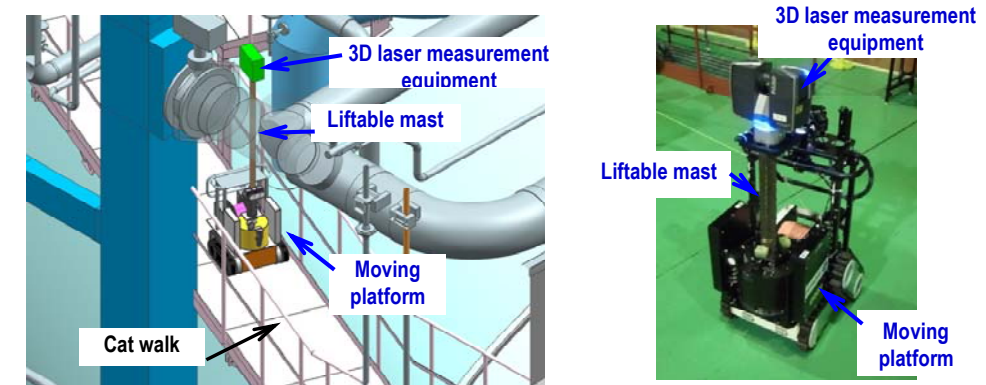
Figure 13: 3D laser scan measurement image at Unit 1 torus room and external appearance of remote-controlled equipment

- To use in evaluating obstacles as required for works, including water stoppage at the PCV inside the Unit 1 Reactor Building torus room, which is currently being planned, 3D data in the torus room will be collected using remote-controlled equipment with 3D laser-measurement equipment mounted (commenced on October 31 and scheduled for completion on November 10) (see Figure 13.)

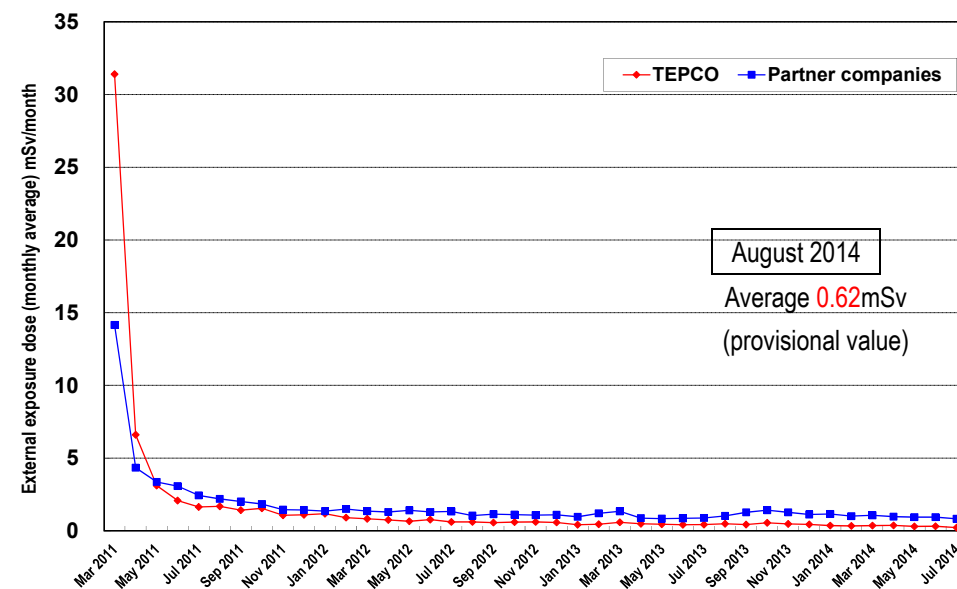
Figure 15: Changes in monthly individual worker exposure dose (monthly average exposure dose since March 2011)

- The average exposure dose of workers remained at approx. 1mSv/month by implementing measures to reduce the exposure dose, and allocating/relocating workers as required based on the forecast dose for each work. (Reference: annual average exposure dose 20mSv/year  $\approx$  1.7mSv/month)
- For most workers, the exposure dose is sufficiently within the limit and at a level which allows them to continue engaging in radiation work.

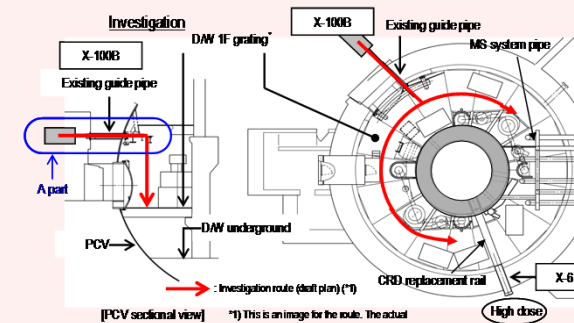
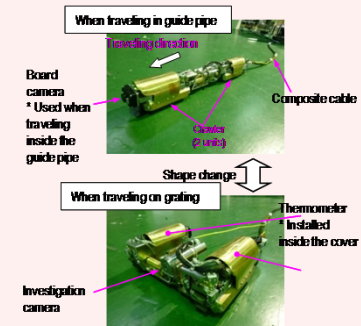
- Crawler-type equipment with a shape-changing structure which allows it to enter the PCV from the narrow access entrance (bore:  $\phi$ 100mm) and stably move on the grating is currently under development. A field demonstration is scheduled for the 2<sup>nd</sup> half of FY2014.

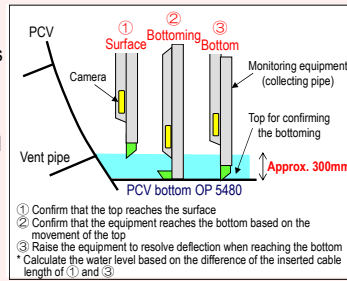
Method to measure water levels when re-installing monitoring instrumentation for Unit 2 PCV

- The instrumentation was removed on May 27, 2014 and new instruments were reinstalled on June 5 and 6. The trend of added instrumentation will be monitored for approx. one month to evaluate its validity.

- The measurement during the installation confirmed that the water level inside the PCV was approx. 300mm from the bottom.

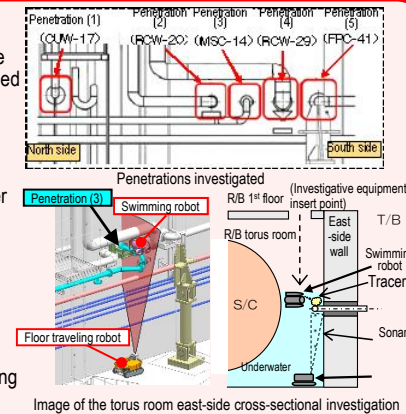
- The torus room walls were investigated (on the north side of the east-side walls) using equipment specially developed for that purpose (a swimming robot and a floor traveling robot).
- At the east-side wall pipe penetrations (five points), "the status" and "existence of flow" were checked.
- A demonstration using the above two types of underwater wall investigative equipment showed how the equipment could check the status of penetration.
- Regarding Penetrations 1 - 5, the results of checking the sprayed tracer (\*) by camera showed no flow around the penetrations. (investigation by the swimming robot)
- Regarding Penetration 3, a sonar check showed no flow around the penetrations. (investigation by the floor traveling robot)

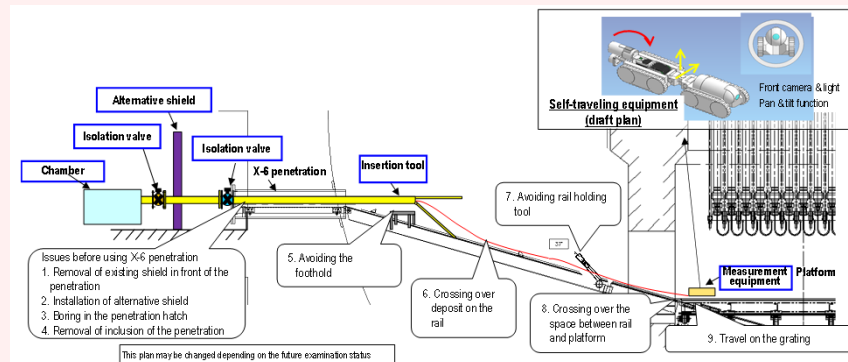
- [Investigative outline]
  - Inserting the equipment from Unit 2 X-6 penetration(\*) and accessing inside the pedestal using the CRD rail to conduct investigation.
- [Status of investigative equipment development]
  - Based on issues confirmed by the CRD rail status investigation conducted in August 2013, the investigation method and equipment design are currently being examined. A demonstration is scheduled in the field in the 2nd half of FY2014.

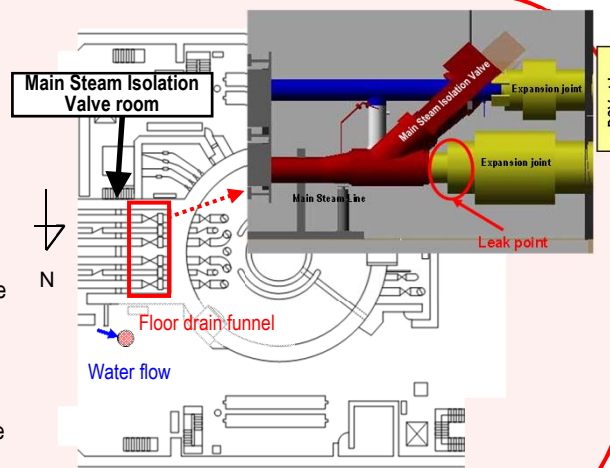
Outline of the water-flow status

From April 23, image data has been acquired by camera and the radiation dose measured via pipes for measurement instrumentation, which connect the air-conditioning room on the Reactor Building 2nd floor with the Main Steam Isolation Valve Room on the 1st floor. On May 15, water flow from the expansion joint of one Main Steam Line was detected.

This is the first leak from PCV detected in Unit 3. Based on the images collected in this investigation, the leak volume will be estimated and the need for additional investigations will be examined. The investigative results will also be utilized to examine water stoppage and PCV repair methods.

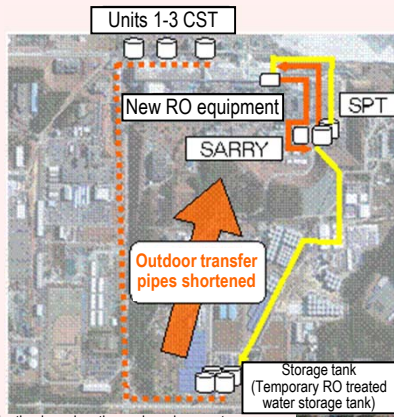
- Operation of the reactor water injection system using Unit 3 CST as a water source commenced (from July 5, 2013). Compared to the previous systems, in addition to the shortened outdoor line, the reliability of the reactor water injection system was enhanced, e.g. by increasing the amount of water-source storage and enhancing durability.
- By newly installing RO equipment inside the Reactor Building by the end of FY2014, the reactor water injection loop (circulation loop) will be shortened from approx. 3km to approx. 0.8km\*.
- \* The entire length of contaminated water transfer pipes is approx. 2.1km, including the transfer line of surplus water to the upper heights (approx. 1.3km).

\*1 Unit 4 T/B operation floor is one of the installation proposals, which will be determined after further examination based on the work environment  
 \*2 A detailed line configuration will be determined after further examination

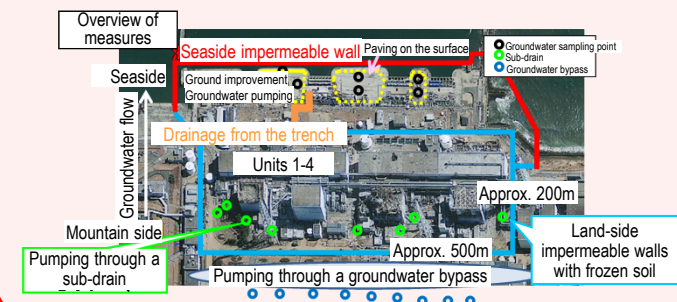
- Removing contaminated water in branch trenches and closing them (completed on September 19, 2013)
    - Treatment and removal of contaminated water in the seawater pipe trench

- Unit 2: November 14, 2013 – April 25, 2014, treatment of cesium and strontium. From October 16, space filling is underway.
      - Unit 3: November 15, 2013 – July 28, 2014, treatment of cesium. Drilling of holes to install frozen/ temperature-measurement pipes, and preparation for space filling is underway.
