Main works and steps for decommissioning

I. Confirmation of the reactor conditions

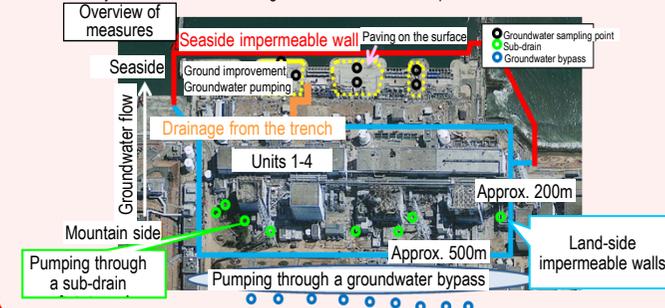
- Unit 2: November 25 to December 18, 2014 - tunnel sections were filled with cement-based materials. February 24, 2015 - filling of the Vertical Shafts commenced.

- Unit 3: February 5, 2015 - filling of tunnel sections commenced.
 - Unit 4: February 14 - March 21, 2015 - filling of tunnel sections was completed.
