Main works and steps for decommissioning

Fuel removal from Unit 4 SFP had been completed and preparatory works to remove fuel from Unit 1-3 SFP and fuel debris (Note 1) removal are ongoing.

TEPCO Fukushima Daiichi Nuclear Power Station Site Layout

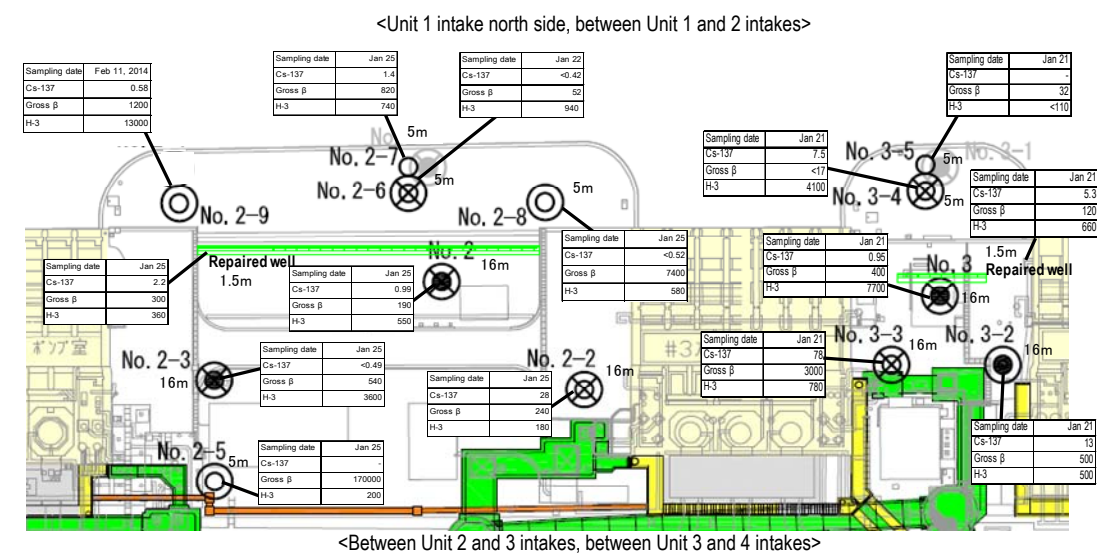
Figure 4: Groundwater density on the Turbine Building east side

- Regarding radioactive materials in the groundwater near the bank between the Unit 3 and 4 intakes, the density of gross β radioactive materials at groundwater Observation Hole No. 3-2 has been increasing since December 2015 and currently stands at around 1,000 Bq/L. Since April 1, 2015, pumping of groundwater continued (at the well point between the Unit 3 and 4 intakes: April 1 – September 16, 2015; at the repaired well point: from September 17, 2015).
