Main works and steps for decommissioning

Fuel removal from Unit 4 SFP had been completed and preparatory works to remove fuel from Unit 1-3 SFP and fuel debris (Note 1) removal are ongoing.

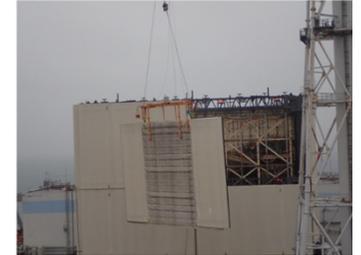
Toward fuel removal from Unit 1 SFP, works to dismantle the building cover are underway.

Dismantlement of the building cover started in July 2015 and dismantlement of wall panels started in September 2016. The work is being conducted steadily, with anti-scattering measures fully implemented and the density of radioactive materials monitored.

(Dismantlement of Unit 1 building cover wall panels)

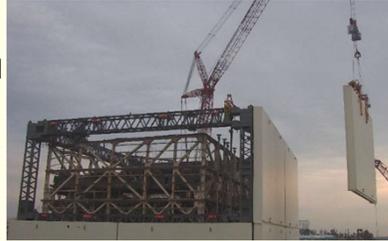
No significant variation attributable to the work was identified at the dust monitors installed on the workplace and near the site boundary. Measures to prevent erroneous alerts have been implemented for the dust monitors near the site boundary.

<Dismantlement of wall panels>

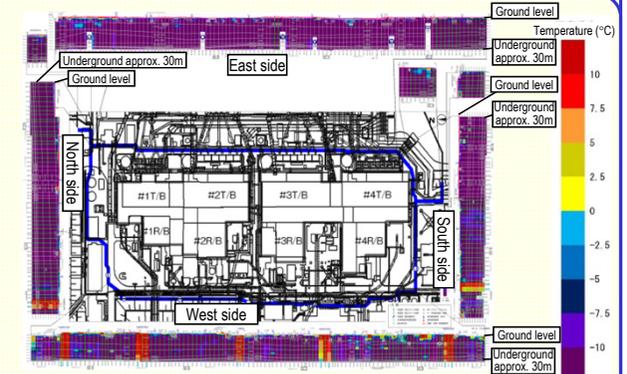
The groundwater level on the upstream side exceeds the level on the down stream side on both sea and mountain sides. The difference has been expanding, and then remained.

The water inflow-outflow balance will be checked to evaluate the effect of the land-side impermeable walls (on part of the sea side).

< Underground temperature of the land-side impermeable walls >
