Main decommissioning work and steps

Fuel removal from the spent fuel pool was completed in December 2014 at Unit 4 and started from April 15, 2019 at Unit 3. Dust density in the surrounding environment is being monitored and work is being implemented with safety first. Work continues sequentially toward the start of fuel removal from Units 1 and 2 and debris (Note 1) retrieval from Units 1-3.

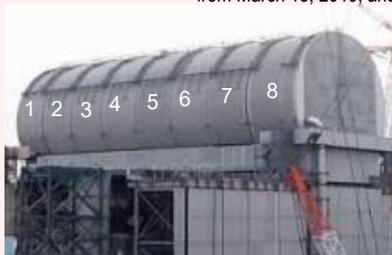
Installation of dome roof (February 21, 2019)
