## Main decommissioning work and steps

Fuel removal from the spent fuel pool was completed in December 2014 at Unit 4 and started from April 15, 2019 at Unit 3. Dust density in the surrounding environment is being monitored and work is being implemented with safety first. Work continues sequentially toward the start of fuel removal from Units 1 and 2 and debris (Note 1) retrieval from Units 1-3.

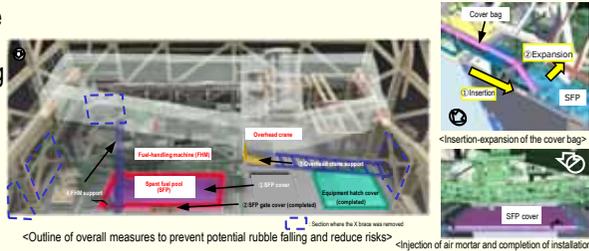
As part of work to remove the falling roof on the south side of the Reactor Building operating floor, a cover will be installed over the SFP to prevent rubble falling on the pool and reduce risks. Before the actual installation, a mockup test of the work was conducted to confirm that there was no problem with the insertion of the rolled SFP cover bag and its extension. At present, the final check for the work, including training, is underway.

After the check, the bag will be inserted on the SFP from the east side of the Reactor Building from around mid-June 2020. The bag will then be expanded by air, air mortar injected in the bag and the cover installation completed by around late June.

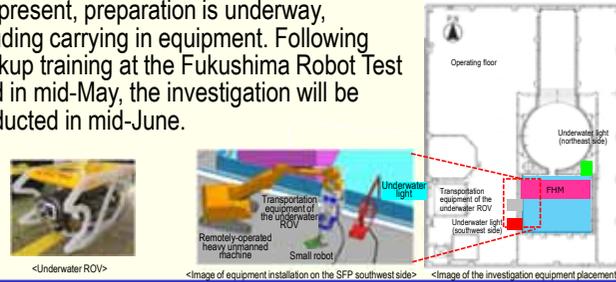
### Investigation inside the Unit 2 SFP in mid-June

Before fuel removal from the SFP, a remote-controlled investigation inside the SFP using an underwater ROV with a camera will be conducted to check the fuel top and any potential obstacles.

At present, preparation is underway, including carrying in equipment. Following mockup training at the Fukushima Robot Test Field in mid-May, the investigation will be conducted in mid-June.

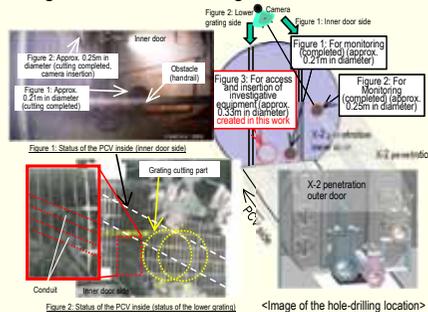
Toward investigating the inside of the Unit 1 Primary Containment Vessel (PCV), an access route is being constructed. As pre-investigation before cutting obstacles inside the PCV, a camera was inserted from the completed hole to check the inside and confirm that no fallen objects which may affect future cutting work were present.

After the pre-investigation, work to create the third hole (approx. 0.33 m in diameter; Figure 3) in the inner door started and was completed on April 22. As the following access route construction work, cutting of obstacles will start from around mid-May if possible.

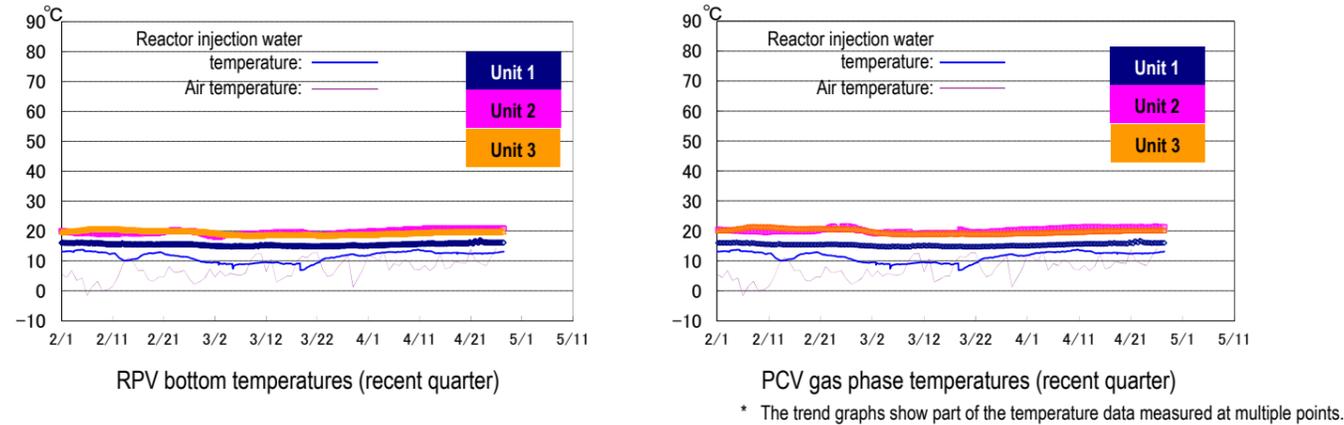
### 1. Temperatures inside the reactors

Through continuous reactor cooling by water injection, the temperatures of the Reactor Pressure Vessel (RPV) bottom and the Primary Containment Vessel (PCV) gas phase were maintained within the range of approx. 15 to 25°C for the past month, though they varied depending on the unit and location of the thermometer.

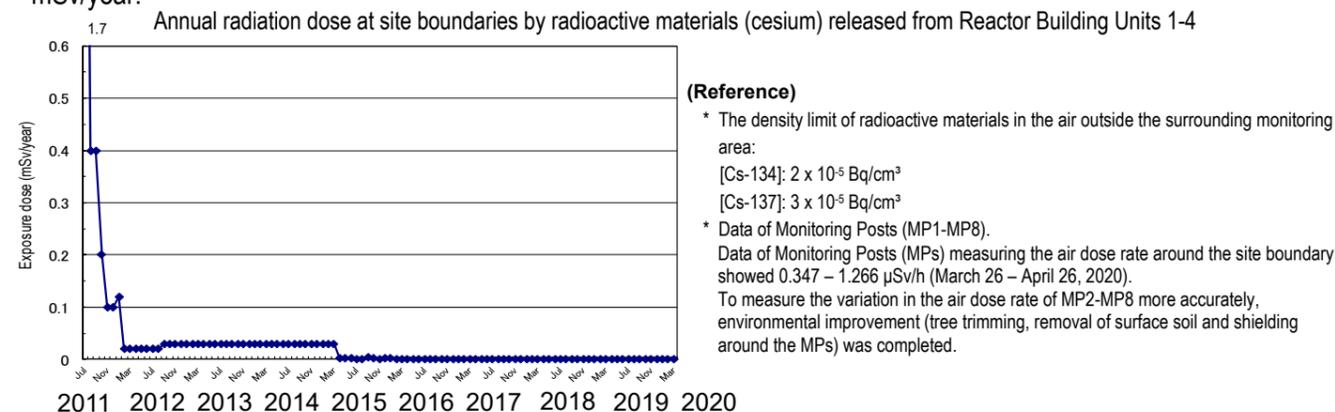
### 2. Release of radioactive materials from the Reactor Buildings

As of March 2020, the density of the radioactive materials newly released from Reactor Building Units 1-4 into the air and measured at the site boundary was evaluated at approx.  $3.4 \times 10^{-12}$  Bq/cm<sup>3</sup> and  $1.4 \times 10^{-11}$  Bq/cm<sup>3</sup> for Cs-134 and Cs-137 respectively, while the radiation exposure dose due to the release of radioactive materials there was less than 0.00014 mSv/year.

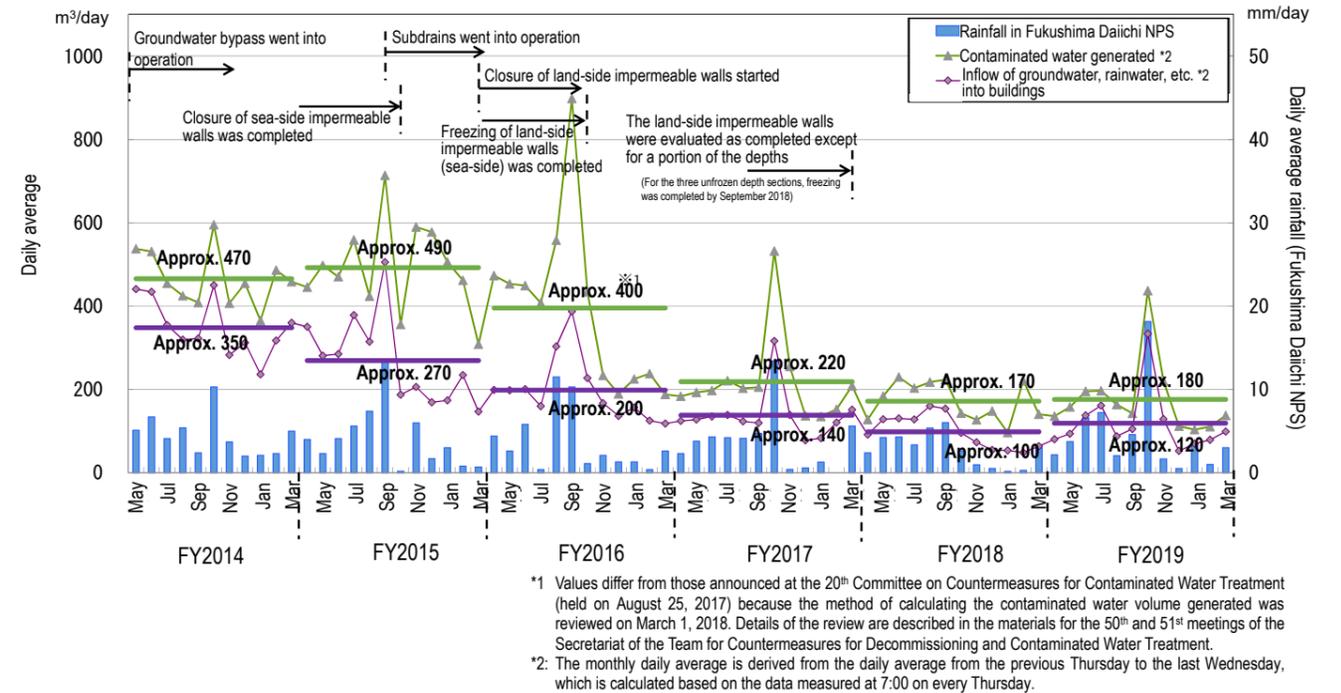
Figure 1: Changes in contaminated water generated and inflow of groundwater, rainwater, into buildings

- Multi-layered measures, including pumping up by subdrains and land-side impermeable walls, which were implemented to control the continued generation of contaminated water, suppressed the groundwater inflow into buildings.
- After "redirecting" measures (groundwater bypass, subdrains, land-side impermeable walls and others) were steadily implemented, the generation amount reduced from approx. 470 m<sup>3</sup>/day (the FY2014 average) when the measures were first launched to approx. 180 m<sup>3</sup>/day (the FY2019 average).
- Measures will continue to further reduce the volume of contaminated water generated.

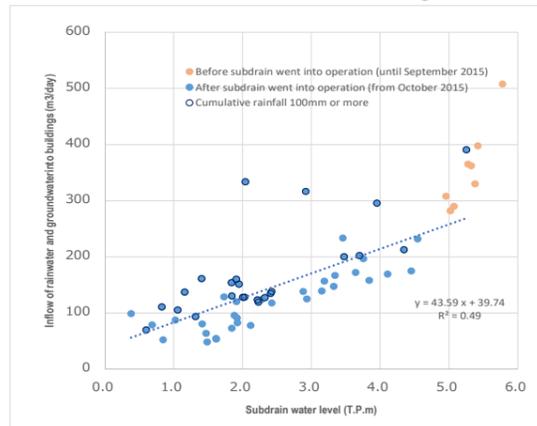
Figure 2: Correlation between inflow such as groundwater and rainwater into buildings and the water level of Units 1-4 subdrains

- To maintain the level of groundwater, work to install additional subdrain pits and to recover existing ones is underway. The additional pits are scheduled to start operation sequentially, from a pit which work is completed (12 of 14 new subdrain pits went into operation). For recovering the existing pits, work for all three pits scheduled was completed. All of them went into operation from December 26, 2018. Work to recover another pit started from November 2019 (No. 49 pit).
- To eliminate the need to suspend water pumping while cleaning the subdrain transfer pipe, the pipe will be duplicated. Installation of the pipe and ancillary facilities was completed.
- Since the subdrains went into operation, the inflow to buildings tended to decline to under 150 m<sup>3</sup>/day when the subdrain water level declined below T.P. 3.0 m but increased during rainfall.

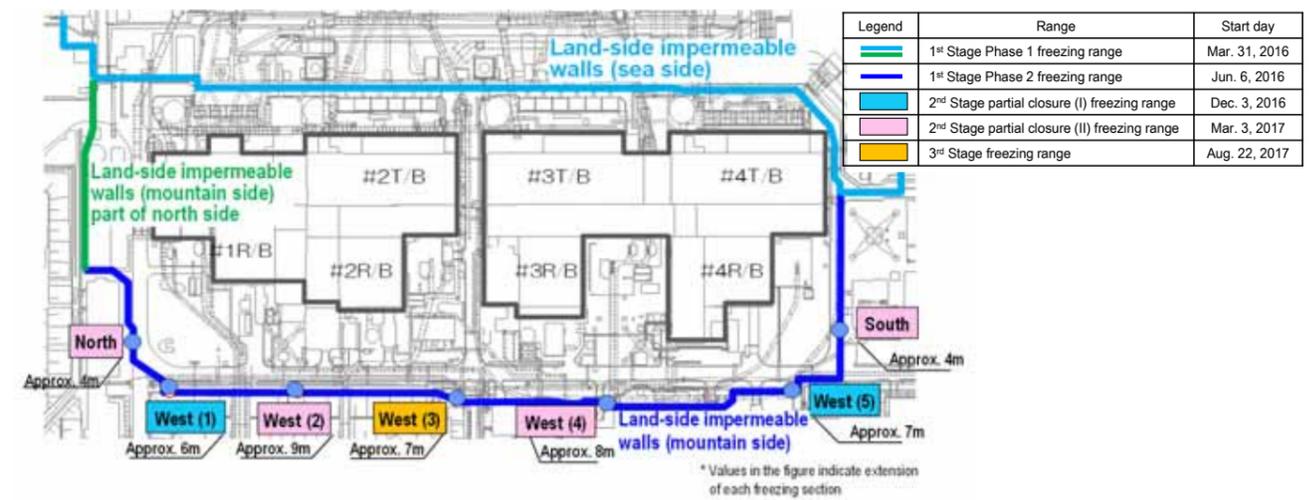
Figure 3: Closure parts of the land-side impermeable walls (on the mountain side)

- The groundwater level in the area inside the land-side impermeable walls has been declining every year. On the mountain side, the difference between the inside and outside increased to approx. 5-6 m. The water level in the bank area has remained low (T.P. 1.6-1.7 m) compared to the ground surface (T.P. 2.5 m).

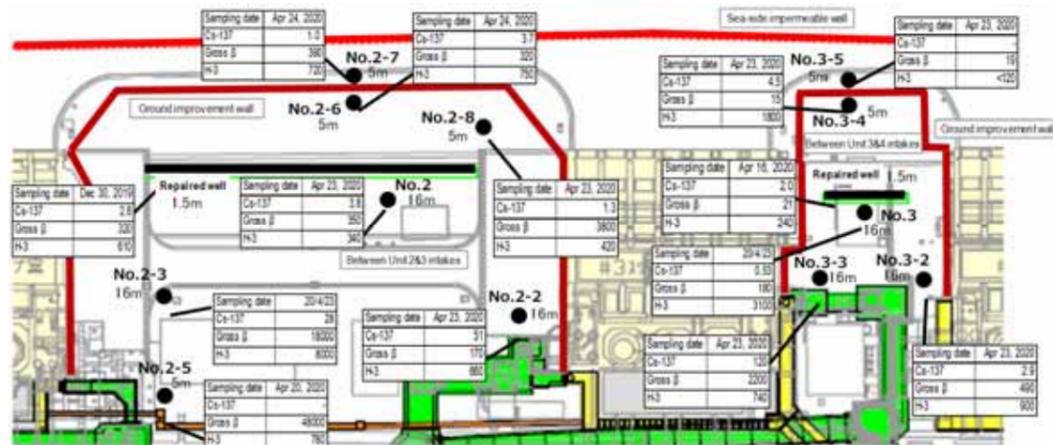
Figure 5: Groundwater concentration on the Turbine Building east side

<Between Unit 2 and 3 intakes, between Unit 3 and 4 intakes>

- At No. 1-12, the concentration of gross  $\beta$  radioactive materials has been increasing from around 500 Bq/L since December 2019 and currently stands at around 1,800 Bq/L. Since August 15, 2013, pumping of groundwater continued (at the well point between the Unit 1 and 2 intakes: August 15, 2013 – October 13, 2015 and from October 24; at the repaired well: October 14-23, 2015).

- At No. 2-6, the concentration of gross  $\beta$  radioactive materials had been increasing from around 100 Bq/L since May 2019 and currently stands at around 300 Bq/L. Since December 18, 2013, pumping of groundwater continued (at the well point between the Unit 2 and 3 intakes: December 18, 2013 - October 13, 2015; at the repaired well: from October 14, 2015).

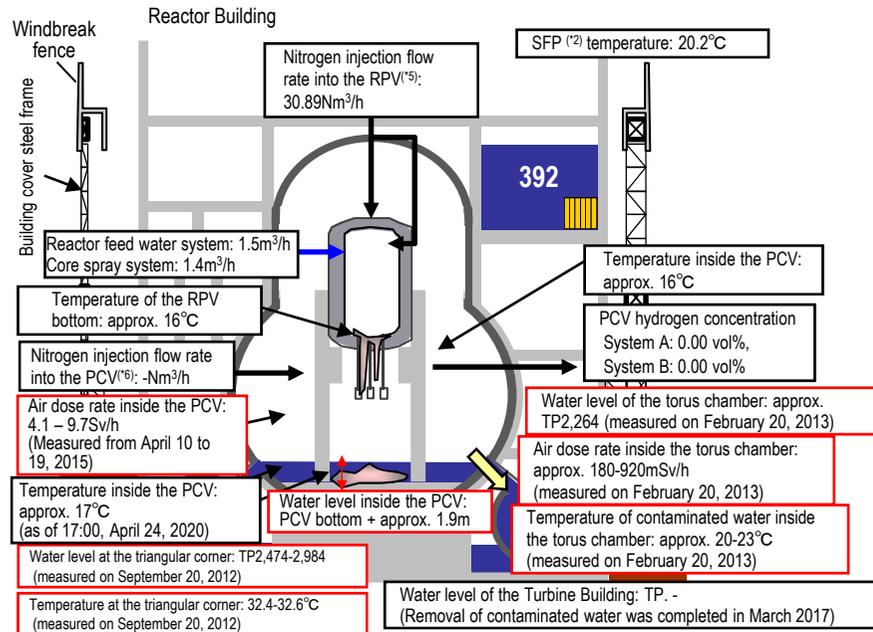
Air dose rate inside the Reactor Building:  
 Max. 5,150mSv/h (1F southeast area) (measured on July 4, 2012)

Investigations inside PCV	1st (Oct 2012)	2nd (Apr 2015)	3rd (Mar 2017)
	- Acquiring images - Measuring air temperature and dose rate - Measuring water level and temperature - Sampling contaminated water - Installing permanent monitoring instrumentation	Confirming the status of PCV 1st floor - Acquiring images - Measuring air temperature and dose rate - Replacing permanent monitoring instrumentation	Confirming the status of PCV 1st basement floor - Acquiring images - Measuring air temperature and dose rate - Sampling deposit - Replacing permanent monitoring instrumentation
Leakage points from PCV	- PCV vent pipe vacuum break line bellows (identified in May 2014) - Sand cushion drain line (identified in November 2013)

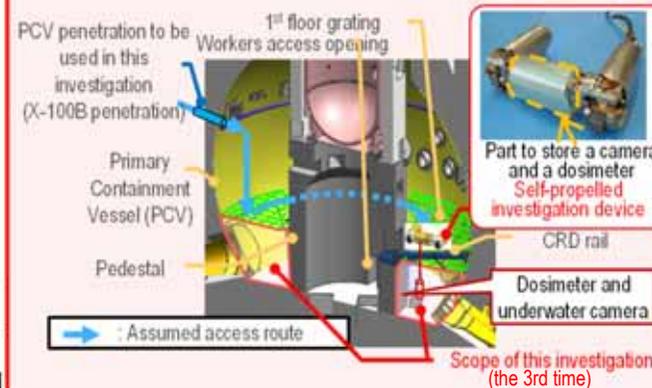
<Image of investigation inside the PCV>

- In April 2015, a device, which entered the inside of the PCV through a narrow access opening (bore:  $\phi$  100 mm), collected information such as images and airborne dose inside the PCV 1st floor.
- In March 2017, the investigation using a self-propelled investigation device, conducted to inspect the spreading of debris to the basement floor outside the pedestal, took images of the PCV bottom status for the first time. The status inside the PCV will continue to be examined based on the collected image and dose data.

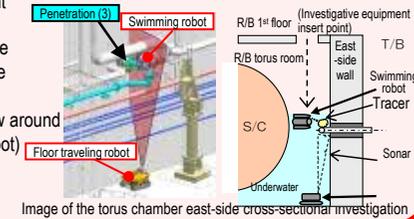
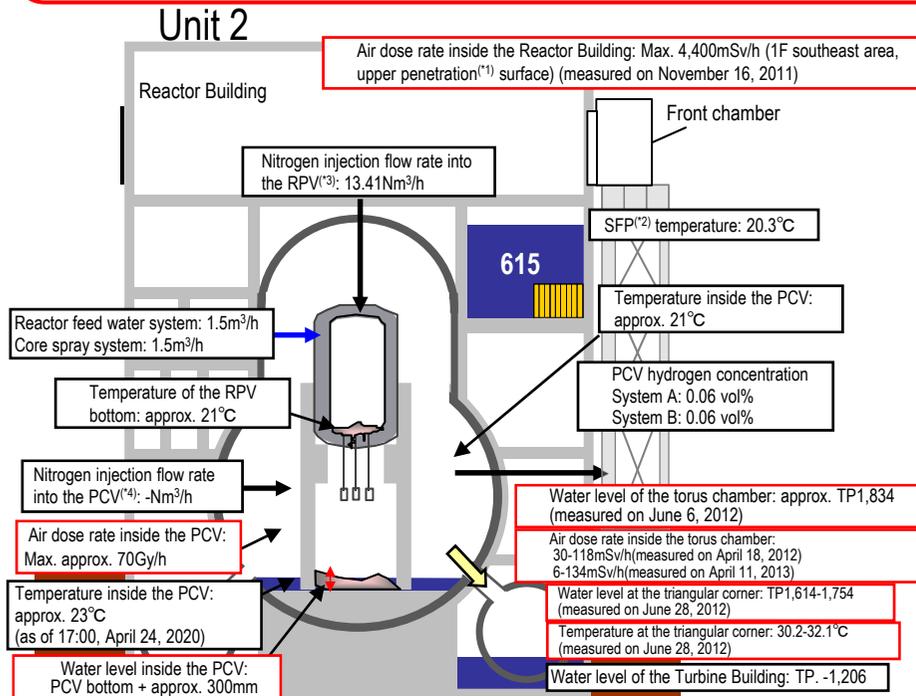
## Investigative results on torus chamber walls

Investigations inside PCV	1st (Jan 2012)	- Acquiring images - Measuring air temperature
	2nd (Mar 2012)	- Confirming water surface - Measuring water temperature - Measuring dose rate
	3rd (Feb 2013 - Jun 2014)	- Acquiring images - Sampling contaminated water - Measuring water level - Installing permanent monitoring instrumentation
	4th (Jan - Feb 2017)	- Acquiring images - Measuring dose rate - Measuring air temperature
	5th (Jan 2018)	- Acquiring images - Measuring dose rate - Measuring air temperature
	6th (Feb 2019)	- Acquiring images - Measuring dose rate - Measuring air temperature - Grasping characteristics of a portion of deposit
Leakage points from PCV	- No leakage from torus chamber rooftop - No leakage from all inside/outside surfaces of S/C

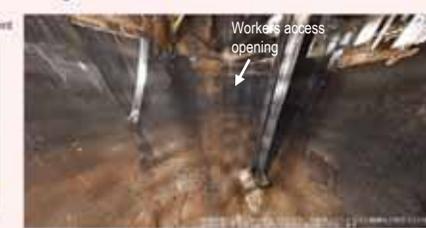
- The results of this series of investigations confirmed fallen and deformed gratings and a quantity of deposit inside the pedestal.
- On January 19, 2018, the status below the platform inside the pedestal was investigated using an investigative device with a hanging mechanism. From the analytical results of images obtained in the investigation, deposits probably including fuel debris were found at the bottom of the pedestal. In addition, multiple parts higher than the surrounding deposits were also detected. We presumed that there were multiple routes of fuel debris falling. Obtained data were processed in panoramic image visualization to acquire clearer images.

- On February 13, 2019, an investigation touching the deposits at the bottom of the pedestal and on the platform was conducted and confirmed that the pebble-shaped deposits, etc. could be moved and that hard rock-like deposits that could not be gripped may exist.

- In addition, images, etc. would help determine the contour and size of the deposits could be collected by moving the investigative unit closer to the deposits than the previous investigation.

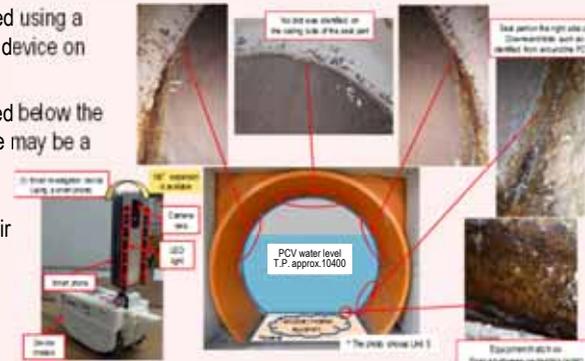
- As part of the investigation into the PCV to facilitate fuel debris retrieval, the status around the Unit 3 PCV equipment hatch was investigated using a small self-traveling investigation device on November 26, 2015.
- Given blots such as rust identified below the water level inside the PCV, there may be a leakage from the seal to the extent of bleeding. Methods to investigate and repair the parts, including other PCV penetrations with a similar structure, will be considered.

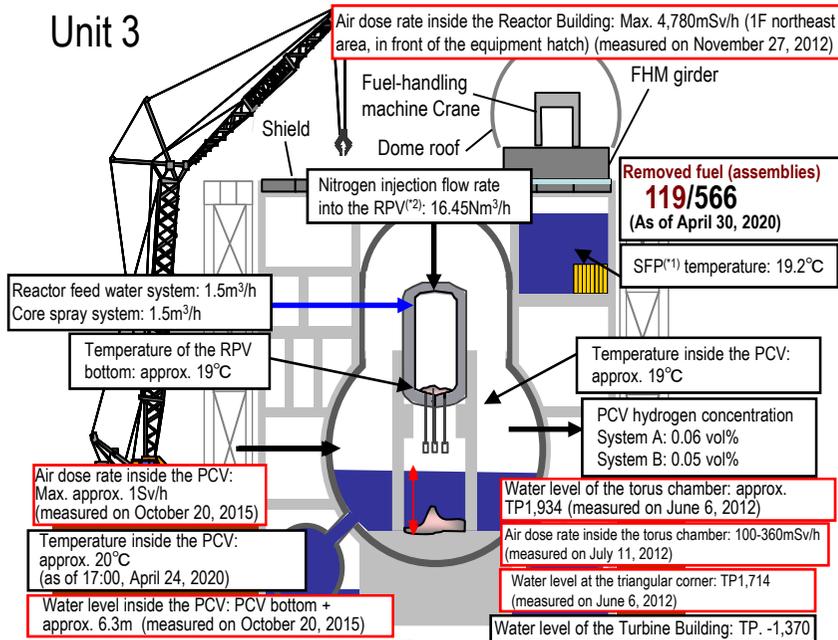
### Unit 3

Investigations inside PCV	1st (Oct – Dec 2015)	- Acquiring images - Measuring air temperature and dose rate - Measuring water level and temperature - Sampling contaminated water - Installing permanent monitoring instrumentation (December 2015)
	2nd (Jul 2017)	- Acquiring images - Installing permanent monitoring instrumentation (August 2017)
Leakage points from PCV	- Main steam pipe bellows (identified in May 2014)

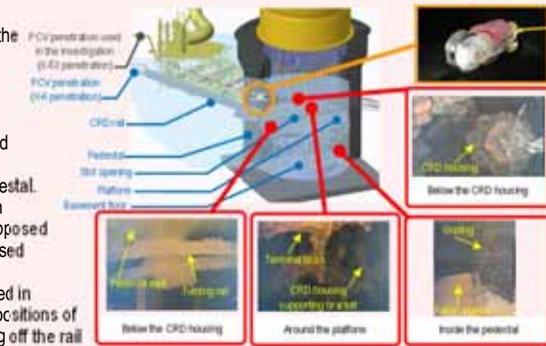
Status inside the pedestal

- Analysis of image data obtained in the investigation identified damage to multiple structures and the supposed core internals. Consideration about fuel removal based on the obtained information will continue.

- Videos obtained in the investigation were reproduced in 3D. Based on the reproduced images, the relative positions of the structures, such as the rotating platform slipping off the rail with a portion buried in deposits, were visually understood.

- For the purpose of confirming the status inside the PCV, an investigation device was inserted into the PCV from X-53 penetration on October 20 and 22, 2015 to obtain images, data of dose and temperature and sample contaminated water. No damage was identified on the structure and walls inside the PCV and the water level was almost identical with the estimated value. In addition, the dose inside the PCV was confirmed to be lower than in other Units.

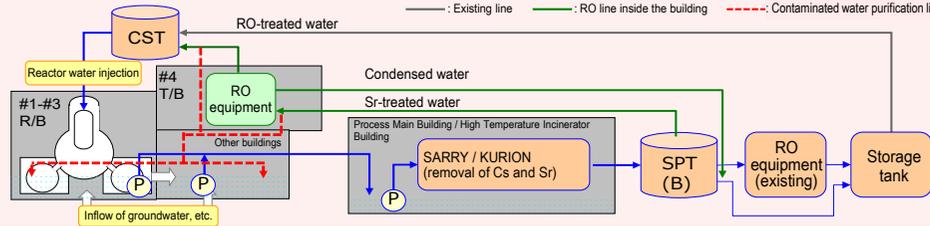
- To reduce the risk of contaminated-water leakage, the circulation loop was shortened by installing a reverse osmosis (RO) device in the Unit 4 Turbine Building within the circulation loop, comprising the transfer of contaminated water, water treatment and injection into the reactors. Operation of the installed RO device started from October 7 and 24-hour operation started from October 20. Installation of the new RO device inside the building shortened the circulation loop from approx. 3 to 0.8 km.

\* The entire length of contaminated water transfer pipes is approx. 2.1km, including the transfer line of surplus water to the upper heights (approx. 1.3km).

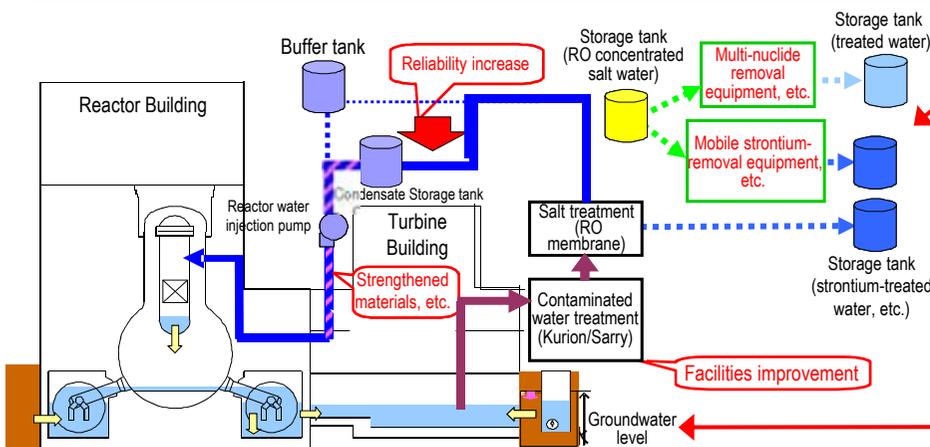
Contaminated water (RO concentrated salt water) is being treated using seven types of equipment including the multi-nuclide removal equipment (ALPS). Treatment of the RO concentrated salt water was completed on May 27, 2015, with the exception of the remaining water at the tank bottom. The remaining water will be treated sequentially toward dismantling the tanks.

The strontium-treated water from other facilities than the multi-nuclide removal equipment will be re-purified in the multi-nuclide removal equipment to further reduce risks.

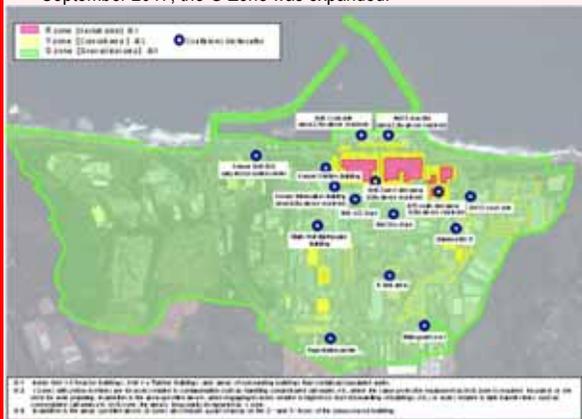
**Optimization of radioactive protective equipment**  
Based on the progress of measures to reduce environmental dosage on site, the site is categorized into two zones: highly contaminated area around Unit 1-4 buildings, etc. and other areas to optimize protective equipment according to each category aiming at improving safety and productivity by reducing load during work.  
From March 2016, limited operation started. From March and September 2017, the G Zone was expanded.

R zone (Anorak area)	Y zone (Coverall area)	G zone (General wear)
Full face mask 	Full face or half face mask 1, 2 	Disposable disposable mask 
Anorak on coverall Or double coveralls 	Coverall 	General P3 Dedicated on-site wear

\*1 For works in buildings including water-treatment facilities (multi-nuclide removal equipment, etc.) (including site visits), wear a full-face mask.  
\*2 For works in tank areas containing concentrated salt water or Si-treated water (including works not handling concentrated salt water, etc.), patrol, on-site investigation for work planning, and site visits) and works related to tank transfer sites, wear a full-face mask.  
\*3 Specified sign works (patrol, monitoring, delivery of goods brought from outside, etc.)
