Main decommissioning work and steps

Progress status

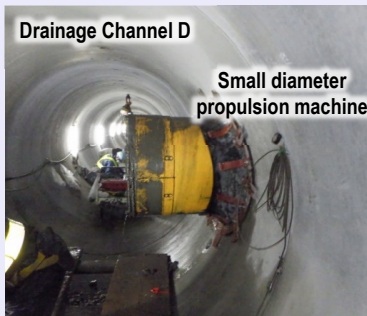
<Construction status of Drainage Channel D>
(Small diameter propulsion work)

To eliminate the risk of heavy rain from an early stage, work to extend Drainage Channel D is underway.

By operating Drainage Channel D, drainage in areas with a low dose on the west side of the site can be conveyed to the inside of the port during rainfall to prevent the existing drainage channel from flooding. Flowing down associated by flooding to around the Units 1-4 buildings can also be prevented.

Preparation such as installing the drainage gate proceeds and the drainage channel is expected to go into operation within August.

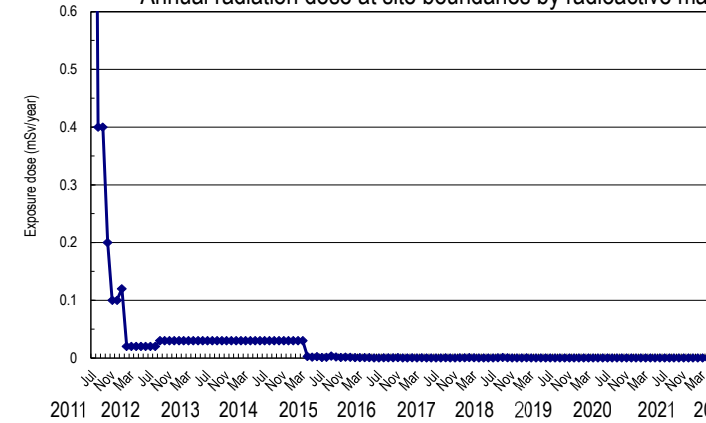
Annual radiation dose at site boundaries by radioactive materials (cesium) released from Reactor Building Units 1-4

As of June 2022, the concentration of radioactive materials newly released from Reactor Building Units 1-4 into the air and measured at the site boundary was evaluated at approx. 3.0×10^{-12} Bq/cm³ and 2.3×10^{-12} Bq/cm³ for Cs-134 and -137 respectively, while the radiation exposure dose due to the release of radioactive materials there was less than 0.00006 mSv/year.

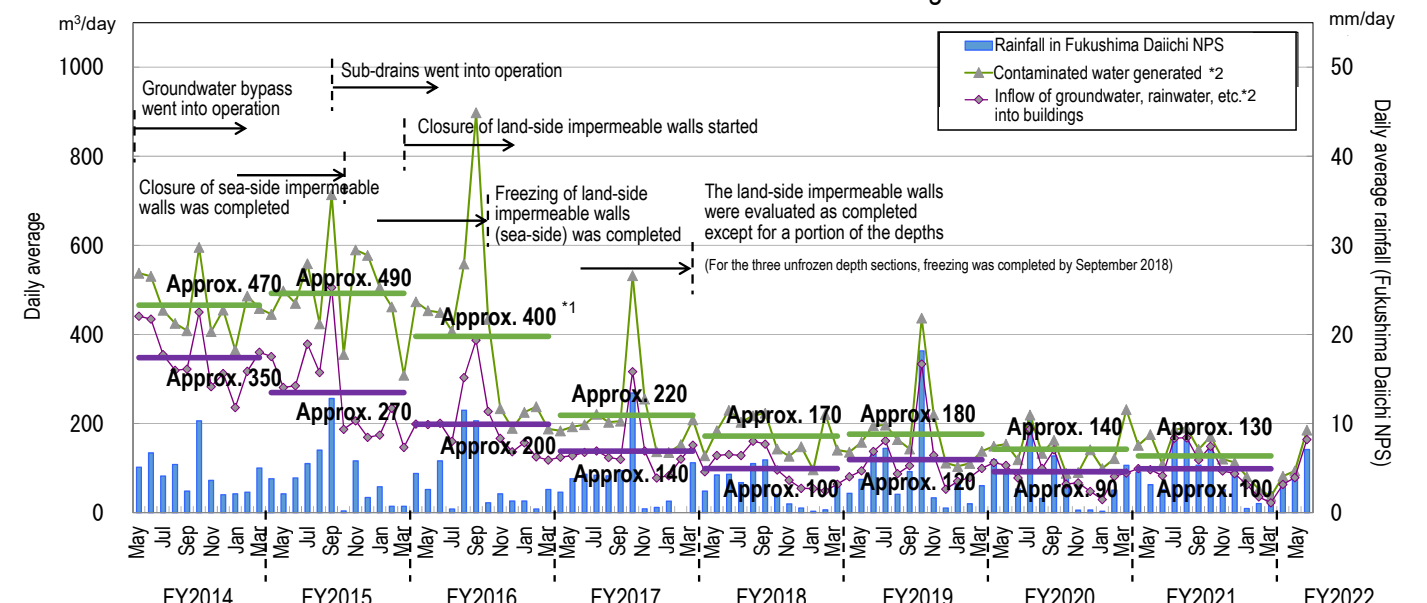
Figure 1: Changes in contaminated water generated and inflow of groundwater and rainwater into buildings

- Multi-layered measures, including pumping up by sub-drains and land-side impermeable walls, which were implemented to control the continued generation of contaminated water, suppressed the groundwater inflow into buildings.
- After implementing “redirecting” measures (groundwater bypass, sub-drains, land-side impermeable walls and others) and rainwater prevention measures, including repairing damaged portions of building roofs, the amount of contaminated water generated within FY2021 declined to approx. 130 m³/day.
- Measures will continue to further reduce the amount of contaminated water generated.

*1 Values differ from those announced at the 20th Committee on Countermeasures for Contaminated Water Treatment (held on August 25, 2017) because the method of calculating the contaminated water volume generated was reviewed on March 1, 2018. Details of the review are described in the materials for the 50th and 51st meetings of the Secretariat of the Team for Countermeasures for Decommissioning and Contaminated Water Treatment.
*2: The monthly daily average is derived from the daily average from the previous Thursday to the last Wednesday, which is calculated based on the data measured at 7:00 on every Thursday.

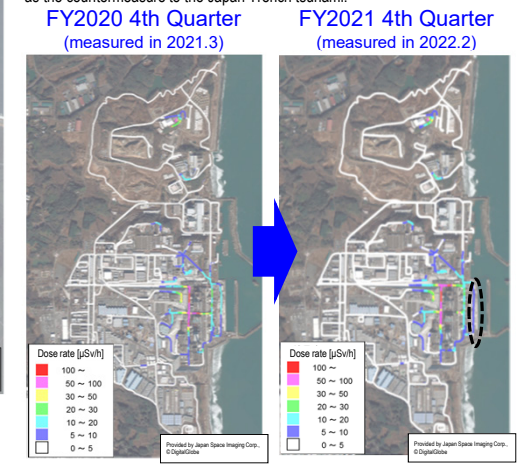
<Travel survey results of major roads within the site>
The dose rate has been declining every year. In particular, in the area on the east side of the Turbine Building shown a black dotted line, the dose rate declined by facing related to installation of the seawall as the countermeasure to the Japan Trench tsunami.
