## Main decommissioning work and steps

# I. Confirmation of the reactor conditions

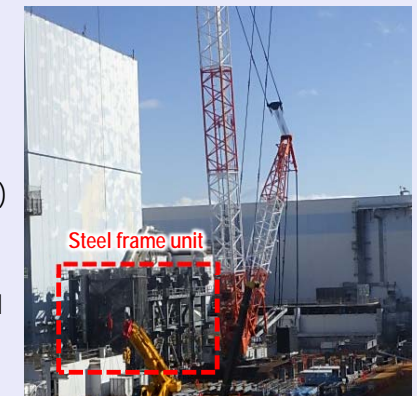
Outside the building, steel structure having been assembled in a low-dose area outside the site was transferred into the site and work to assemble the steel structure for the gantry of fuel removal started from January 23 on the south side of the Reactor Building. Work continues with prioritizing safety above all.

< Whole view of Unit 2 Reactor Building south yard (February 10, 2023) >

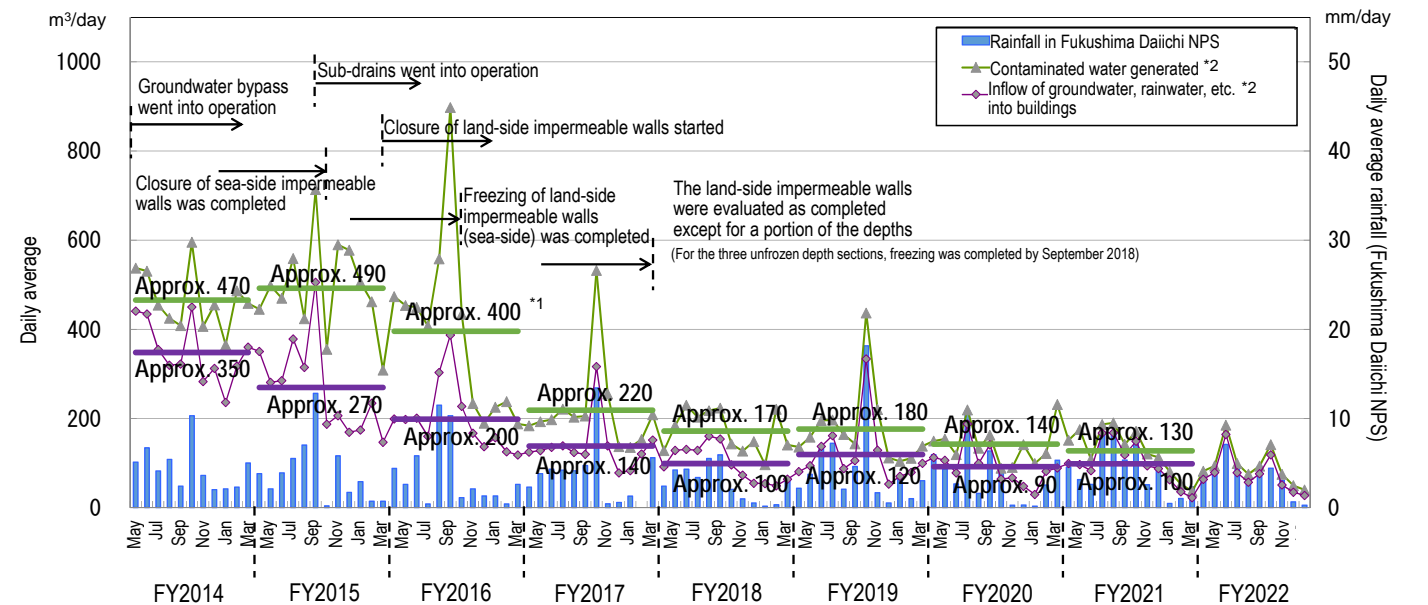
- Multi-layered measures, including pumping up by sub-drains and land-side impermeable walls, which were implemented to control the continued generation of contaminated water, suppressed the groundwater inflow into buildings.
- After implementing “redirecting” measures (groundwater bypass, sub-drains, land-side impermeable walls and others) and rainwater prevention measures, including repairing damaged portions of building roofs, the amount of contaminated water generated within FY2021 declined to approx. 130 m<sup>3</sup>/day.
- Measures will continue to further reduce the amount of contaminated water generated.

\*1 Values differ from those announced at the 20<sup>th</sup> Committee on Countermeasures for Contaminated Water Treatment (held on August 25, 2017) because the method of calculating the contaminated water volume generated was reviewed on March 1, 2018. Details of the review are described in the materials for the 50<sup>th</sup> and 51<sup>st</sup> meetings of the Secretariat of the Team for Countermeasures for Decommissioning and Contaminated Water Treatment.

\*2: The monthly daily average is derived from the daily average from the previous Thursday to the last Wednesday, which is calculated based on the data measured at 7:00 on every Thursday.

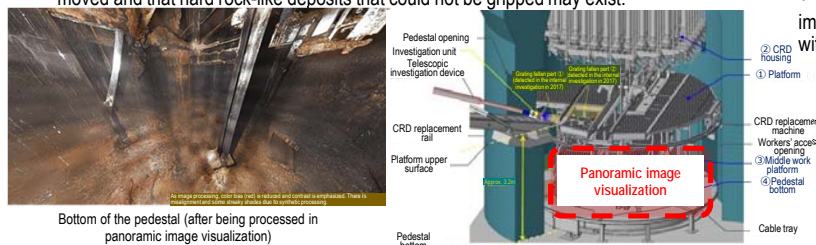
- In February 2019, an investigation touching the deposits at the bottom of the pedestal and on the platform was conducted and confirmed that the pebble-shaped deposits, etc. could be moved and that hard rock-like deposits that could not be gripped may exist.

- In January 2017, a camera was inserted from the PCV penetration to inspect the conditions of the rail on which the robot traveled. The results of a series of investigations confirmed some gratings had fallen and deformed as well as a quantity of deposit inside the pedestal.

- In January 2018, the conditions below the platform inside the pedestal were investigated. Based on the analytical results of images obtained in the investigation, deposits, probably including fuel debris, were found at the bottom of the pedestal. Moreover, multiple parts exceeding the surrounding deposits were also detected. We presumed that there were multiple instances of fuel debris falling.

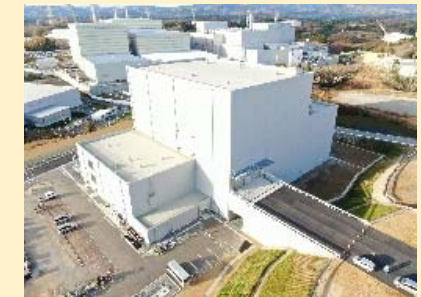
Whole view of the Additional Solid Waste Incinerator Building

To incinerate trimmed trees and combustible rubble (woods, packing materials, paper and others), work to install the Additional Solid Waste Facility is underway.

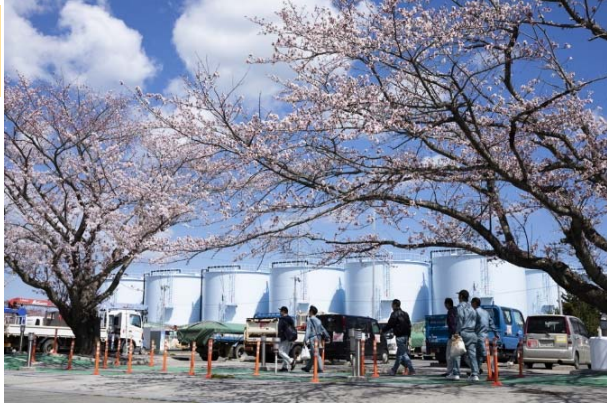
In May 2018, within about 96% of the site, workers are allowed to wear light equipment such as general workwear and disposable dust-protective masks.

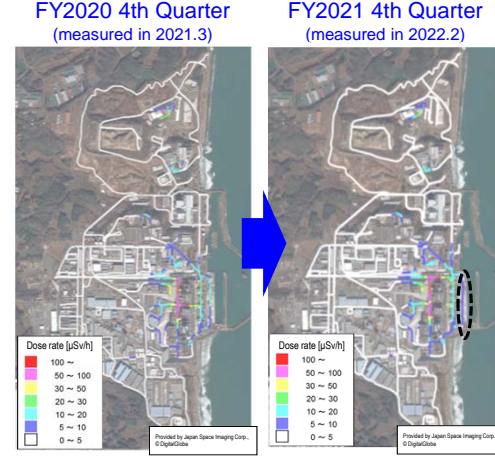
<Travel survey results of major roads within the site>  
The dose rate has been declining every year. In particular, in the area on the east side of the Turbine Building shown a black dotted line, the dose rate declined by facing related to installation of the seawall as the countermeasure to the Japan Trench tsunami.
