Main decommissioning work and steps

Fuel removal from the spent fuel pool was completed in December 2014 at Unit 4 and on February 28, 2021 at Unit 3. Work continues sequentially toward the start of fuel removal from Units 1 and 2 and debris (Note 1) retrieval from Units 1-3.

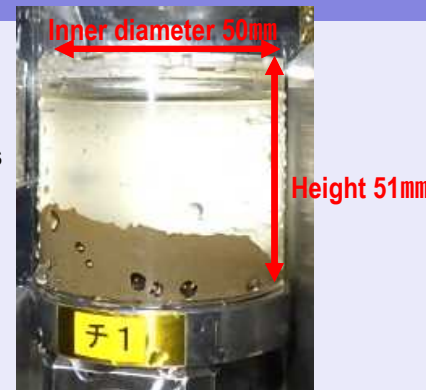
< Deposit sampling container >

Regarding the deposit samples acquired by the ROV-E investigation in the Unit 1 Primary Containment Vessel (PCV) internal investigation, deposits and supernatant in sampled PCV inclusive water will be separated and the deposits will then be transported to an external analysis institute for detailed analysis.

The external analysis institute will conduct an analysis, aiming to acquire information related to accident development by determining the types and amounts of elements and nuclides contained in samples and examining the particle generation process.

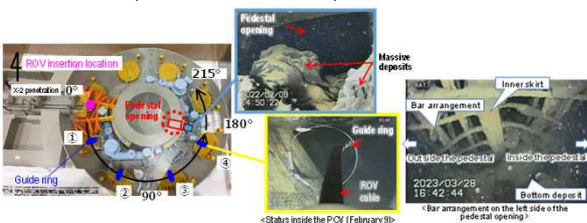
In February 2022, the guide ring* was installed to facilitate the investigation. From March 28, 2023, the investigation inside the pedestal by ROV-A2 started and confirmed that a portion of the bar arrangement was exposed. Regarding the soundness of the pedestal, based on the past earthquake resistant evaluation by the International Research Institute for Nuclear Decommissioning (IRID), it was evaluated that even though a portion of the pedestal was lost, there would be no serious risk. However, as the present information is very limited, the investigation will continue to acquire as much information as possible for continued evaluation.

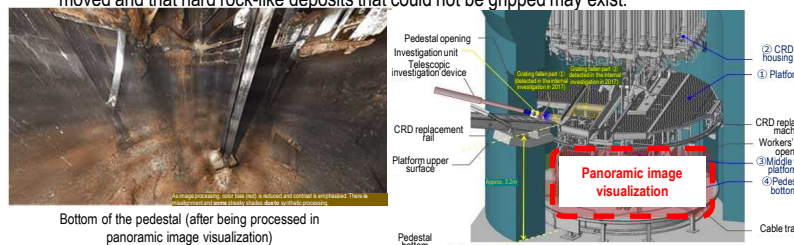
- In January 2017, a camera was inserted from the PCV penetration to inspect the conditions of the rail on which the robot traveled. The results of a series of investigations confirmed some gratings had fallen and deformed as well as a quantity of deposit inside the pedestal.

- In January 2018, the conditions below the platform inside the pedestal were investigated. Based on the analytical results of images obtained in the investigation, deposits, probably including fuel debris, were found at the bottom of the pedestal. Moreover, multiple parts exceeding the surrounding deposits were also detected. We presumed that there were multiple instances of fuel debris falling.

- In February 2019, an investigation touching the deposits at the bottom of the pedestal and on the platform was conducted and confirmed that the pebble-shaped deposits, etc. could be moved and that hard rock-like deposits that could not be gripped may exist.

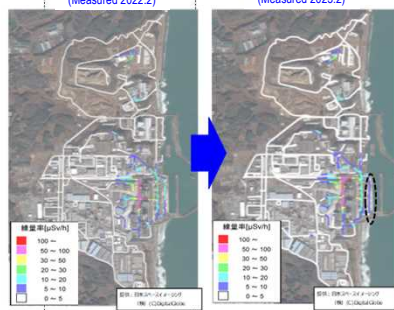
<p><FY2021 4th Quarter> (Measured 2022.2)</p> <p><FY2022 4th Quarter> (Measured 2023.2)</p> <p>It was confirmed that compared with the last fiscal year, the dose rate has been declining on roads near the southeast side of the Unit 4 Turbine Building and the west side of the Process Main Building (area circled by yellow dot line).</p>
