Main decommissioning work and steps

Unit 1 Progress status of work toward fuel removal

I. Confirmation of the reactor conditions

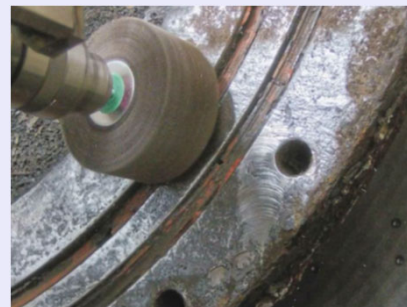
< Cleaning of X-6 penetration flange surface >

Regarding X-6 penetration, cleaning of the X-6 penetration flange surface was completed before removing deposit. Toward future deposit removal inside X-6 penetration, installation of the equipment and other related work is underway.

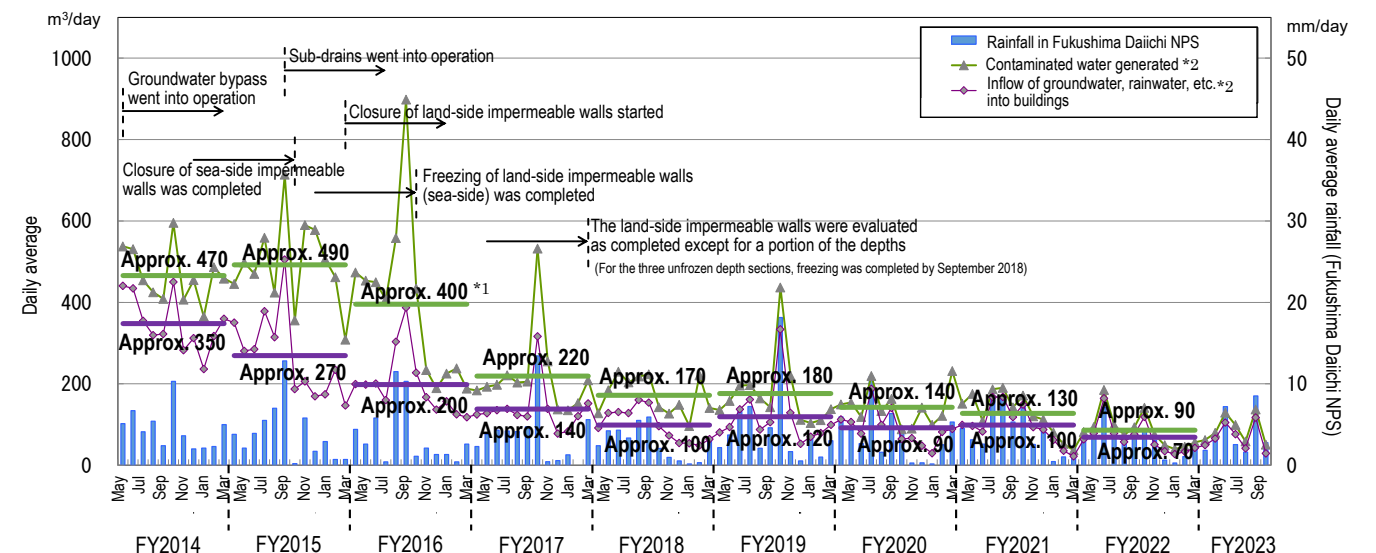
Figure 1: Changes in contaminated water generated and inflow of groundwater and rainwater into buildings

- Status of contaminated water generated
 - Multi-layered measures, including pumping up by sub-drains and land-side impermeable walls, which were implemented to control the continued generation of contaminated water, suppressed the groundwater inflow into buildings.
 - After implementing “redirecting” measures (groundwater bypass, sub-drains, land-side impermeable walls and others) and rainwater prevention measures, including repairing damaged portions of building roofs and due to less rainfall than in previous normal years without concentrated heavy rain of 100 mm/day or more, the amount of contaminated water generated within FY2022 declined to approx. 90 m³/day.
 - Measures will continue to further reduce the amount of contaminated water generated.

*1 Values differ from those announced at the 20th Committee on Countermeasures for Contaminated Water Treatment (held on August 25, 2017) because the method of calculating the contaminated water volume generated was reviewed on March 1, 2018. Details of the review are described in the materials for the 50th and 51st meetings of the Secretariat of the Team for Countermeasures for Decommissioning and Contaminated Water Treatment.
*2: The monthly daily average is derived from the daily average from the previous Thursday to the last Wednesday, which is calculated based on the data measured at 7:00 on every Thursday.

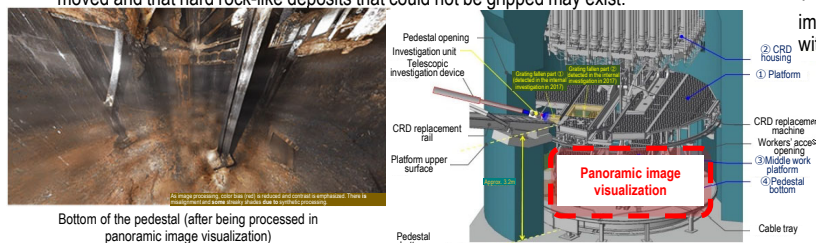
- In January 2017, a camera was inserted from the PCV penetration to inspect the conditions of the rail on which the robot traveled. The results of a series of investigations confirmed some gratings had fallen and deformed as well as a quantity of deposit inside the pedestal.

- In January 2018, the conditions below the platform inside the pedestal were investigated. Based on the analytical results of images obtained in the investigation, deposits, probably including fuel debris, were found at the bottom of the pedestal. Moreover, multiple parts exceeding the surrounding deposits were also detected. We presumed that there were multiple instances of fuel debris falling.

- In February 2019, an investigation touching the deposits at the bottom of the pedestal and on the platform was conducted and confirmed that the pebble-shaped deposits, etc. could be moved and that hard rock-like deposits that could not be gripped may exist.
