Outline of Decommissioning, Contaminated Water and Treated Water Management Secretariat of the Team for Countermeasures for Decommissioning, Contaminated Water and Treated Water Management

Progress Status and Future Challenges of the Mid-and-Long-Term Roadmap toward Decommissioning of TEPCO Holdings Fukushima Daiichi Nuclear Power Station (Outline)

Progress status

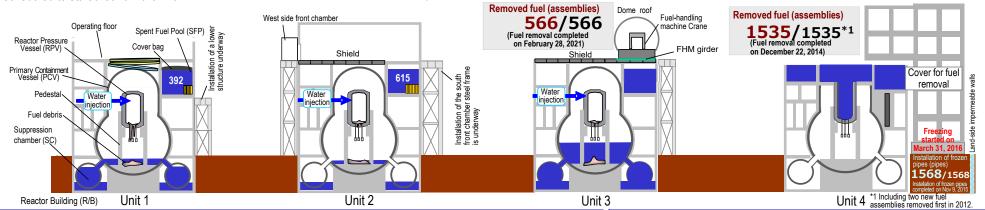
<Image of shielding installation (south side) January 10, 2024>

Before installing a large cover over the Unit 1 Reactor Building (R/B), high-dose parts were detected on the south-side wall. As a countermeasure to reduce exposure, shielding will be installed in the high-dose parts.

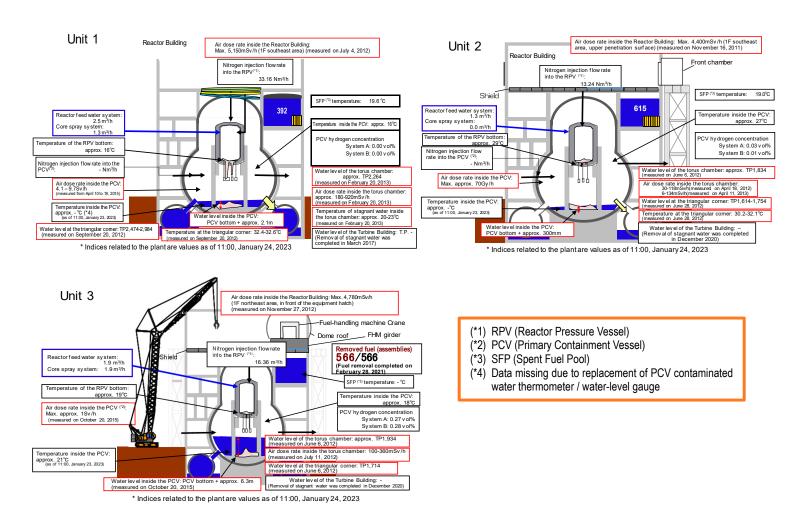
Through continuous reactor cooling by water injection, the temperatures of the Reactor Pressure Vessel (RPV) bottom and the Primary Containment Vessel (PCV) gas phase were maintained as shown below for recent, though it varied depending on the unit and location of the thermometer.

*1 The trend graphs show part of the temperature data measured at multiple points. *2 A part of data could not be measured due to maintenance and inspection of the facility and other work.

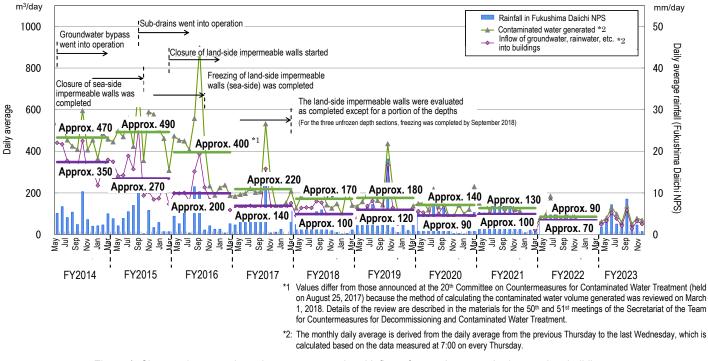
Figure 1: Changes in contaminated water generated and inflow of groundwater and rainwater into buildings

- Status of contaminated water generated
- · Multi-layered measures, including pumping up by sub-drains and land-side impermeable walls, which were buildings
- After implementing "redirecting" measures (groundwater bypass, sub-drains, land-side impermeable walls and others) water generated within FY2022 declined to approx. 90 m³/day.
- Measures will continue to further reduce the amount of contaminated water generated.

and rainwater prevention measures, including repairing damaged portions of building roofs and due to less rainfall than in previous normal years without concentrated heavy rain of 100 mm/day or more, the amount of contaminated

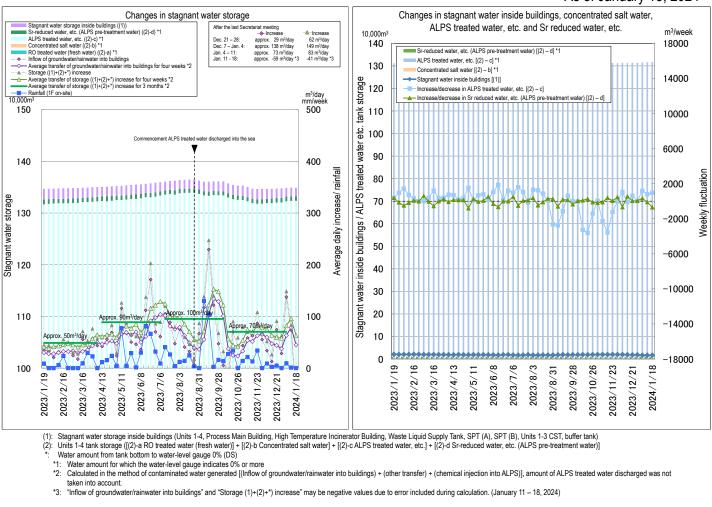
Figure 3: Status of stagnant water storage

- \geq Storage status of contaminated water and amount of ALPS treated water, etc. stored in tanks
- The amount of ALPS treated water, etc. was approx. 1,319,709 m³ as of January 18, 2024.
- The amount of ALPS treated water discharged into the sea was approx. 23,353 m³ as of January 24, 2024.

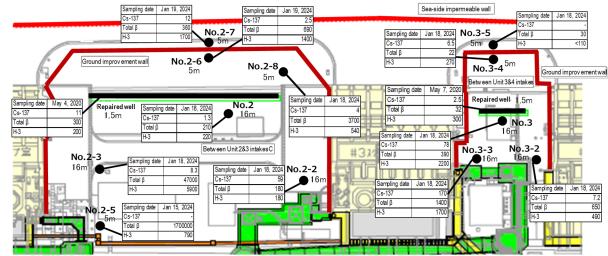
<Between Unit 2 and 3 intakes, between Unit 3 and 4 intakes> Figure 4: Groundwater concentration on the Turbine Building east side

90 declined and remained low after steel pipe sheet piles for the sea-side impermeable walls were installed and connected. Regarding the concentration of Cs-137, a temporary increase was sometimes observed on the north side of the Unit 5 and 6 outlets and near the south outlet due to the influence of weather, marine meteorology and other factors. Regarding the concentration of Sr-90, variation was observed in FY2021 in the area outside the port (north and south outlets). Monitoring of the tendency continues, including the potential influence of the weather, marine meteorology and others. During the period of discharge of ALPS treated water, the concentration of tritium increased at the sampling point near the discharge outlet, but this was considered as within the assumed range based on the

and has been declining long term, despite temporary increases in Cs-137 and Sr-90 observed during rainfall. They have remained below the level of those in the Units 1-4 intake open channel area and been declining following the completed installation and connection of steel pipe sheet piles for the sea-side impermeable walls.

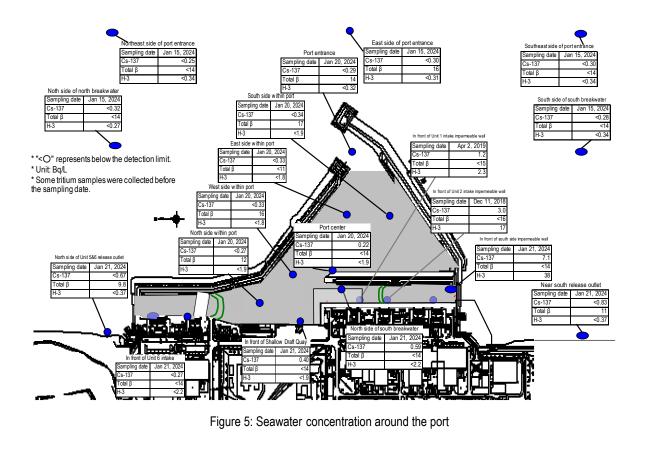
<Unit 1 intake north side, between Unit 1 and 2 intakes>

- In the open channel area of seawater intake for Units 1 to 4, the concentration of radioactive materials in seawater has remained below the legal discharge limit and been declining long term, despite the temporary increases in Cs-137 and Sr-90 observed during rainfall. They have also been declining following the completed installation and the connection of steel pipe sheet piles for the sea-side impermeable walls. The concentration of Cs-137 remained slightly higher in front of the south-side impermeable walls and slightly lower on the north side of the east breakwater since March 20, 2019, when the silt fence was transferred to the center of the open channel due to mega float-related construction.

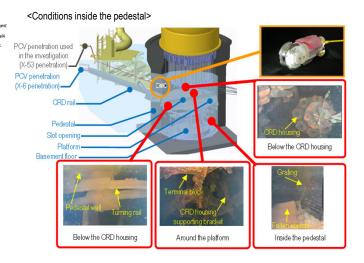
• In July 2017, the inside of the PCV was investigated using the underwater ROV (remotely operated underwater vehicle) to inspect the inside of the pedestal. Analysis of the imagery obtained in the investigation identified damage to multiple structures and the supposed core internals.

· Videos obtained in the investigation were reproduced in 3D. Based on the reproduced images, the relative positions of the structures, such as the rotating platform slipping off the rail with a portion buried in deposits, were visually understood.
