## Main decommissioning work and steps

Fuel removal from the spent fuel pool was completed on December 22, 2014 at Unit 4 and February 28, 2021 at Unit 3. Trial fuel debris retrieval at Unit 2 commenced on September 10, 2024 and a milestone of the Mid-and-Long-Term Roadmap "Commencing fuel debris retrieval at the first Unit" was achieved.

# I. Confirmation of the reactor conditions

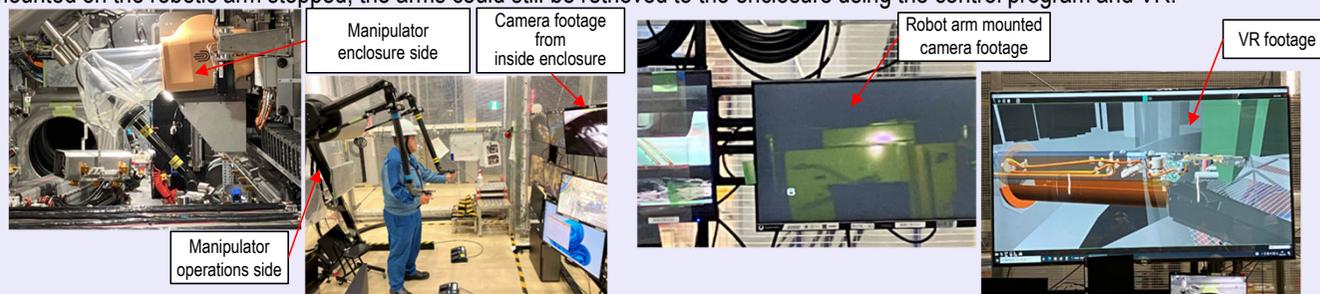
Manipulator operations

Performing operations while checking camera footage and virtual reality

On-site work will be performed using large devices that are completely remotely operated, and the difficulty level of the work is extremely high, so maintenance tasks are being performed on a mockup of the facility that assumes the risks.

Currently, visibility during camera replacement is being checked, and training on using the manipulator to replace the cameras, as well as operations to withdraw the arm in the event of emergency, are underway. During the test, it was confirmed that even if all the cameras mounted on the robotic arm stopped, the arms could still be retrieved to the enclosure using the control program and VR.

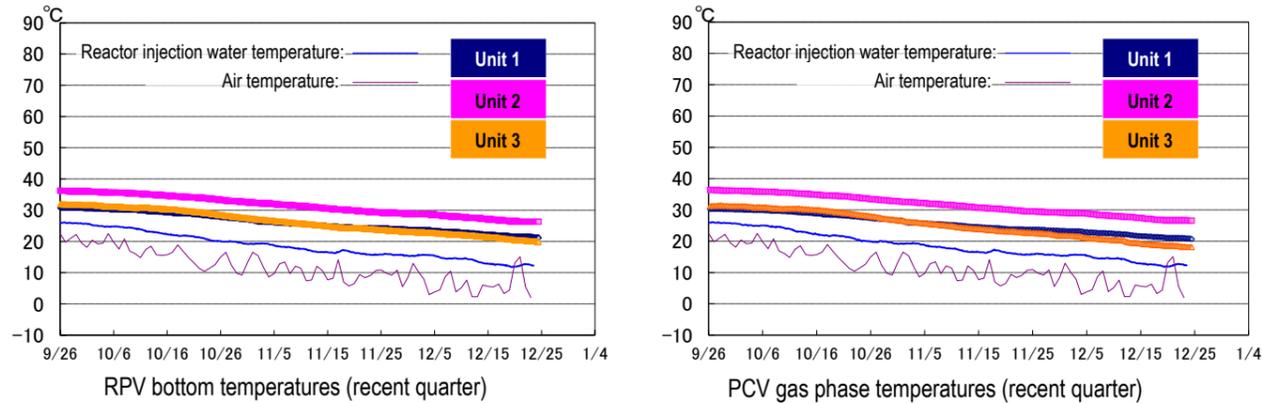
Through continuous reactor cooling by water injection, the temperatures of the Reactor Pressure Vessel (RPV) bottom and the Primary Containment Vessel (PCV) gas phase were maintained as shown below for recent, though they varied depending on the unit and location of the thermometer.

\*1 The trend graphs show part of the temperature data measured at multiple points.  
\*2 A part of data could not be measured due to maintenance and inspection of the facility and other work.

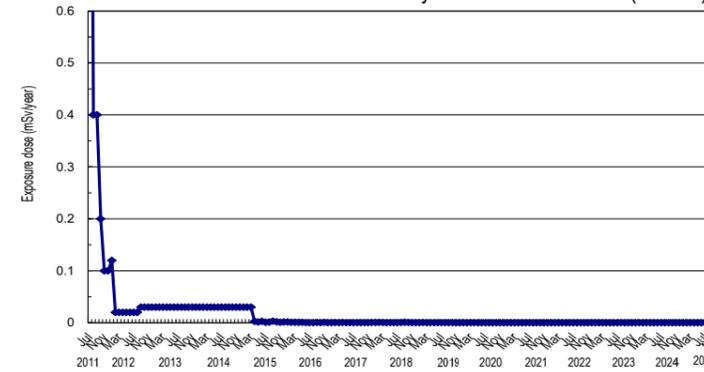
## Annual radiation dose at site boundaries by radioactive materials (cesium) released from Reactor Building Units 1-4

- \* The concentration limit of radioactive materials in the air outside the surrounding monitoring area:  
[Cs-134]:  $2 \times 10^{-5}$  Bq/cm<sup>3</sup>  
[Cs-137]:  $3 \times 10^{-5}$  Bq/cm<sup>3</sup>
- \* Data of Monitoring Posts (MP1-MP8).  
Data of Monitoring Posts (MPs) measuring the air dose rate around the site boundary showed 0.280-0.952 μSv/h (November 26 – December 23, 2025).  
To measure the variation in the air dose rate of MP2-MP8 more accurately, work to improve the environment (trimming trees, removing surface soil and shielding around the MPs) was completed.

Note 1: Different formulas and coefficients were used to evaluate the radiation dose in the facility operation plan and monthly report. The evaluation methods were integrated in September 2012. As the fuel removal from the spent fuel pool (SFP) commenced for Unit 4, the radiation exposure dose from Unit 4 was added to the items subject to evaluation since November 2013. The evaluation has been changed to a method considering the values of continuous dust monitors since FY2015, with data to be evaluated monthly and announced the following month.

Note 2: Radiation dose was calculated using the evaluation values of release amount from Units 1-4 and Units 5 and 6. The radiation dose of Unit 5 and 6 was evaluated based on expected release amount during operation until September 2019 but the evaluation method was reviewed and changed to calculate based on the actual measurement results of Units 5 and 6 from October.

Note 3: Dose assessment has been changed since July 2024 due to the change of standard meteorology, etc. in the implementation plan (effective July 8, 2024).

As of November 2025, the concentration of radioactive materials newly released from Reactor Building Units 1-4 into the air and measured at the site boundary was evaluated at approx.  $5.1 \times 10^{-12}$  Bq/cm<sup>3</sup> and  $1.1 \times 10^{-11}$  Bq/cm<sup>3</sup> for Cs-134 and -137 respectively, while the radiation exposure dose due to the release of radioactive materials there was less than 0.00003 mSv/year.

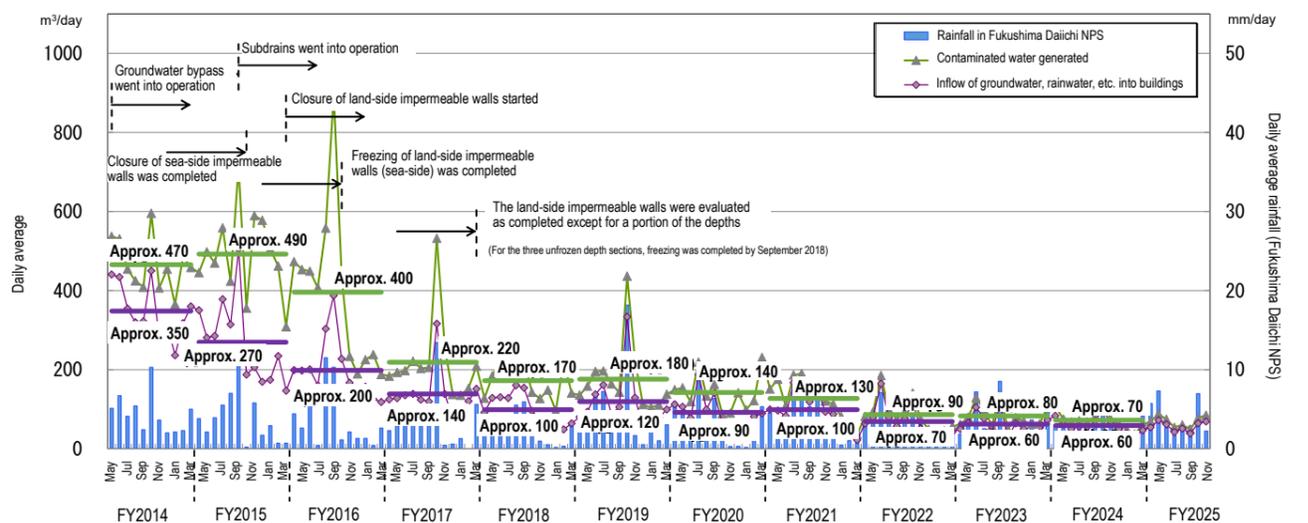
Figure 1: Changes in contaminated water generated and inflow of groundwater and rainwater into buildings

\*1 Values differ from those announced at the 20<sup>th</sup> Committee on Countermeasures for Contaminated Water Treatment (held on August 25, 2017) because the method of calculating the contaminated water volume generated was reviewed on March 1, 2018. Details of the review are described in the materials for the 50<sup>th</sup> and 51<sup>st</sup> meetings of the Secretariat of the Team for Countermeasures for Decommissioning and Contaminated Water Treatment.

\*2: The monthly daily average is derived from the daily average from the previous Thursday to the last Wednesday, which is calculated based on the data measure

- Multi-layered contaminated water management measures, including land-side impermeable walls and subdrains, have stabilized the groundwater at a low level and the increased contaminated water generated during rainfall is being suppressed by repairing damaged portions of building roofs facing onsite. Through these measures, the generation of contaminated water has been suppressed and reduced from approx. 540 m<sup>3</sup>/day (in May 2014) before implementing measures to approx. 70 m<sup>3</sup>/day (in FY2024). It was confirmed that the milestone of “suppressing the amount of contaminated water generated to 100 m<sup>3</sup>/day or less during average rainfall within FY2025,” which was achieved in FY2023, has been maintained in FY2024.
- Measures will proceed to further reduce the amount of contaminated water generated and suppress to approx. 50-70 m<sup>3</sup>/day by FY2028.

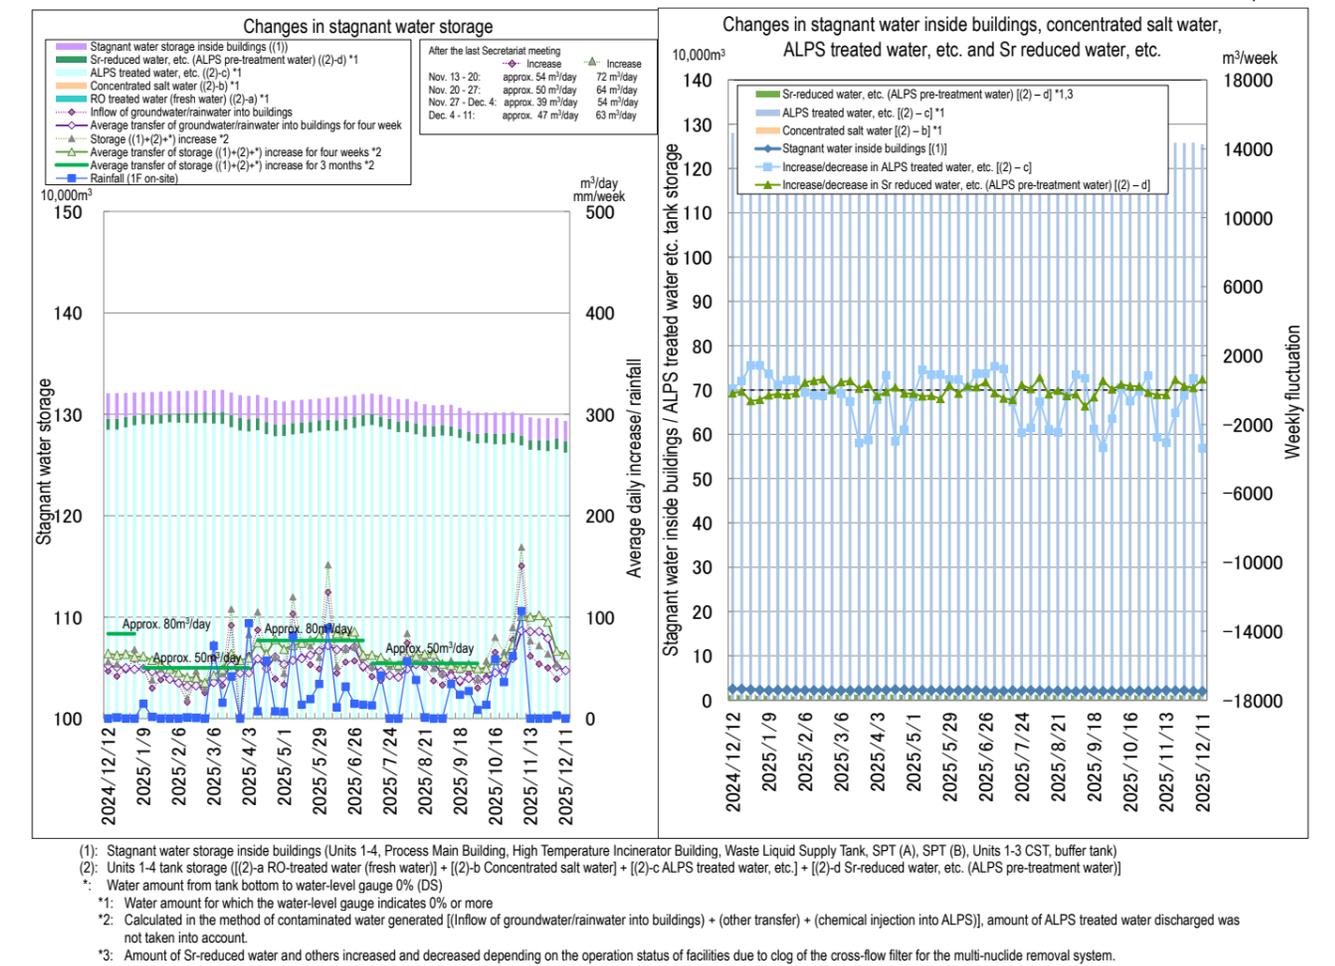
Figure 3: Status of stagnant water storage

As of December 11, 2025

- The total volume of ALPS treated water discharged into the sea since the discharge commenced on August 24, 2023, was approx. 133,321 m³ as of the completion of the sixth discharge in FY2025.

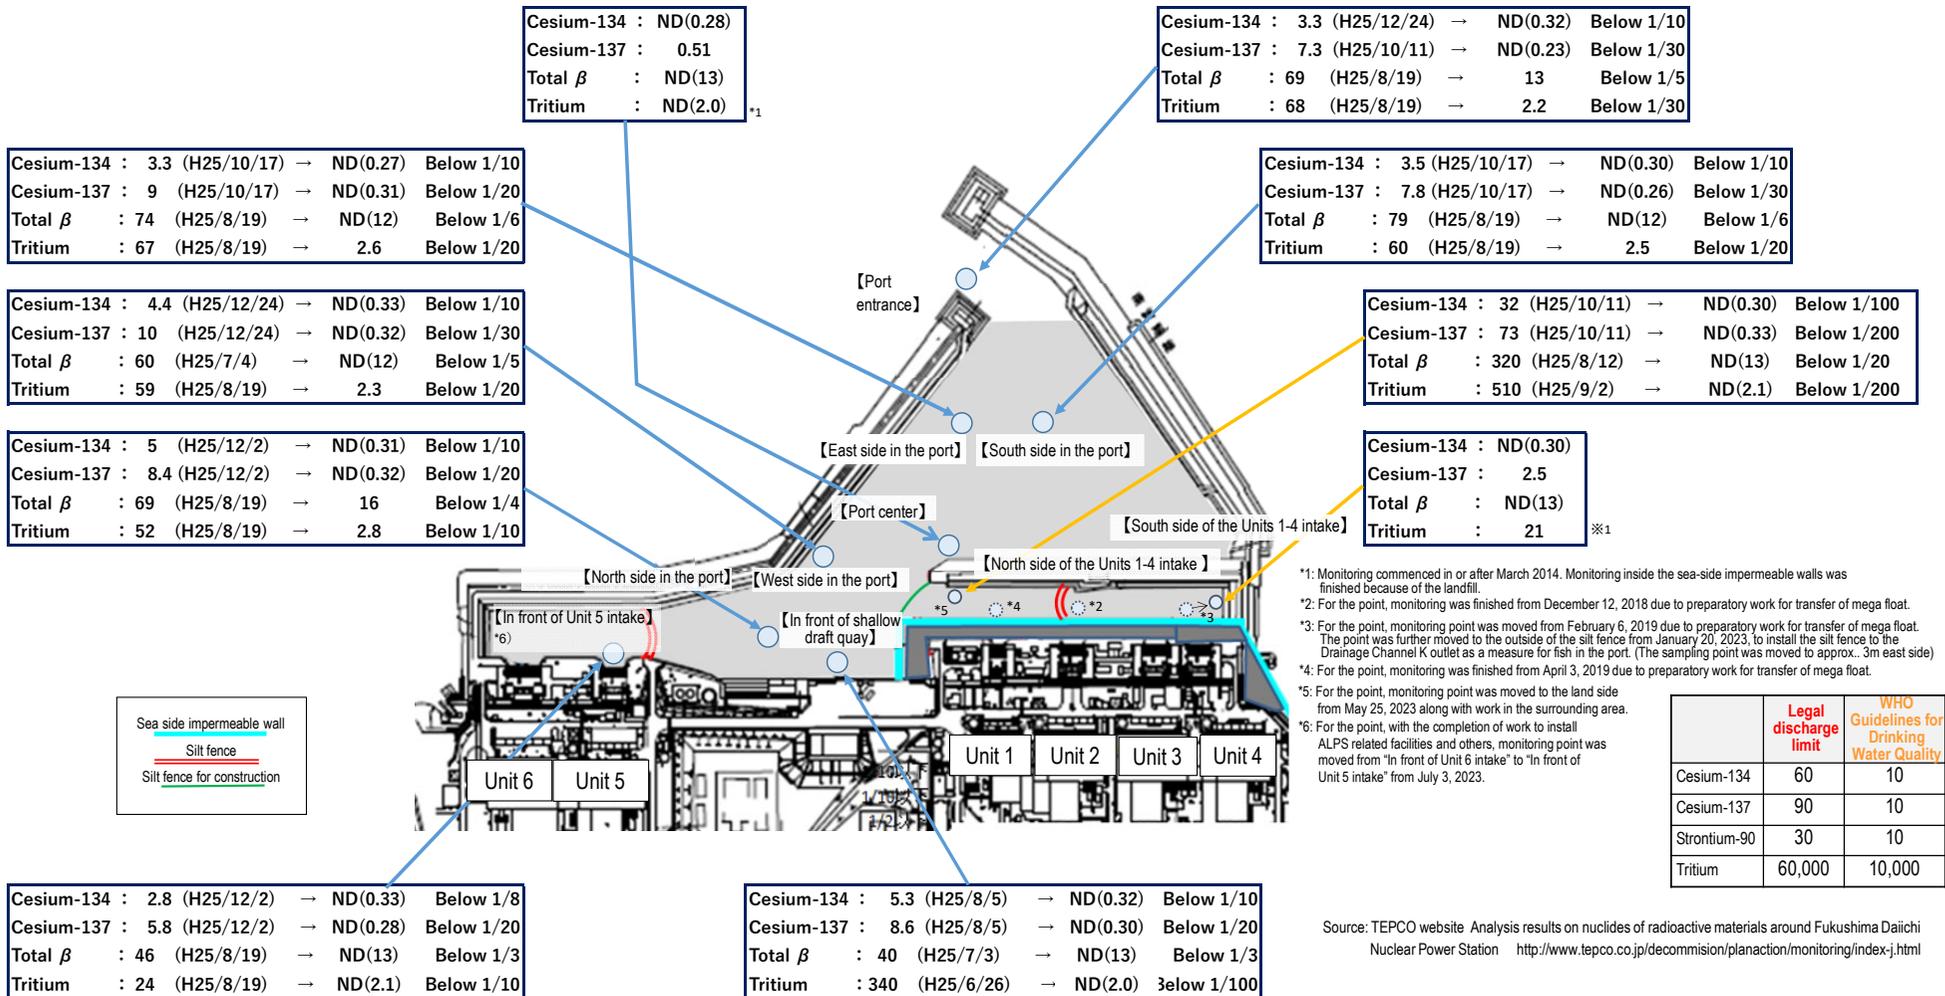
Note: The Total β measurement value is the total radioactivity concentration of radioactive materials that emit β-ray (Potassium-40, Cesium-137, Strontium-90, progeny nuclide Yttrium-90, etc.). In general, approx. 12 Bq/L of natural nuclide Potassium-40 is included in seawater.

Summary of TEPCO data as of December 23, 2025

- In the open channel area of the seawater intake for Units 1 to 4, the concentration of radioactive materials in seawater has remained below the legal discharge limit and been declining long term, despite the temporary increases in Cs-137 and Sr-90 observed during rainfall. They have also been declining following the completed installation and the connection of steel pipe sheet piles for the sea-side impermeable walls. The concentration of Cs-137 remained slightly higher in front of the south-side impermeable walls and slightly lower on the north side of the east breakwater since March 20, 2019, when the silt fence was transferred to the center of the open channel due to mega float-related construction.

- In the port area, the concentration of radioactive materials in seawater has remained below the legal discharge limit and been declining long term, despite temporary increases in Cs-137 and Sr-90 observed during rainfall. They have remained below the level of those in the Units 1-4 intake open channel area and been declining following the completed installation and connection of steel pipe sheet piles for the sea-side impermeable walls.

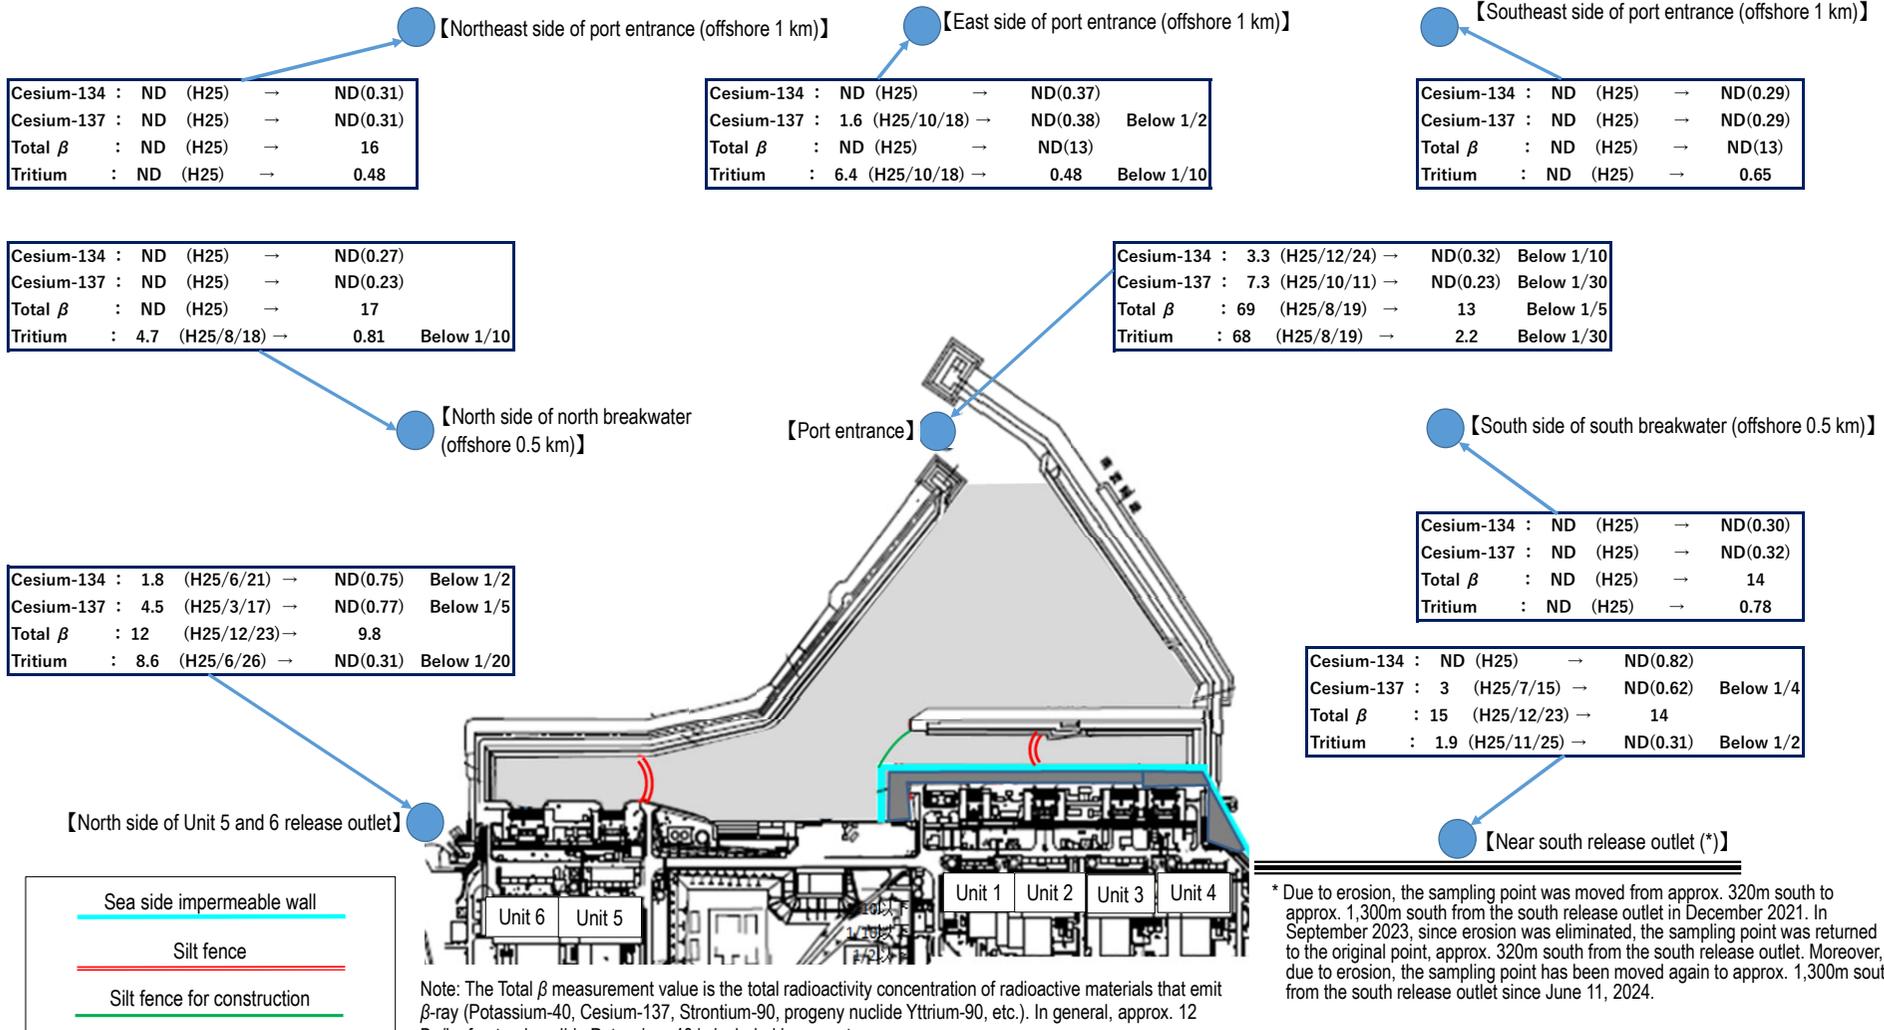
## Status of seawater monitoring around outside of the port (comparison between the highest values in 2013 and the latest values)

Unit (Bq/L); ND represents a value below the detection limit; values in ( ) represent the detection limit; ND (2013) represents ND throughout 2013

Legal discharge limit	WHO Guidelines for Drinking Water Quality
Cesium-134	60	10
Cesium-137	90	10
Strontium-90	30	10
Tritium	60,000	10,000

\* Due to erosion, the sampling point was moved from approx. 320m south to approx. 1,300m south from the south release outlet in December 2021. In September 2023, since erosion was eliminated, the sampling point was returned to the original point, approx. 320m south from the south release outlet. Moreover, due to erosion, the sampling point has been moved again to approx. 1,300m south from the south release outlet since June 11, 2024.

- In the area outside the port, regarding the concentration of radioactive materials in seawater, those of Cs-137 and Sr-90 declined and remained low after steel pipe sheet piles for the sea-side impermeable walls were installed and connected. For Cs-137 concentrations, a temporary increase was sometimes observed on the north side of the Units 5 and 6 outlets and near the south outlet due to the influence of weather, marine meteorology and other factors. For Sr-90 concentrations, variation was observed in FY2021 in the area outside the port (north and south outlets). Monitoring of the tendency continues, including the potential influence of weather, marine meteorology and others. During the period for which ALPS treated water was discharged, the tritium concentration increased at the sampling point near the discharge outlet, but this was considered within the assumed range based on the oceanic dispersion simulation results.

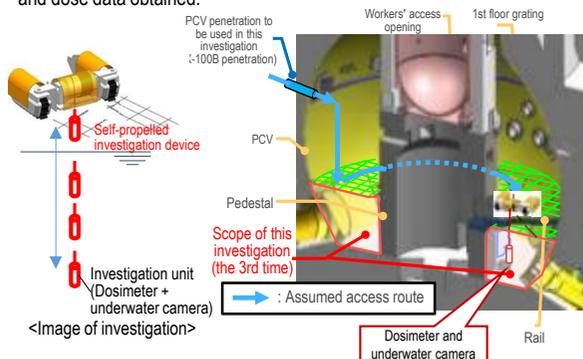
- In April 2015, a device having entered the inside of the PCV via a narrow opening (bore:φ100 mm) collected information such as images and airborne dose inside the PCV 1st floor.
- In March 2017, an investigation using a self-propelled investigation device was conducted to inspect the spreading of debris to the basement floor outside the pedestal, with images taken of the PCV bottom status for the first time. The conditions inside the PCV will continue to be examined, based on the imagery and dose data obtained.

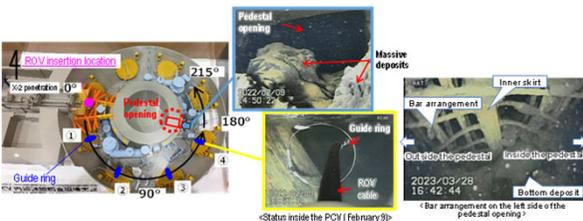
In February 2022, "the guide ring" was installed to facilitate the investigation. From March 28, 2023, the investigation inside the pedestal by ROV-A2 started and confirmed that a portion of the bar arrangement was exposed. Regarding the soundness of the pedestal, based on the past earthquake resistant evaluation by the International Research Institute for Nuclear Decommissioning (IRID), it was evaluated that even though a portion of the pedestal was lost, there would be no serious risk. However, as the present information is very limited, the investigation will continue to acquire as much information as possible for continued evaluation.

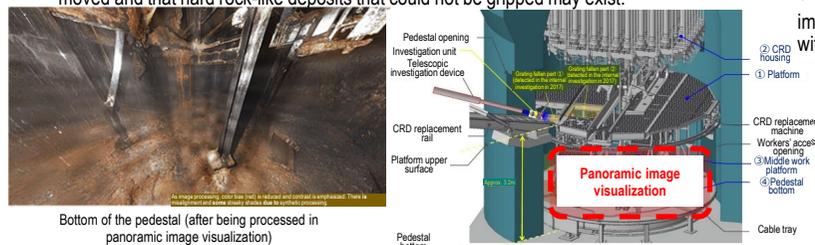
- In January 2017, a camera was inserted from the PCV penetration to inspect the conditions of the rail on which the robot traveled. The results of a series of investigations confirmed some gratings had fallen and deformed as well as a quantity of deposit inside the pedestal.

- In January 2018, the conditions below the platform inside the pedestal were investigated. Based on the analytical results of images obtained in the investigation, deposits, probably including fuel debris, were found at the bottom of the pedestal. Moreover, multiple parts exceeding the surrounding deposits were also detected. We presumed that there were multiple instances of fuel debris falling.

- In February 2019, an investigation touching the deposits at the bottom of the pedestal and on the platform was conducted and confirmed that the pebble-shaped deposits, etc. could be moved and that hard rock-like deposits that could not be gripped may exist.

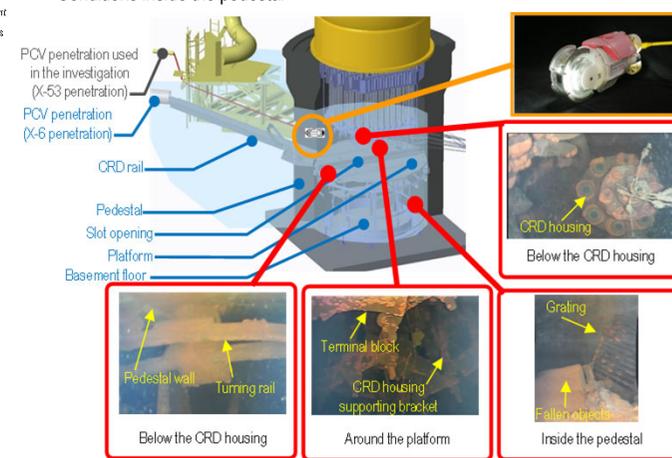
<Conditions inside the pedestal>

- In July 2017, the inside of the PCV was investigated using the underwater ROV (remotely operated underwater vehicle) to inspect the inside of the pedestal. Analysis of the imagery obtained in the investigation identified damage to multiple structures and the supposed core internals.

- Videos obtained in the investigation were reproduced in 3D. Based on the reproduced images, the relative positions of the structures, such as the rotating platform slipping off the rail with a portion buried in deposits, were visually understood.

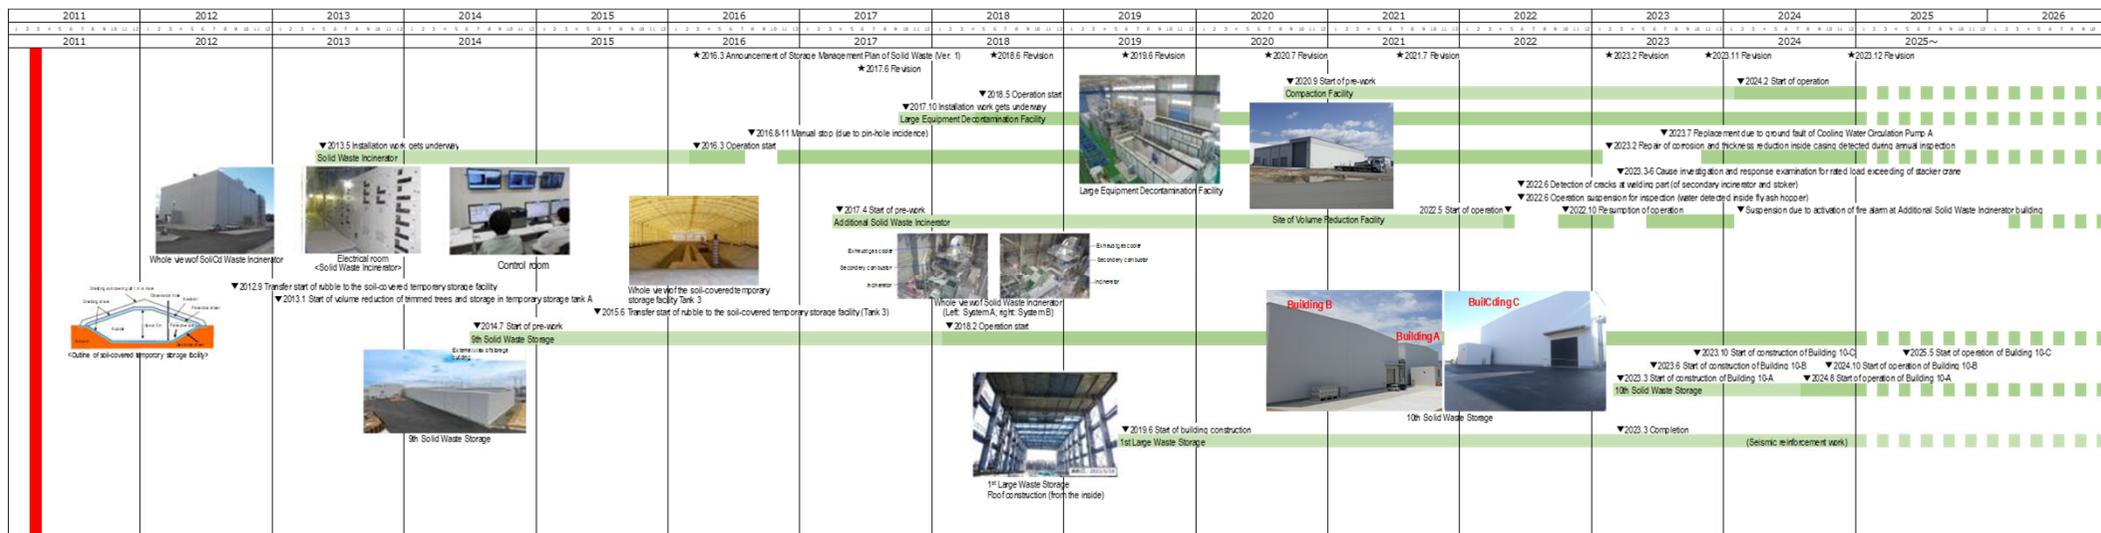
Milestones of the Mid- and Long-Term Roadmap (major target processes)  
Eliminating temporary outdoor storage of rubble and others \* Except for secondary waste of water treatment and materials for reuse or recycling (within FY2028)

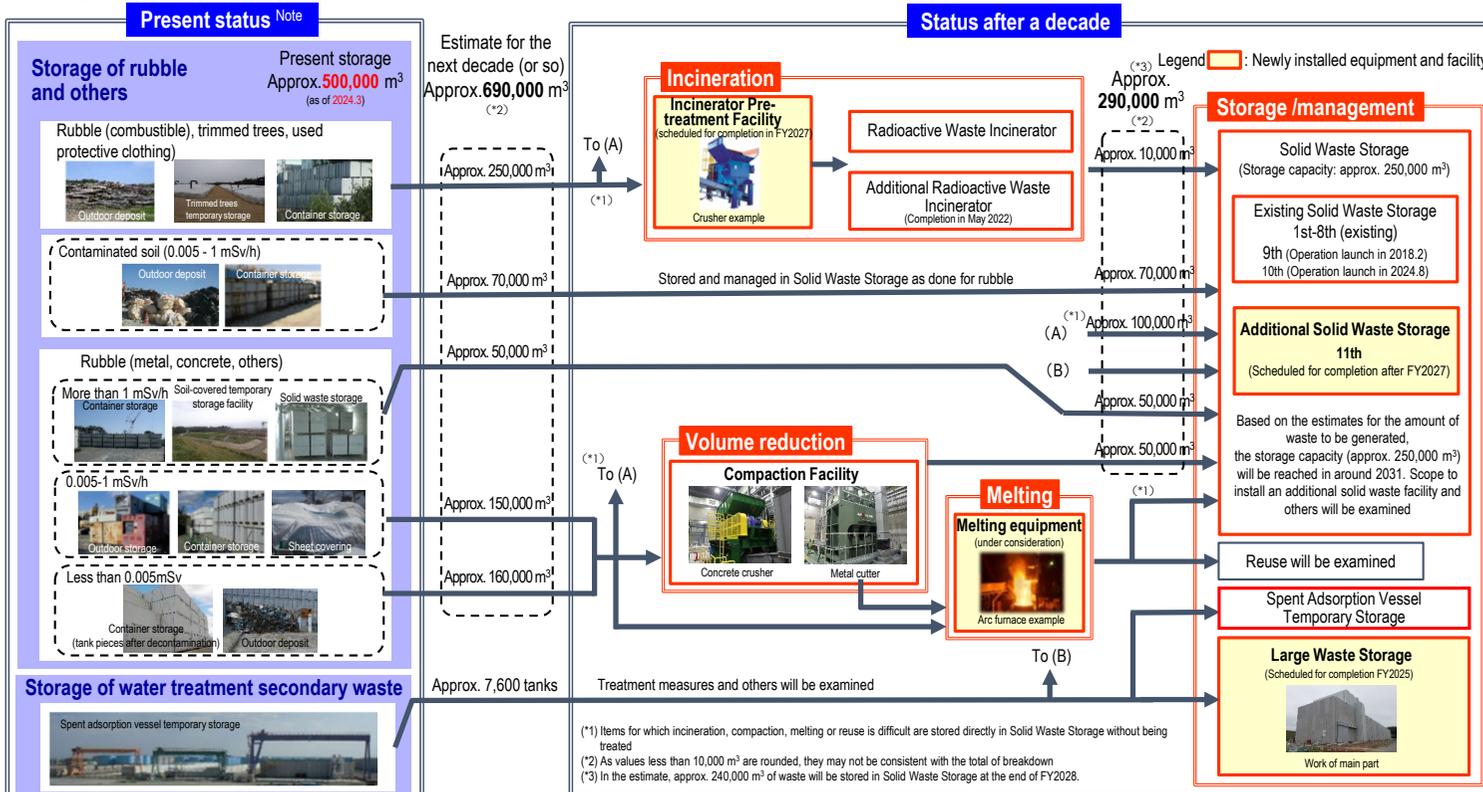
● Solid Waste Storage Management Plan for the Fukushima Daiichi Nuclear Power Station (Revision in December 2024)

Note: Used protective clothing before incineration and BG-level concrete waste for which treatment and reuse is decided at present are not included.
