Fukushima Daiichi Nuclear Power Station Unit 3 PCV Internal Investigation (non-submerged area) using a Micro-drone

August 28, 2025

Tokyo Electric Power Company Holdings, Inc.

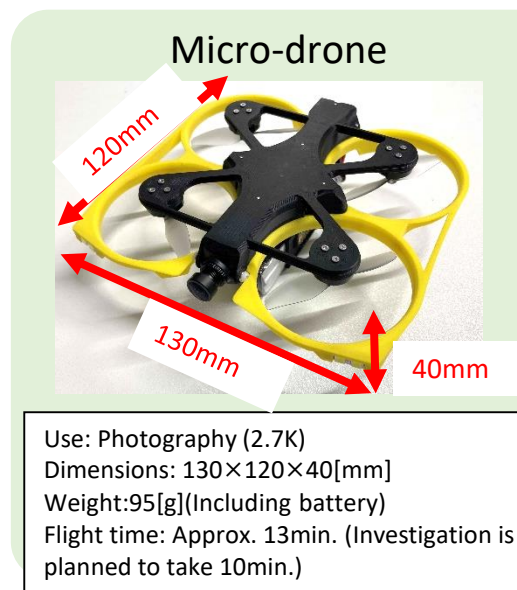
Concept diagram of Unit 3 micro-drone investigation
