Soundness Verification of Unit 4 Reactor Building at Fukushima Daiichi Nuclear Power Station

May 16, 2012

Tokyo Electric Power Company

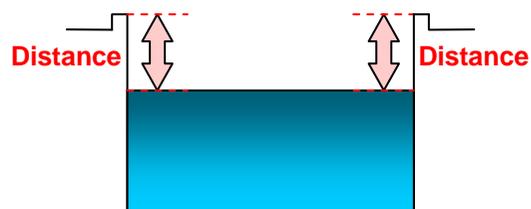
1) Building not tilted

The distances between the floor surface and the water levels of the reactor well and spent fuel pool are measured to check if the building is tilted or not. (It has already been confirmed that the building is not tilted based on the measurement results acquired on February 7, 2012 and April 12, 2012.)

The distances are the same

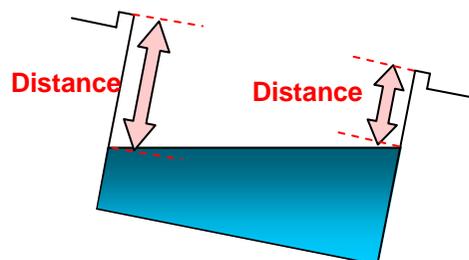
2) Building tilted

Difference in the distances

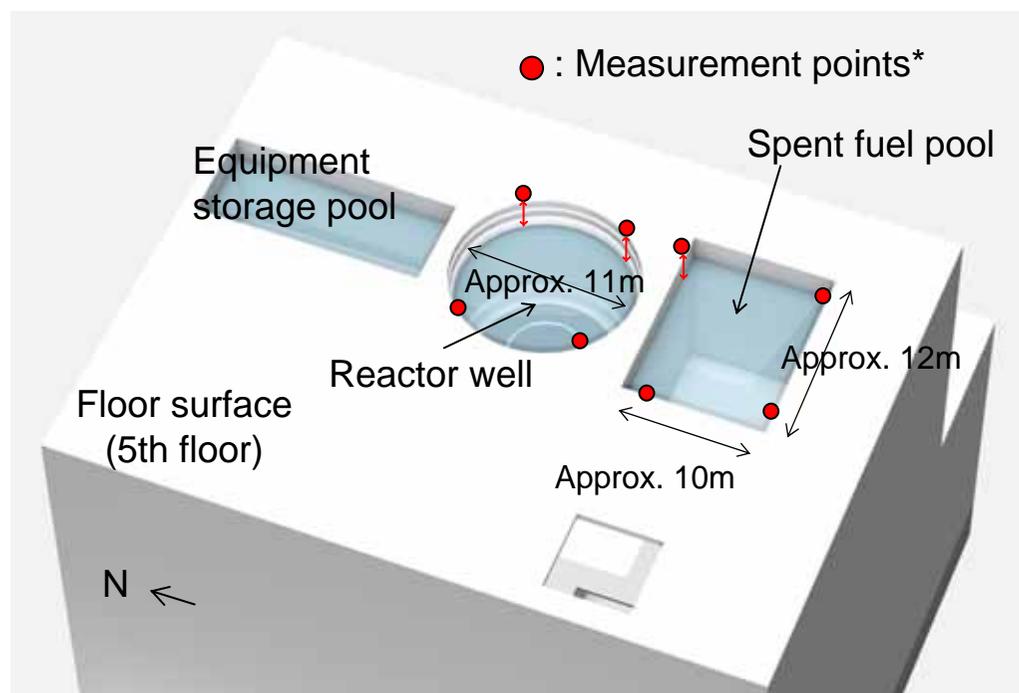
Measurement Points (Floor surface of the 5th floor)

* The measurement points are set according to the progress statuses of debris removal and cover installation for fuel removal.

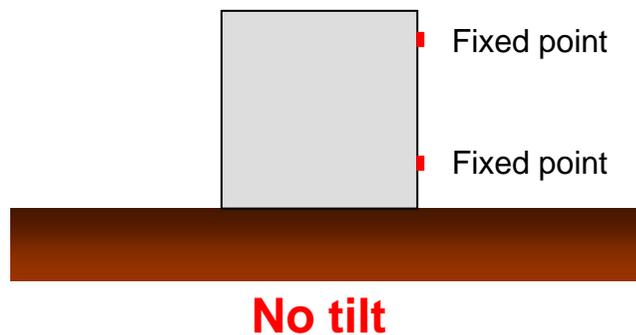
1) Building not tilted

The outer wall perpendicularity is measured by using an optical equipment (fixed points set on the upper and lower side of the wall).

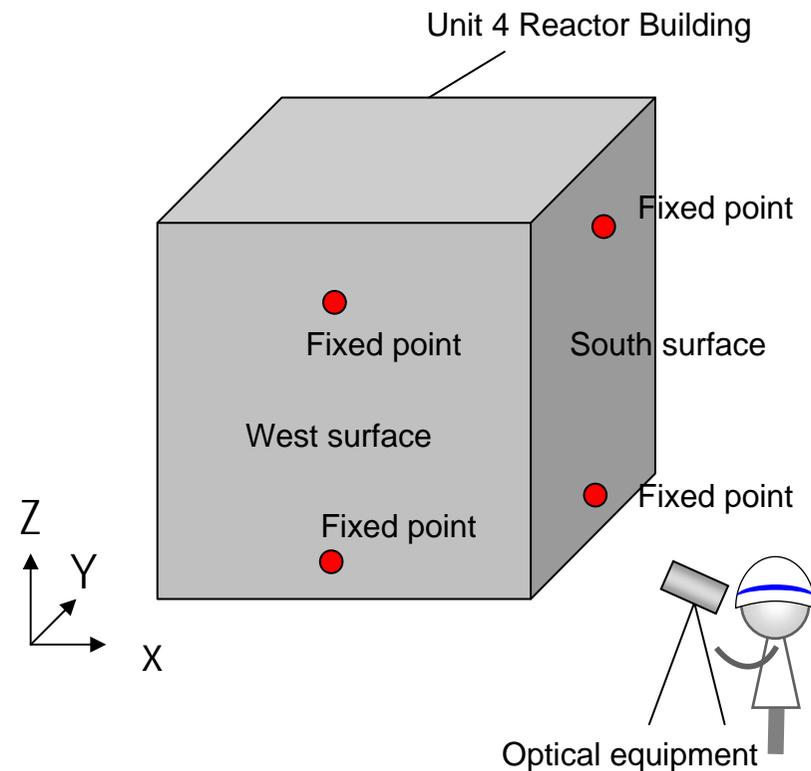
Measurement

* North/East surfaces cannot be measured they're blocked by existing buildings.

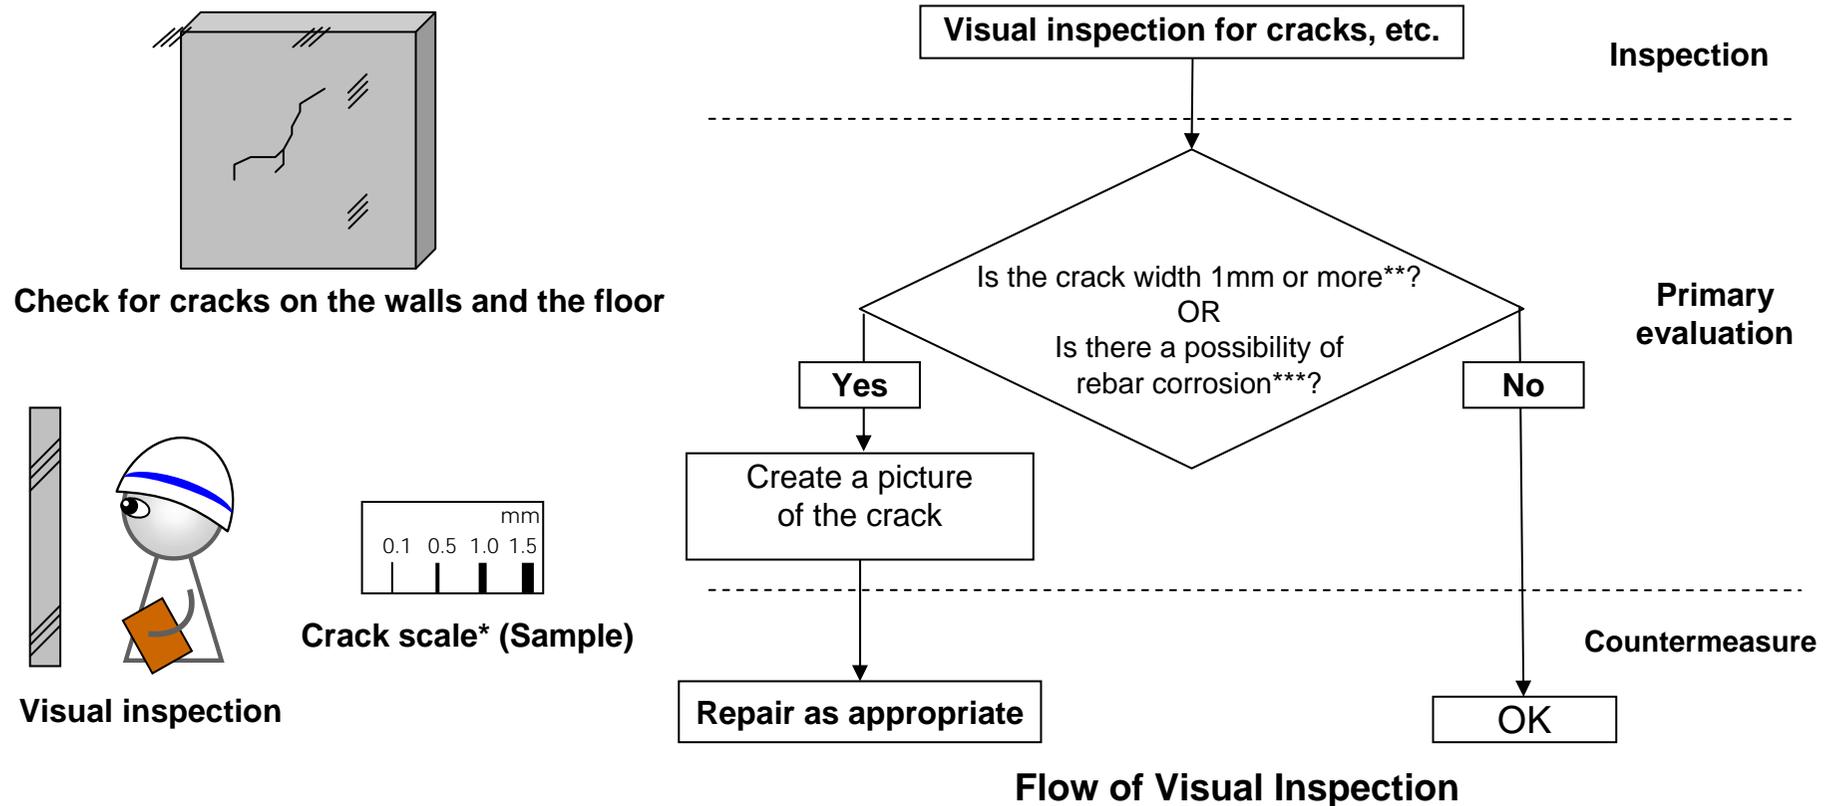
The concrete floor and walls of the spent fuel pool (building frame) are visually inspected for defects such as cracks. In the case that cracks with the width of 1mm or more are found, repair must be done as appropriate.

* Crack scale: Used to measure the width of a crack. (Put the scale on a crack to measure its width.)

** In the case that the crack width is 1mm or more, the durability of the building must be reviewed in accordance with "Maintenance and Management of Structures in Nuclear Facilities" specified by the Architectural Institute of Japan.

*** In the case that rebar corrosion which may affect the durability of the building is found.

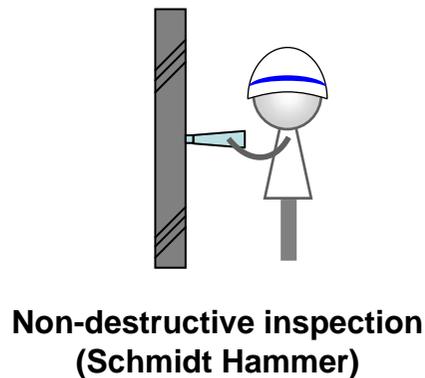
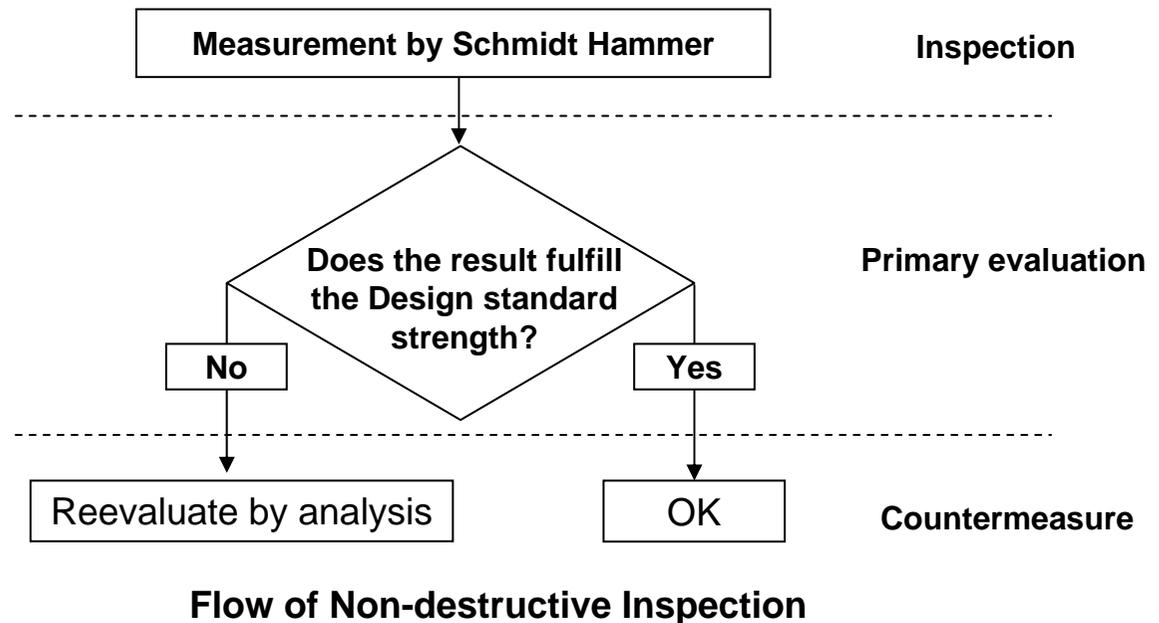
The concrete strength of the spent fuel pool is measured by non-destructive inspection techniques (such as Schmidt Hammer*) to confirm that the strength fulfills the design standard.

* Schmidt Hammer Technique: A non-destructive inspection technique to estimate concrete strength by hammering the concrete and measuring the impact returned.

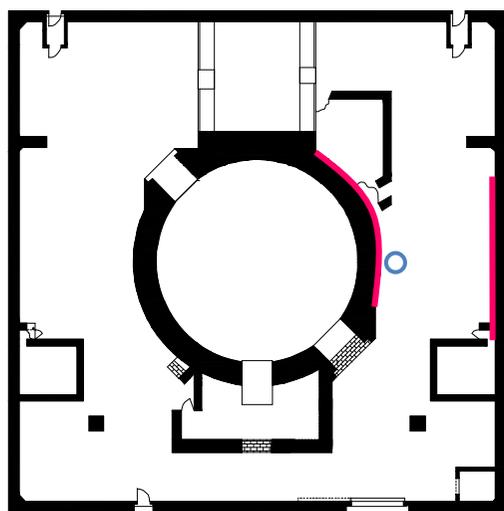
1st Floor

The proposed areas subject to inspection are indicated in the plans below. Inspection is done within the range in which safety is ensured, considering the factors such as debris and radiation dose.
