Main works and steps for decommissioning

Summary of TEPCO data as of May 27

TEPCO Fukushima Daiichi Nuclear Power Station Site Layout

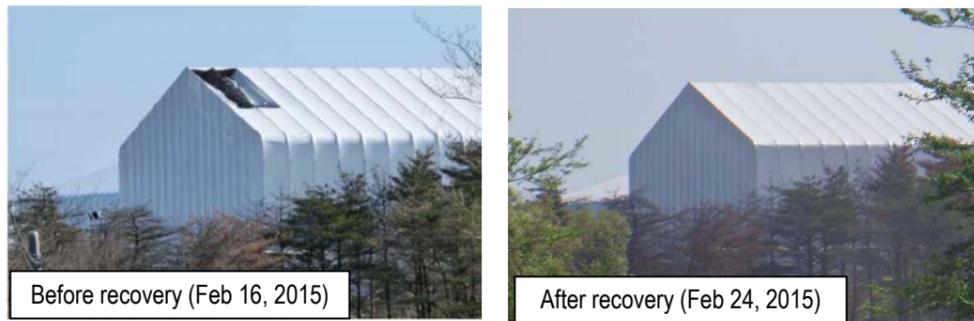
Figure 10: Recovery status of A tent

- Damage was detected in the upper sheet of the temporary rubble storage area A1 (A tent), which temporarily stored a high dose of rubble (below 30 mSv/h) under shields (February 16). Repair of the damaged portion of the upper sheet was completed (April 24). The sheets were presumably turned off following the disconnection of sheet guides having fixed the sheets to the tent frames, which, in turn, was hit by a larger gulf of wind.

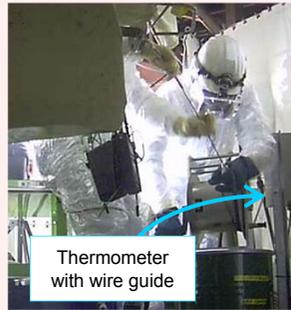
Removal situation of broken thermometer inside Unit 2 RPV

- (1) Replacement of the RPV thermometer
 - As the thermometer installed at the Unit 2 RPV bottom after the earthquake had broken, it was excluded from the monitoring thermometers (February 19, 2014).

- On April 17, 2014, removal of the broken thermometer failed and was suspended. Rust-stripping chemicals were injected and the broken thermometer was removed on January 19, 2015. A new thermometer was reinstalled on March 13, 2015. The thermometer has been used as a part of permanent supervisory instrumentation since April 23.
