Main works and steps for decommissioning

Fuel removal from Unit 4 SFP had been completed and preparatory works to remove fuel from Unit 1-3 SFP and fuel debris (Note 1) removal are ongoing.

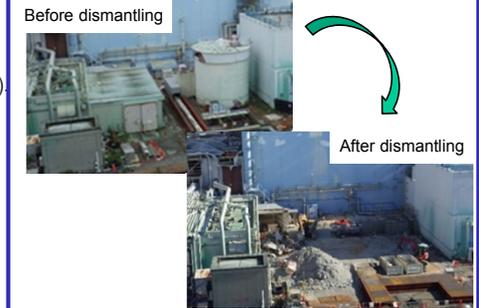
(Preparation around the Unit 2 Reactor Building)

Toward fuel removal from Unit 2 SFP, preparation around the building is underway.

Dismantling of hindrance buildings around the Reactor Building has been underway since September 2015 to clear a work area within which to install large heavy-duty machines, etc.
