Main works and steps for decommissioning

Fuel removal from Unit 4 SFP had been completed and preparatory works to remove fuel from Unit 1-3 SFP and fuel debris (Note 1) removal are ongoing.

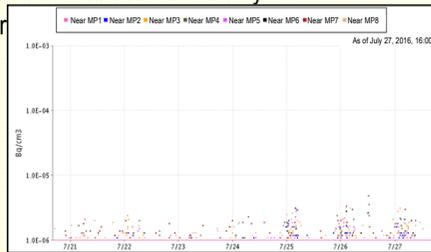
(Alert setting value: 1×10^{-5} Bq/cm³)
<Measurement results of site-boundary dust monitors>

Real-time disclosure of measurement results from dust monitors near the site boundary

To provide timelier and clearer information regarding the environmental impact on the area around the site, real-time data of the measurement results near the site boundary has been disclosed since July 12.

- On July 3, a “high alert” indicating an increased density of dust radiation was issued from the dust monitor near the monitoring post (MP) No. 8.
- The cause was considered to be natural nuclides for the following reasons: no abnormality was detected in other dust monitors and plant parameters; the wind was blowing from outside the site; there was no on-site work around the monitor that could be attributable to dust increase; only natural nuclides (bismuth 214 and Thallium 208) were found in the nuclide analysis on the filter used at the time the alert was issued; and the density increase tendency resembled the alert insurance caused by natural nuclides in August 2015.
- Real-time disclosure of values collected from continuous monitors near MPs started on July 12 (the data has been updated every ten minutes).

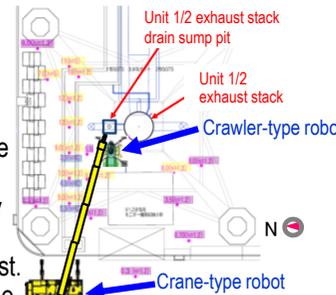
<Layout of remote-controlled robots>

Investigation on the Unit 1/2 exhaust stack drain sump pit

Regarding the exhaust stack drain sump pit, where evaluated as "investigation required" in the comprehensive risk reviewing, the water level and quality will be investigated and measures will be taken by using a remote-controlled robots and other equipment because of the high dose around the pit.

On-site preparation started on July 25 to implement an investigation inside the pit from mid- to late-August. Accumulated water found inside the pit would be released in the building.

➤ Response to the Unit 1/2 exhaust stack drain sump pit

- Regarding the Unit 1/2 exhaust stack drain sump pit, where evaluated as “investigation required” in the comprehensive risk review, the water level and quality will be investigated and measures will be taken by using a remote-controlled robot and other equipment because of the high dose around the pit.
- On-site preparation started on July 25 to implement an investigation inside the pit from mid- to late- August.
- Accumulated water found inside the pit would be released in the building.

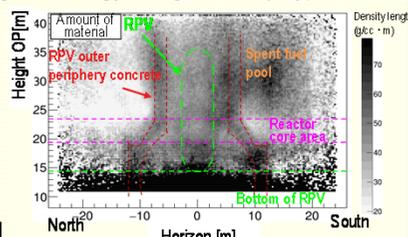
<Muon measurement results>

The investigation confirmed the existence of high-density materials, which was considered as fuel debris, at the bottom of the RPV, and in the lower part and outer periphery of the reactor core. It was assumed that a large part of the fuel debris existed at the bottom of the RPV.

The results of this investigation will be utilized when considering how to remove fuel debris.

Capturing the location of fuel debris inside the reactor by measurement using muons

Period	Evaluation results
Mar - Jul 2016	Confirmed the existence of high-density materials, which was considered as fuel debris, at the bottom of RPV, and in the lower part and the outer periphery of the reactor core. It was assumed that a large part of fuel debris existed at the bottom of RPV.

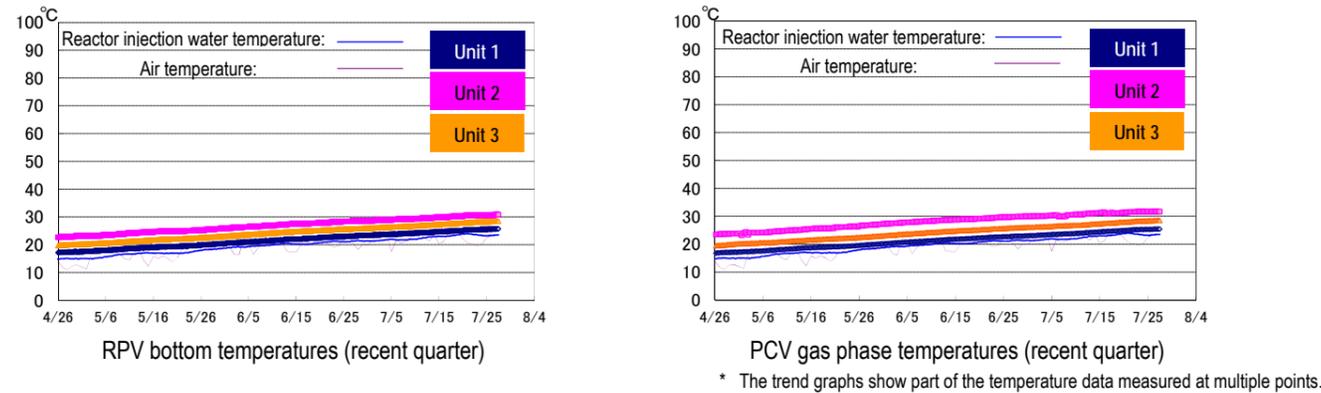
1. Temperatures inside the reactors

Through continuous reactor cooling by water injection, the temperatures of the Reactor Pressure Vessel (RPV) bottom and the Primary Containment Vessel (PCV) gas phase have been maintained within the range of approx. 20 to 35°C for the past month, though they vary depending on the unit and location of the thermometer.

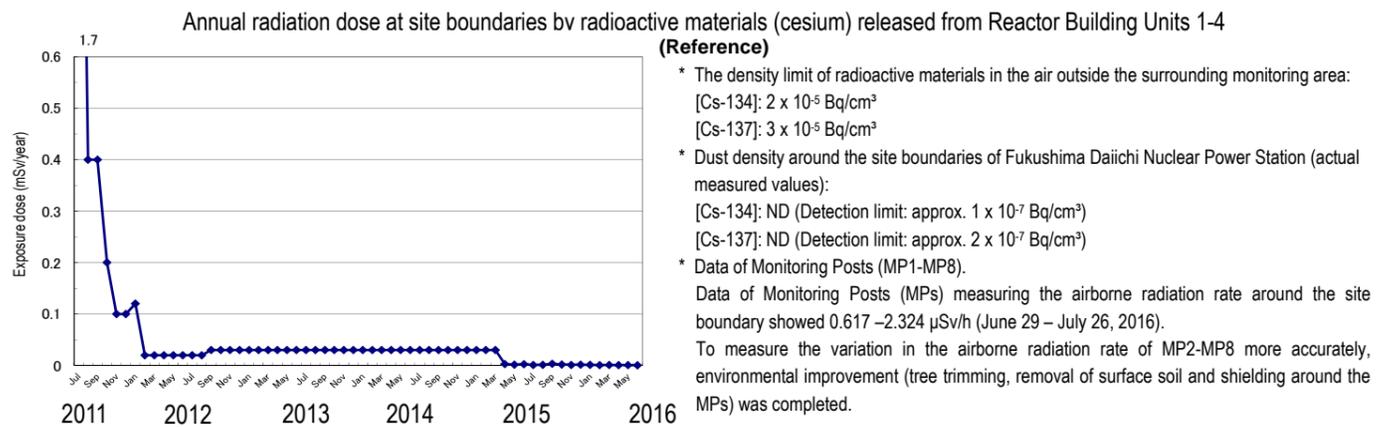
2. Release of radioactive materials from the Reactor Buildings

As of June 2016, the density of radioactive materials newly released from Reactor Building Units 1-4 in the air and measured at the site boundary was evaluated at approx. 4.1×10^{-12} Bq/cm³ for Cs-134 and 9.6×10^{-12} Bq/cm³ for Cs-137 respectively. The radiation exposure dose due to the release of radioactive materials was less than 0.00029 mSv/year at the boundary.

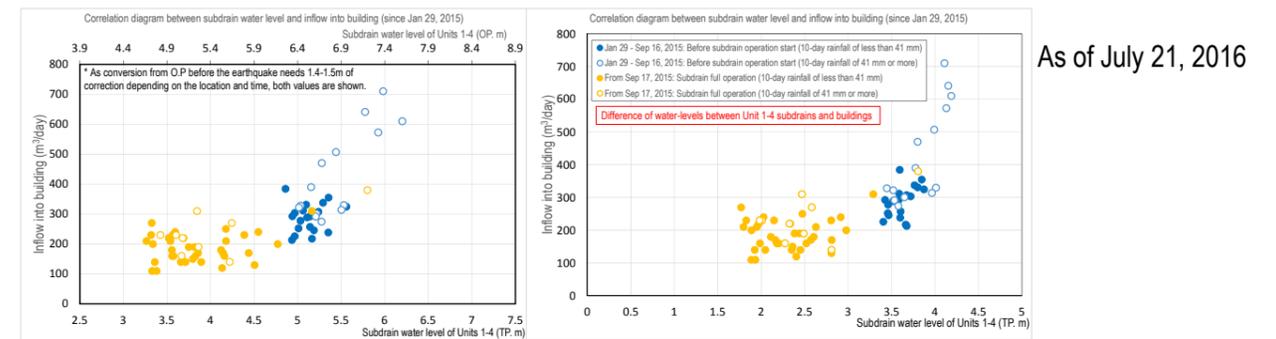
Figure 1: Evaluation of inflow into buildings after the subdrains went into operation

- However, given insufficient data on the effect of rainfall after the subdrains went into operation, the effect of the inflow into buildings will be reviewed as necessary by accumulating data.

- Inflow into buildings declined to approx. 150 - 200 m³/day when the subdrain water level decreased to approx. T.P. 3.5 m or when the difference in the water levels with buildings decreased to approx. 2 m after the subdrains went into operation.

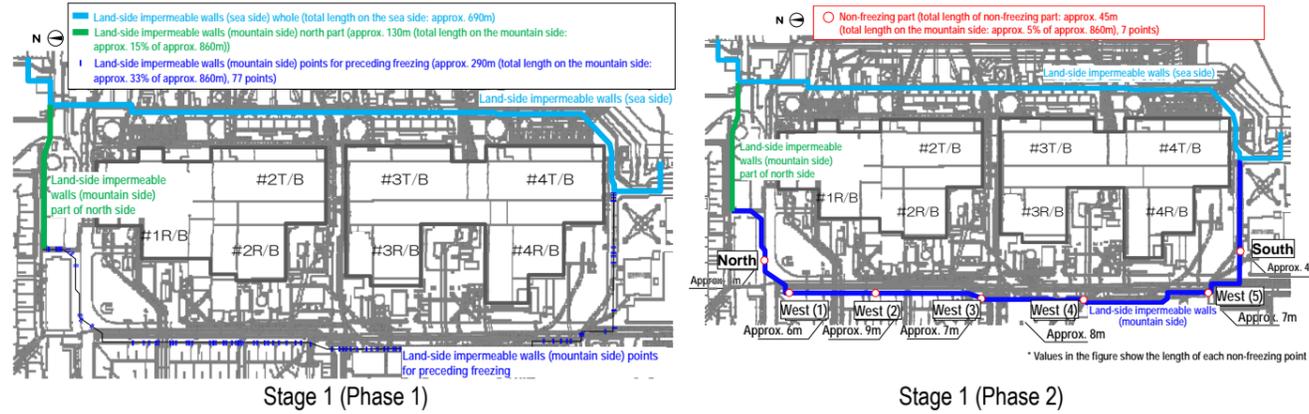
Figure 2: Scope of freezing of land-side impermeable walls

- During Phase 1, the status is being confirmed from the following perspectives: the difference in groundwater levels between the inside and outside and the decrease in groundwater inflow into the area of 4m above sea level of the land-side impermeable walls (on the sea side); difference in groundwater levels between the inside and outside of the land-side impermeable walls (on the mountain side); and the freezing status of the whole land-side impermeable walls.

- ✓ Stage 1: (Phase 1: freezing started on March 31) "Whole sea side," "part of the north side" and "preceding frozen parts of the mountain side (parts with difficulty in freezing due to significant intervals between frozen pipes, etc.)" will be frozen simultaneously.
(Phase 2: freezing started on June 6) The remaining parts on the mountain side will be frozen except the "unfrozen parts" of Stage 1 when the effect of the sea-side impermeable walls begins to emerge.
- ✓ Stage 2: Between Stages 1 and 3.
- ✓ Stage 3: Complete closure.

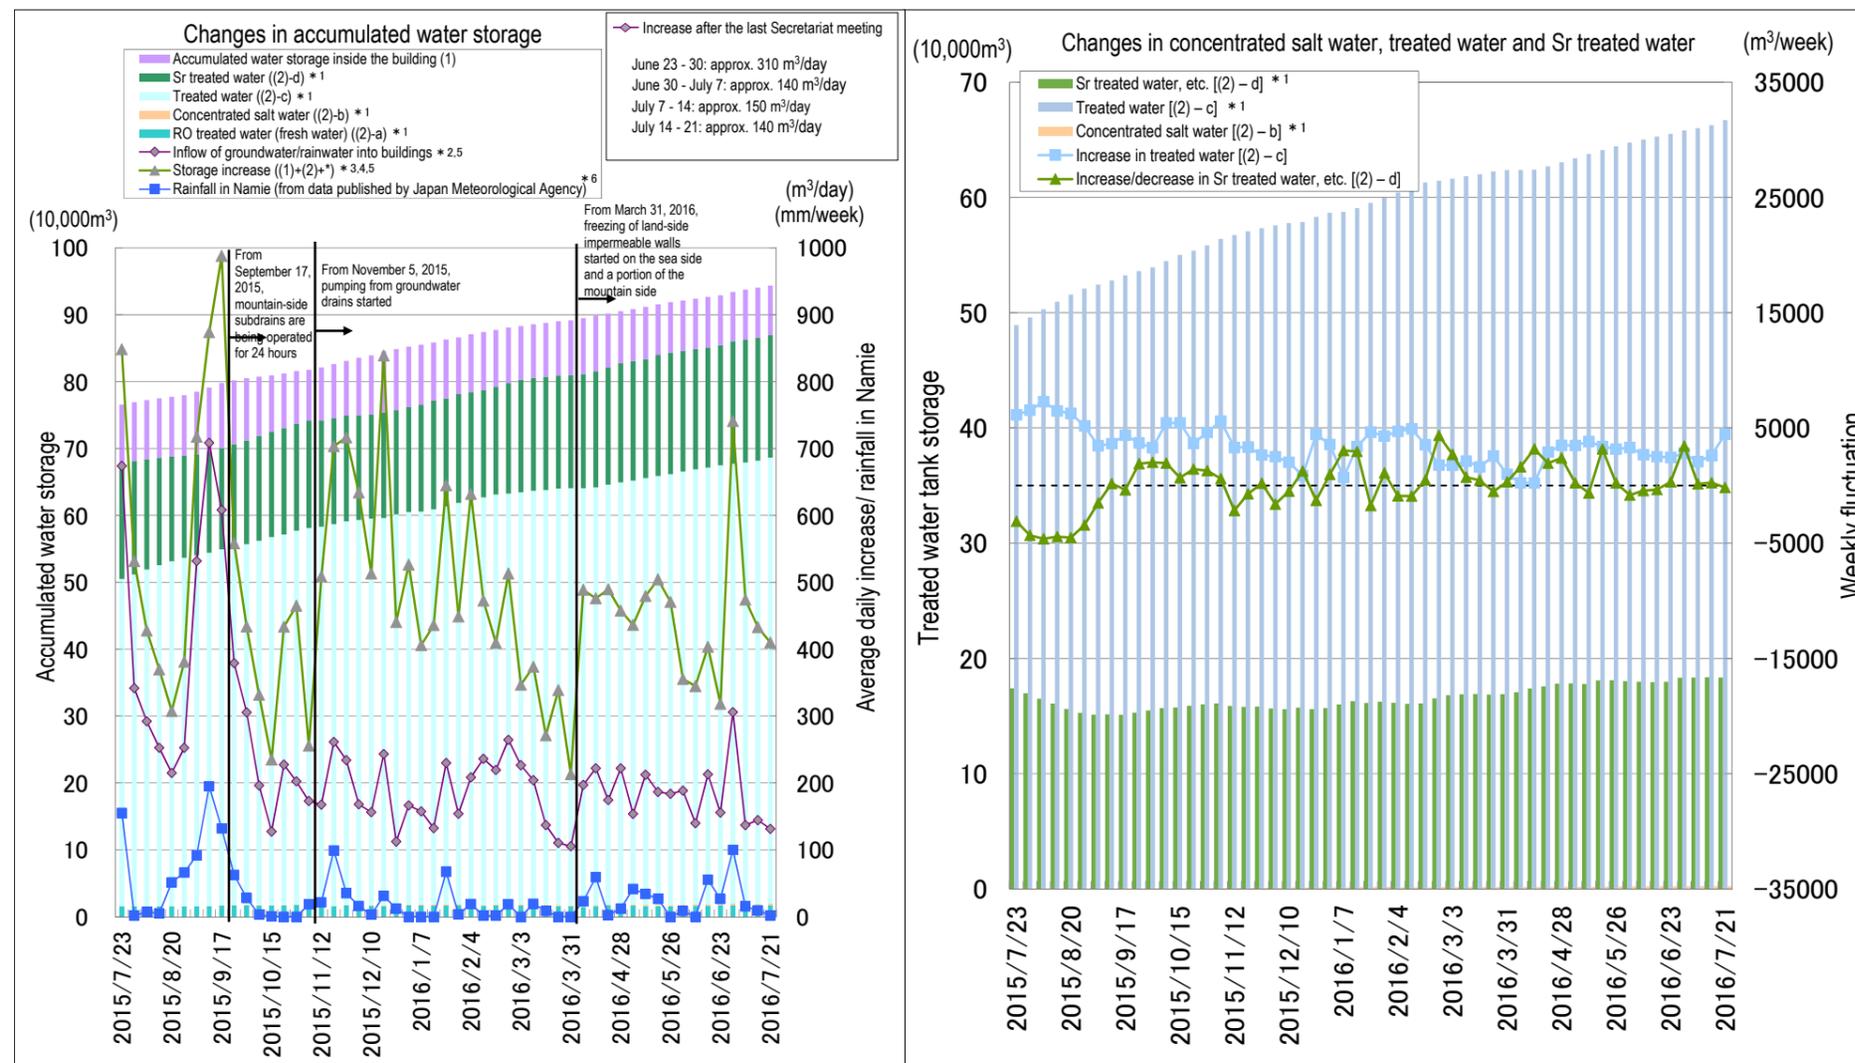
Figure 3: Status of accumulated water storage

As of July 21, 2016

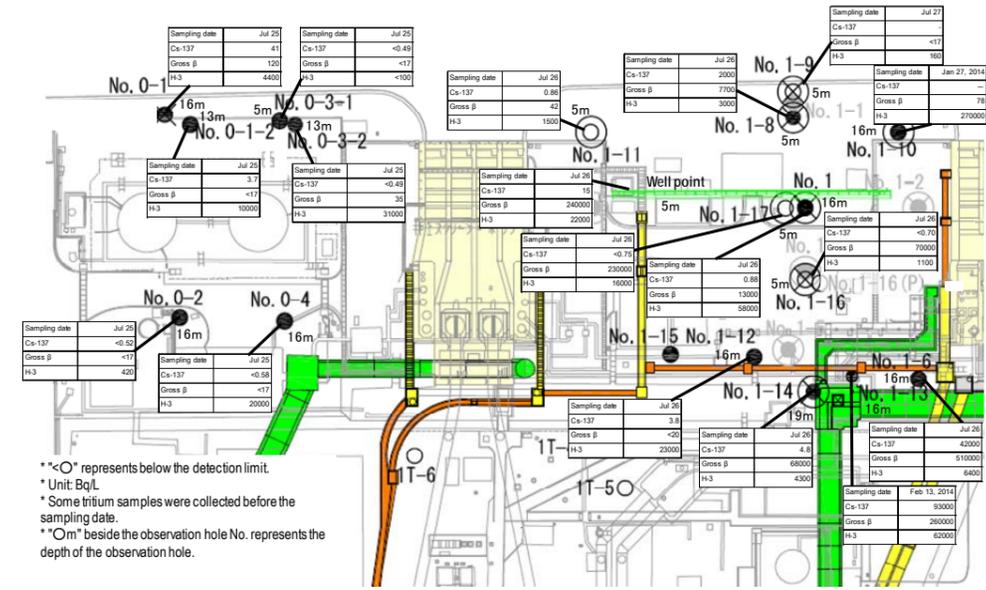
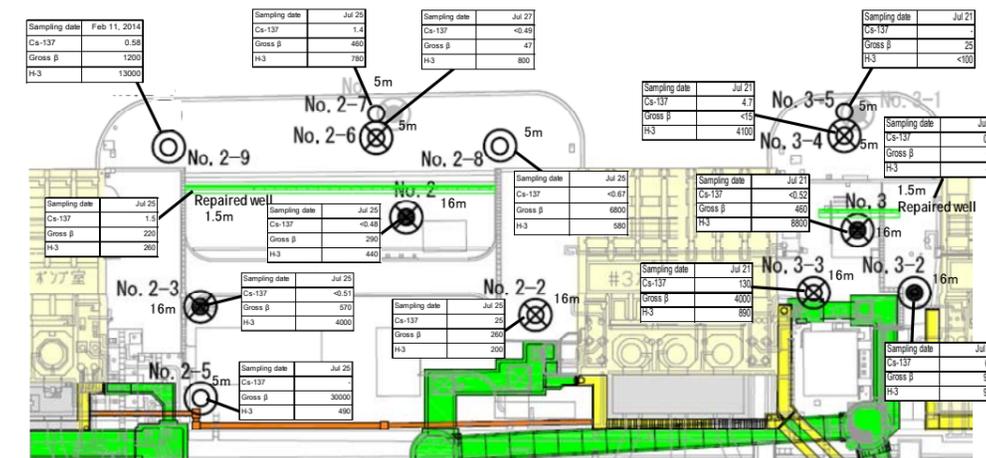
Figure 4: Groundwater density on the Turbine Building east side

<Unit 1 intake north side, between Unit 1 and 2 intakes>

<Between Unit 2 and 3 intakes, between Unit 3 and 4 intakes>

- Regarding radioactive materials in the groundwater near the bank between the Unit 2 and 3 intakes, though the density of gross β radioactive materials at groundwater Observation Hole No. 2-5 had remained constant at around 10,000 Bq/L, it had increased to 500,000 Bq/L since November 2015 and currently stands at around 30,000 Bq/L. Since December 18, 2013, pumping of groundwater continued (at the well point between the Unit 2 and 3 intakes: December 18, 2013 - October 13, 2015; at the repaired well: from October 14, 2015).

- Regarding radioactive materials in the groundwater near the bank between the Unit 3 and 4 intakes, the density has remained within the same range recently recorded. Since April 1, 2015, pumping of groundwater continued (at the well point between the Unit 3 and 4 intakes: April 1 – September 16, 2015; at the repaired well: from September 17, 2015).

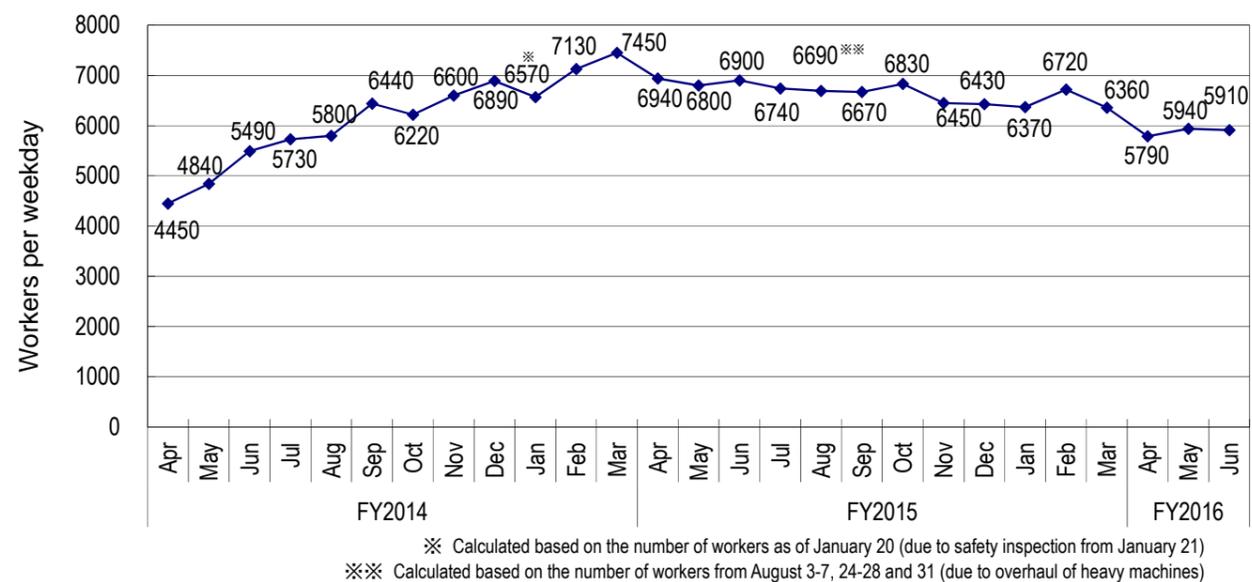
Figure 6: Changes in the average number of workers per weekday for each month since FY2013

- It was confirmed with the prime contractors that the estimated manpower necessary for the work in August 2016 (approx. 5,910 per day: TEPCO and partner company workers)* would be secured at present. The average numbers of workers per day for each month (actual values) were maintained, with approx. 4,500 to 7,500 since FY2014 (see Figure 6).

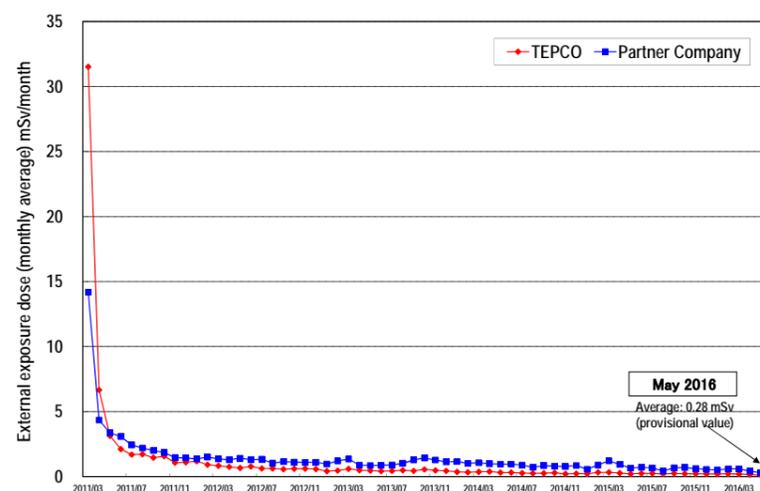
Figure 7: Changes in monthly individual worker exposure dose (monthly average exposure dose since March 2011)

- The monthly average exposure dose of workers remained at approx. 1 mSv/month during FY2013, FY2014 and FY2015. (Reference: Annual average exposure dose 20 mSv/year \div 12 months = 1.7 mSv/month)

- For most workers, the exposure dose was sufficiently within the limit and allowed them to continue engaging in radiation work.

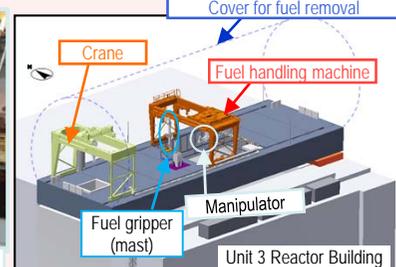
Image of entire fuel handling facility inside the cover

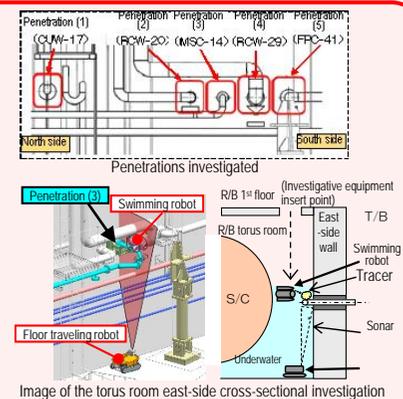
Investigative results on torus room walls

- The torus room walls were investigated (on the north side of the east-side walls) using equipment specially developed for that purpose (a swimming robot and a floor traveling robot).
- At the east-side wall pipe penetrations (five points), "the status" and "existence of flow" were checked.
- A demonstration using the above two types of underwater wall investigative equipment showed how the equipment could check the status of penetration.
- Regarding Penetrations 1 - 5, the results of checking the sprayed tracer (*) by camera showed no flow around the penetrations. (Investigation by the swimming robot)
- Regarding Penetration 3, a sonar check showed no flow around the penetrations. (Investigation by the floor traveling robot)

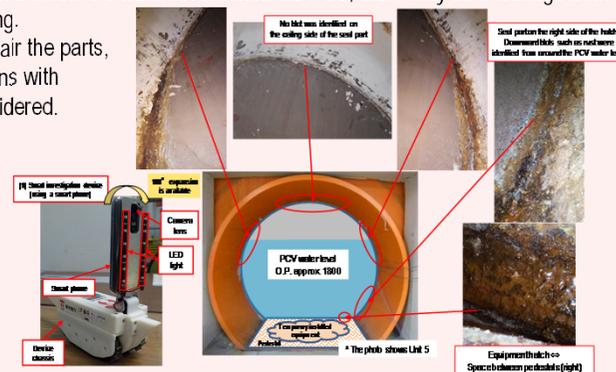
As part of the investigation into the PCV to facilitate fuel debris removal, the status around the Unit 3 PCV equipment hatch was investigated using a small self-traveling investigation device on November 26, 2015.

Given blots such as rust identified below the water level inside the PCV, there may be a leakage from the seal to the extent of bleeding. Methods to investigate and repair the parts, including other PCV penetrations with a similar structure, will be considered.

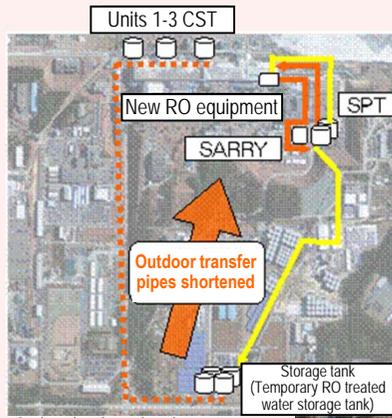
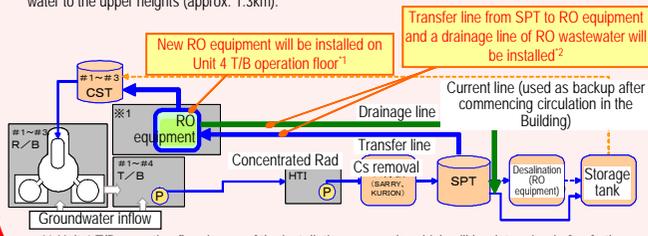
Work to improve the reliability of the circulation water injection cooling system and pipes to transfer accumulated water.

- Operation of the reactor water injection system using Unit 3 CST as a water source commenced (from July 5, 2013). Compared to the previous systems, in addition to the shortened outdoor line, the reliability of the reactor water injection system was enhanced, e.g. by increasing the amount of water-source storage and enhancing durability.
- By newly installing RO equipment inside the Reactor Building, the reactor water injection loop (circulation loop) will be shortened from approx. 3km to approx. 0.8km*.
- * The entire length of contaminated water transfer pipes is approx. 2.1km, including the transfer line of surplus water to the upper heights (approx. 1.3km).

*1 Unit 4 T/B operation floor is one of the installation proposals, which will be determined after further examination based on the work environment
 *2 A detailed line configuration will be determined after further examination

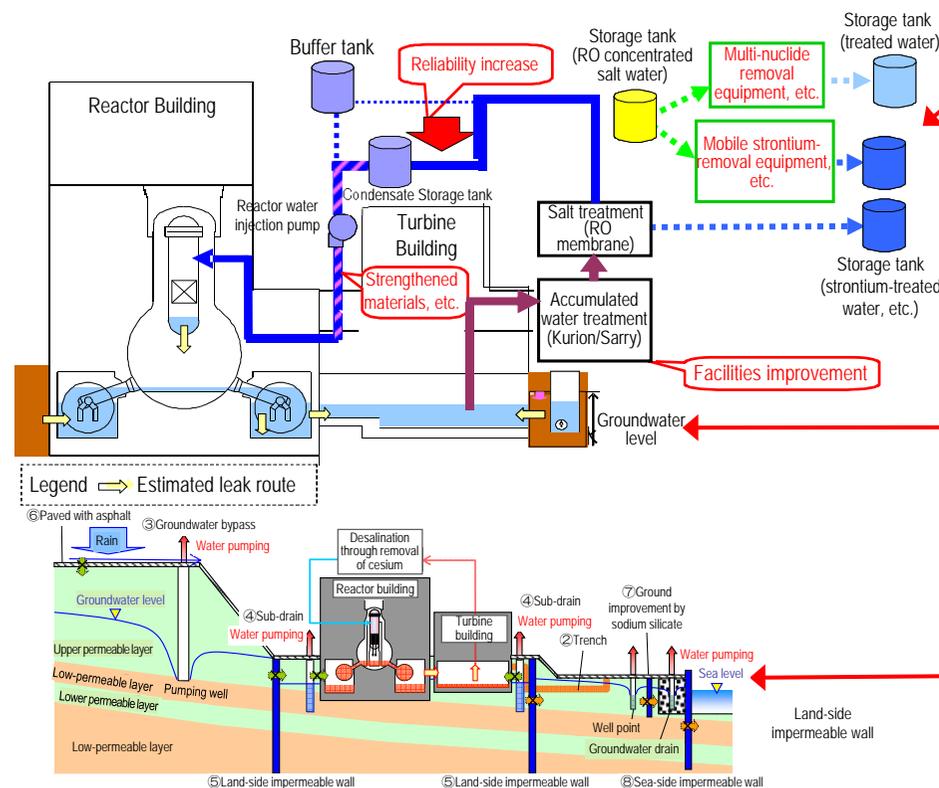
Contaminated water (RO concentrated salt water) is being treated using seven types of equipment including the multi-nuclide removal equipment (ALPS). Treatment of the RO concentrated salt water was completed on May 27, 2015, with the exception of the remaining water at the tank bottom. The remaining water will be treated sequentially toward dismantling the tanks.

The strontium-treated water from other facilities than the multi-nuclide removal equipment will be re-purified in the multi-nuclide removal equipment to further reduce risks.

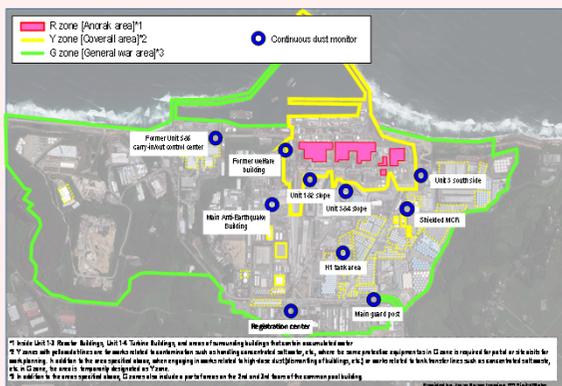
Based on the progress of measures to reduce environmental dosage on site, the site is categorized into two zones: highly contaminated area around Unit 1-4 buildings, etc. and other areas to optimize protective equipment according to each category aiming at improving safety and productivity by reducing load during work.

From March 8, 2016, limited operation started in consideration of workers' load.

R zone (Anorak area)	Y zone (Coverall area)	G zone (General wear)
Full-face mask 	Full-face or half-face masks *1, *2 	Disposable disposable mask
Anorak on coverall Or double coveralls 	Coverall 	General*3 Dedicated on-site wear

*1 For works in buildings including water treatment facilities (multi-nuclide removal equipment, etc.) (excluding site visits), wear a full-face mask.
 *2 For works in tank areas containing concentrated salt water or Sr-treated water (excluding works not handling concentrated salt water, etc.), patrol, on-site investigation for work planning, and site visits) and works related to tank transfer lines, wear a full-face mask.
 *3 Specified light works (patrol, monitoring, delivery of goods brought from outside, etc.)
