Main decommissioning works and steps

All fuel has been removed from Unit 4 SFP and preparatory work to fuel removal from Unit 1-3 SFP and fuel debris (Note 1) retrieval is ongoing.

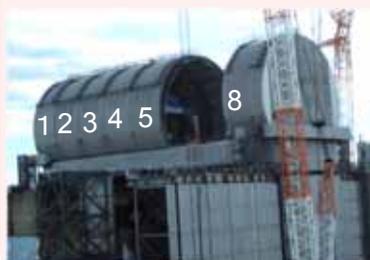
Installation of dome roof (December 19)

Prior to the installation of a cover for fuel removal, removal of large rubble from the spent fuel pool was completed in November 2015. To ensure safe and steady fuel removal, training of remote control was conducted at the factory using the actual fuel-handling machine which will be installed on site (February – December 2015). Measures to reduce dose on the Reactor Building top floor (decontamination, shields) were completed in December 2016. Installation of a cover for fuel removal and a fuel-handling machine is underway from January 2017.

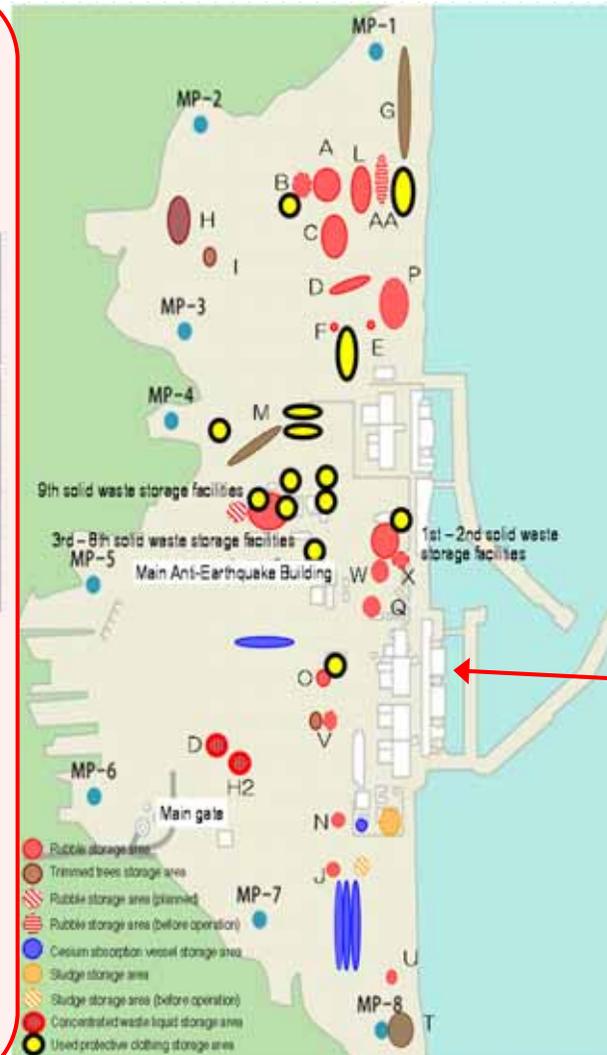
Installation of dose-rate monitors

To help workers in the Fukushima Daiichi Nuclear Power Station precisely understand the conditions of their workplaces, a total of 86 dose-rate monitors were installed by January 4, 2016.
