Status of Preparations for the Unit 2 Primary Containment Vessel Internal Investigation

December 27, 2018

Tokyo Electric Power Company Holdings, Inc.

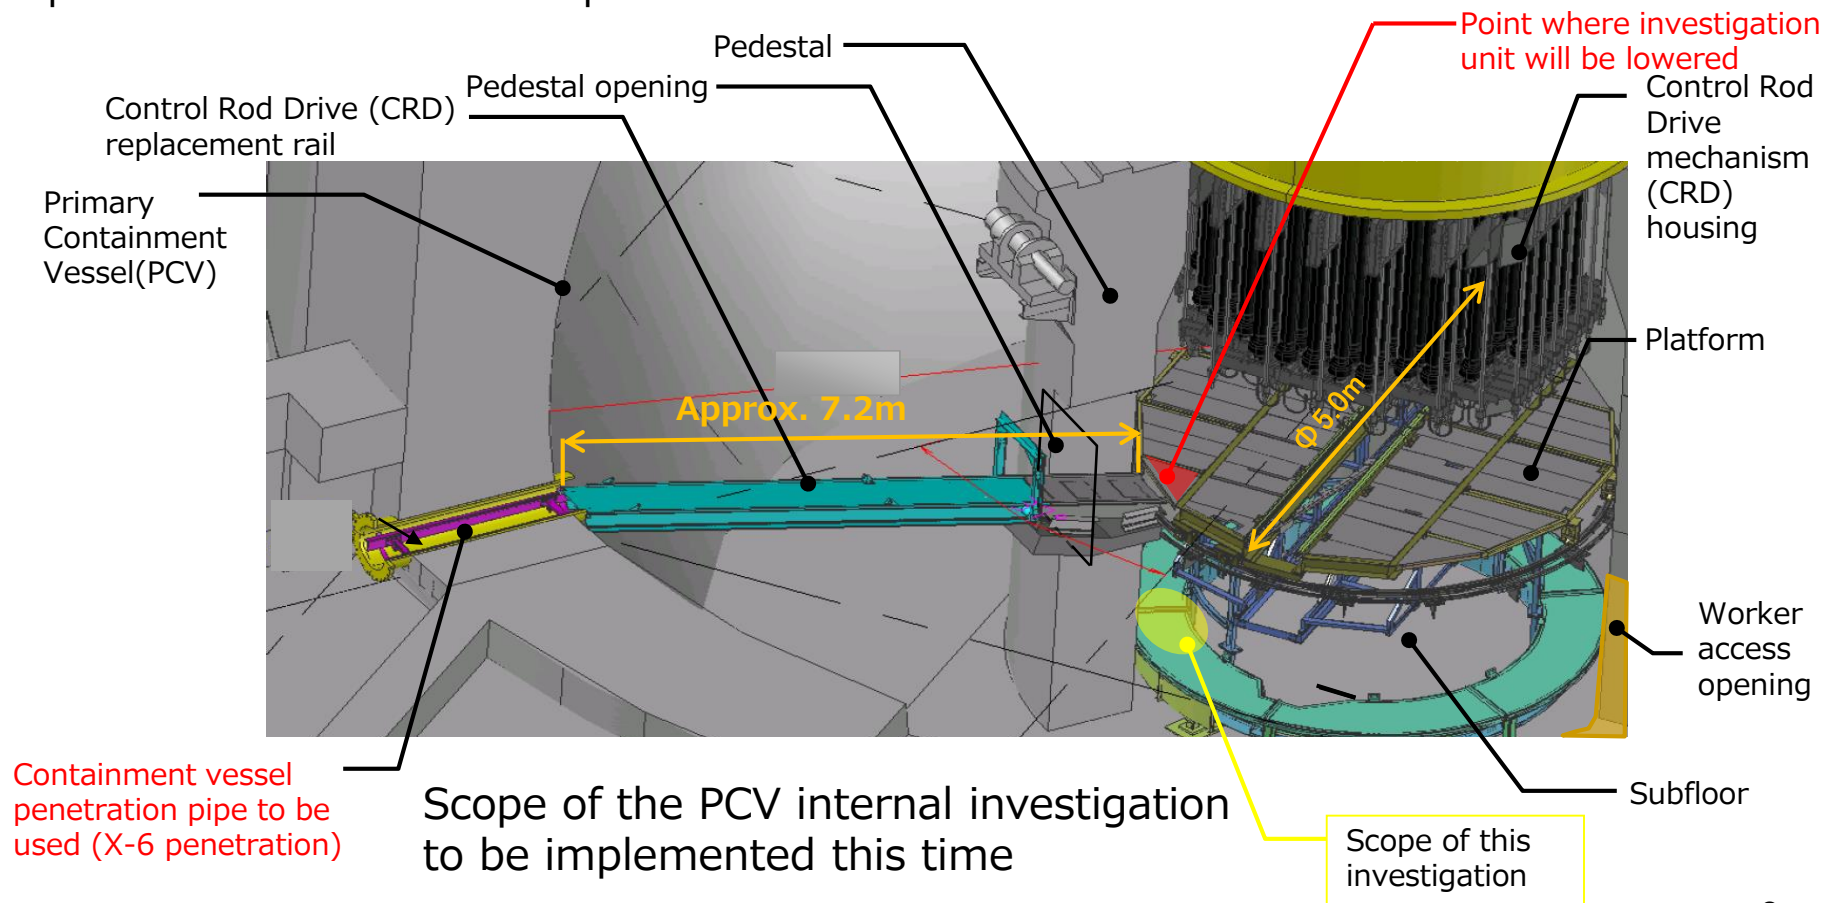
2 Overview of the PCV Internal Investigation to be implemented **TEPCO**

- Since the nature (hardness, frailty, etc.) of the deposits observed at the bottom of the Unit 2 pedestal is unknown, it is important to ascertain in advance whether or not these deposits can be removed by grasping them.
- During this investigation the investigation unit will be lowered from the same location it was lowered to the bottom of the pedestal during the January 2018 investigation to touch the deposits at the bottom of the pedestal and observe its behavior.

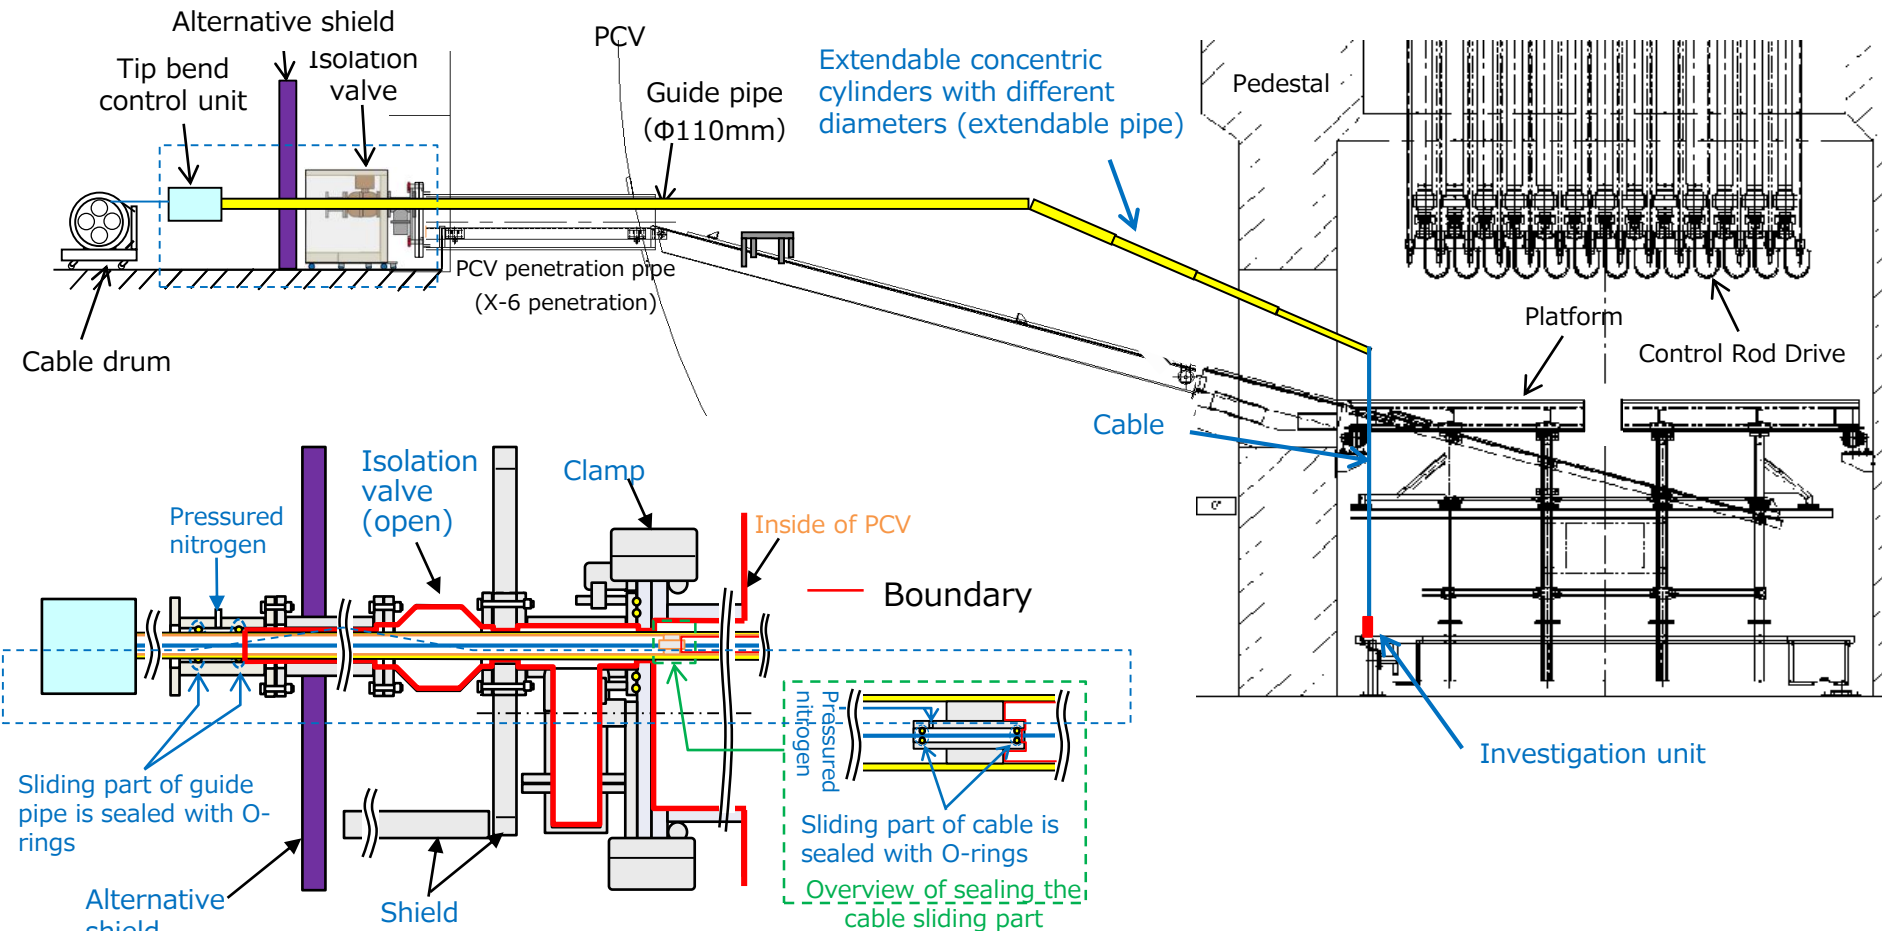
3 Investigation method (2/2)

- As with the PCV internal investigation conducted in January~February, 2017, a boundary will be formed as shown below by sealing the sliding part of the guide pipe with double O-rings and pressurizing the pipe with nitrogen to prevent gas inside PCV from leaking outside and affecting the surrounding environment during the investigation. A similar boundary will be formed for the sliding part of the cable as well.

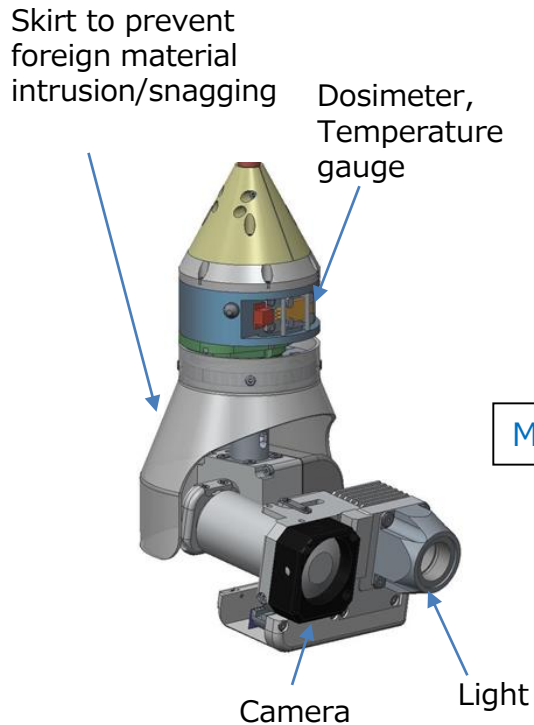
Investigation unit used in January, 2018

- The cameras and lights on the end of the investigation unit have been modified, and the unit has been equipped with a finger-like mechanism.
- After the finger mechanism is allowed to come in contact with the deposits, the fingers will be actuated to subject the deposits to mechanical force and observe the behavior of the deposits.

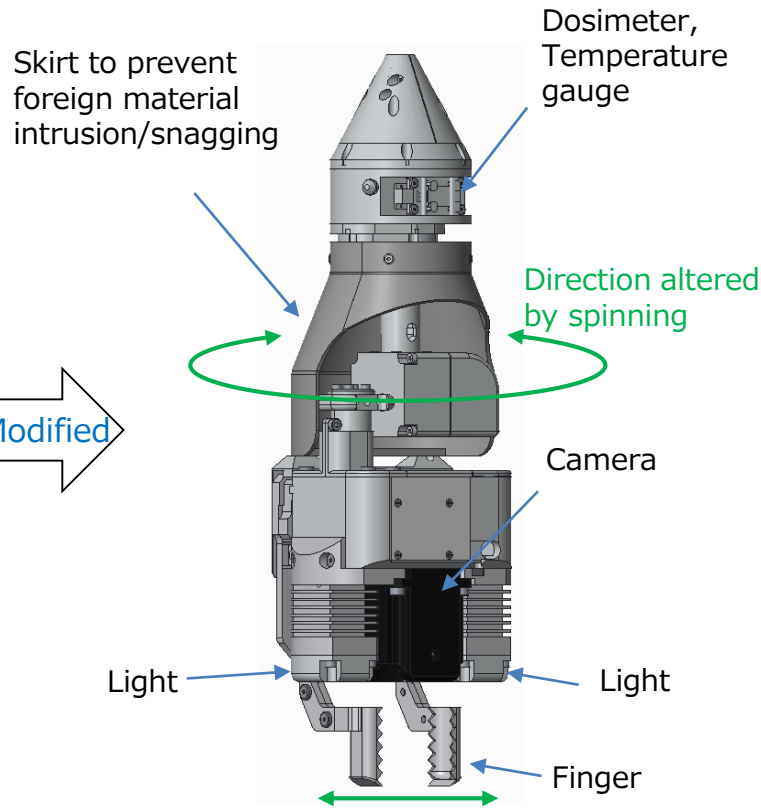
Opens/closes after coming in contact with deposits
Investigation unit to be used this time

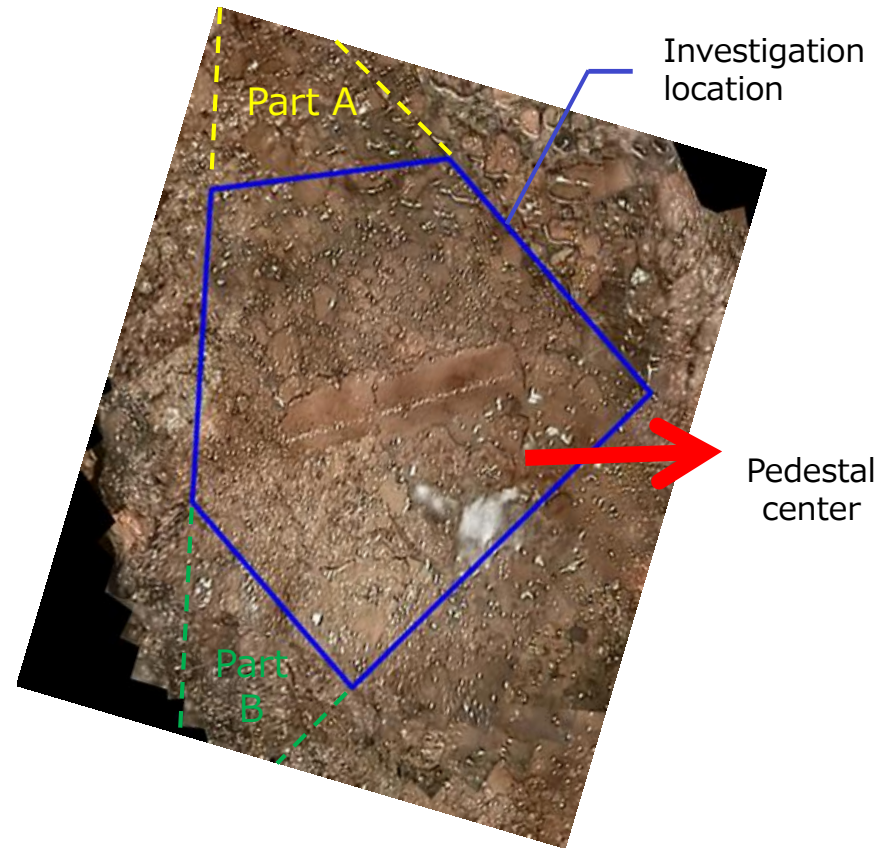
Scope of access at the bottom of the pedestal during this investigation
(reflected in the video shot in January, 2018)

- Area A : Inaccessible because the extendable pipe touches the pedestal wall
- Area B : Inaccessible due to the shape of the opening left by the fallen grating

Positional relationship of CRD rail and fallen grating

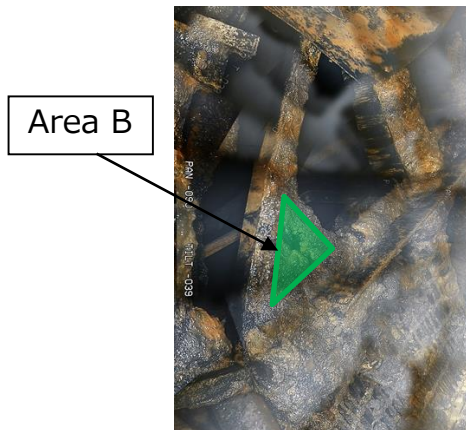
Result of investigation in area B
(taken in January, 2017)
